## **VISUAL TREE INSPECTION AND DECAY DETECTION AT WESTBOURNE HOUSE BASINGSTOKE ROAD**

**Prepared on instructions from:  
Beechwood Tree Care Limited  
2 Playhatch Farm Cottages  
Playhatch  
RG4 9QX**

**7 September 2026**

**Ref: SPH/DD-VTA-26/17.08**

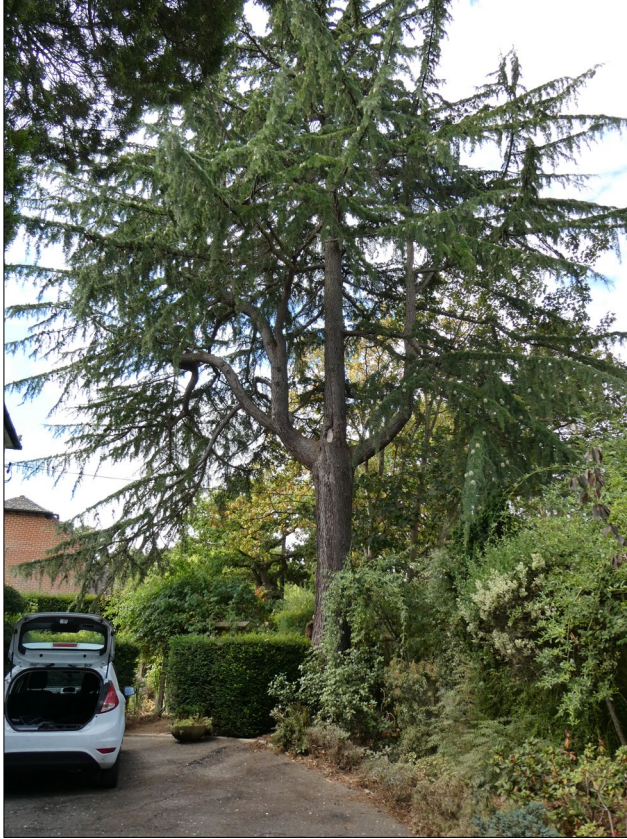
Figure 2. Cedar in front garden.

- 2.2.1 The tree is located within the front garden of Westbourne House, 6.6 metres from the front elevation, see Figure 2 on page 6. The site contains a detached two storey residential property with wrap around garden. The site is occupied and in constant use. The Basingstoke Road (B3349) is approximately 5 metres from the tree and is in frequent use. The tree is within falling distance of the property and highway.

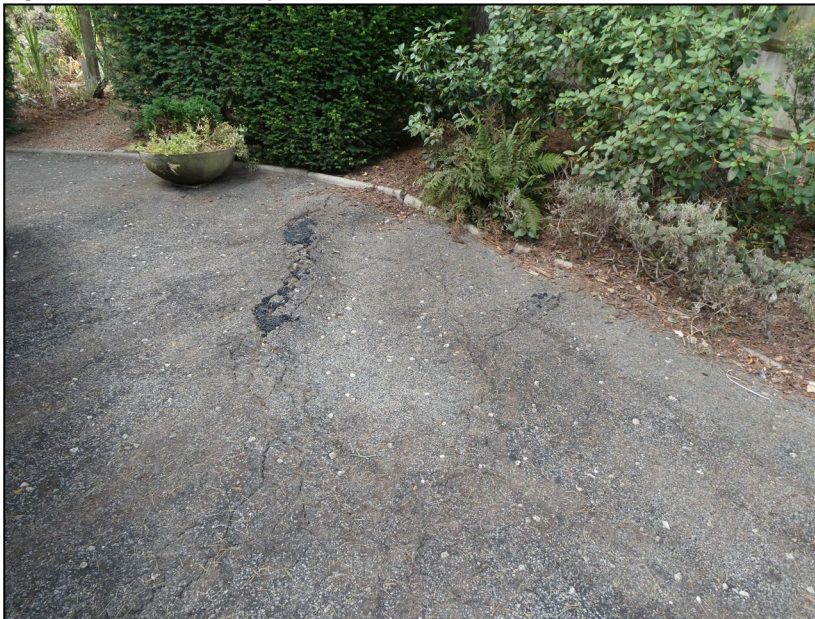
Figure 3. Root activity under tarmac.

- 4.1.2 Roots can create conflicts in urban areas, and such damage is visible in the adjacent tarmac. In the surveyor's opinion planting deodar cedar too close to residential properties eventually results in excess shading, branches encroaching the property, restricting light to windows and recreational spaces and ultimately pressure to prune or remove the tree. As cedar age they become difficult and costly to manage and do not respond well to repeated pruning. The trees' location to the north of the property will result in a loss of ambient light only.

- 4.1.4 The tree has potential for further growth and is considered to be within 1/3<sup>rd</sup> of the mature (final) dimensions. The damage observed to the tarmac will continue and therefore at some stage remedial works will be required to restore or replace it. Replacing it with a flexible porous surface will help to reduce the need for frequent maintenance.

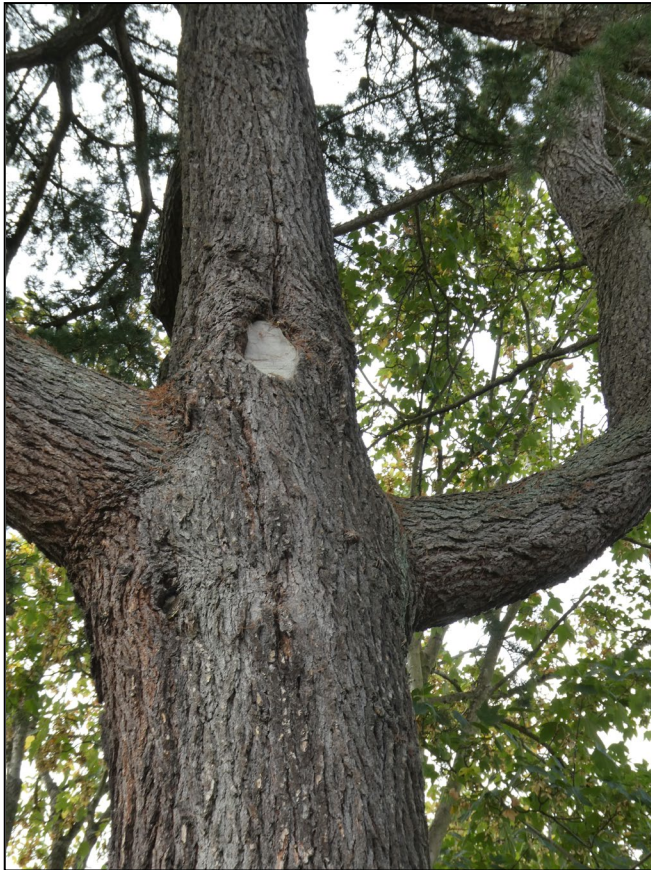
Figure 4. Wound and bark defect.

- 3.2.5 The main stem has a natural taper to the first branches. A small branch wound is visible at 5.2 metres AGL on the east side along with a vertical wound above and below the branch wound that has the appearance of a crack, see Figure 3 below. The main stem has a trident like appearance where the main stem subdivides with two co-dominant stems at 5.2 metres AGL, see Figure 4 below.

- 3.2.6 The branch wound and crack were examined from a scaffold tower using a stainless-steel probe and IML PD400 Resi drill. The branch wound is hard and is occluding with no evidence of decay see Figure 4 above. The bark crack was also examined, probed and drilled, it is shallow and has the appearance of a bark inclusion, see Figure 5 on page 8. The IML drilling (results included at Appendix 1), no evidence of decay was detected. A slight fall in amplitude was detected in drilling 7 that is associated with the bark inclusion.

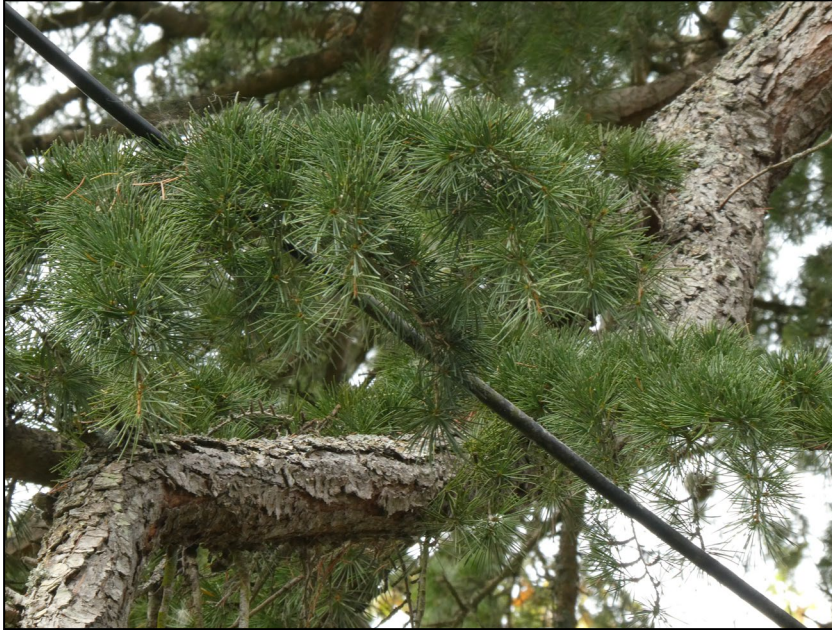
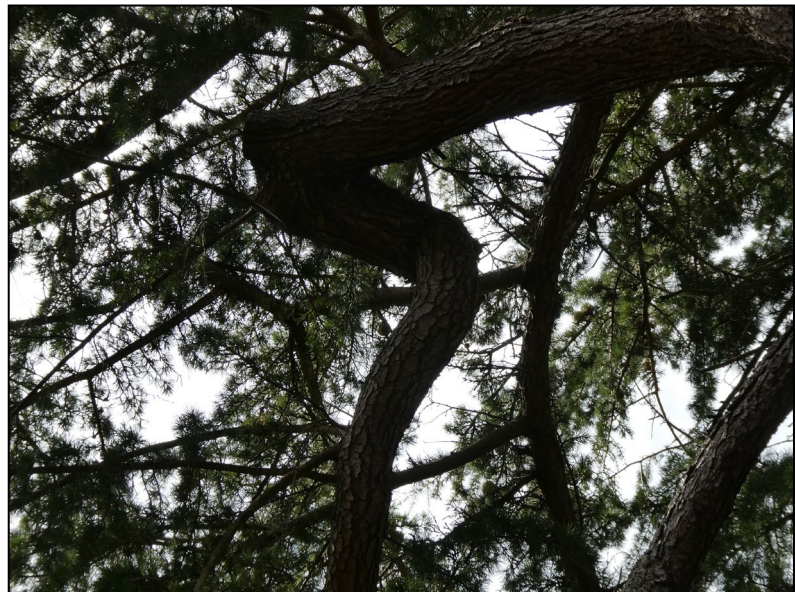
Figure 6. Utility lines and unusual branch union

- 3.2.7 There are several unusual lateral limb unions and utility lines passing through the canopy, see Figure 6 on page 9. The physiological attributes of trees provide a general indication of vitality and may include but are not limited to, needle colour and density, incremental growth and fruit (cone) production and when the crown was observed through binoculars the crown attributes were typical of the species with no major deadwood or physiological decline, see Figure 6 on page 9.

- 5.1.1 Any branches obstructing the utility wires must be pruned back to create a minimum 500-millimetre clearance, where the branch(es) are adjacent to overhead electric wires this may require a greater clearance and the utility supplier will set the specification. The work should be undertaken within 6 months of the date of this report.
- 5.1.2 The dog leg branch shown in Figure 6 should be removed to prevent premature failure. This work should be undertaken within 6 months of the date of this report.
- 5.1.3 It would be prudent to have the tree visually inspected by a qualified tree surgeon on an annual basis and in particular after any severe weather event.
- 5.1.4 The tree should be fully re-inspected in 3 years.

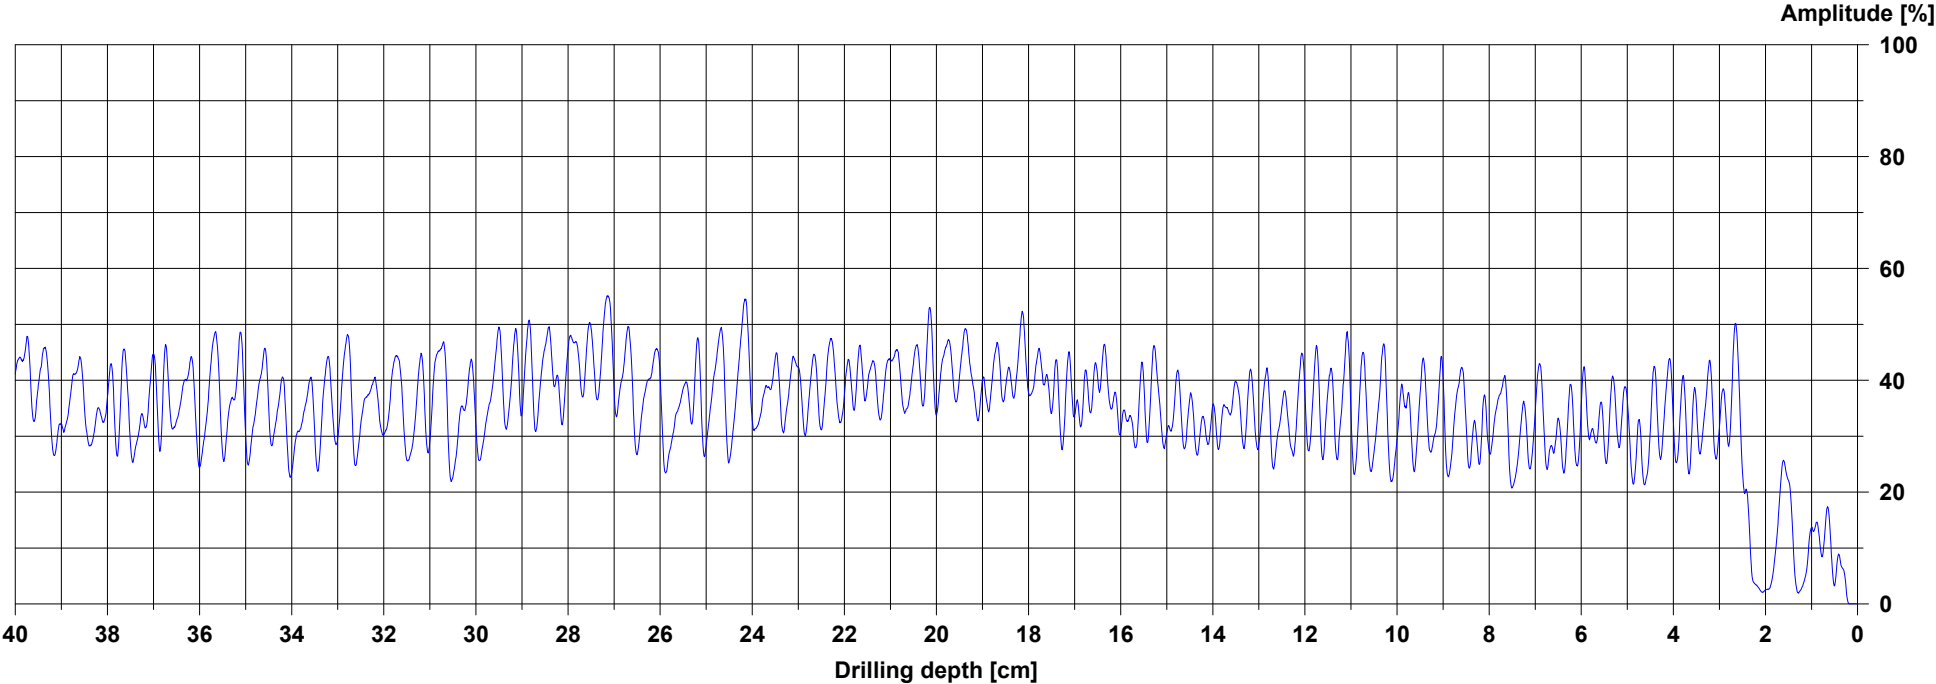
Control drilling at 1.5 metres AGL. No significant decay at the test location. Good annual increment definition.

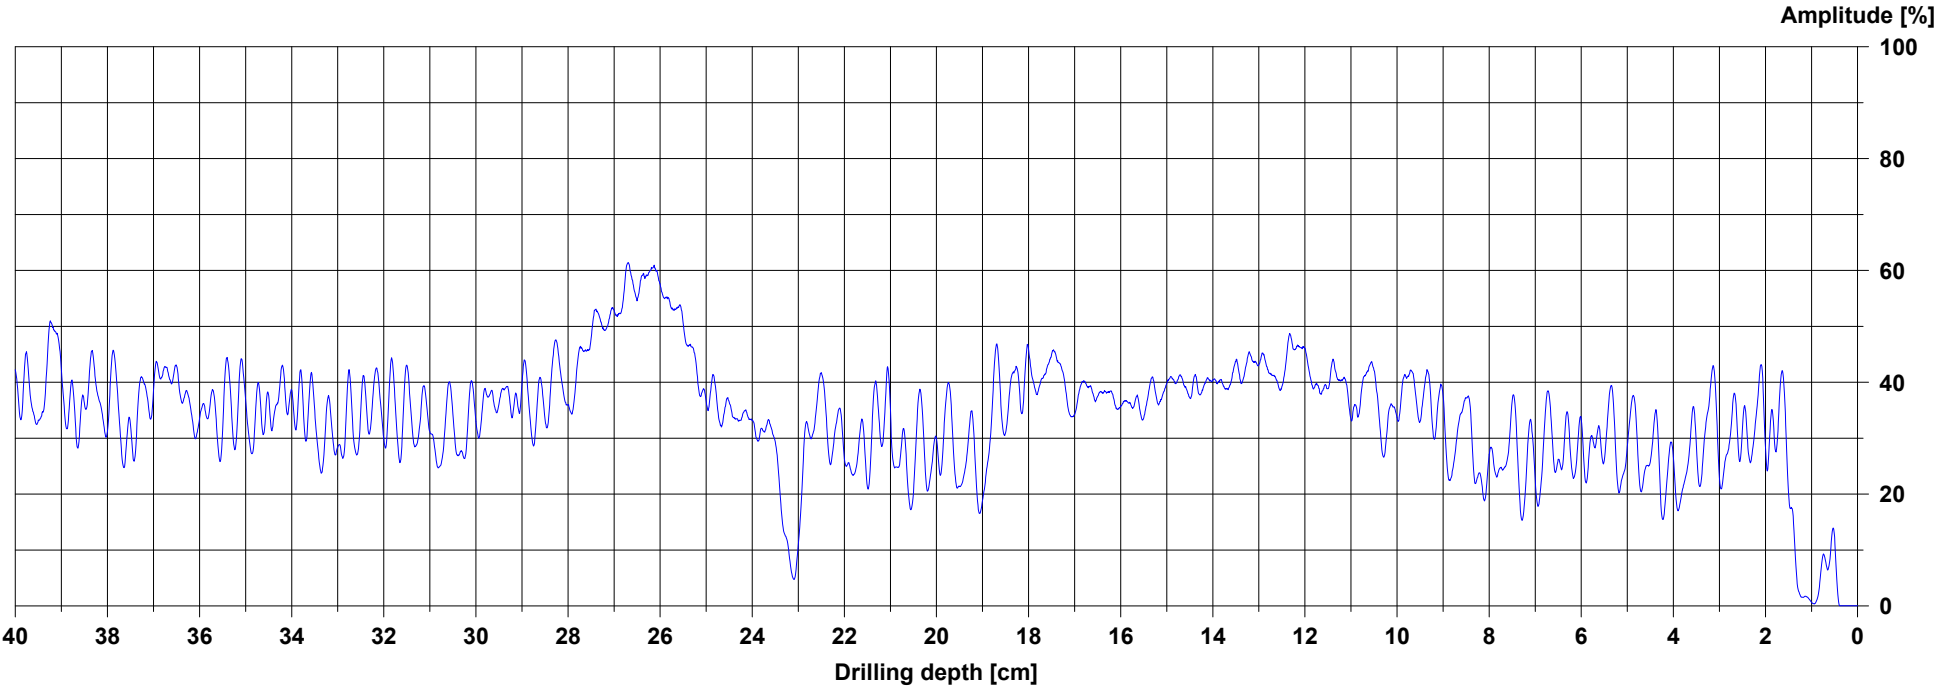
Test just above stem wound circa 5.4m no significant decay detected. Sudden fall at 23cm due to stem inclusion.

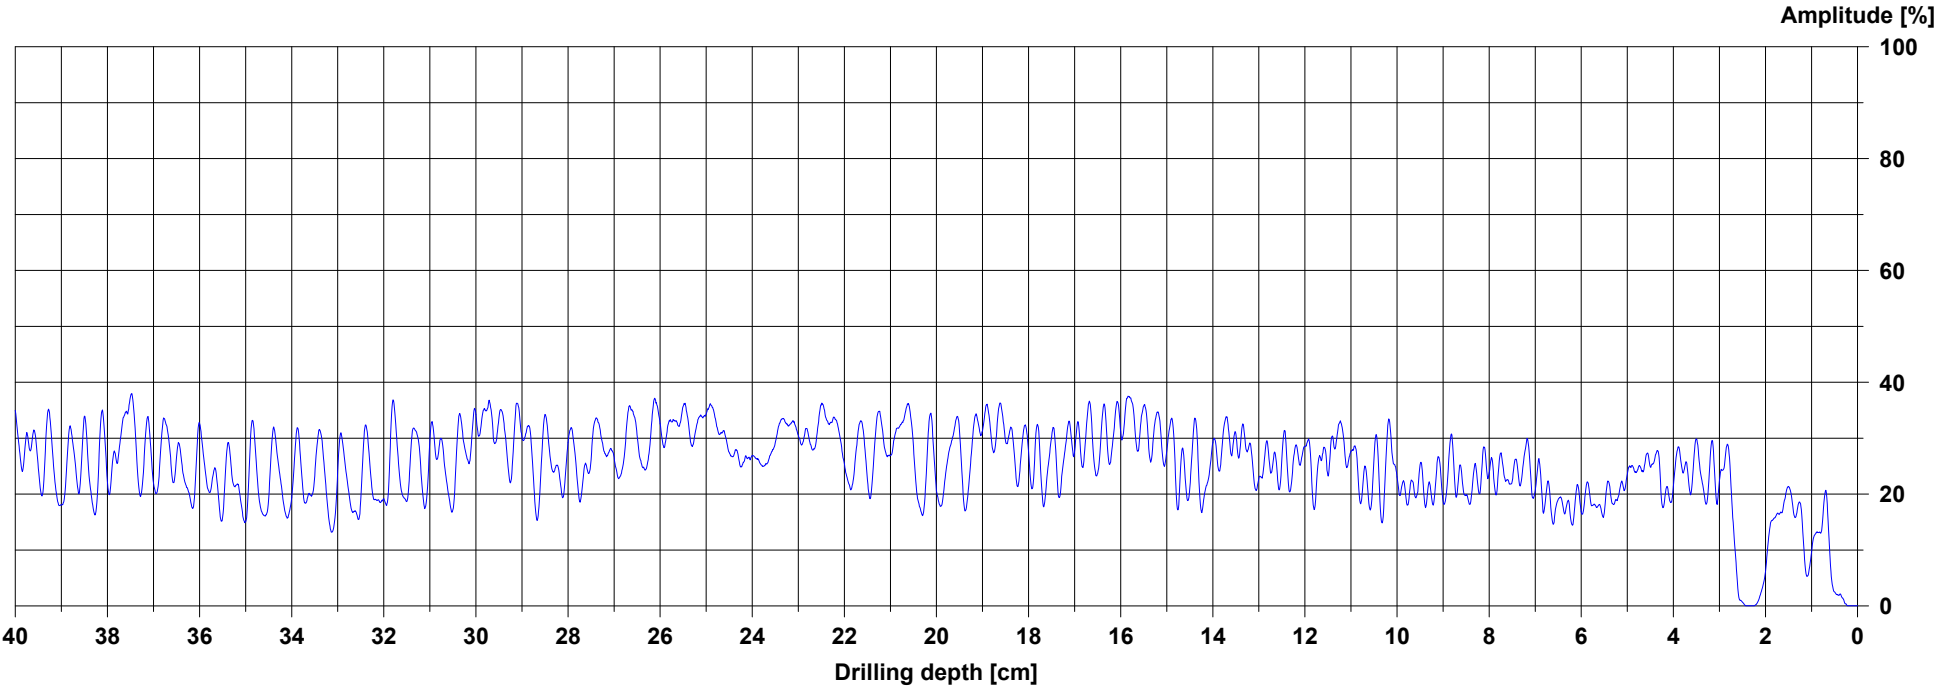
Test just below the stem wound at 5.2m. No significant decay at the test location.

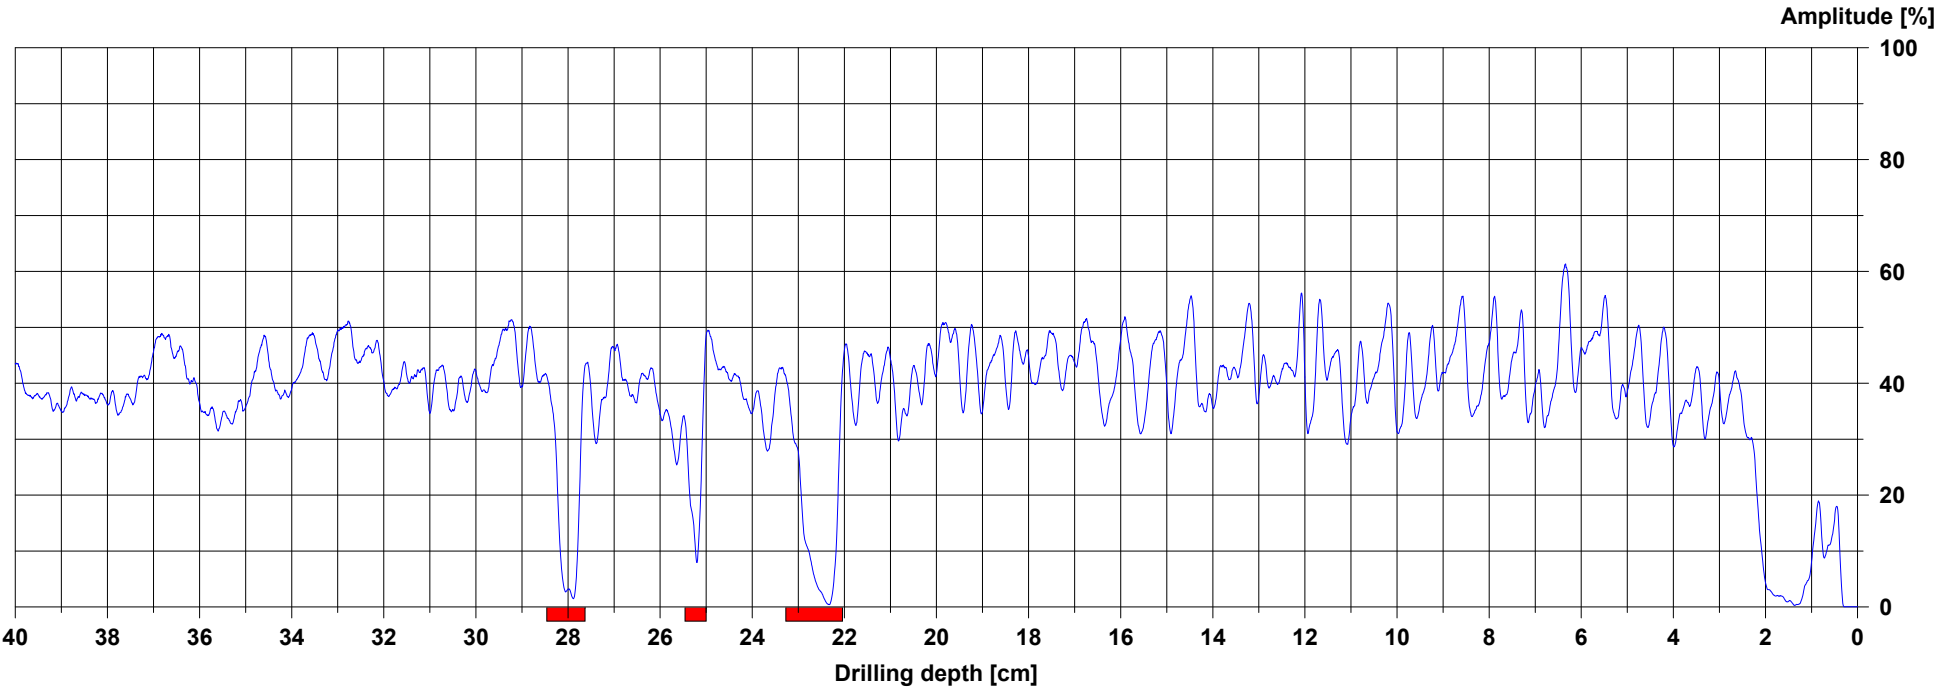
- From 22,04 cm to 23,27 cm : Decay
- From 25,00 cm to 25,46 cm : Decay
- From 27,63 cm to 28,46 cm : Decay

Three isolated areas of decay. East side close to ground level.

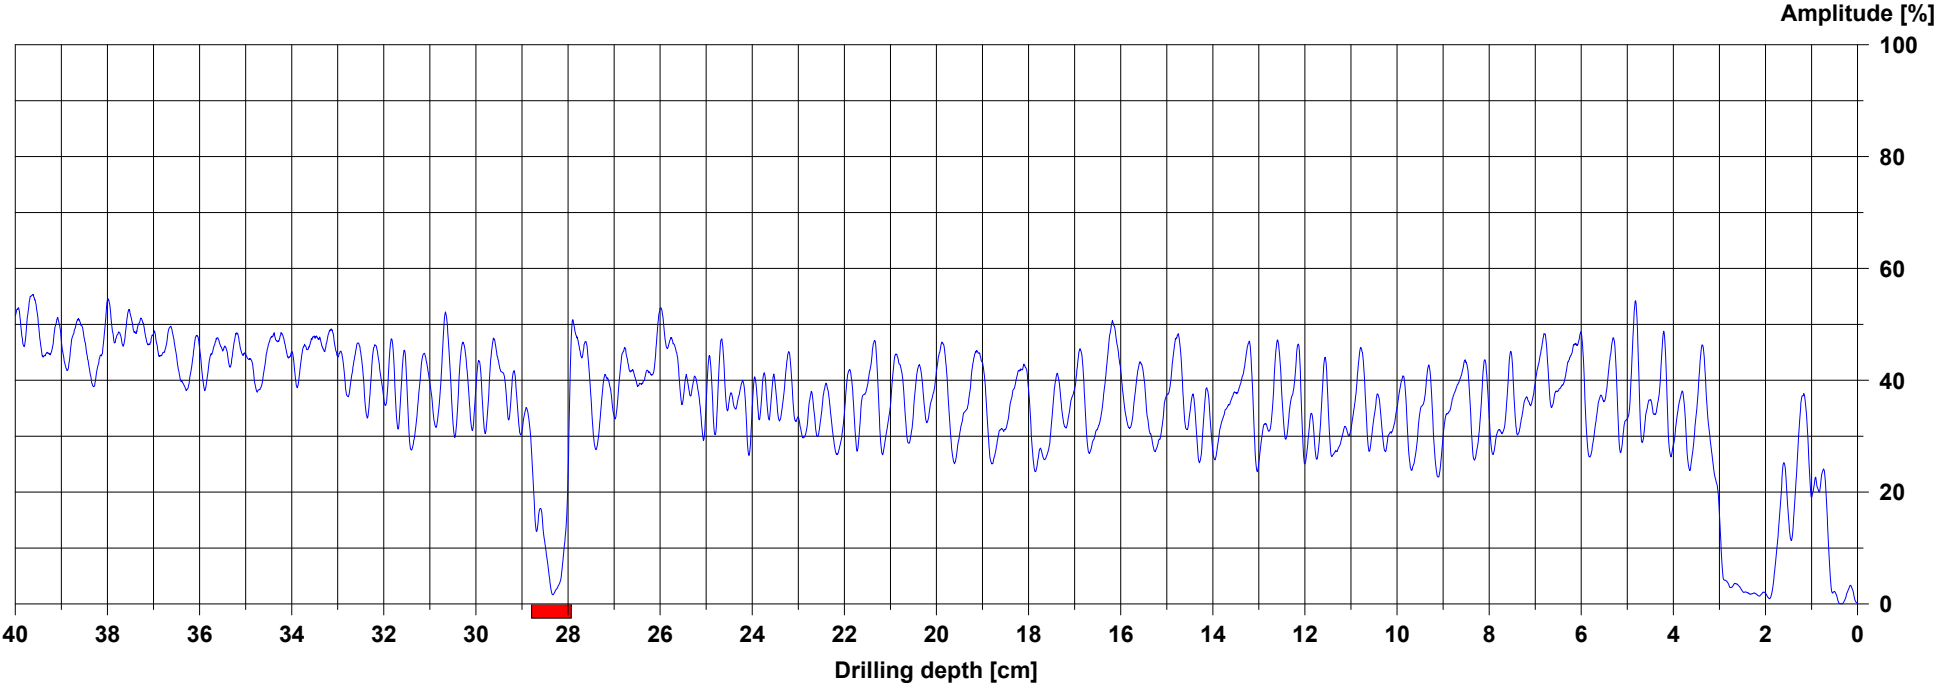
■ From 27,93 cm to 28,79 cm : Decay

Low density behind the bark due to vascular system. Isolated area of decay at 28cm north side close to ground level.

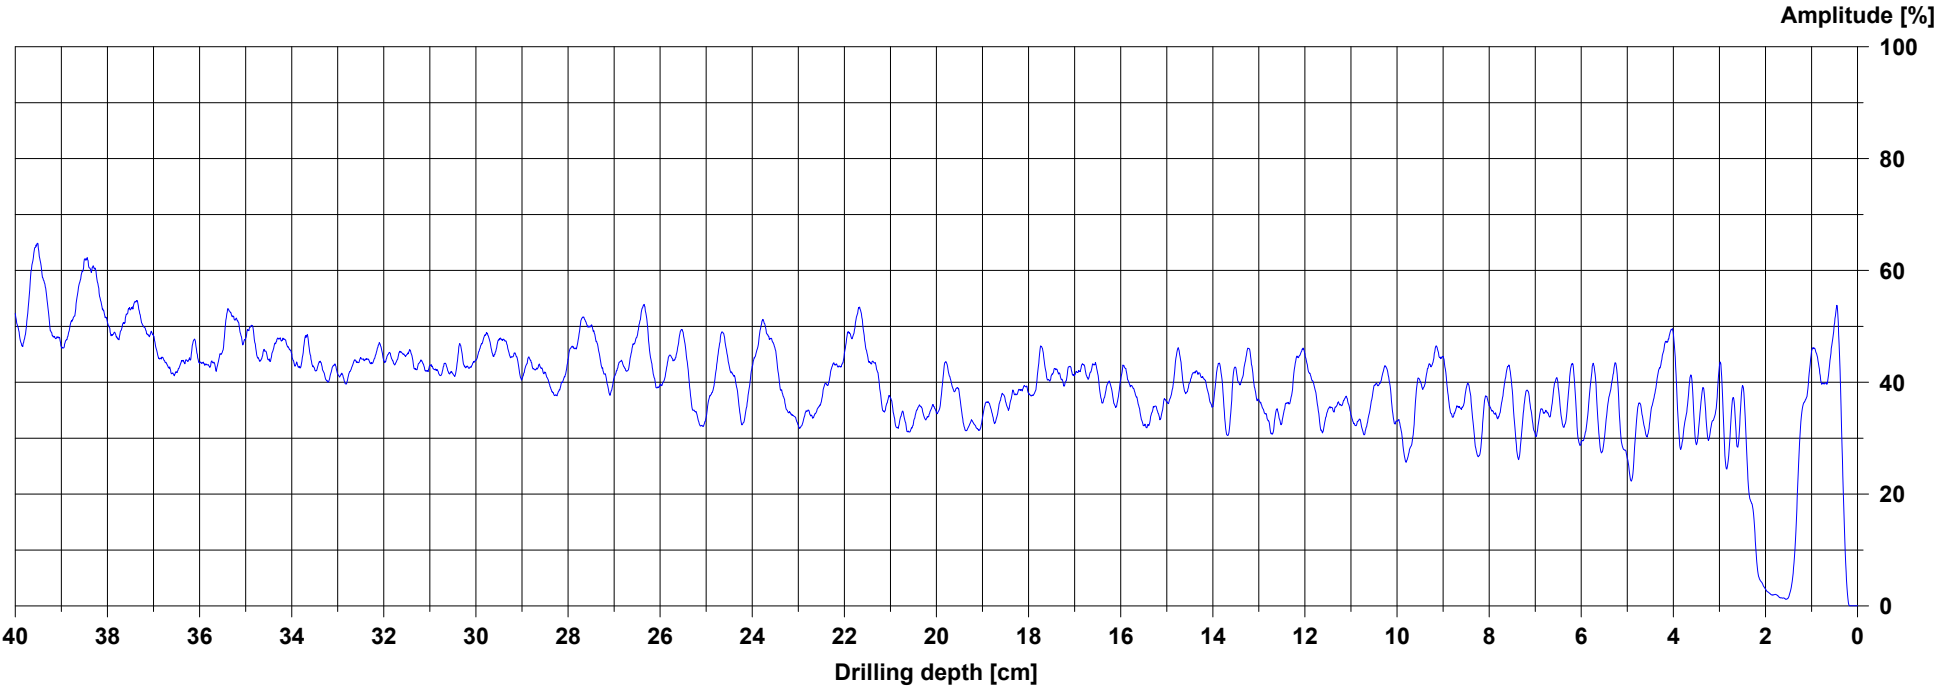
Low amplitude behind bark due to vascular system. No significant decay at the test location.

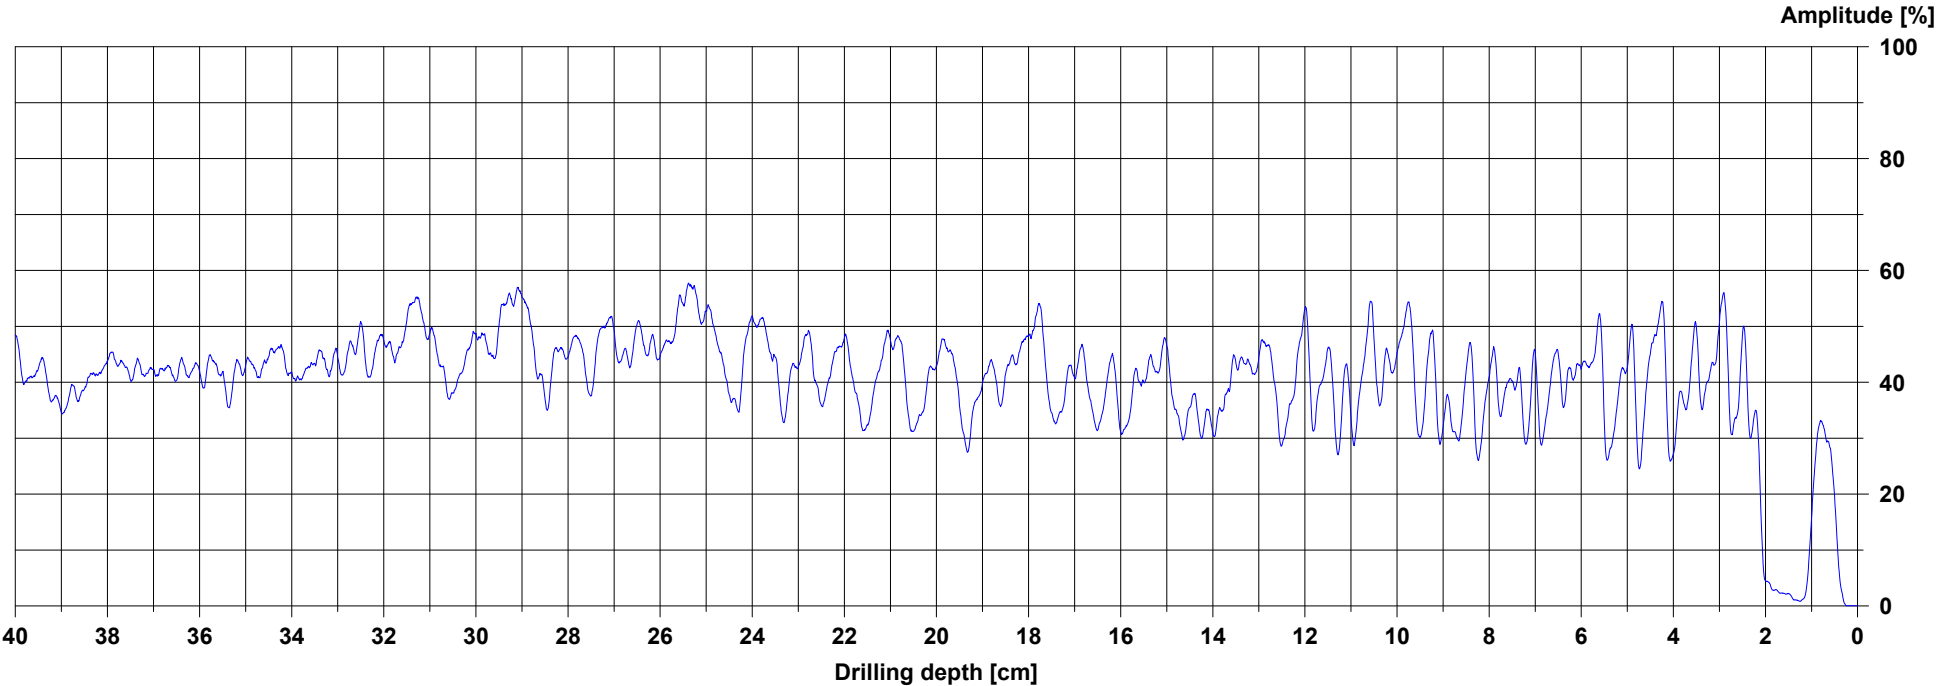
Low amplitude behind bark due to vascular system. Annual increment definition diminishes at 32cm. May be incipient decay or drill not running true.
