LAND EAST AND WEST OF HYDE END ROAD, SHINFIELD  
DESIGNER'S RESPONSE

BLOOR HOMES (SOUTHERN) AND THE UNIVERSITY OF READING  
11 February 2026

| <b>Document Reference:</b> | HD068 – R016 |

# Road Safety Audit – Hyde End Road, Shinfield, On-Site and Access Proposals

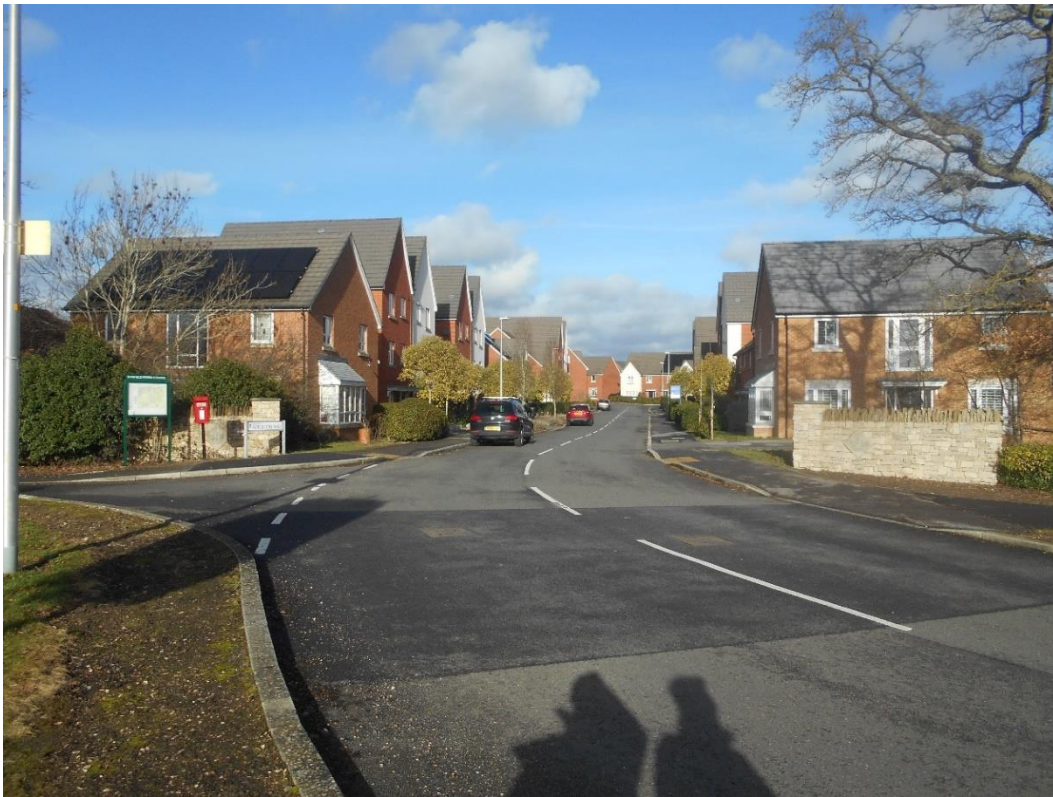
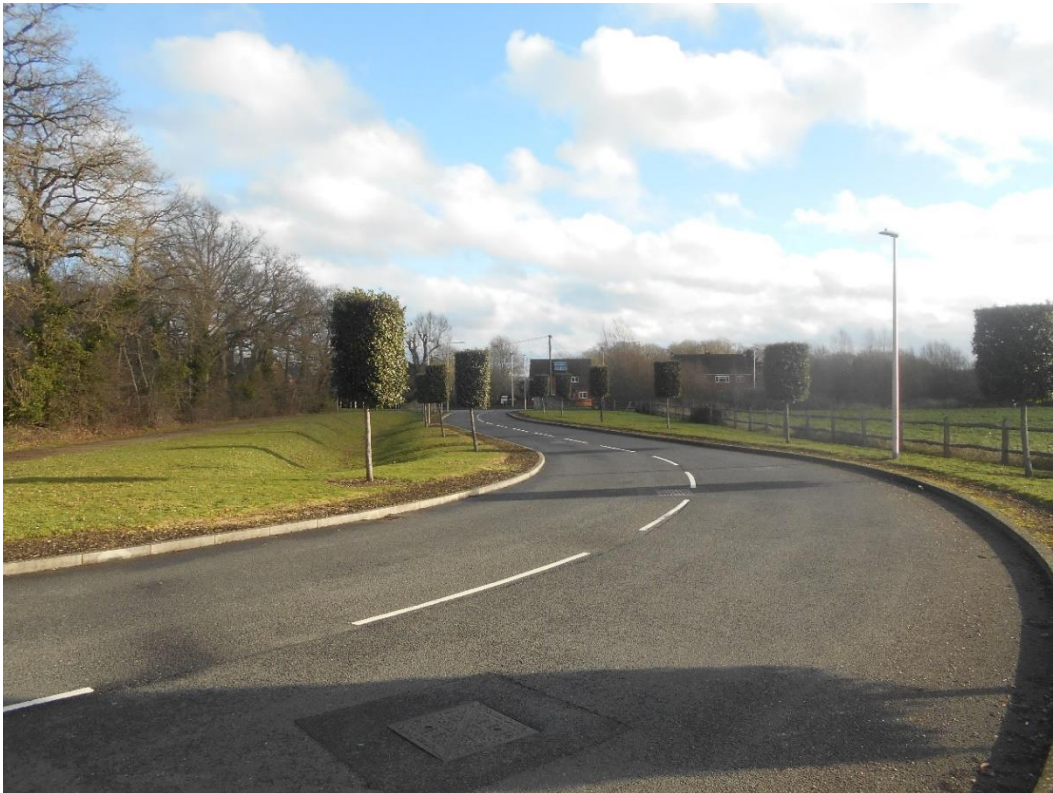
*Views to left and right for a driver emerging from the new access on Appleton Way*

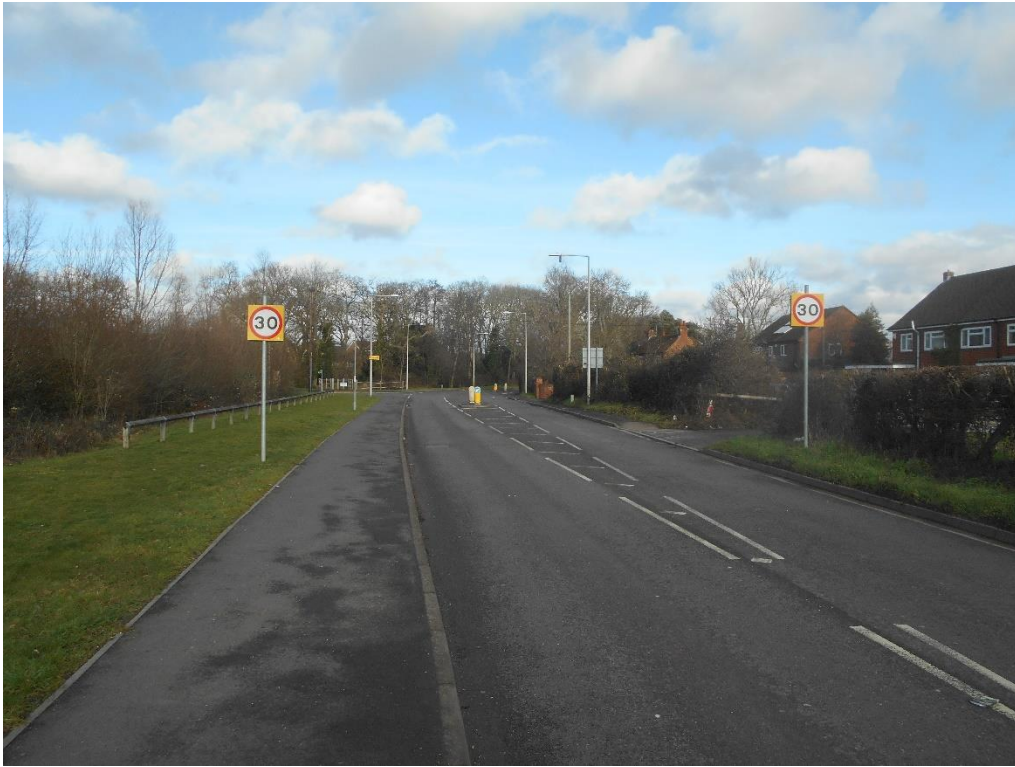
*Looking north on Hyde End Road from the site of the proposed Toucan crossing. The path on the left is to be widened to 3.0 metres to accommodate shared use, with a 0.5 metre wide block paved margin*

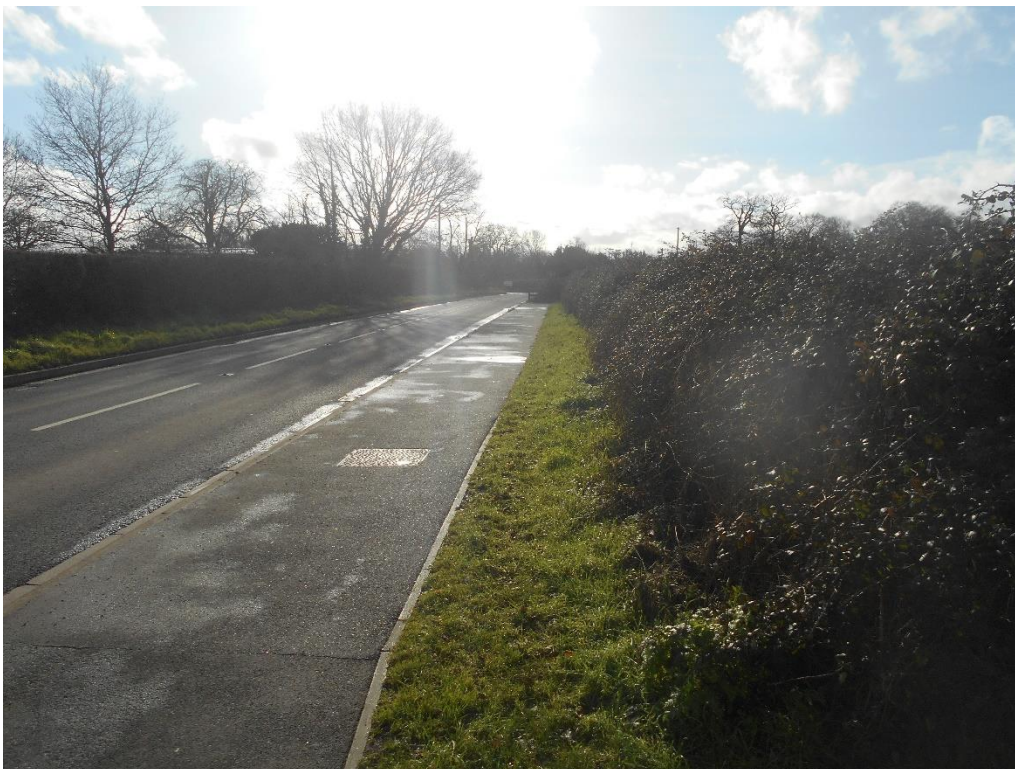
*Looking south on Hyde End Road from the site of the proposed Toucan crossing. The path is to be widened to 3.0 metres to accommodate shared use, which will link with an existing hoggin path at its southern end*

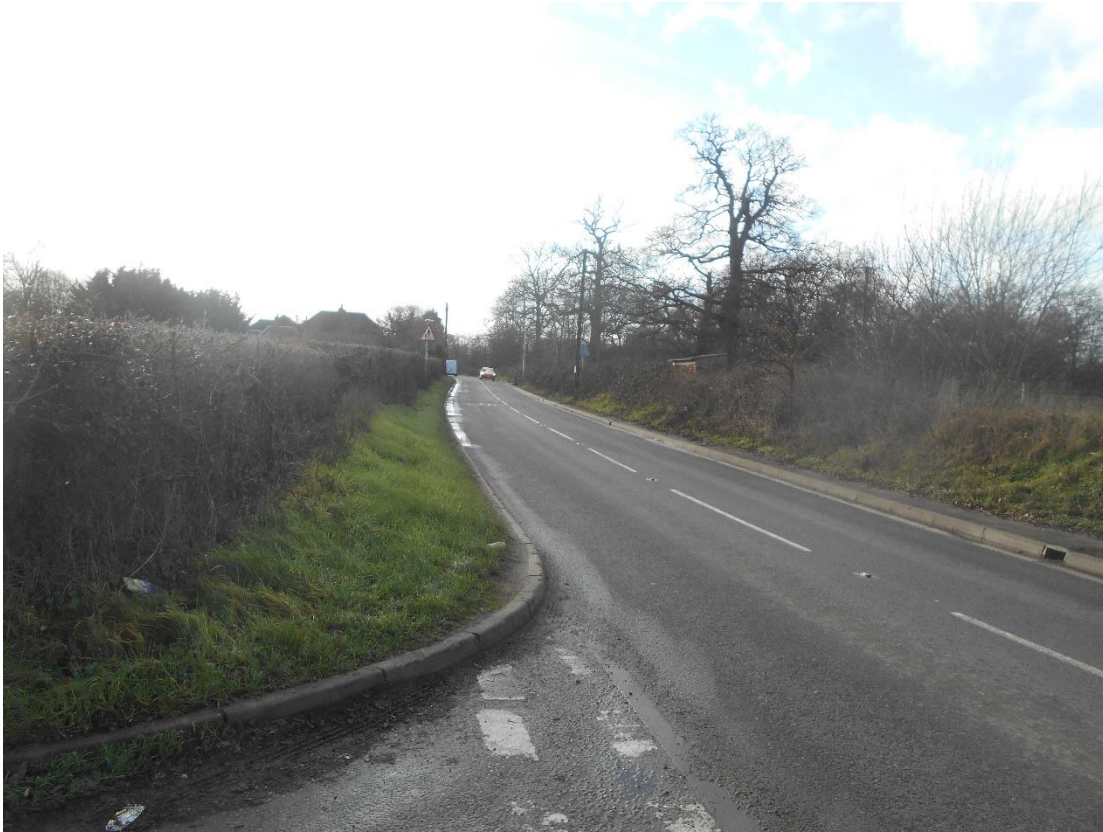
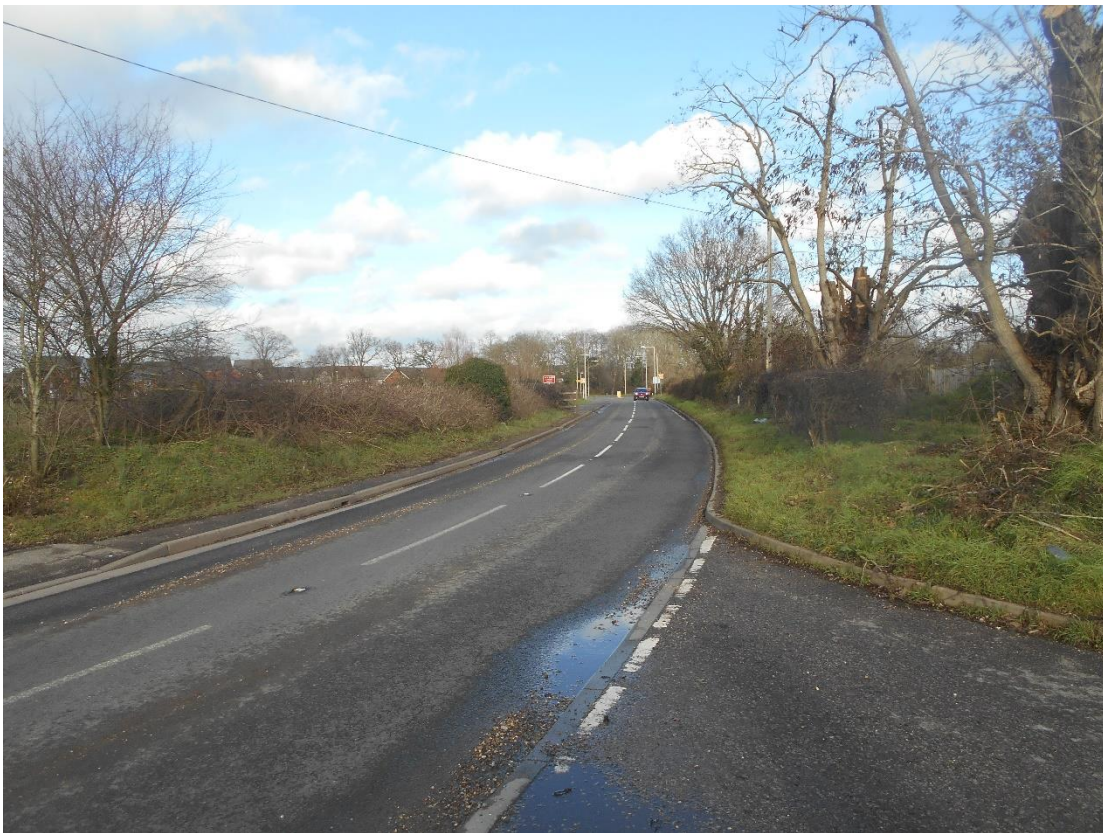
*Views to left and right for a driver emerging from the new access on Hyde End Road*

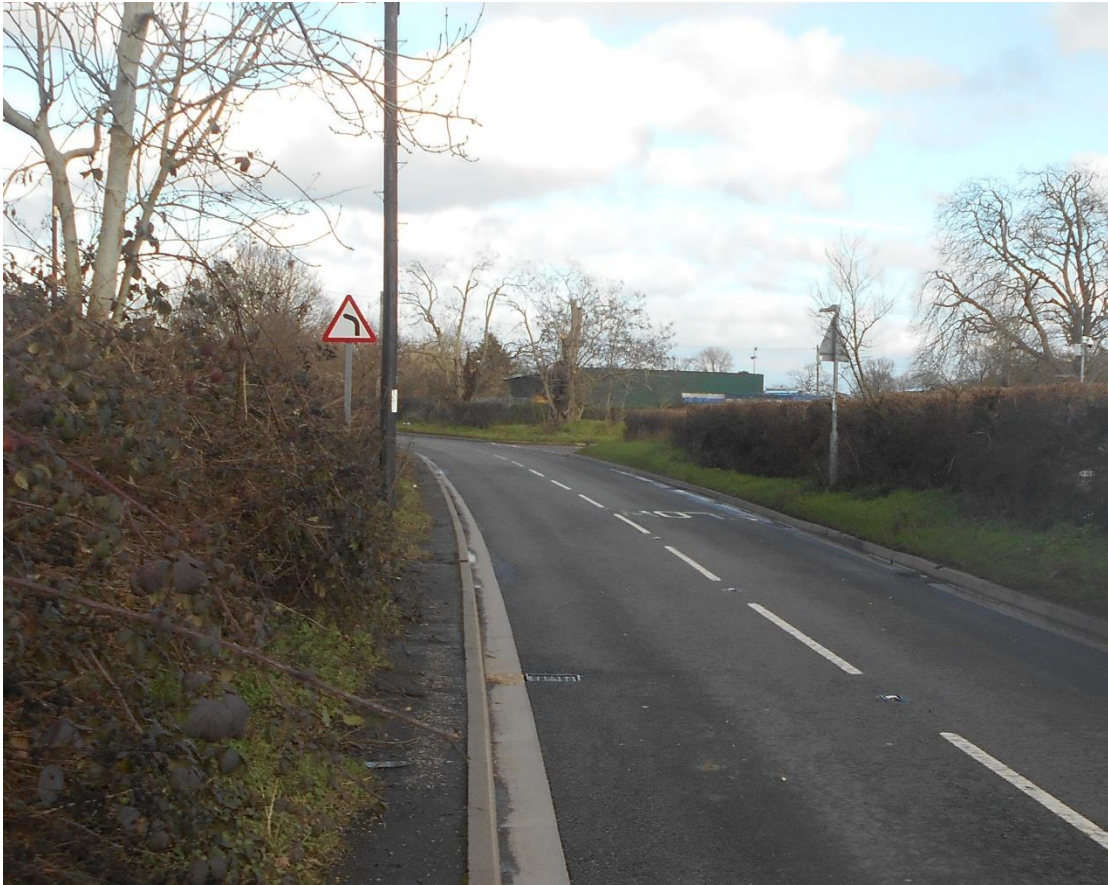
*Looking north on Hyde End Road The new access will replace the existing access on the right*

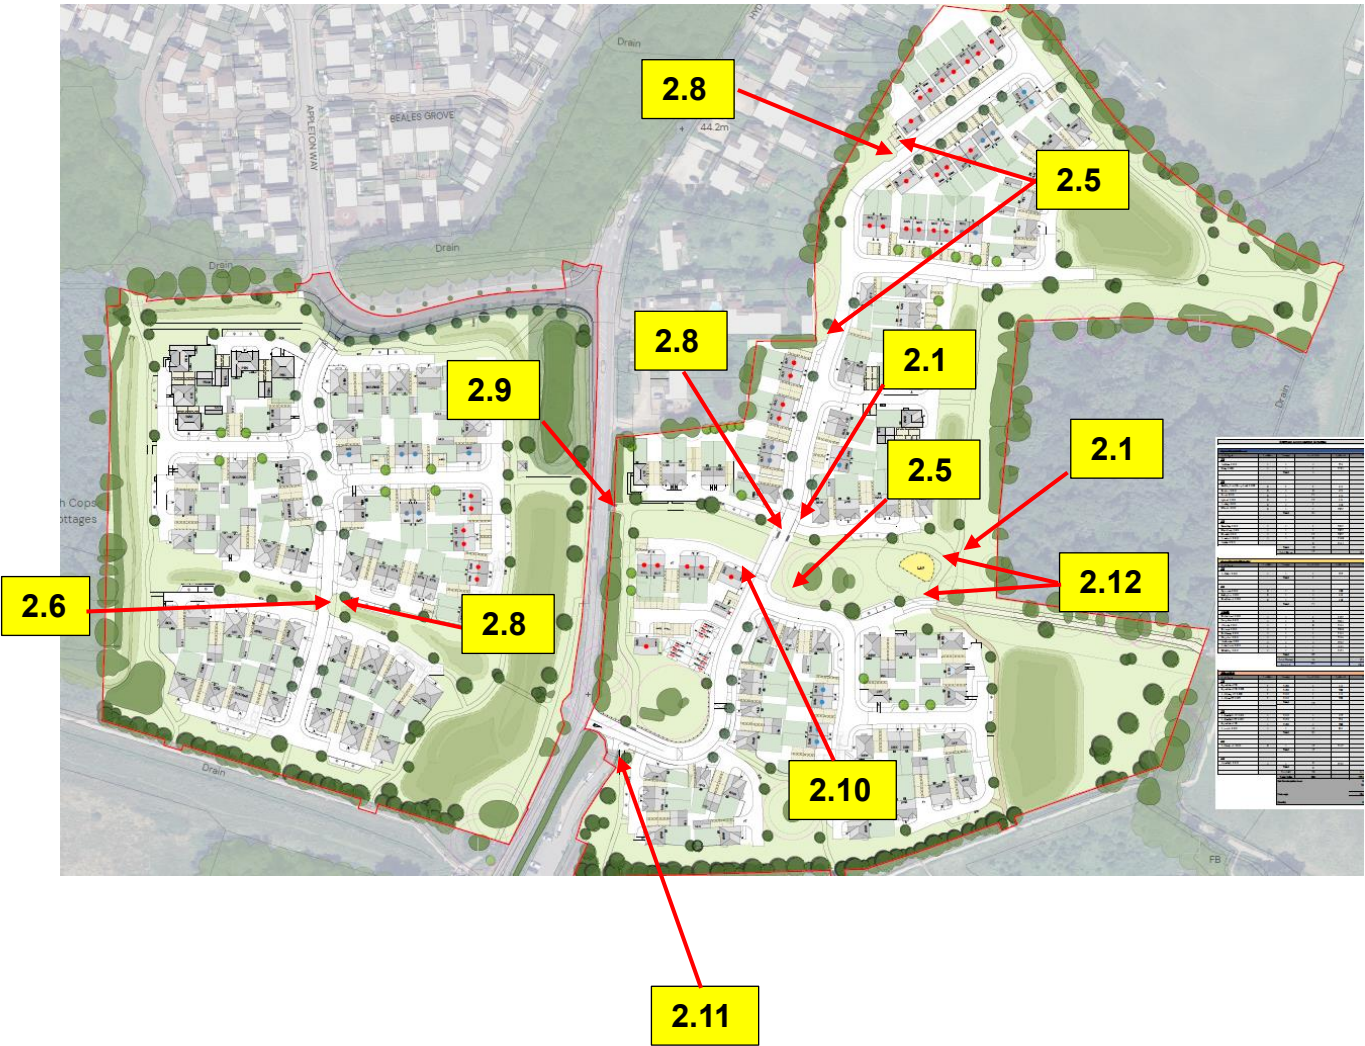
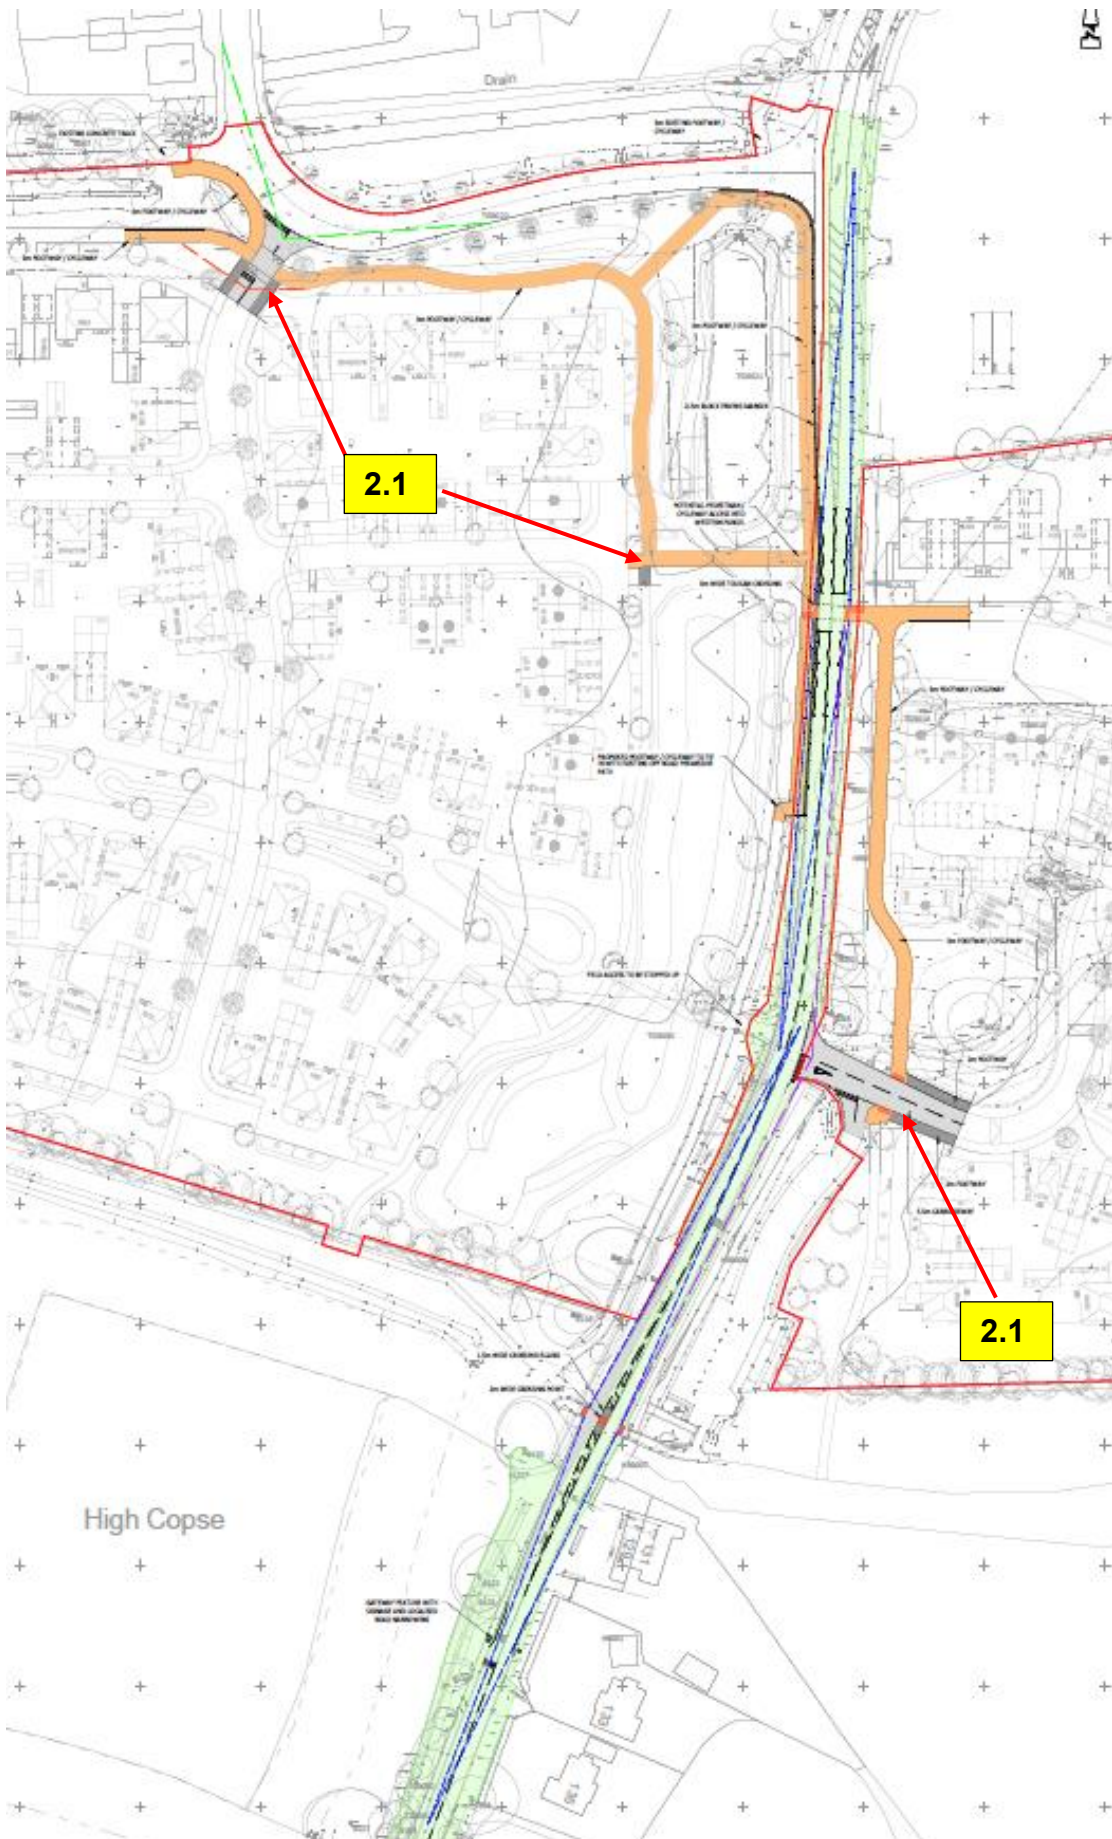
Appendix B: Key Plan showing Audit Problems

## **2. Safety Issues Raised in this Stage 1 Road Safety Audit.** (see Appendix B for locations)
