DUCKWORTHS  
ARBORICULTURE

## TREE INSPECTION REPORT

65 HILMANTON  
LOWER EARLEY  
WOKINGHAM  
BERKSHIRE  
RG6 4HN

Ref: SCD 05386/2020

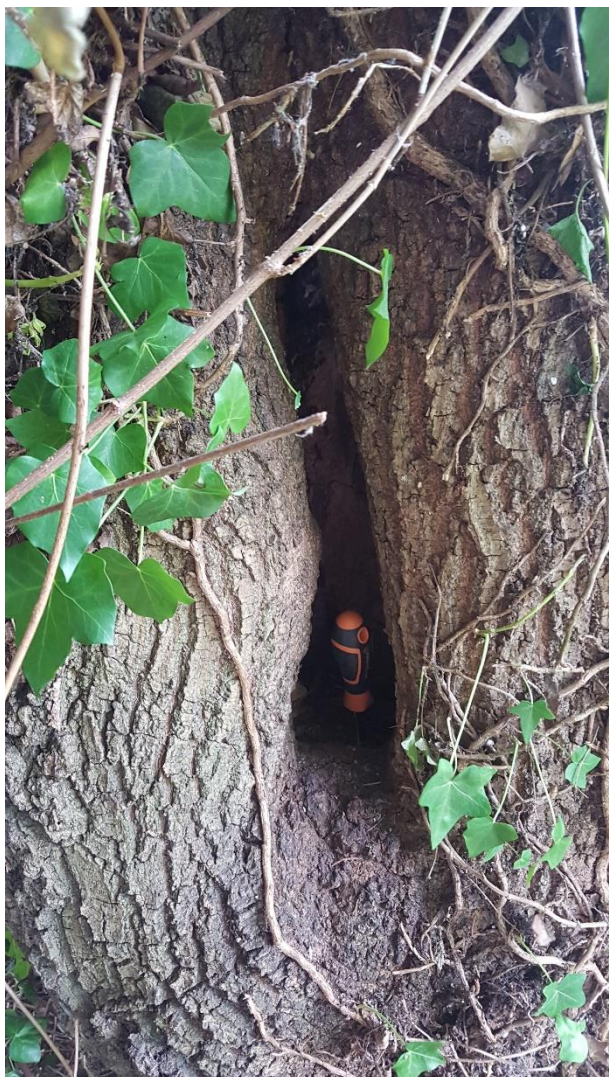
| <b>Trunk</b> | | STEM: Stem partially obscured by ivy and boundary fence. Wound on south side of trunk at 910mm above ground level (100x400mm) Good ribs of growth around cavity. Organic matter built up in hole. Cavity can be probed downwards at least 400mm (at least as long as the probe – see photo 1) and this cavity is thought to connect up with the cavity previously mentioned on the north side of the base. Audible decay below this wound where accessible and elsewhere around lower trunk. | | | | | | |

Photo 1 – Cavity on south side with metal probe.

| <b>Work Required</b> | | T5 Ash - Reduce to approximately 6-8m monolith and retain for habitat value. | | | | <b>Priority</b> | 3 Months | |

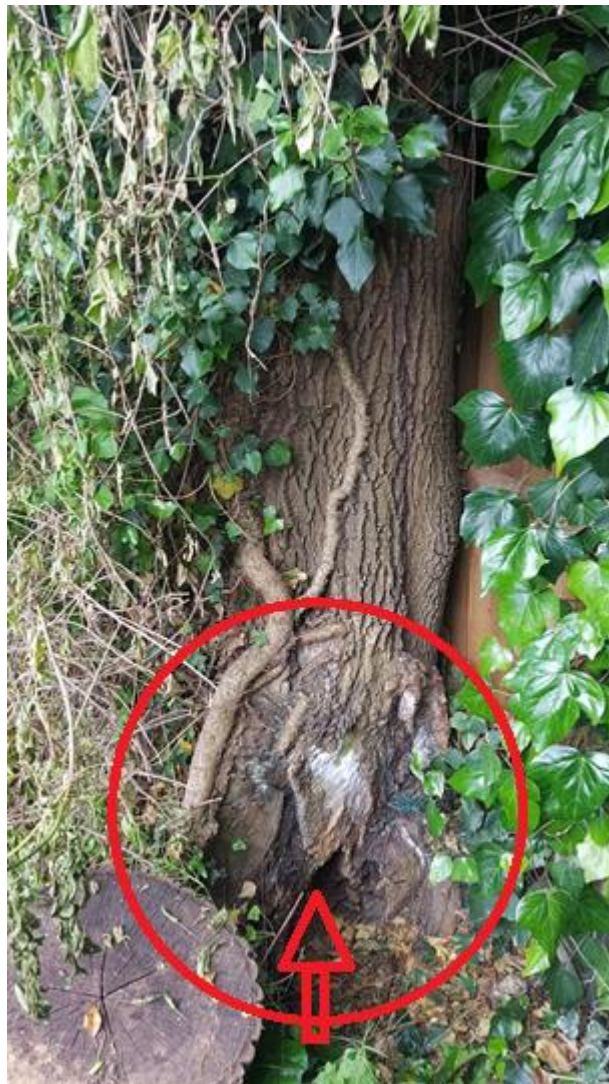
| <b>Roots &amp; Surrounding Ground</b> | | BASE: Base partially obscured by ivy and boundary fencing. Large tree, previously twin stem with two fairly even sized trunks from ground level up until 2016 when the northern-most trunk failed. Wood from the cleared stump remains on site. The base of the tree was evidently undermined by both a tight fork with area of bark inclusion and a central column of decay (see photo 6). The failure of the second trunk has left a large wound (680 x 1007mm) at the now asymmetrical base of the Ash (photo2). Some new bark growth around wound site but there is a large cavity centrally under tree which can be probed upwards to over 500mm. Audible decay. No fungal fruiting bodies visible. Frass and decay evident. | | | | | | |

Photo 2 – Basal wound and cavity.

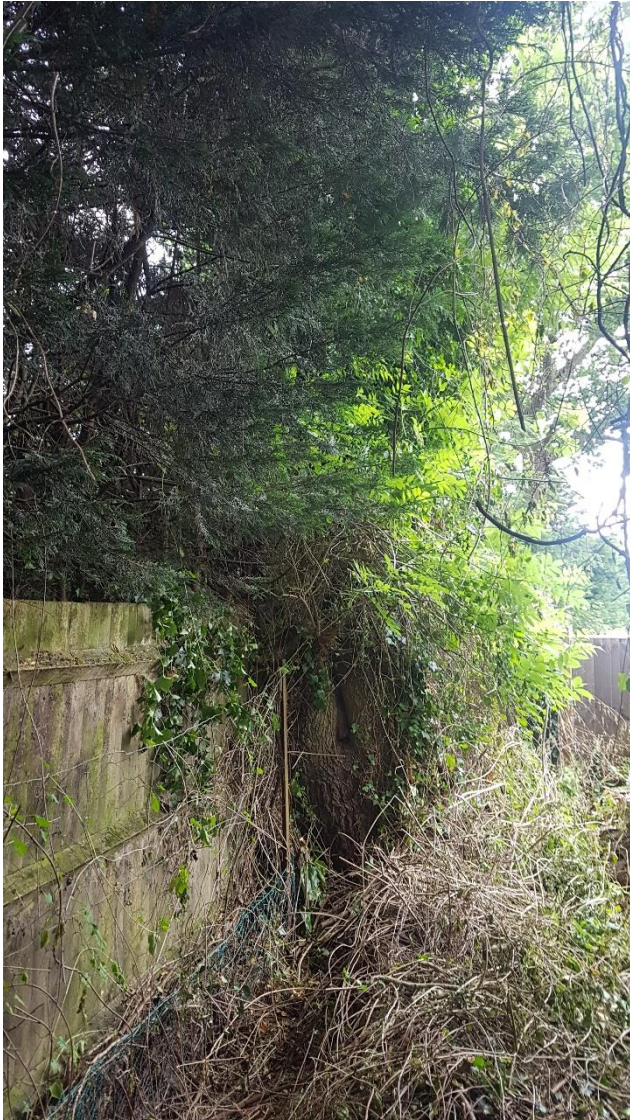
Photo 3 – Base of tree growing adjacent to boundary

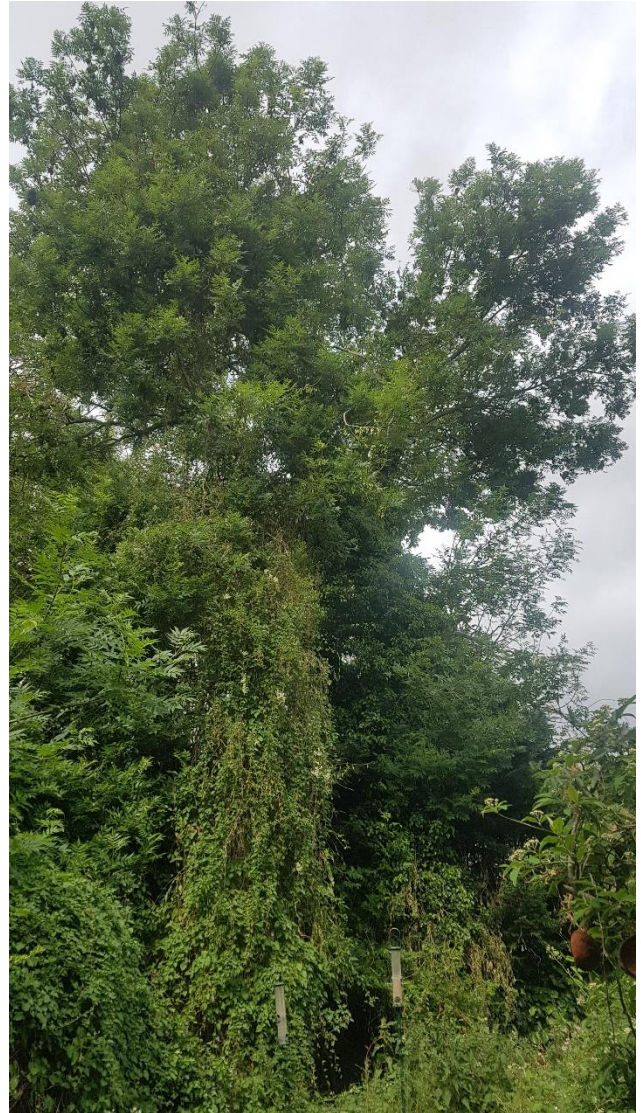
| Ffb, decay, other plants, exudates, structural integrity | | CANOPY: Branch forks obscured by ivy and climbing plants. Foliage dense and even. The tree has a history of branch failure with some tear out wounds visible around 30-40mm diameter which is a cause of concern for neighbours. Dense climbing plants throughout canopy. | | | | | | |

Photo 4 – Tree canopy and vine.

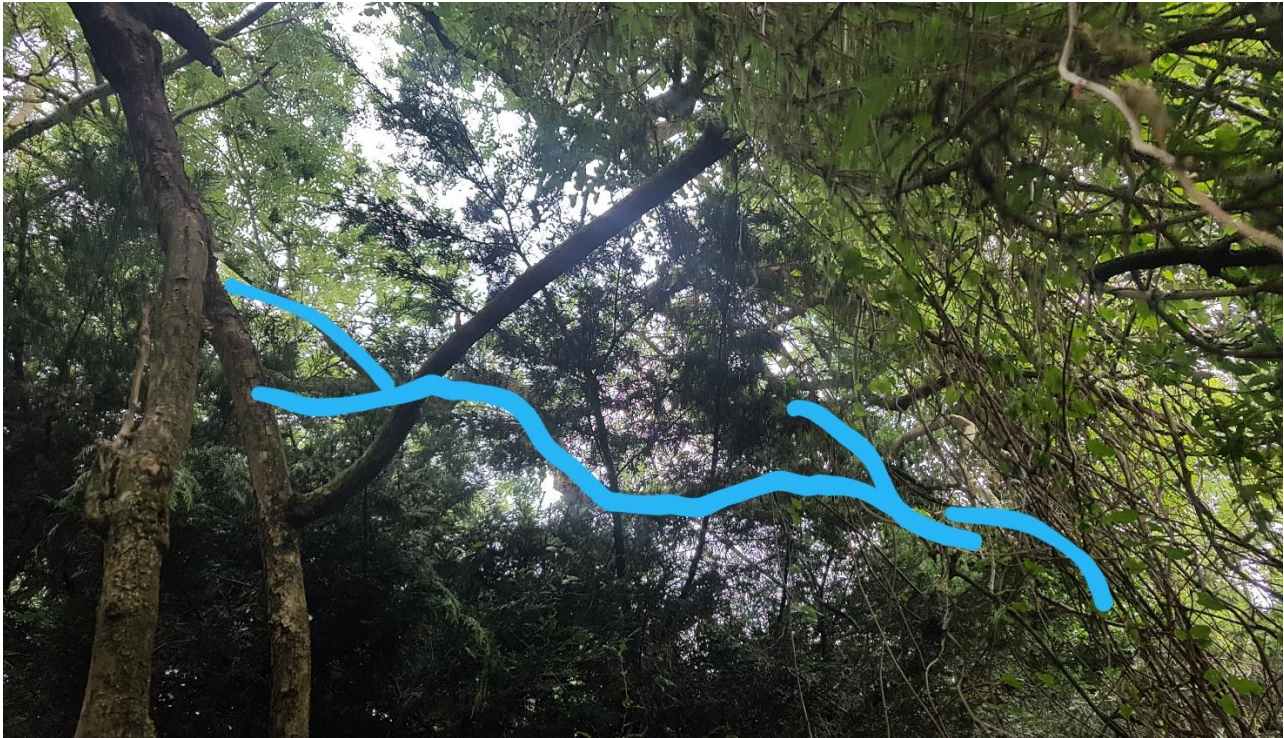
| <b>Primary Ascending Stems</b> | | Long, over-extended (etiolated) branch on southwest wide of the canopy extends well beyond that of the natural boundary shape and is supported within the branches of the adjacent trees within the neighbouring property. Branch union obscured. | | | | | | |
| <b>Twigs and Leaves</b> | | Given the significance of the defects noted, I do not consider it viable to retain the tree with a lesser reduction of the tree's canopy. The tree is currently supported by the etiolated lateral branch which extends into the canopies of neighbouring trees and by the weight of the Russian Vine on the south side of the canopy. The removal or reduction of these features is likely to increase the risk of stem failure. | | | | | | |

**Photo 5 – Line showing route of over-extended branch on southwest side of canopy, growing beyond natural canopy extents and resting in neighbouring trees. This branch is expected to be proving some support to tree stability making a light or partial reduction of the tree's canopy unviable.**

| Biotic/abiotic factors. | | I am therefore recommending that the tree be removed as it is a potentially hazardous tree in a high occupancy area. [REDACTED] would like to retain the tree in some form for the benefit of local wildlife, my recommendation is that the tree be felled to a 6-8m monolith and maintained for habitat value. | | | | | | |

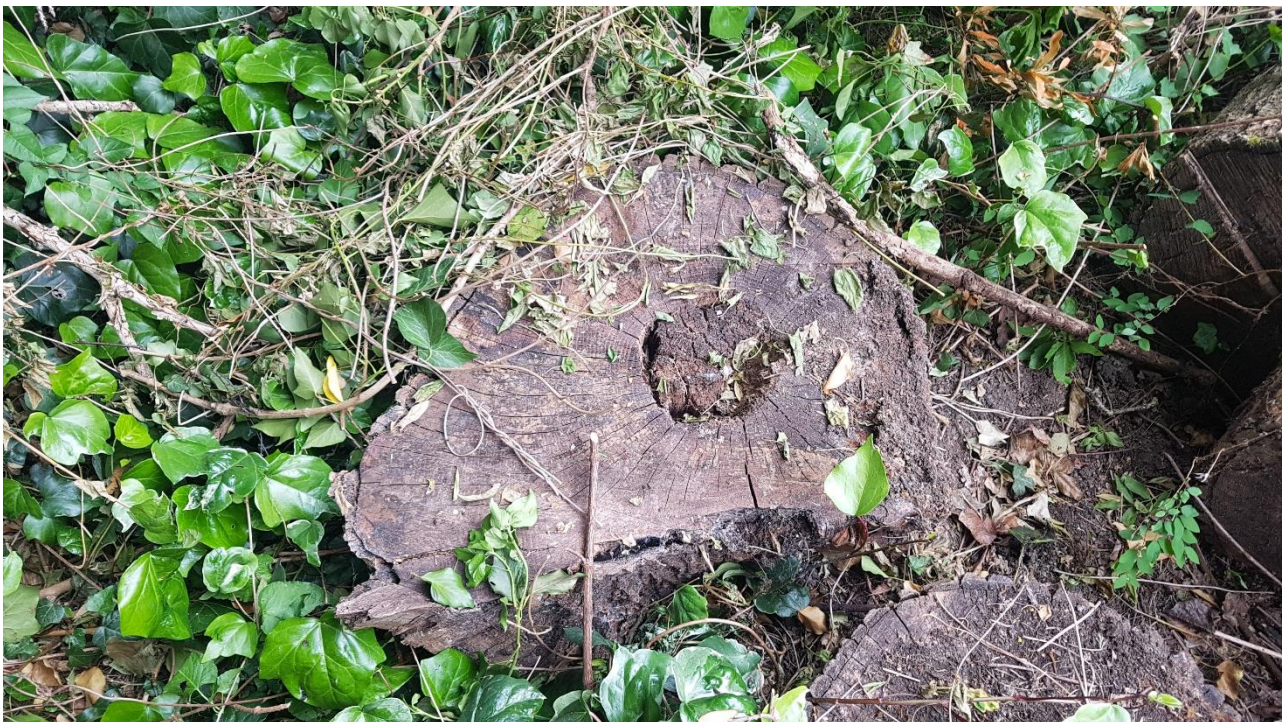
**Photo 6 – Cross section of wood from fallen trunk. Note asymmetrical base and central column of decay.**
