# ARBORICULTURAL REPORT

TREE CONDITION SURVEY

105A - 107A FINCHAMPSTEAD ROAD  
WOKINGHAM  
BERKSHIRE  
RG41 2PF

Ref: 07014 / 2026

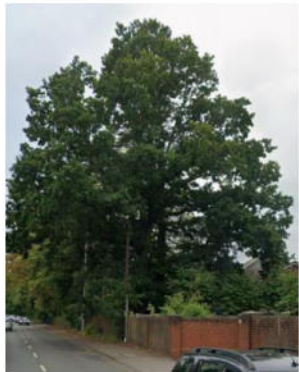
| Ref: | Species | Measurements | Survey Notes | Condition | Other Data | Recommendations | Photo |
|---|---|---|---|---|---|---|---|
| T001 | Pedunculate oak<br>( <i>Quercus robur</i> ) | Height (m): 15-20<br>Crown Radius (m): 8N,<br>7E, 4S, 10W<br>DBH (cm): 78<br>Life Stage: Mature<br>Life Exp.: 40+ Years | <p>Mature oak. Gravel parking directly at base. Car port built around trunk. Corrugated roof touching trunk but not yet causing damage to bark or trunk.</p> <p>Base clear, bark intact. Broad even root collar. Smooth, regular buttressing. Sound intonation even and satisfactory. No fungal fruiting bodies evident or audible decay.</p> <p>Single stem.</p> <p>Low crown over footpath and drive. Short dead branch stubs in crown. Minor dead twigs throughout canopy but foliage density normal and generally healthy.</p> <p>Elongated low branch on west side of crown towards dwelling extends beyond adjacent crown. Some dieback towards branch tips.</p> <p>Dead branches in crown over highway.</p> | Good | <p>Public Amenity Value: High<br/>Wildlife Value: High</p> | <p>Crown lift to create 3m canopy clearance over pavement.</p> <p>Remove 2x slender low pendulous branches under 100mm on west side of crown low over drive.</p> <p>Reduce elongated branch over drive by 2-3m back in line with surrounding crown to reduce weight / exposure and associated risk of stem failure.</p> <p>Remove deadwood</p> <p>Cut back carport roof to create growing space for trunk.</p> <p><b>Timescale:</b><br/>11-Dec-2026<br/>(6 Months)</p> | |

| Ref: | Species | what3words<br>(Location Identifier) | Recommendations | Work<br>Timescale |
|---|---|---|---|---|
| T001 | Pedunculate oak | ///safety.comb.young | <p>Crown lift to create 3m canopy clearance over pavement.</p> <p>Remove 2x slender low pendulous branches under 100mm on west side of crown low over drive.</p> <p>Reduce elongated branch over drive by 2-3m back in line with surrounding crown to reduce weight / exposure and associated risk of stem failure.</p> <p>Remove deadwood</p> <p>Cut back carport roof to create growing space for trunk.</p> | 11-Dec-2026<br>(6 Months) |

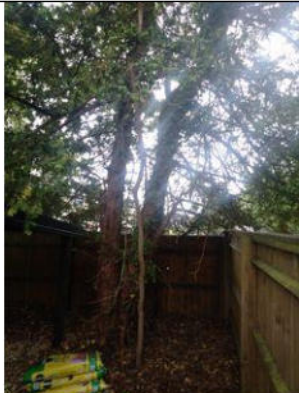
| Ref: | Species | Measurements | Survey Notes | Condition | Other Data | Recommendations | Photo |
|---|---|---|---|---|---|---|---|
| T002 | English yew<br>( <i>Taxus baccata</i> ) | Height (m): 5-10<br>Crown Radius (m): 2N,<br>1.5E, 3.5S, 3.5W<br>DBH (cm): 25<br>Stems: 2<br>Life Stage: Mature<br>Life Exp.: 20+ Years | <p>Twin stem from ground level. Light ivy growth. Emerging epicormic growth on trunks.</p> <p>Heavily suppressed canopy. Dead branches in lower crown. Needles sparse and chlorotic.</p> <p>Tree in decline but with the potential to recover.</p> | Poor | <p>Public Amenity Value: Moderate<br/>Wildlife Value: Low</p> | <p>Crown lift to create 3m canopy clearance over pavement</p> <p><b>Timescale:</b><br/>11-Jun-2027<br/>(1 Year)</p> | |

| Ref: | Species | what3words<br>(Location Identifier) | Recommendations | Work<br>Timescale |
|---|---|---|---|---|
| T002 | English yew | ///notes.reward.error | Crown lift to create 3m canopy clearance over pavement | 11-Jun-2027<br>(1 Year) |

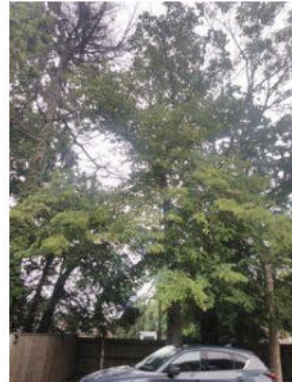
| Ref: | Species | Measurements | Survey Notes | Condition | Other Data | Recommendations | Photo |
|---|---|---|---|---|---|---|---|
| T003 | European lime<br>( <i>Tilia x europaea</i> ) | Height (m): 15-20<br>Crown Radius (m): 3.5N, 5.5E, 3S, 4.5W<br>DBH (cm): 48<br>Life Stage: Mature<br>Life Exp.: 40+ Years | <p>Mature tree within gravel drive. Circle of granite sets around base, haunched with concrete. Restricted future growth.</p> <p>Light ivy growth on trunk. Where accessible no fungal fruiting bodies evident.</p> <p>Fully occluded wound on north side of trunk 300mm wide x 850 high. Sound intonation even. Cut small stumps of epicormic growth at base.</p> <p>Resident advised recent trenching for services carried out by statutory undertakers which may have severed tree roots. Works undertaken within last 3 years. Any impact on tree health from these works are likely to be apparent in tree health by now. Cut roots may affect tree stability which will not be visible in a survey. Currently no sign of rootplate movement or instability.</p> <p>Single stem. 2.5m canopy clearance above ground level. Foliage slightly sparse but within the parameters of normal for a healthy Lime.</p> | Fair | Public Amenity Value: Good<br>Wildlife Value: Good | No works identified | |

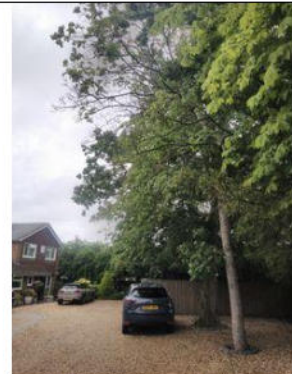
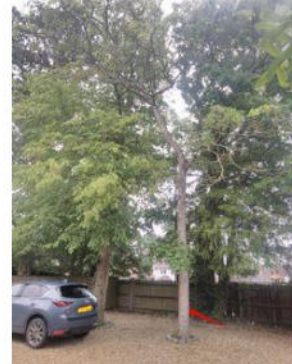
| Ref: | Species | Measurements | Survey Notes | Condition | Other Data | Recommendations | Photo |
|---|---|---|---|---|---|---|---|
| T004 | Sycamore<br>( <i>Acer pseudoplatanus</i> ) | Height (m): 10-15<br>Crown Radius (m): 3N, 1E, 4S, 7W<br>DBH (cm): 32<br>Life Stage: Over Mature<br>Life Exp.: <10 years | <p>Slender tree within gravel drive. Tight circle of granite sets around base, haunched with concrete. Restricted future growth. Light ivy growth on trunk. Resident advised recent trenching for services carried out by statutory undertakers which may have severed tree roots.</p> <p>Works undertaken within last 3 years. Single stem. Suppressed, etiolated crown.</p> <p>Shedding flakes of bark on trunk indicate meristem dysfunction / decline. kinked trunk 7m above ground level.</p> <p>Canopy 75% defoliated. Major deadwood over drive. Poor vitality.</p> <p>Tree in terminal decline, not expected to recover.</p> | Poor | Public Amenity Value: Moderate<br>Wildlife Value: Moderate | <p>Fell to ground level</p> <p><b>Timescale:</b><br/>11-Dec-2026<br/>(6 Months)</p> | |

| Ref: | Species | what3words<br>(Location Identifier) | Recommendations | Work<br>Timescale |
|---|---|---|---|---|
| T004 | Sycamore | ///weeks.risky.escape | Fell to ground level | 11-Dec-2026<br>(6 Months) |

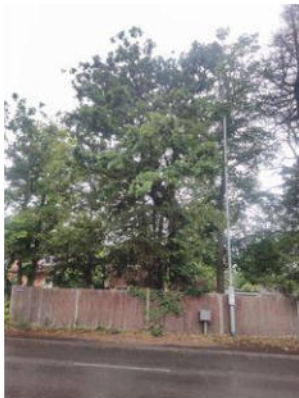
| Ref: | Species | Measurements | Survey Notes | Condition | Other Data | Recommendations | Photo |
|---|---|---|---|---|---|---|---|
| T005 | Pedunculate oak<br>( <i>Quercus robur</i> ) | Height (m): 10-15<br>Crown Radius (m): 3.5N, 5.5E, 6S, 4W<br>DBH (cm): 70<br>Life Stage: Mature<br>Life Exp.: 40+ Years | <p>Mature tree in narrow landscape bed. Rooting area mostly covered by gravel drive. Semi-circle of granite sets around base, haunched with concrete.</p> <p>Mature Yew directly at base. Small girdling root on west side of trunk from Yew. Mature ivy stems on trunk. Where accessible no fungal fruiting bodies evident. Sound intonation even.</p> <p>Resident advised recent trenching for services carried out which may have impacted tree roots. Works undertaken within last 3 years. Any impact on tree health from these works are likely to be apparent in tree health by now. Cut roots may affect tree stability which will not be visible in a survey. Currently no sign of rootplate movement or instability.</p> <p>Single stem. Bud proliferation and epicormic growth on trunk. Low dead branch stump on north side 2.5m long, 4m above ground level end over low occupancy area.</p> <p>Main trunk forks 5m above ground level. Asymmetrical canopy over highway. One short dead branch in crown over road.</p> <p>Apical dieback at tips in very upper crown, otherwise foliage dense and even. Vitality good.</p> | Fair | Public Amenity<br>Value: Good<br>Wildlife Value: Good | <p>Sever ivy.<br/>Remove dead branch over road</p> <p><b>Timescale:</b><br/>11-Dec-2026<br/>(6 Months)</p> | |

| Ref: | Species | what3words<br>(Location Identifier) | Recommendations | Work<br>Timescale |
|---|---|---|---|---|
| T005 | Pedunculate oak | ///hush.critic.shirts | <p>Sever ivy.</p> <p>Remove dead branch over road</p> | 11-Dec-2026<br>(6 Months) |

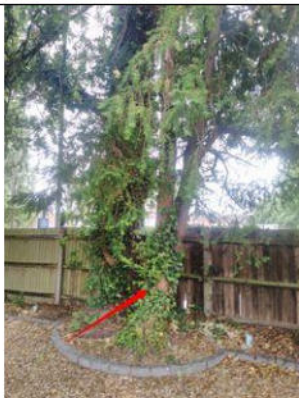
| Ref: | Species | Measurements | Survey Notes | Condition | Other Data | Recommendations | Photo |
|---|---|---|---|---|---|---|---|
| T006 | English yew<br>( <i>Taxus baccata</i> ) | Height (m): 5-10<br>Crown Radius (m): 2N, 3.5E, 3.5S, 3W<br>DBH (cm): 15<br>Stems: 2<br>Life Stage: Mature<br>Life Exp.: 20+ Years | <p>Mature tree in narrow landscape bed. Rooting area mostly covered by gravel drive. Semi-circle of granite sets around base, haunched with concrete.</p> <p>Mature oak directly at base. Swept lower trunk south. Light ivy growth on trunk. Stem forks 1.3m above ground level.</p> <p>Trunks above fork grow more or less vertically. Heavily suppressed, asymmetrical canopy due to proximity of Oak.</p> <p>Needles slightly sparse and chlorotic. Small dead branches in lower crown over low occupancy area. Tree lacks vitality.</p> | Fair | Public Amenity<br>Value: Moderate<br>Wildlife Value: Low | No works identified | |

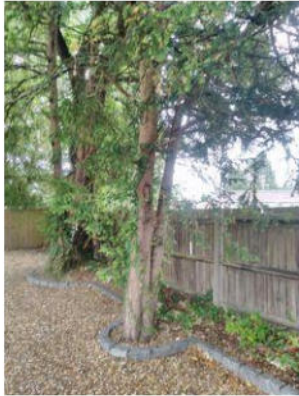
| Ref: | Species | Measurements | Survey Notes | Condition | Other Data | Recommendations | Photo |
|---|---|---|---|---|---|---|---|
| T007 | English yew<br>( <i>Taxus baccata</i> ) | Height (m): 5-10<br>Crown Radius (m): 1N,<br>2.5E, 3S, 3W<br>DBH (cm): 20<br>Stems: 2<br>Life Stage: Mature | <p>Mature tree. Rooting area mostly covered by gravel drive. Semi-circle of granite sets around base, haunched with concrete.</p> <p>Light ivy growth on trunk. Base clear, bark intact. No fungal fruiting bodies evident or audible decay.</p> <p>Stem forks 0.5m above ground level. Eastern trunk short, kinked and heavily suppressed, asymmetrical canopy due to proximity of Oak.</p> <p>Needles slightly sparse and chlorotic. Small dead branches in lower crown over low occupancy area. Tree lacks vitality.</p> | Fair | Public Amenity<br>Value: Moderate<br>Wildlife Value: Low | No works identified | |

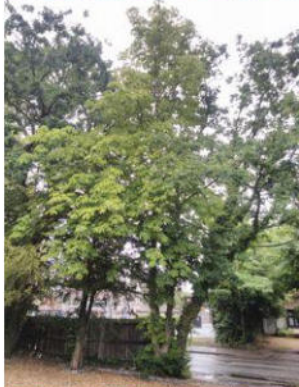
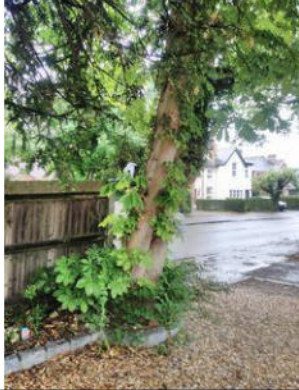
| Ref: | Species | Measurements | Survey Notes | Condition | Other Data | Recommendations | Photo |
|---|---|---|---|---|---|---|---|
| T008 | Horse chestnut<br>( <i>Aesculus hippocastanum</i> ) | Height (m): 10-15<br>Crown Radius (m): 2N,<br>3E, 3S, 4.5W<br>DBH (cm): 30<br>Life Stage: Mature<br>Life Exp.: 40+ Years | <p>Mature tree within tight touching group of 3 trees growing adjacent to the site entrance. Rooting area mostly covered by gravel drive / tarmac. Semi-circle of granite sets around base, haunched with concrete.</p> <p>Light ivy growth and epicormic shoots on trunk. Where accessible, base clear, bark intact. No fungal fruiting bodies evident or audible decay.</p> <p>Swept stem slightly to southwest. Suppressed, Asymmetrical crown due to proximity of adjacent trees.</p> <p>Foliage marginally chlorotic but within the parameters of normal for a healthy Horse chestnut.</p> | Fair | Public Amenity<br>Value: Moderate<br>Wildlife Value: Low | No works identified | |

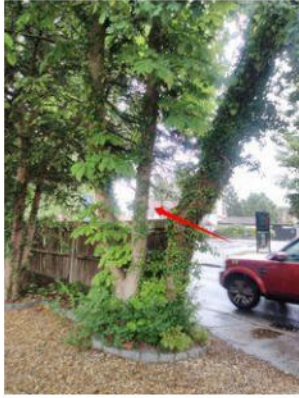
| Ref: | Species | Measurements | Survey Notes | Condition | Other Data | Recommendations | Photo |
|---|---|---|---|---|---|---|---|
| T009 | Pedunculate oak<br>( <i>Quercus robur</i> ) | Height (m): 10-15<br>Crown Radius (m): 2.5<br>DBH (cm): 25<br>Life Stage: Mature<br>Life Exp.: 40+ Years | <p>Middle tree within tight, touching group of 3 trees growing adjacent to the site entrance. Rooting area mostly covered by gravel drive / tarmac. Semi-circle of granite sets around base, haunched with concrete.</p> <p>Light ivy growth on trunk. Trunk in direct contact and occluding round trunk of T008 to a height of 1m above ground level.</p> <p>Where accessible bark intact. No fungal fruiting bodies evident or audible decay. Swept stem slightly to southwest.</p> <p>Suppressed, asymmetrical crown due to proximity of adjacent trees. High slender crown a Suppressed small crown. Limited photosynthetic leaf area. Apical dieback at tips.</p> | Fair | Public Amenity<br>Value: Low<br>Wildlife Value: Low | No works identified | |

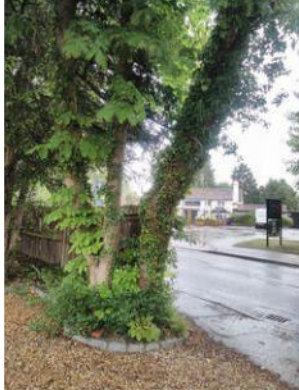
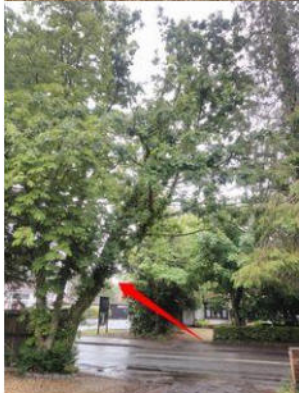
| Ref: | Species | Measurements | Survey Notes | Condition | Other Data | Recommendations | Photo |
|---|---|---|---|---|---|---|---|
| T010 | Pedunculate oak<br>( <i>Quercus robur</i> ) | Height (m): 10-15<br>Crown Radius (m): 1N, 4E, 5.5S, 4.5W<br>DBH (cm): 35<br>Life Stage: Mature<br>Life Exp.: 40+ Years | <p>End tree within tight, group of 3 trees growing adjacent to the site entrance. Rooting area mostly covered by gravel drive / tarmac.</p> <p>Semi-circle of granite sets around base, haunched with concrete. Prolific ivy growth on trunk. Base and lower trunk partially obscured by ivy and dense vegetation. Where accessible bark intact. No fungal fruiting bodies evident or audible decay.</p> <p>Swept stem slightly to South. Trunk kinked 1.5m above ground level and grows out at a low angle over access drive.</p> <p>Epicormic shoots on trunk and branches. Suppressed, Asymmetrical crown due to proximity of adjacent trees.</p> <p>Foliage sparse and clustered. Short incremental growth. Apical dieback at tips. Dead branches in crown over pavement.</p> <p>4m canopy clearance over access. Small superficial bark wound on underside of branch.</p> | Fair | Public Amenity<br>Value: Moderate<br>Wildlife Value: Low<br>Inspection<br>Limitations: Ivy and dense vegetation | <p>Remove deadwood<br/>Sever ivy</p> <p><b>Timescale:</b><br/>11-Dec-2026<br/>(6 Months)</p> | |

| Ref: | Species | what3words<br>(Location Identifier) | Recommendations | Work<br>Timescale |
|---|---|---|---|---|
| T010 | Pedunculate oak | ///retire.bars.junior | <p>Remove deadwood</p> <p>Sever ivy</p> | 11-Dec-2026<br>(6 Months) |
