# ARBORICULTURAL REPORT

## TREE CONDITION SURVEY

10 PALMER CLOSE  
CROWTHORNE  
BERKSHIRE  
RG40 3EB

SEPTEMBER 2024  
Ref: 06498 / 2024

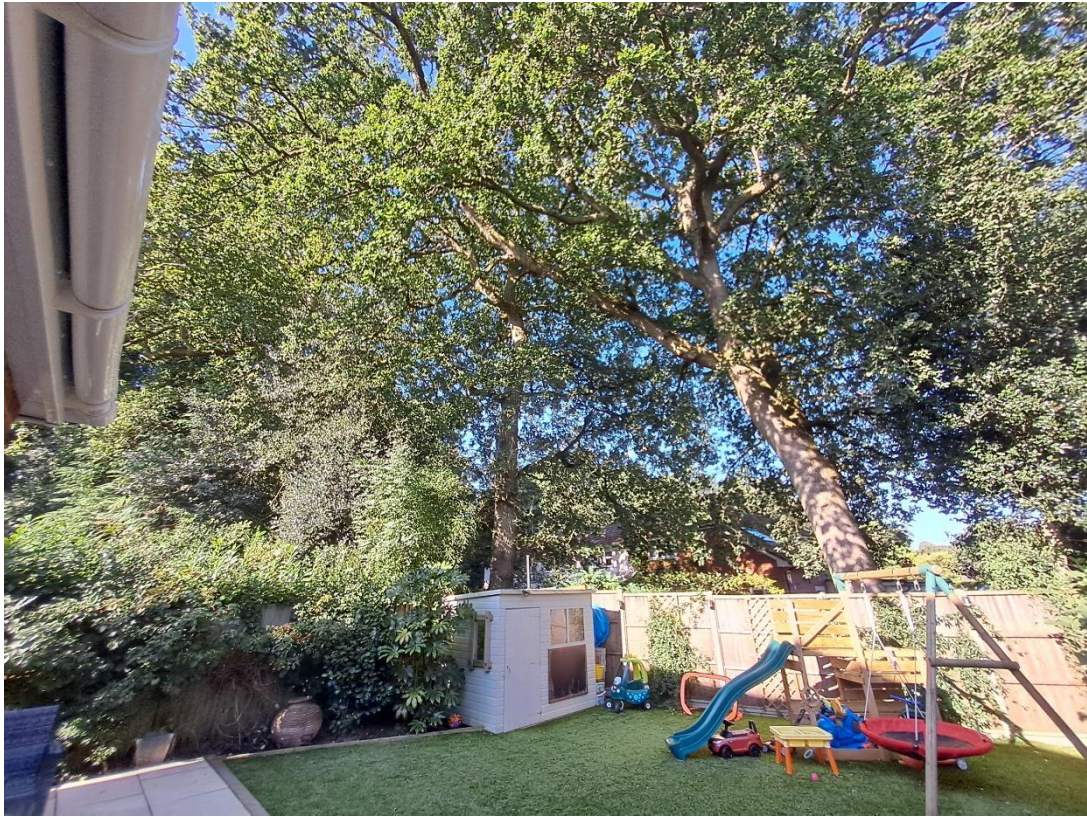
Photo 1 – Tree as viewed from garden of 9 Queens Ride

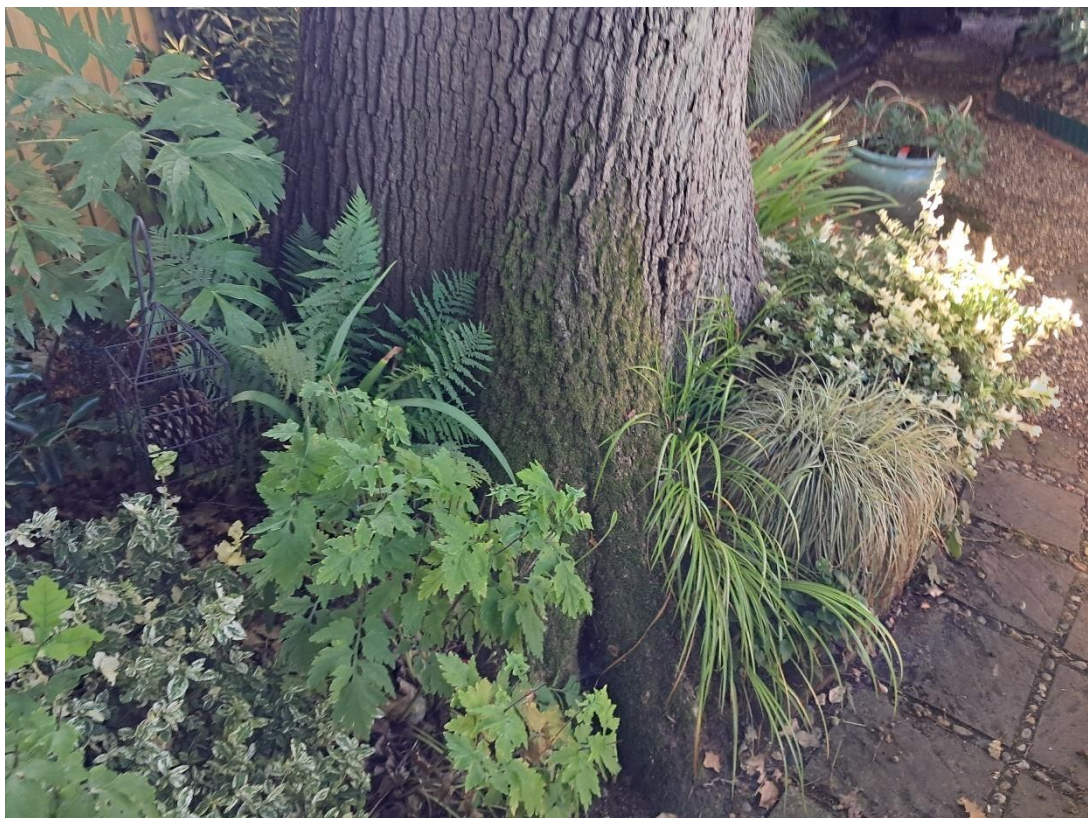
Photo 2 – Tree base as viewed from garden of 10 Palmer Close

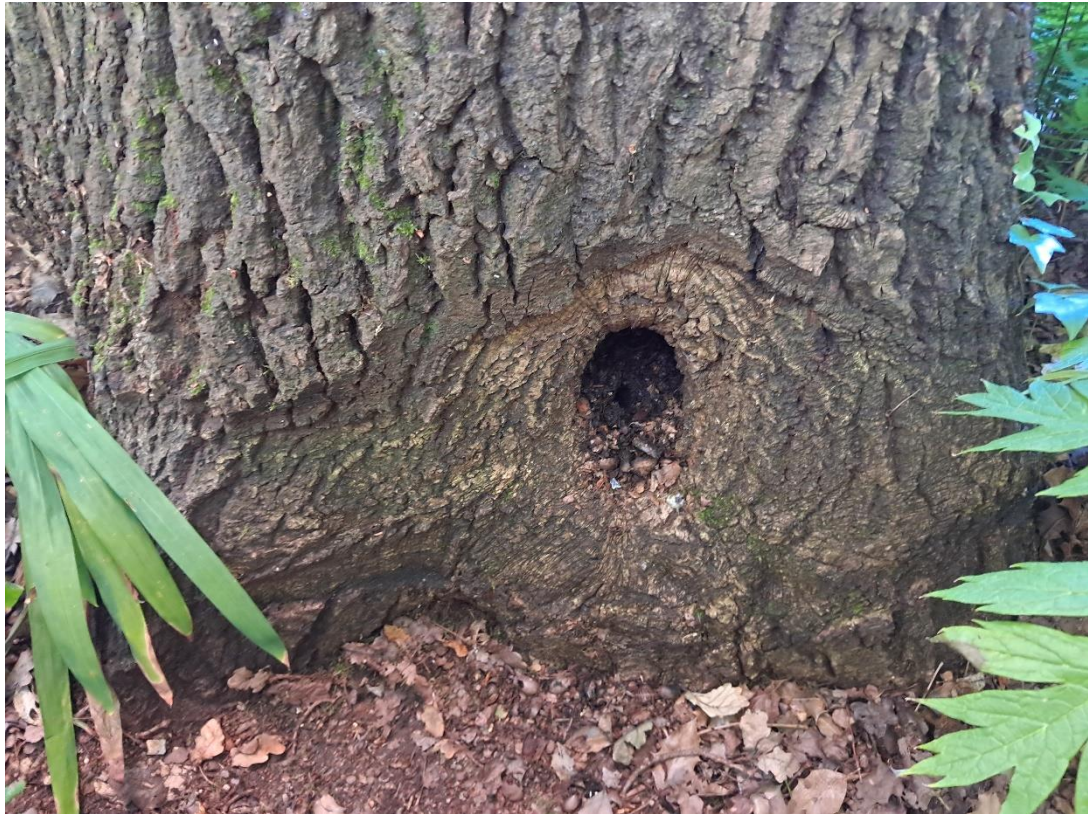
Photo 3 – Small cavity at base of tree with good ribs of adaptive growth

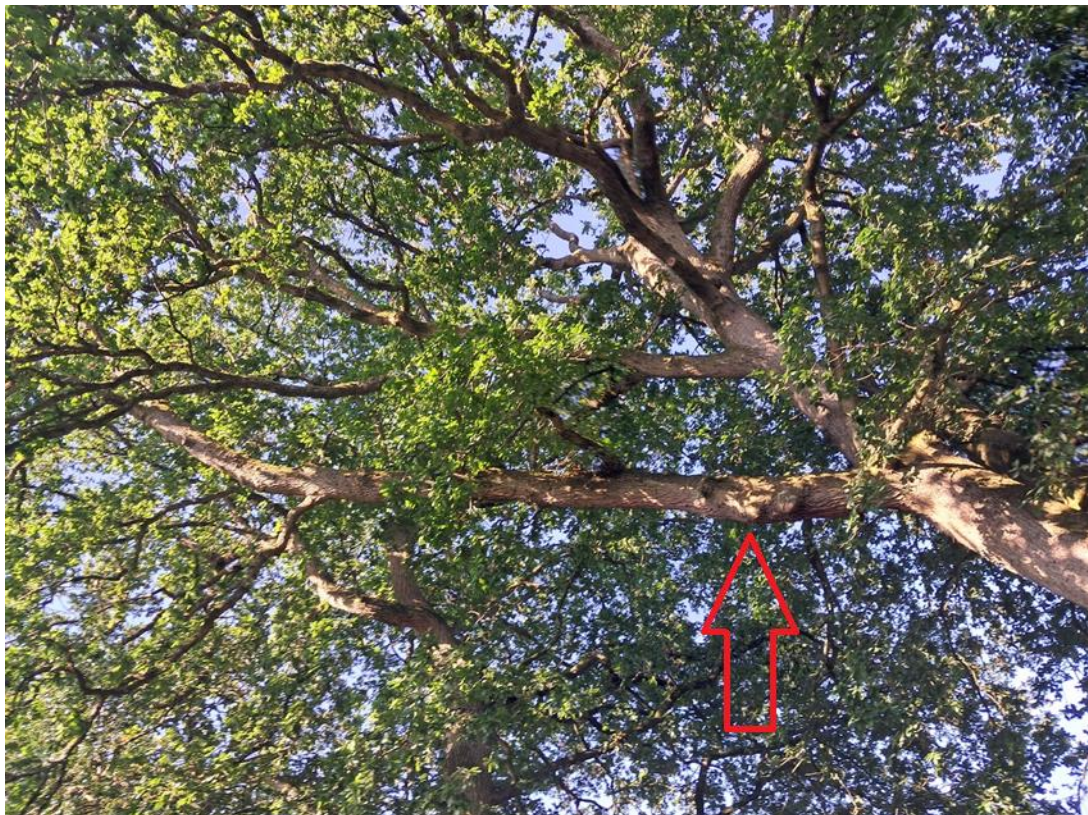
Photo 4 – Large, low lateral branch grows horizontally over garden of 9 Queens Ride – branch tips assuming apical growth beyond the surrounding canopy line.

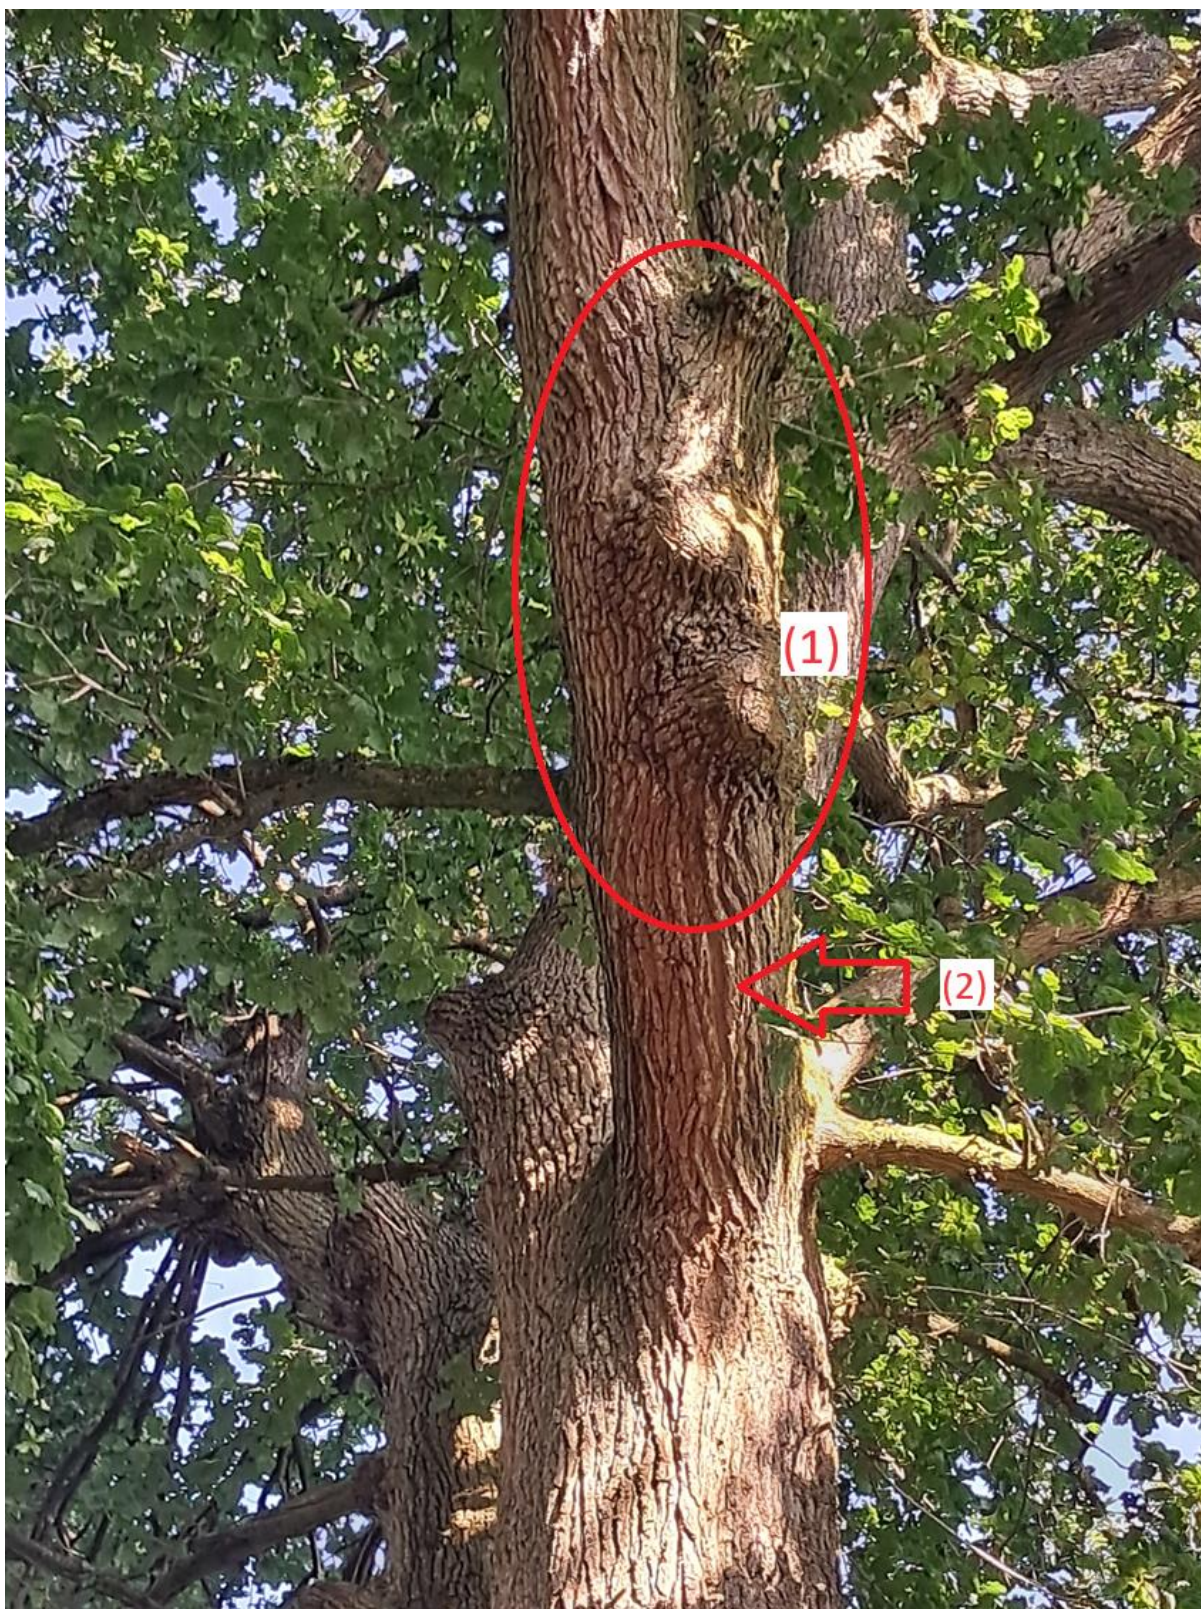
Photo 5 – Reverse tapering of large extended, horizontal branch – note included pruning cuts (1) and changes in ridges in bark on underside of limb (2) indicating rapid growth of limb and possible indication of decay.

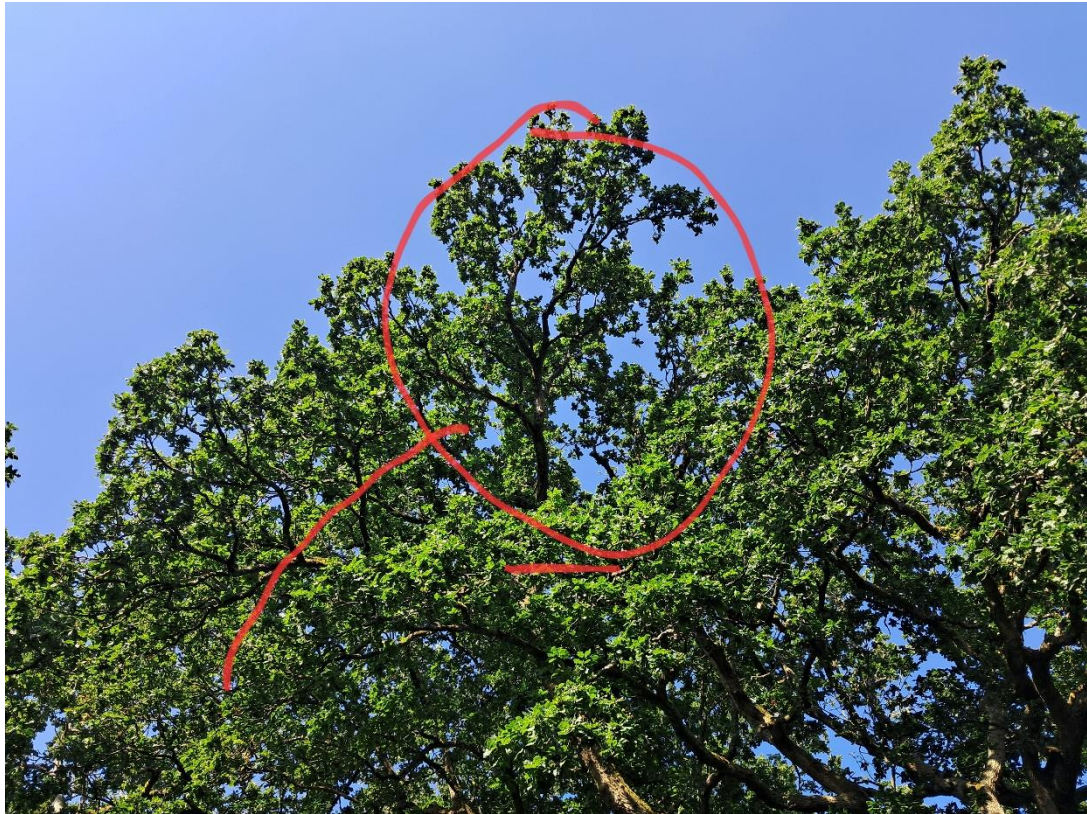
Photo 6 – Tips of large extended, horizontal branch now assuming apical dominance. Indicative lines of pruning cuts and secondary branch removal to reduce weight and exposure of the branch and associated risk of breakage.

| <p><b>Recommended Tree Works:</b></p> <p>1) Remove secondary branch approximately 4m long (as circled in Photo 6) and reduce tips of surrounding secondary branch tips 2-3m (as per Photo 6).</p> <p>Reason: To reduce weight &amp; exposure of elongated branch due to defect present lower down this stem.</p> <p>3) Northwest quadrant – selectively reduce outer branch tips 1-1.5m back to suitable reduction points to reduce overbearing nature of canopy in relation to 9 Queens Ride and to create a small area of useable garden which is not directly under the tree's canopy.</p> <p>3) Crown lift to create 4m canopy clearance above ground level removing small shoots over garden of 10 Palmer Close back to the trunk.</p> <p>The proposed works are minor pruning works to address concerns regarding the form of a large branch over the garden of Queens Ride and to create reasonable clearance to the property. The asymmetrical canopy covers the entire garden of 9 Queens Ride which is oppressive. The proposed minor pruning works will go some way to improving this relationship.</p> <p>Cuts will be graded into the surrounding canopy to leave a sympathetic, natural looking canopy shape. Cuts will not exceed 80mm diameter. The health and amenity of the tree will not be impaired in any way.</p> | | | | | Priority | Within 3 months | | | |

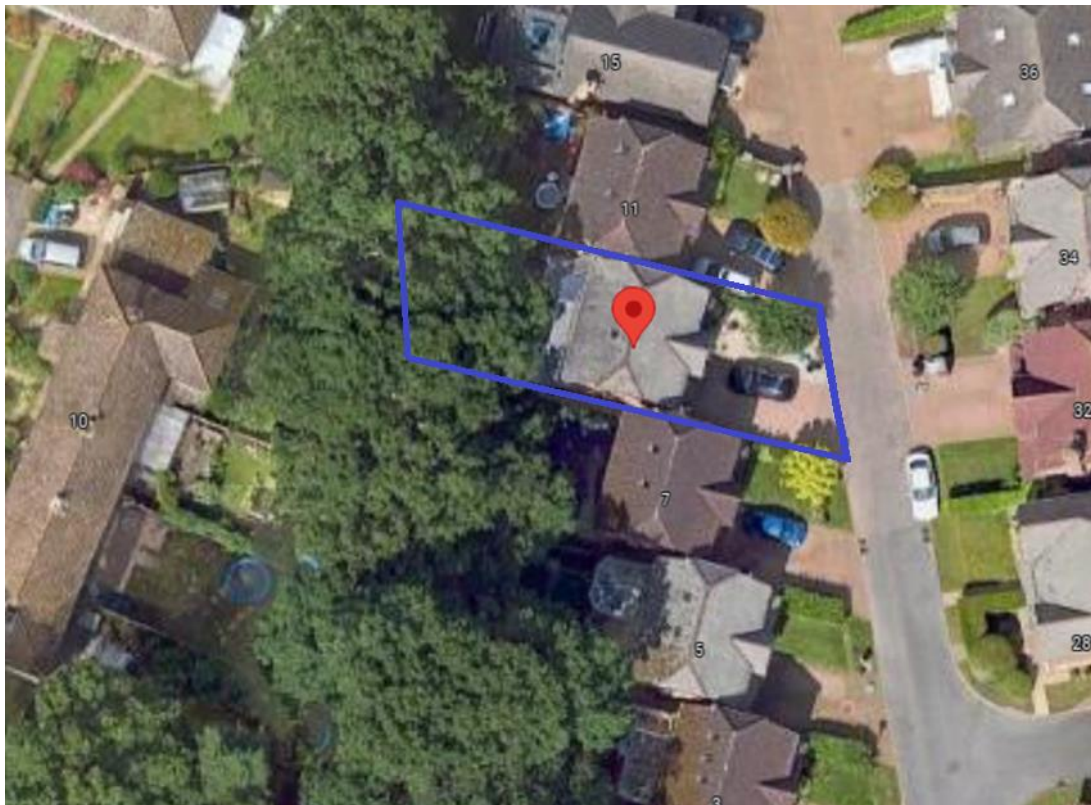
Photo 7 – Google aerial photo shows the entire rear garden of 9 Queens Ride under the canopy of T033 (Oak).
