BS5837:2012

Tree Survey

Grove Service Station
Old Bath Road, Charvil
Reading, RG10 9QJ

Original: 09/01/2025
Revision A: 22/10/2025
Job number: 2688
Report reference: TGA.2688.TreeSurveyRevA

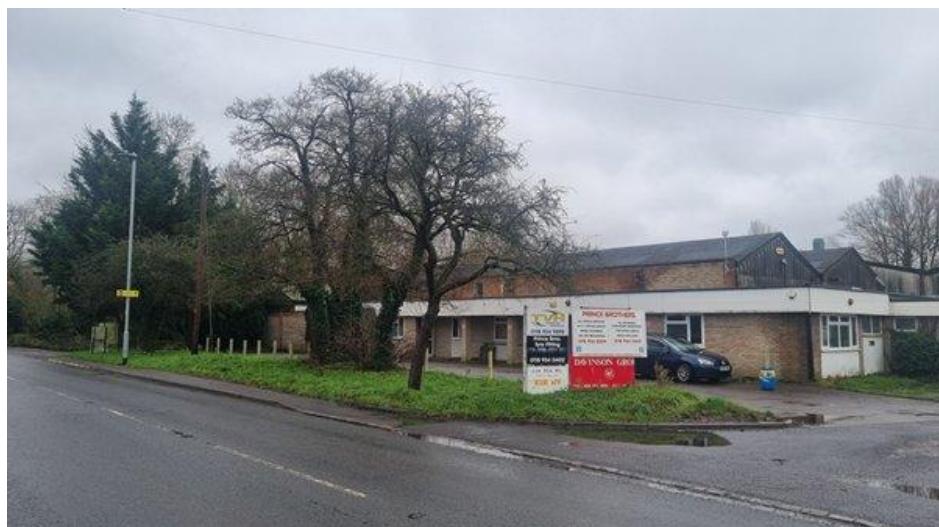
Trees on site frontage T1 – T10

No.	Species	Ht (crown)	Dia (stems)	Crown spread (NESW)	Life stage	ERC	Comments & preliminary recommendations	BS Cat
T1	<i>Crataegus monogyna</i> (Hawthorn)	7(2)	260(1)	3.5, 3.5, 3.5, 3.5	M	10+	Low individual quality but landscape value as part of boundary screening.	C2
T2	<i>Acer campestre</i> (Field Maple)	8(2)	350(1)	4, 2, 4, 4.5	M	20+	Uneven crown shape due to competition with adjacent trees. Ivy on main stem. Scattered deadwood throughout upper crown.	B2
T3	<i>Acer campestre</i> (Field Maple)	10(2)	380(1)	3, 2, 3, 3	M	20+	Uneven crown shape due to competition with adjacent trees. Ivy on main stem. Scattered deadwood throughout upper crown. One of three trees planted in close proximity at base with shared canopy	B2
T4	<i>Acer campestre</i> (Field Maple)	10(2)	280, 390, 320(3)	3, 4.5, 4.5, 2	M	20+	Multi stem from 1m. Uneven crown shape due to competition with adjacent trees. Ivy on main stem. Scattered deadwood throughout upper crown. One of three trees planted in close proximity at base with shared canopy	B2

T5	<i>Acer campestre</i> (Field Maple)	10(2)	400(1)	4, 3.5, 1, 3.5	M	20+	Multi stem from 1m. Uneven crown shape due to competition with adjacent trees. Ivy on main stem. Scattered deadwood throughout upper crown. One of three trees planted in close proximity at base with shared canopy	B2
T6	<i>Crataegus monogyna</i> (Hawthorn)	6(2)	100(6)	3.5, 3.5, 3.5, 3.5	M	10+	Multi stem from ground level. Average estimated diameter given for multiple stems. Ivy throughout crown. Low individual quality but landscape value as part of boundary screening.	C2

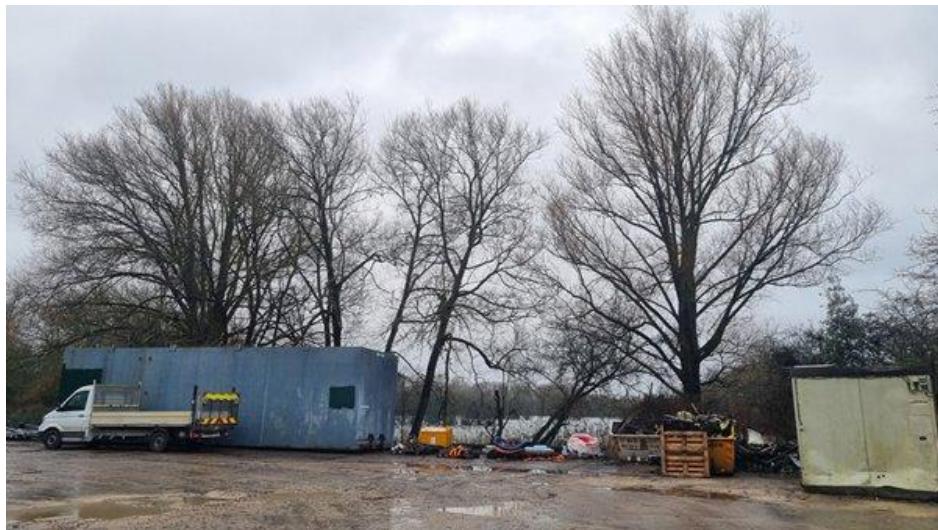
Offsite trees to south of site T14 – T20

No.	Species	Ht (crown)	Dia (stems)	Crown spread (NESW)	Life stage	ERC	Comments & preliminary recommendations	BS Cat
T15	Salix alba (White Willow)	21(4)	390, 380, 400(3)	7.5, 7.5, 7.5, 7.5	M	20+	Multi stem from ground level. Deadwood in crown. Offsite tree. Rooted in area of wet ground. Northern stem leans at an unsustainable angle into site. Recommend this is reduced by 50% of height to boundary line to reduce risk of collapse.	C2
T16	Salix alba (White Willow)	21(4)	520(1)	7.5, 2, 7.5, 7.5	M	20+	Uneven crown shape due to competition with adjacent trees. Deadwood in crown. Offsite tree. Rooted in area of wet ground	C2
T17	Salix alba (White Willow)	21(4)	300, 400(2)	7.5, 7.5, 7.5, 7.5	M	20+	Twin stem from ground level. Stem inaccessible diameter estimated. Deadwood in crown. Offsite tree. Rooted in area of wet ground. Limb in upper crown snapped and laying on canopy of G18 trees.	C2
G18	Salix alba (White Willow)	10(0)	200(1)	3, 3, 3, 3	EM	10+	Canopy extents as indicated on topographical survey. Average estimated dimensions given for group. Low individual quality but landscape value as part of boundary screening. Relatively low quality offsite trees with numerous faults.	C2

T19	Salix alba (White Willow)	21(4)	910(1)	7.5, 7.5, 7.5, 7.5	M	20+	Offsite tree at edge of footpath near lake.	B2
T20	Salix alba (White Willow)	21(4)	870(1)	7, 7.5, 9, 7.5	M	20+	Offsite tree at edge of lake.	B2
T21	Salix caprea (Goat Willow)	4(0)	100(2)	4, 4, 4, 4	SM	20+	Stem diameter estimated. Low quality and not a development constraint. Multistem regrowth from stumps.	C1

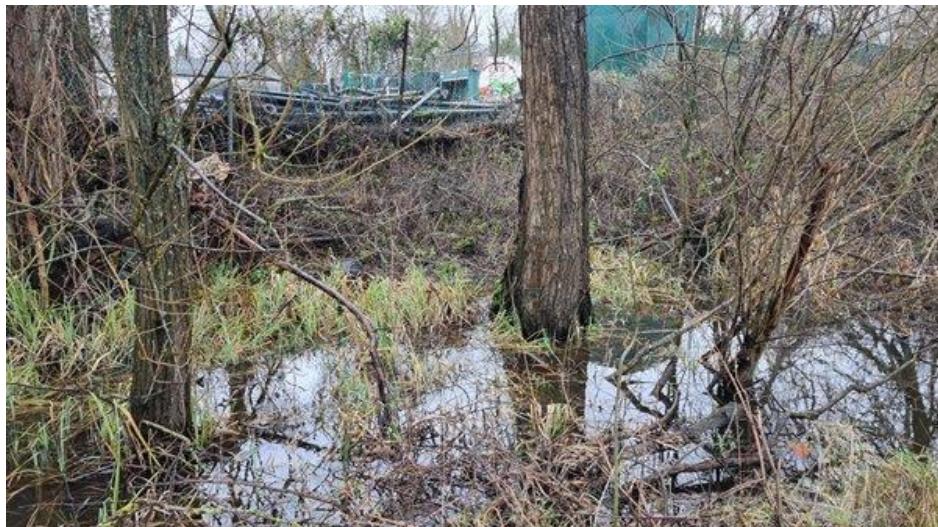
3.2. To the south of the site is a fishing lake. The level of the ground offsite to the south and east is lower than the surface within the site by approximately 1m.

Offsite trees to south at lower level to site within
waterlogged ground

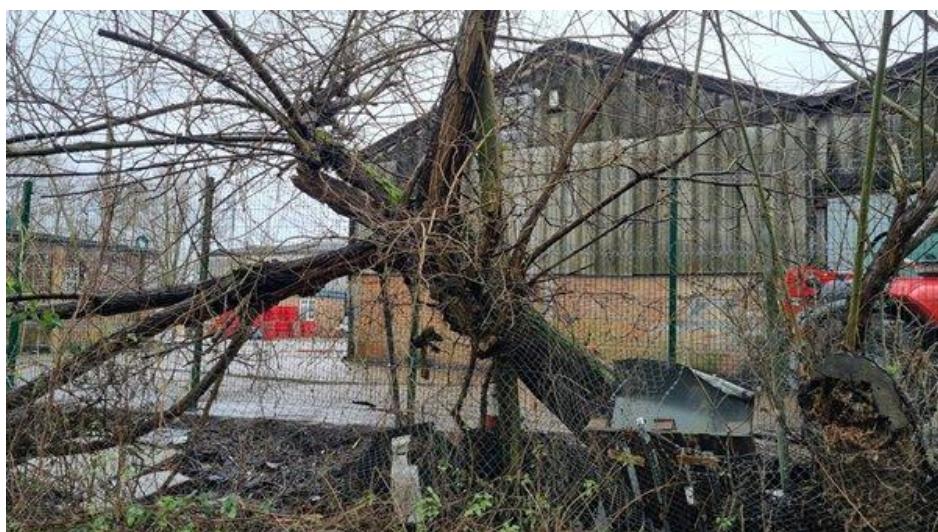
Collapsed U category tree T32

No.	Species	Ht (crown)	Dia (stems)	Crown spread (NESW)	Life stage	ERC	Comments & preliminary recommendations	BS Cat
T29	<i>Quercus robur</i> (Common Oak)	10(0)	150(1)	3, 3, 3, 3	SM	40+	Self-seeded tree on boundary. Poor stem shape	C2
T30	<i>Quercus robur</i> (Common Oak)	10(0)	150(1)	3, 3, 1, 1	SM	40+	Unbalanced crown shape. Self-seeded tree on boundary.	C2
T31	<i>Fraxinus excelsior</i> (Ash)	10(3)	250(1)	3, 3, 3, 3	SM	10+	Limited life expectancy due to Ash dieback disease. Consistent with having self-seeded. Stem diameter estimated. Ivy throughout crown. Low quality and not a development constraint.	C2
T32	<i>Salix caprea</i> (Goat Willow)	13(1)	500(1)	4, 4, 8, 4	M	<10	Located between two fences diameter estimated. Main stem leans at 45 degrees from past collapse. Top of main stem cut off and a few former side branches now form crown. Poor quality and not suitable for retention. Removal recommended.	U

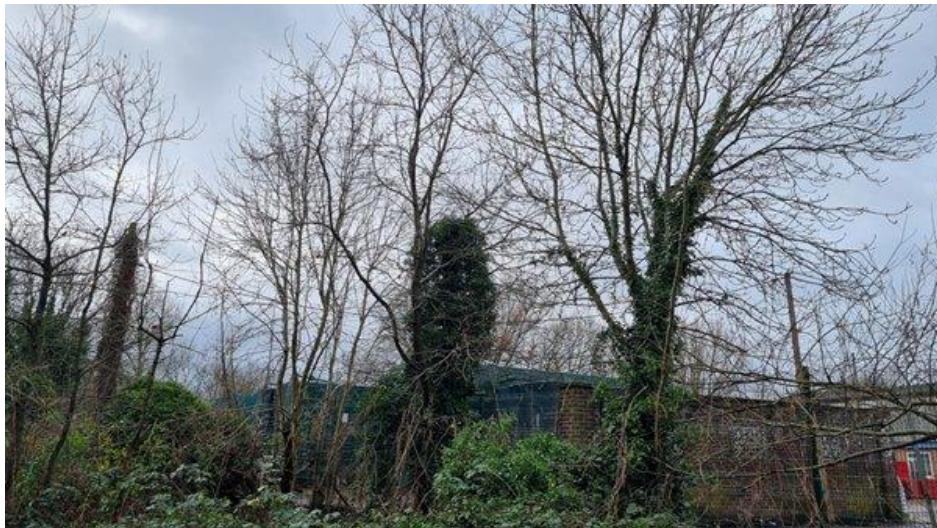
self-seeded sycamore, goat willow and ash on the eastern boundary, as well as just offsite to the south which are also low quality.

Self-seeded ash trees on eastern boundary

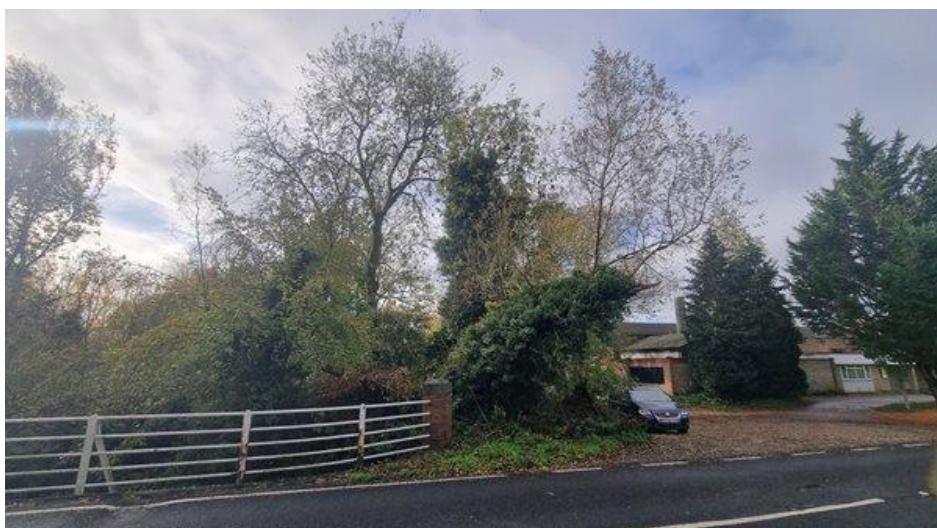
Trees at northeast of site T40 (centre), T38 (centre left)T36 (centre right)

- 4.6. With trees T35 - T39 there is ash dieback visible within the canopy and a reduced level of live foliage. The trees have a limited life expectancy of less than 20 years making them C category. As such it is not considered that these should represent any constraint to development should their removal be

No.	Species	Ht (crown)	Dia (stems)	Crown spread (NESW)	Life stage	ERC	Comments & preliminary recommendations	BS Cat
T35	Fraxinus excelsior (Ash)	13(8)	330(1)	3, 1, 1, 5.5	EM	10+	Sparse with evidence of Ash dieback visible throughout crown. Limited life expectancy. Leaning stem. Unbalanced crown shape. Compromised by ivy infestation. Located 9.75m from T34 and 14.5m from corner of building.	C2
T36	Fraxinus excelsior (Ash)	12(5)	290(1)	4.5, 2, 2, 4.5	EM	10+	Sparse with evidence of Ash dieback visible throughout crown. Limited life expectancy. Unbalanced crown shape. Compromised by ivy infestation. Located 10m from T34 and 11m from corner of building.	C2
T37	Fraxinus excelsior (Ash)	6(2)	100(1)	4, 1, 0, 3	SM	10+	Limited life expectancy due to Ash dieback disease. Stem position estimated as not indicated on topographical survey. Low quality and value.	C2
T38	Fraxinus excelsior (Ash)	16(8)	660(1)	5, 5, 5, 5	M	10+	Limited life expectancy due to Ash dieback disease. Located 15m from T34 and 17m from corner of building. Approximately 50% of leaf cover present due to ash dieback. Deadwood throughout crown.	C2

No.	Species	Ht (crown)	Dia (stems)	Crown spread (NESW)	Life stage	ERC	Comments & preliminary recommendations	BS Cat
T40	Salix fragilis (Crack Willow)	8(1)	300(1)	6, 2, 0, 4	EM	<10	Stem diameter estimated. Approximately 4.5m from edge of roadway. Main stem windblown and leaning at 45° towards road. Main stem snapped out in line with road edge and then cut back presumably to clear storm damage back from road. Not suitable for long term retention due to likelihood of collapsing further onto the road. Poor physiological condition due to few remaining branches. Ivy swamped.	U
T41	Fraxinus excelsior (Ash)	10(7)	450(1)	2, 2, 2, 2	M	<10	4m north of T38. Dead from Ash dieback disease. No live foliage visible. Ivy infested stem. Large branches snapped off and lying at base of tree.	U
T42	Acer campestre (Field Maple)	6(1)	160(1)	2, 4, 3, 2.5	EM	40+	Unbalanced crown shape. 1m west of T38. Uneven crown shape part of understorey.	C2

required. Replacement planting is recommended for trees removed, however an alternative species to Ash would be recommended.

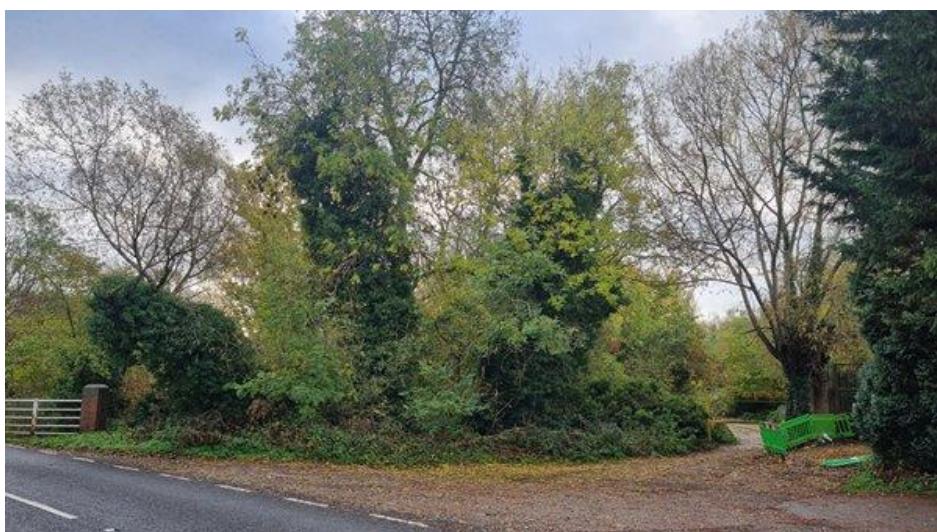
Trees at northeast of site T40 (left) – T35 (right)

T39	Fraxinus excelsior (Ash)	13(8)	330(1)	4.5, 2, 1, 2.5	EM	10+	Limited life expectancy due to Ash dieback disease. Leaning stem. Unbalanced crown shape. Located 8.5m from edge of roadway and 15m from corner of building. Dense ivy on main stem and throughout upper crown.	C2
