## **APPENDIX A**

### **Photographic Record**

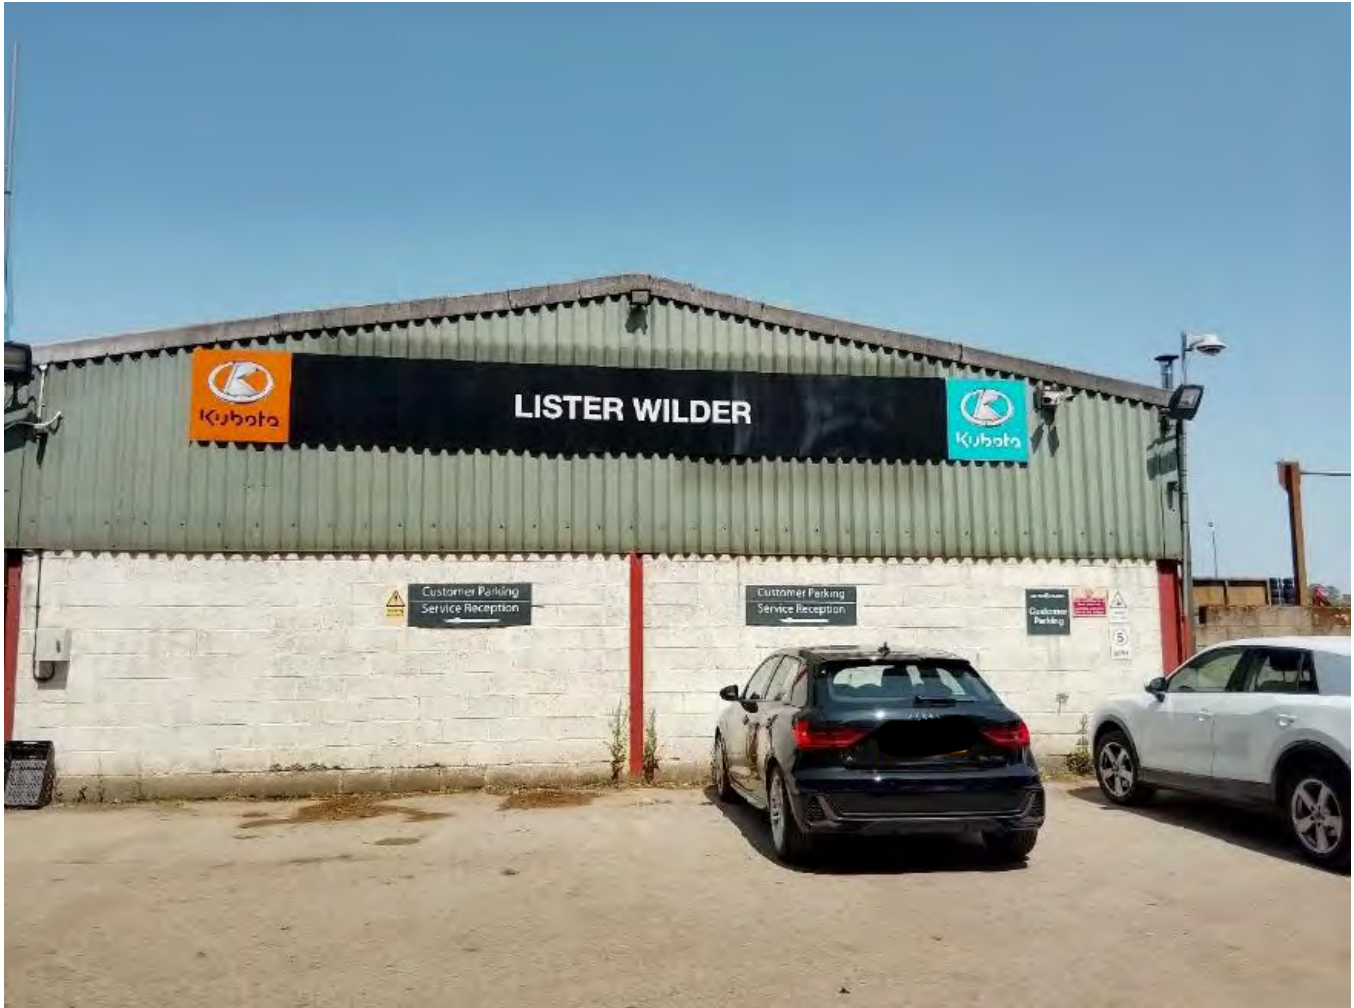
**Photo 1**

View of concrete block and corrugated metal vehicle maintenance workshops from the entrance off White House Lane looking north. Surface covering is comprised of poured concrete.

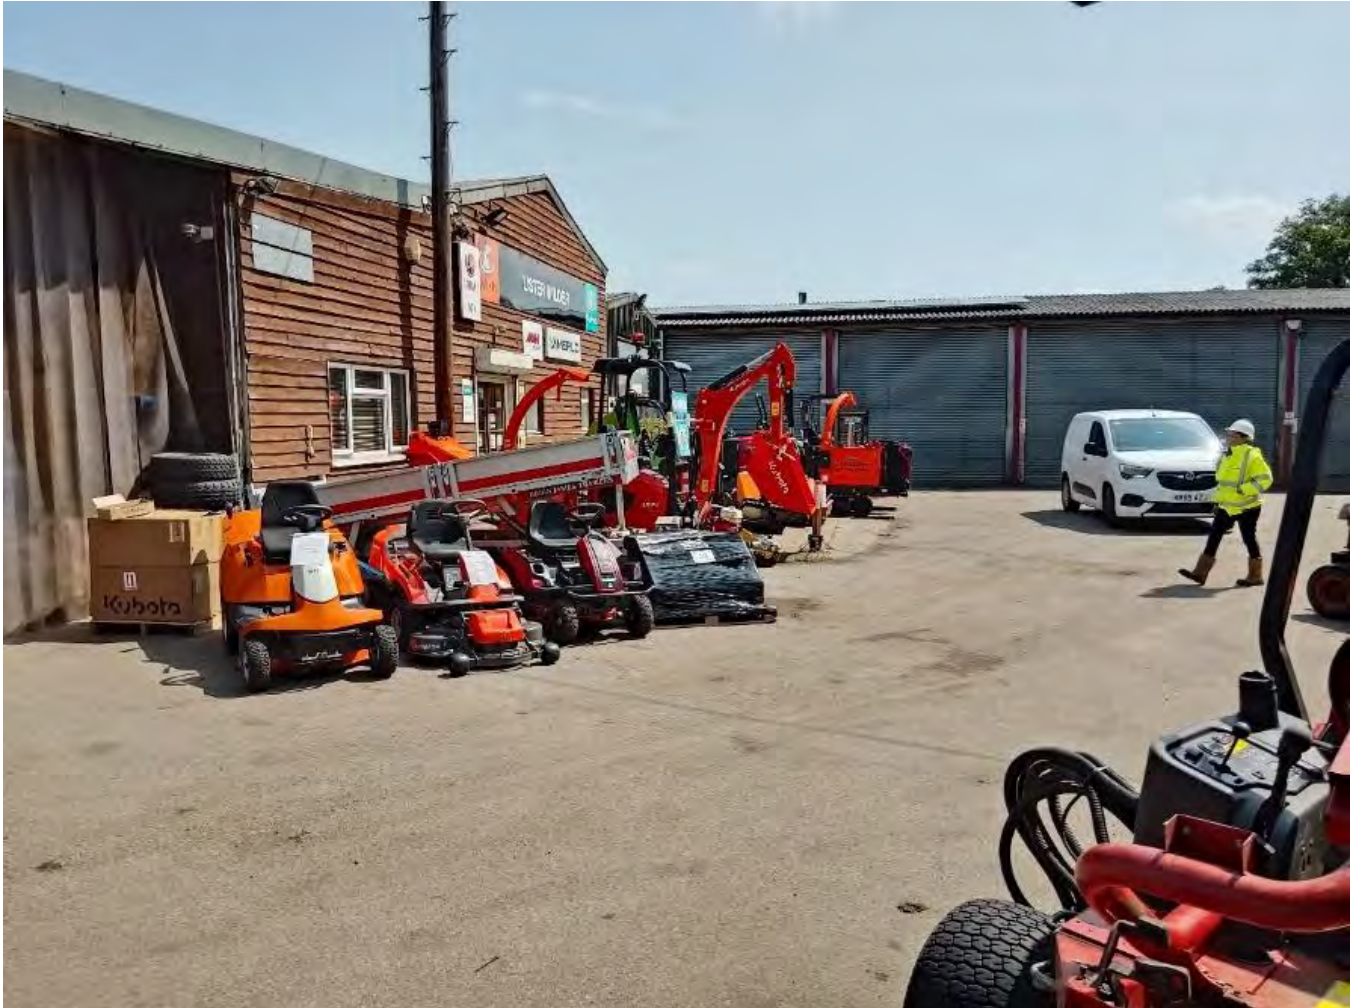
## Photo 2

View of the main retailer's yard with show machinery stored outside looking east. The corrugated metal and concrete block sales offices and showrooms are present on the left of the image. The vehicle maintenance workshops are present in the near distance. Surface covering is comprised of poured concrete.

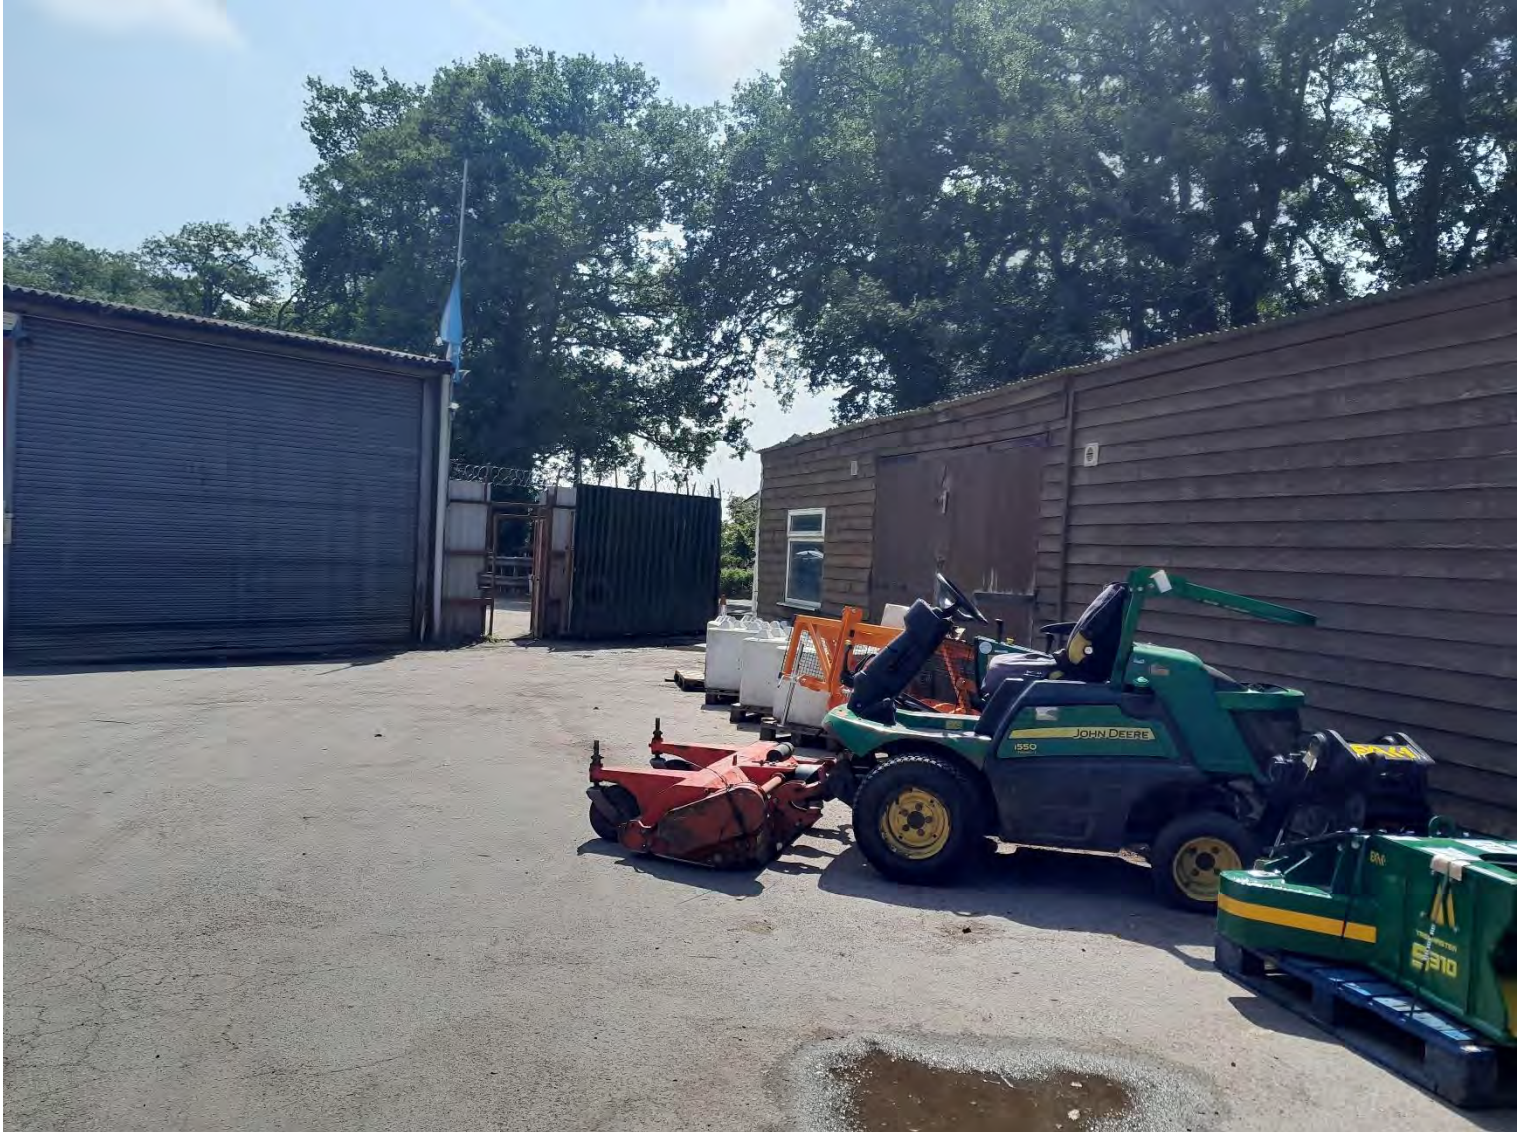
### Photo 3

View of the main retailer's yard with machinery and concrete blocks stored outside a wooden and corrugated metal structure. Further machinery and items were stored within. The main vehicular and pedestrian access is visible in the far centre of the image.

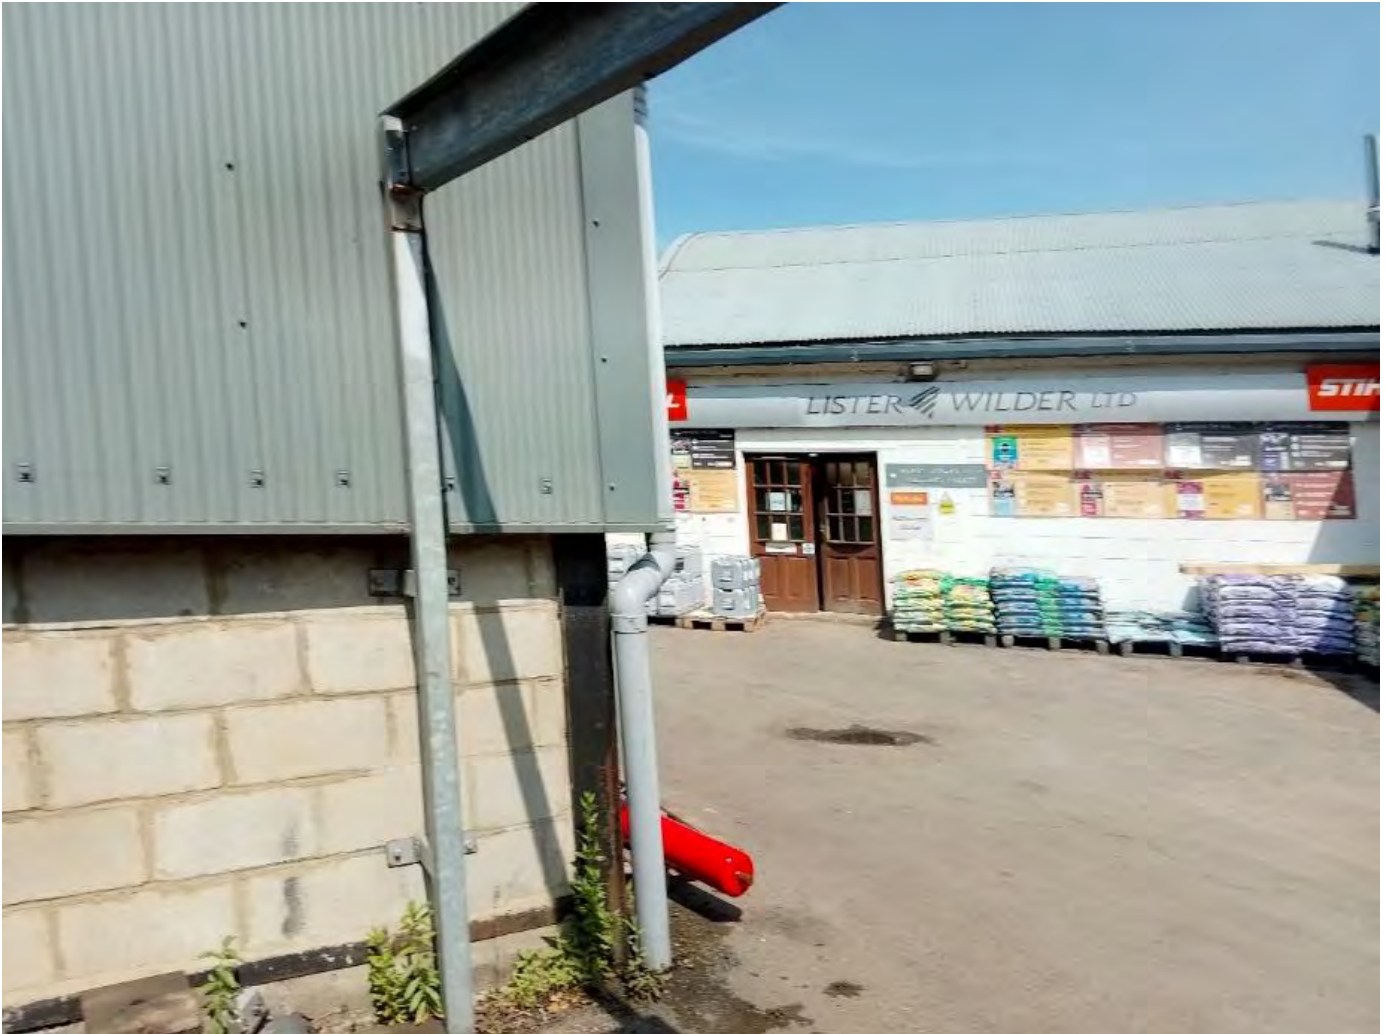
## Photo 4

View of the front of the corrugated metal and concrete block retailers stop looking north. On the left of the image another corrugated metal and concrete block structure of unknown purpose is present. Surface covering is poured concrete.

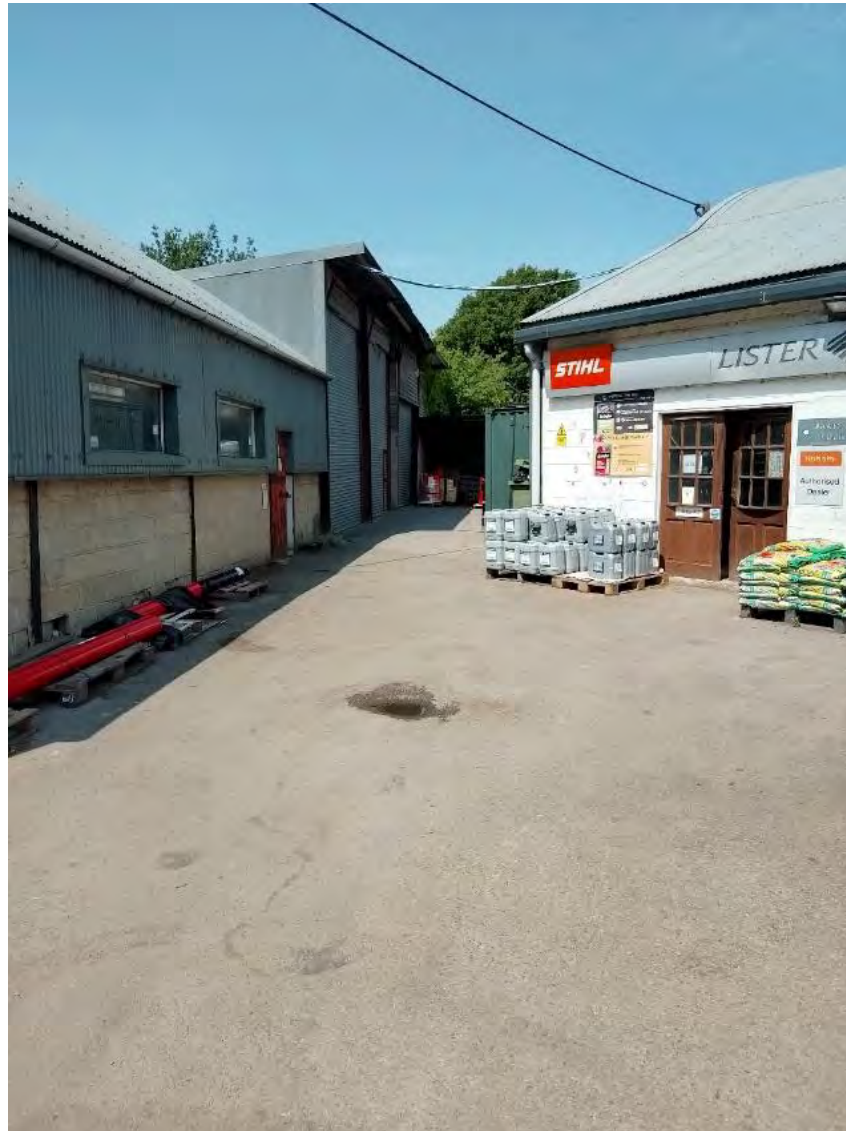
## Photo 5

View of the retailer's yard looking northwest. Further corrugated metal and concrete block structures of unknown purpose are visible in the far distance. Overhead cables are visible crossing the site. Surface covering is poured concrete.

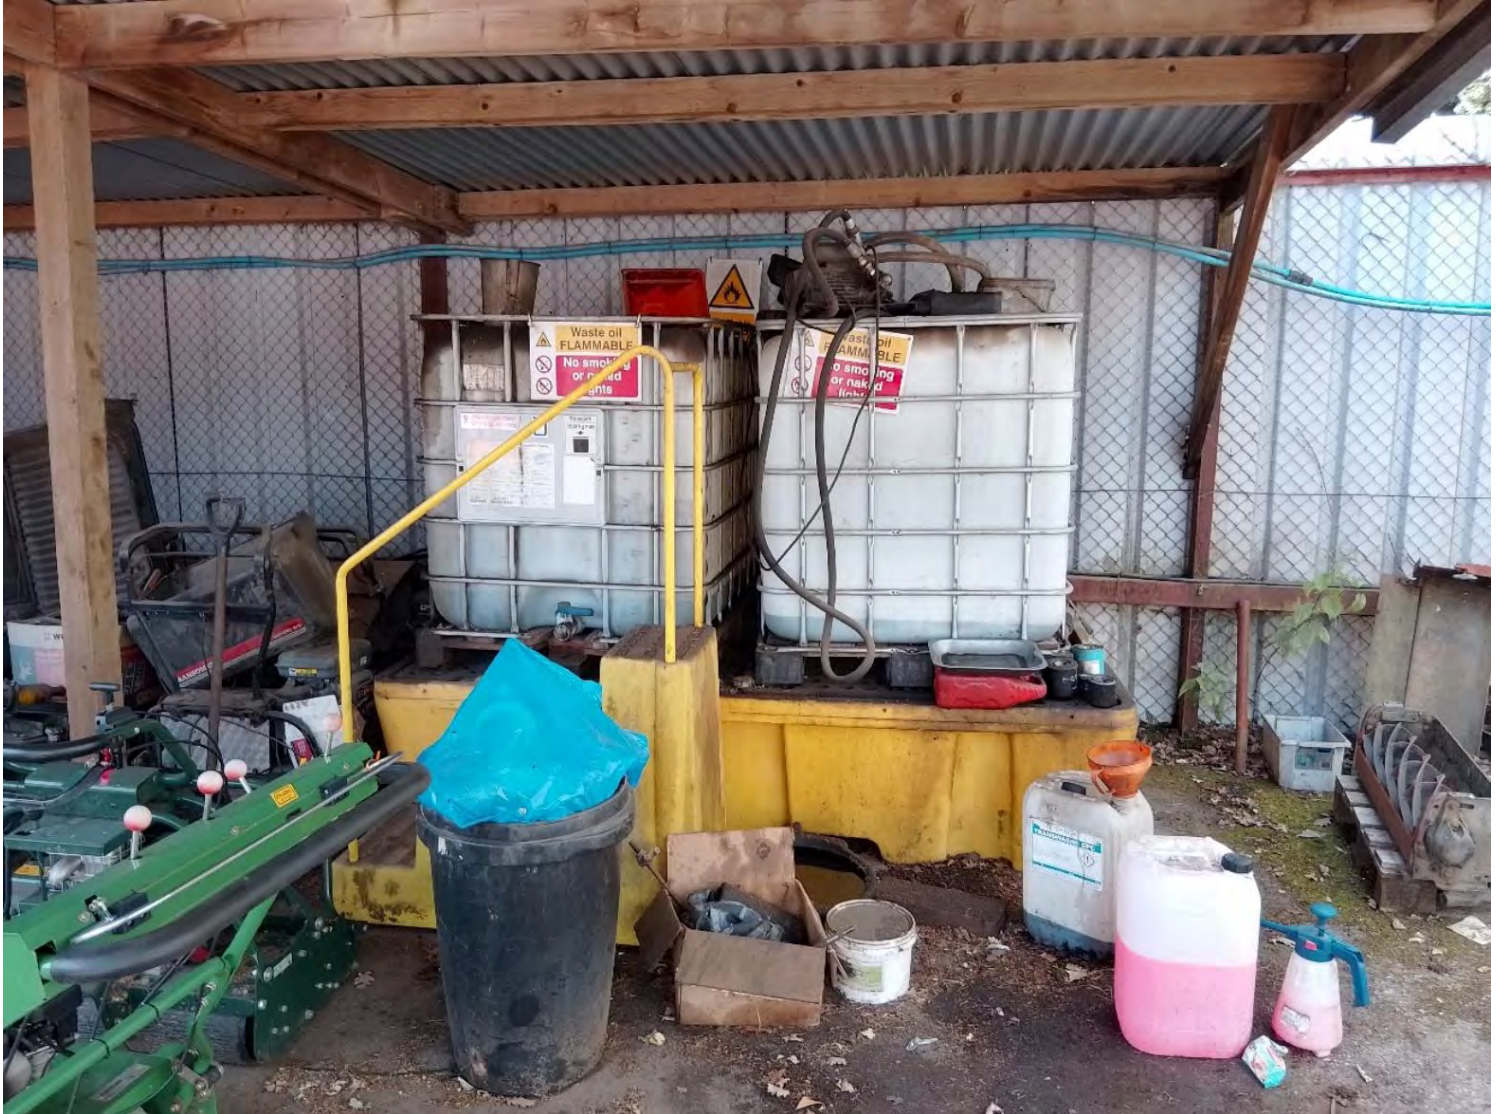
Photo 6

View of two vehicle oil IBCs sited atop plastic bunds in the southwest of the site looking southwest. Further miscellaneous items and open containers are stored in the vicinity. Moderate staining was observed around this area. Surface covering is poured concrete.

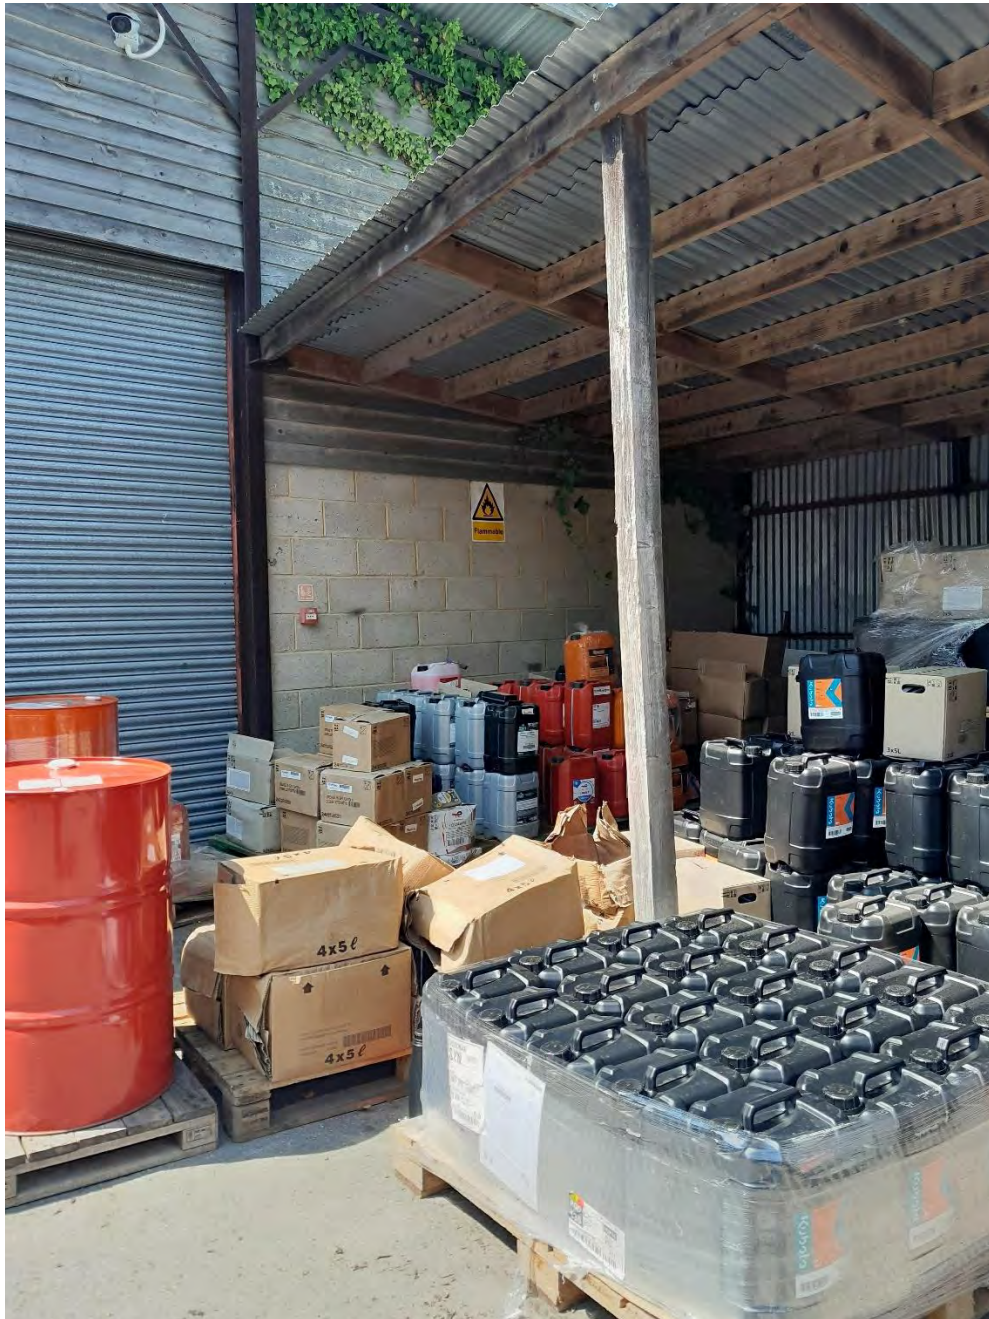
**Photo 7**

View of a covered area of the main retailer's yard looking northwest in which various miscellaneous items are stored. Concrete block, corrugated metal and wooden constructed buildings are visible in the background. Corrugated metal forms the covering. Surface covering is poured concrete

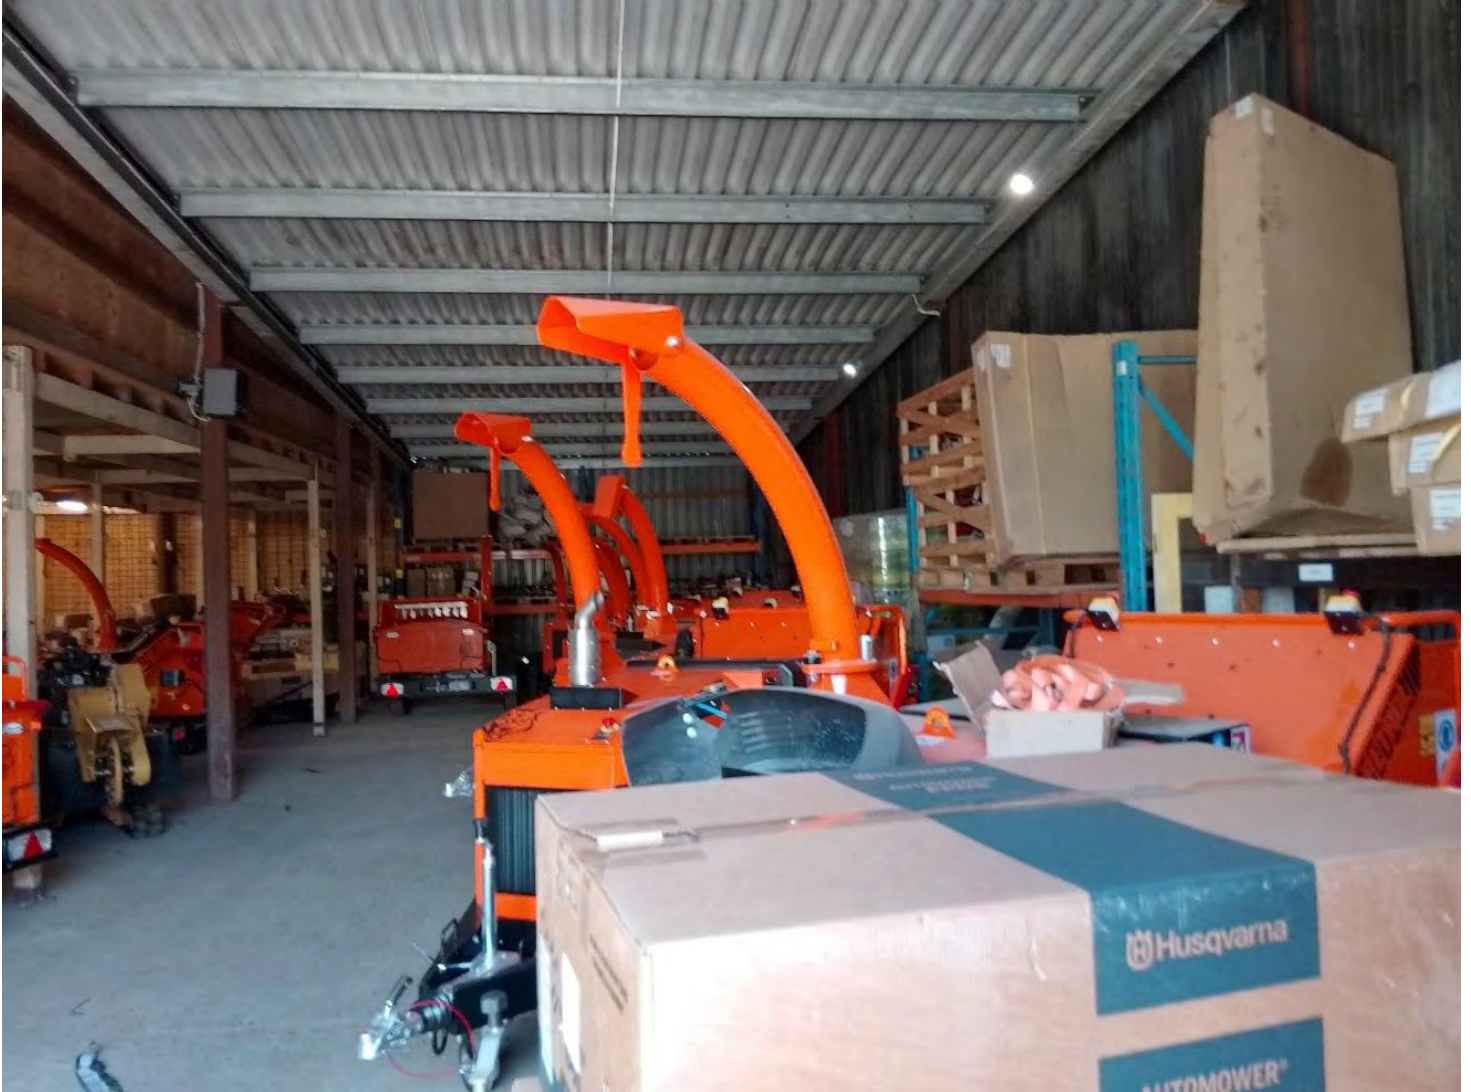
**Photo 8**

View of the inside of a corrugated metal, concrete block and steel beam storage warehouse in the west of the site looking east. Surface covering is poured concrete.

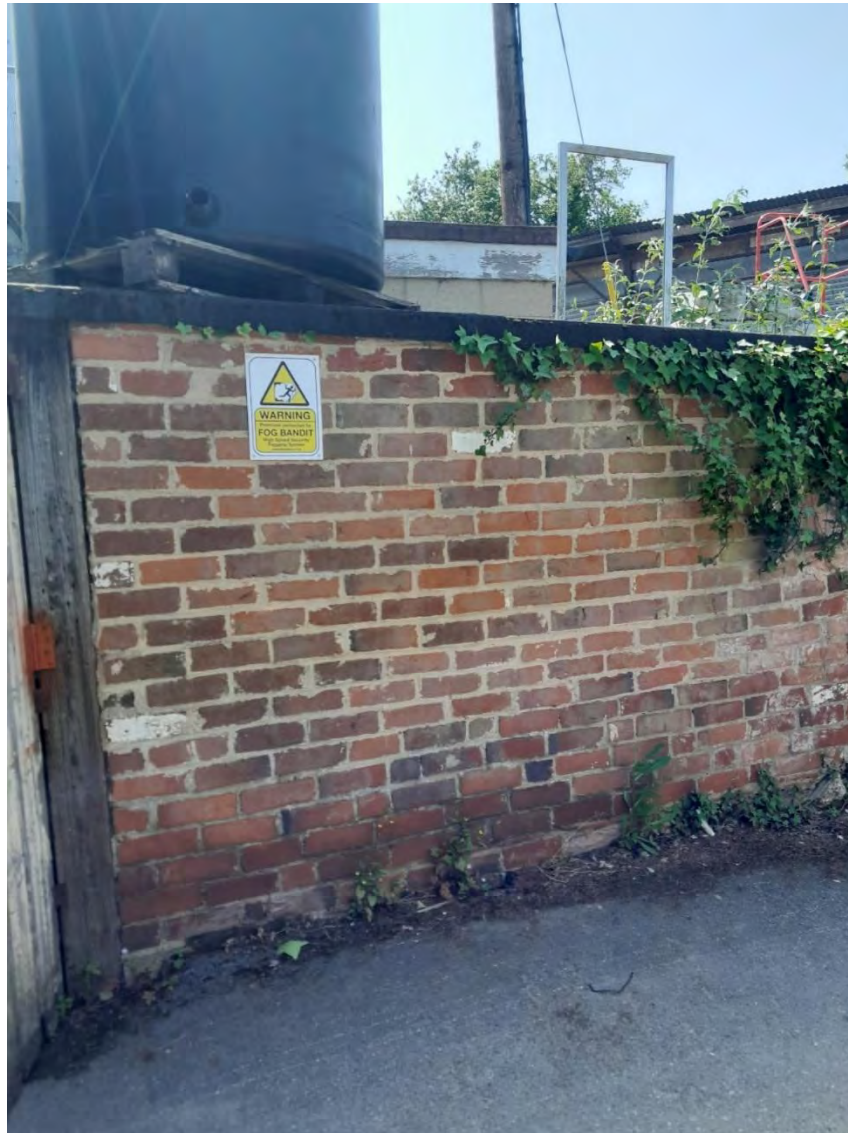
## Photo 9

View of a brick and mortar structure in the west of the site looking south. Within this structure, electrical junction boxes, fuse boxes and wiring was present which is assumed to provide power to the surrounding units.

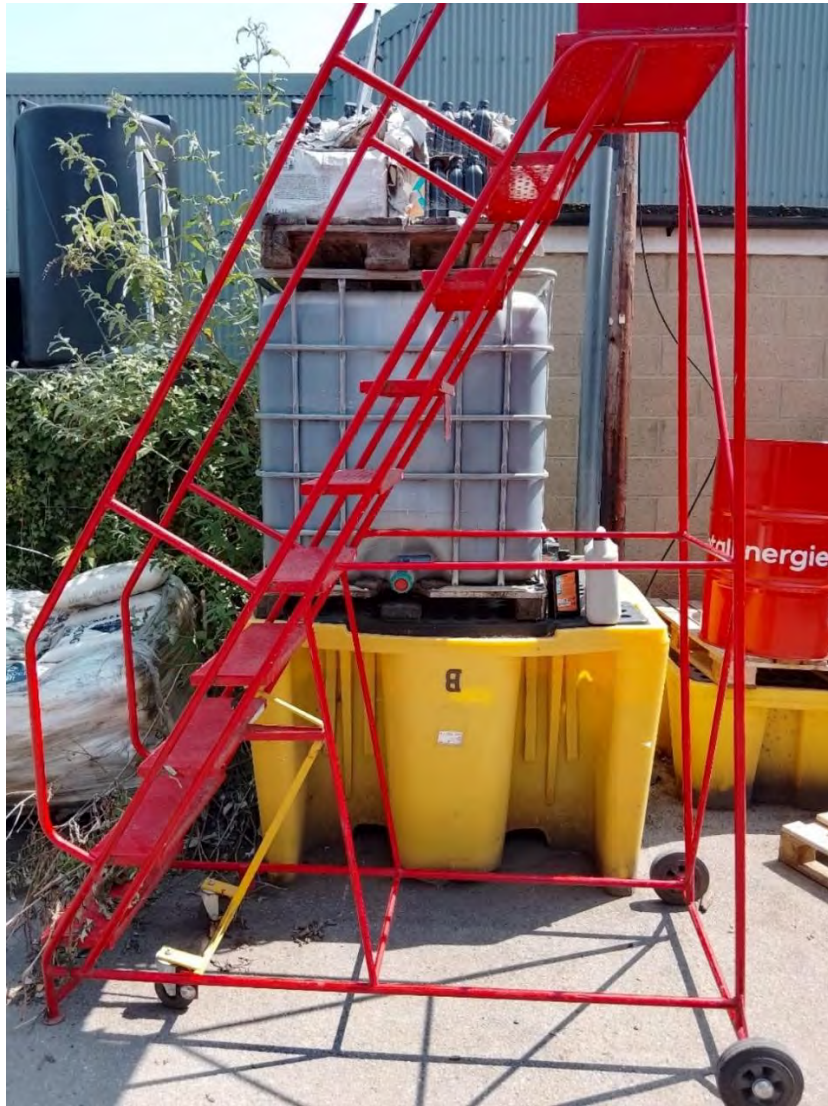
**Photo 10**

View of an IBC with unknown fluid stored on top of a plastic bund in the west of the site looking east. Surface covering is poured concrete.

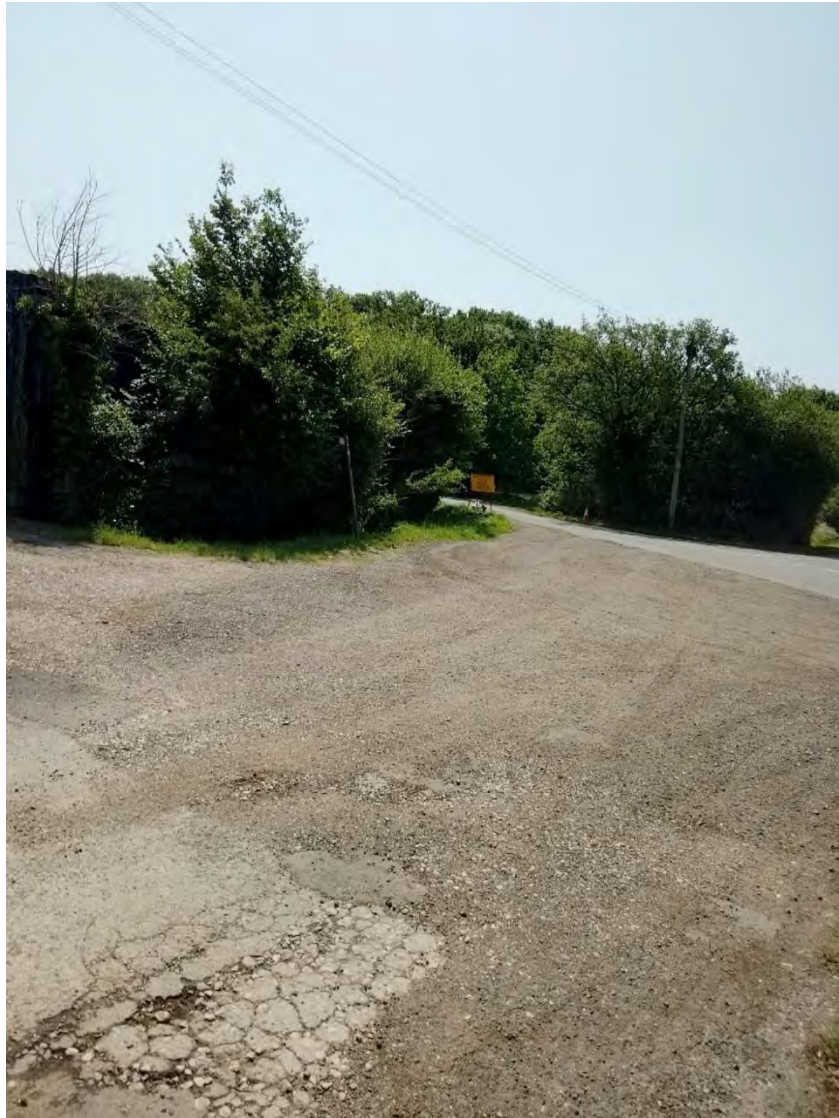
## Photo 11

View of the road access at the junction of Yew Tree Lane and White House Lane looking south.  
Surface covering is compacted gravel and concrete slabs.

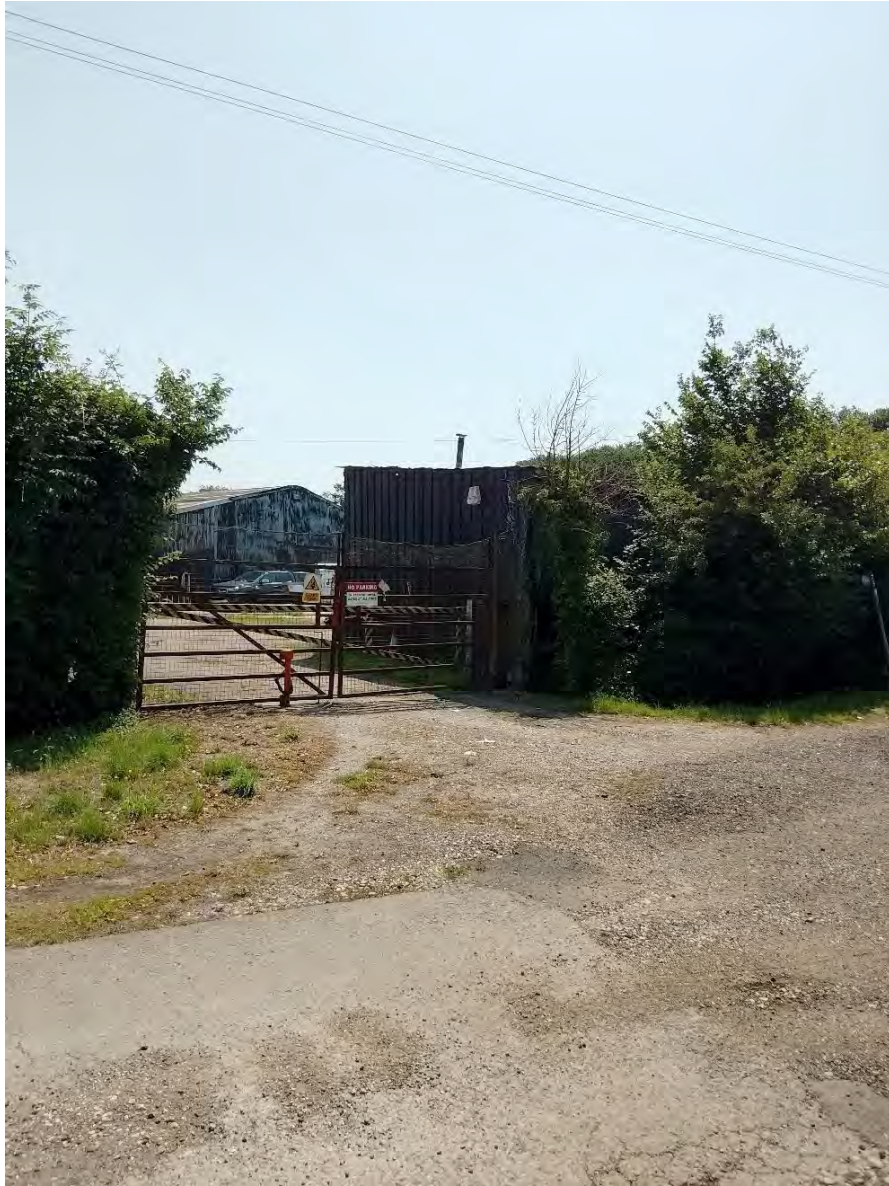
## Photo 12

View of the vehicular access and vehicle access gate off Whitehouse Farm (road) in the west of the site looking east. Surface covering is compacted gravel and concrete slabs.

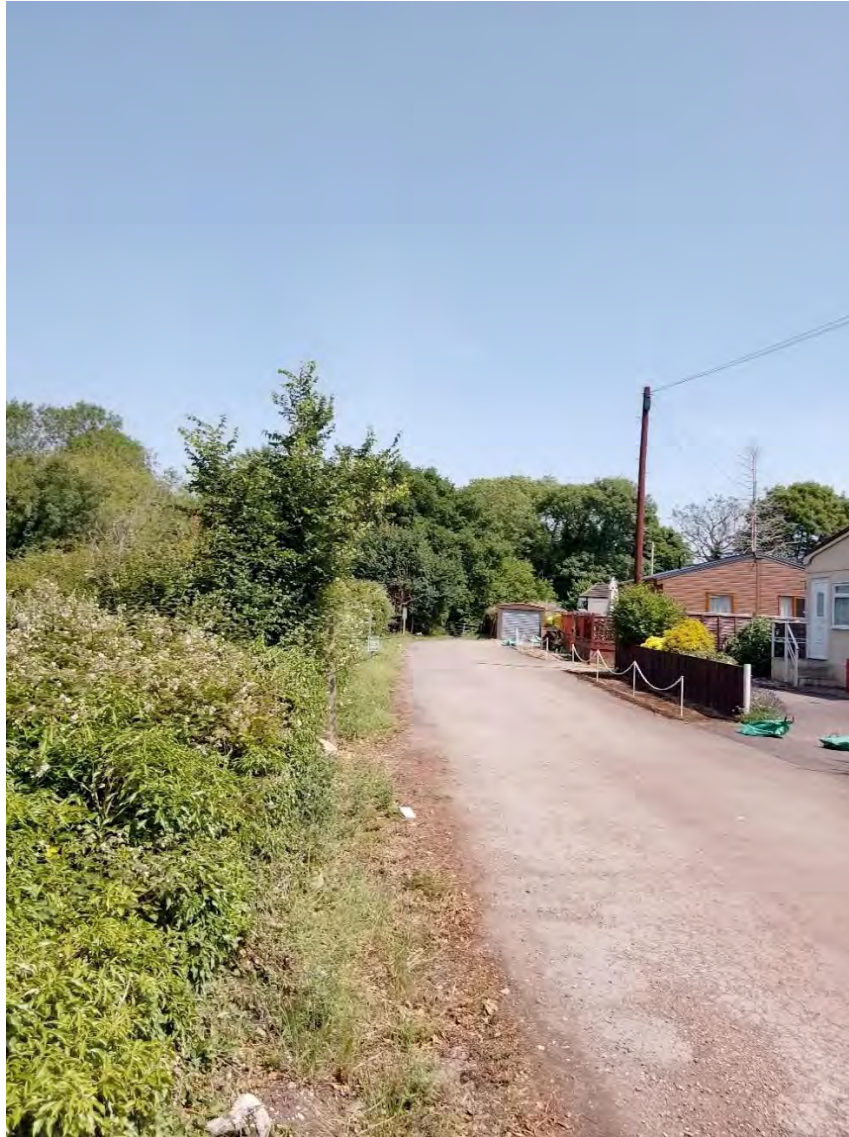
## Photo 13

View of Whitehouse Farm (road) to the residential caravan units beyond the northern site boundary looking north. On the left of the image is the easternmost extent of the Spencers Wood historic landfill.

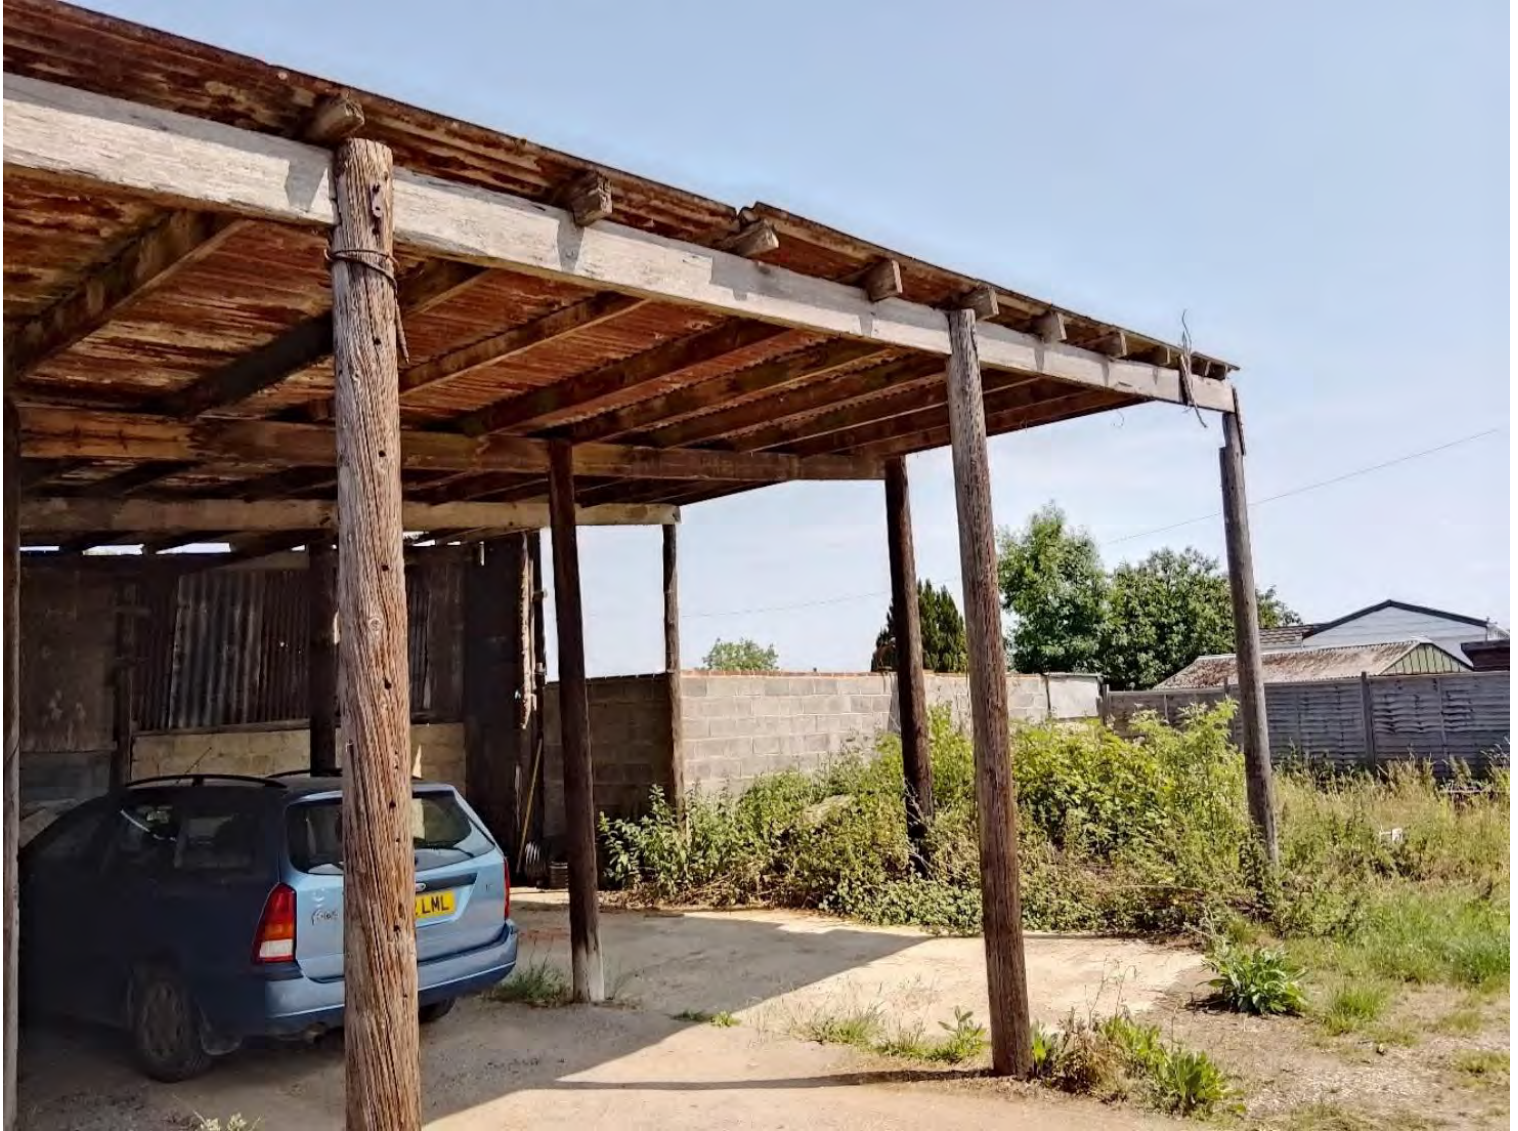
## Photo 14

View of a covered structure in the west of the site with possible asbestos roofing material present looking northeast. The visible concrete block wall and wooden fencing form the northern boundary in this section of the site. Surface covering is poured concrete/concrete slabs and compacted gravel with overgrown vegetation.

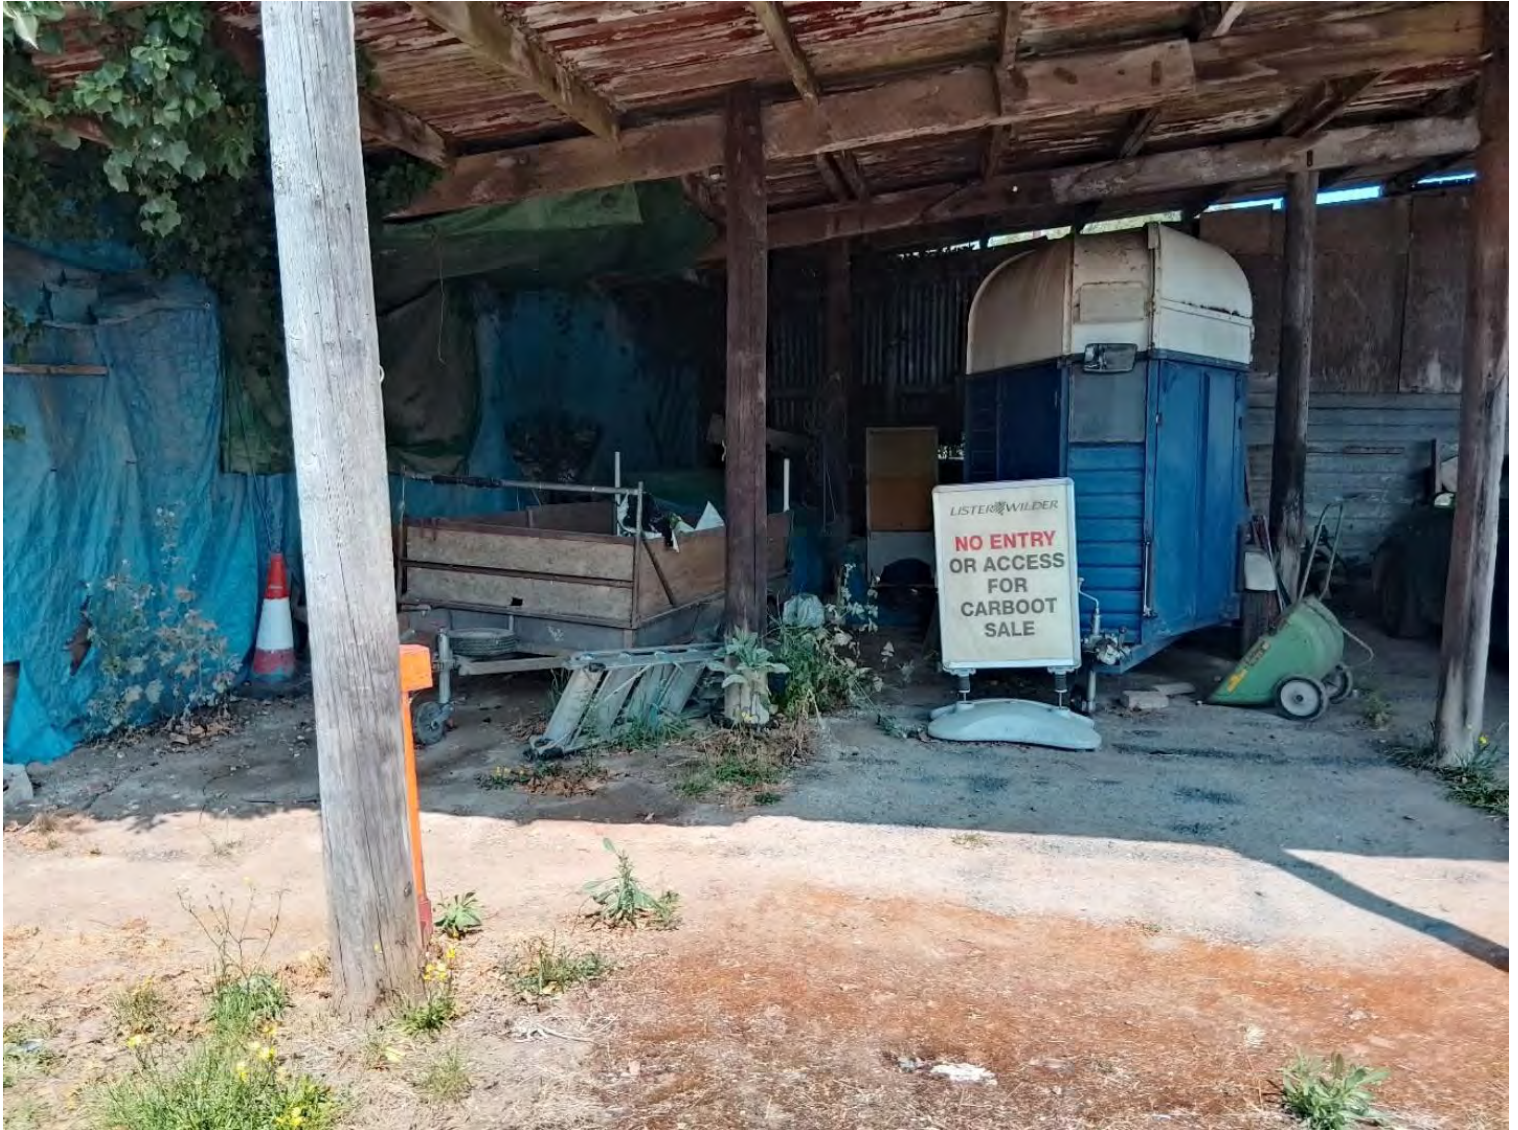
## Photo 15

View of various items stored under a covered structure with possible asbestos roofing material present in the west of the site looking north. Surface covering is poured concrete/concrete slabs and compacted gravel with overgrown vegetation.

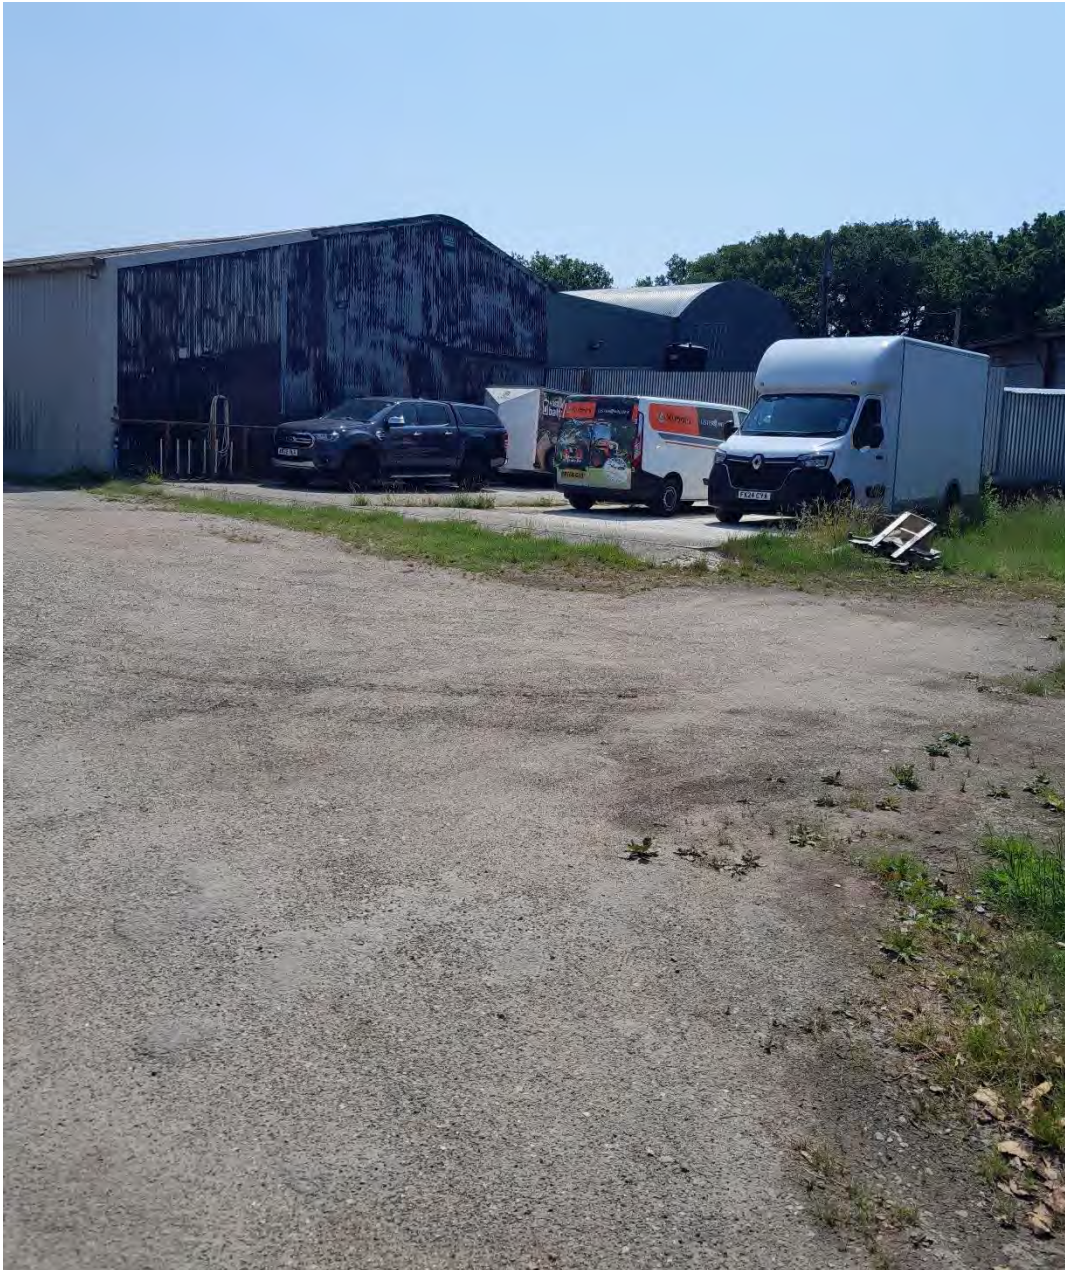
## Photo 16

View of vehicle parking area in the west of the site looking southeast. Corrugated metal structure is visible on the left. Surface covering is poured concrete/concrete slabs and compacted gravel with overgrown vegetation.
