## **APPENDIX A**

### **Photographic Record**

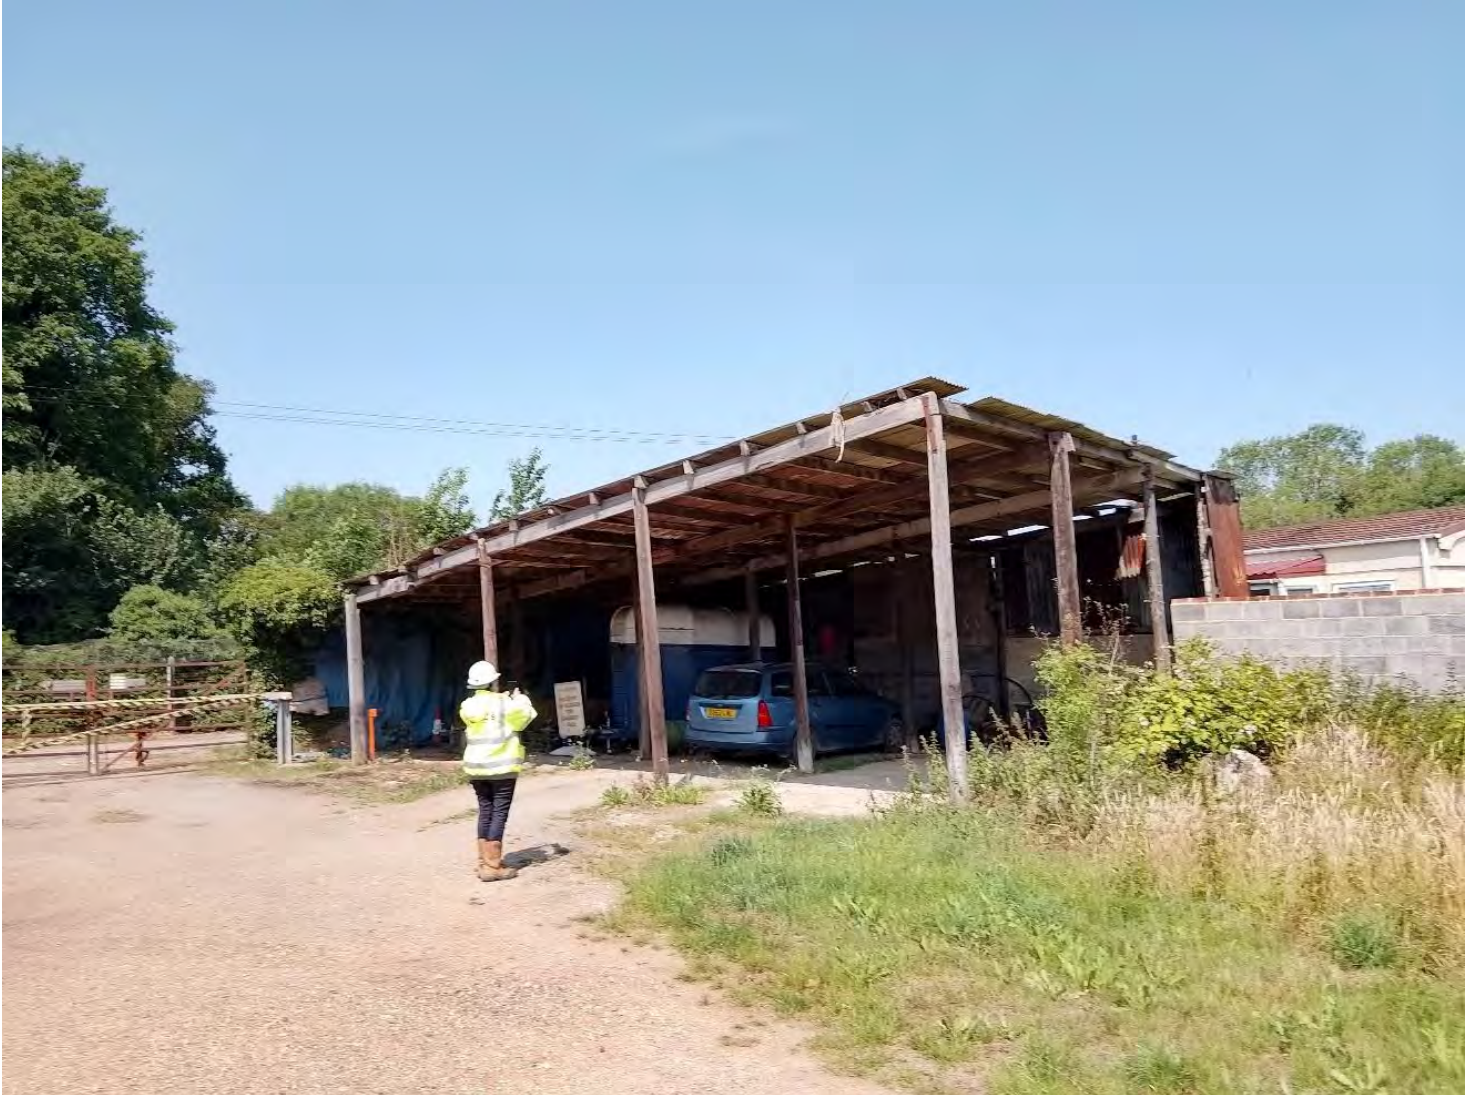
## Photo 17

View of a covered structure in the west of the site with possible asbestos roofing material present looking northwest. The vehicular access gate off Whitehouse Farm (road) is visible on the left of the image. Surface covering is poured concrete/concrete slabs and compacted gravel with overgrown vegetation.

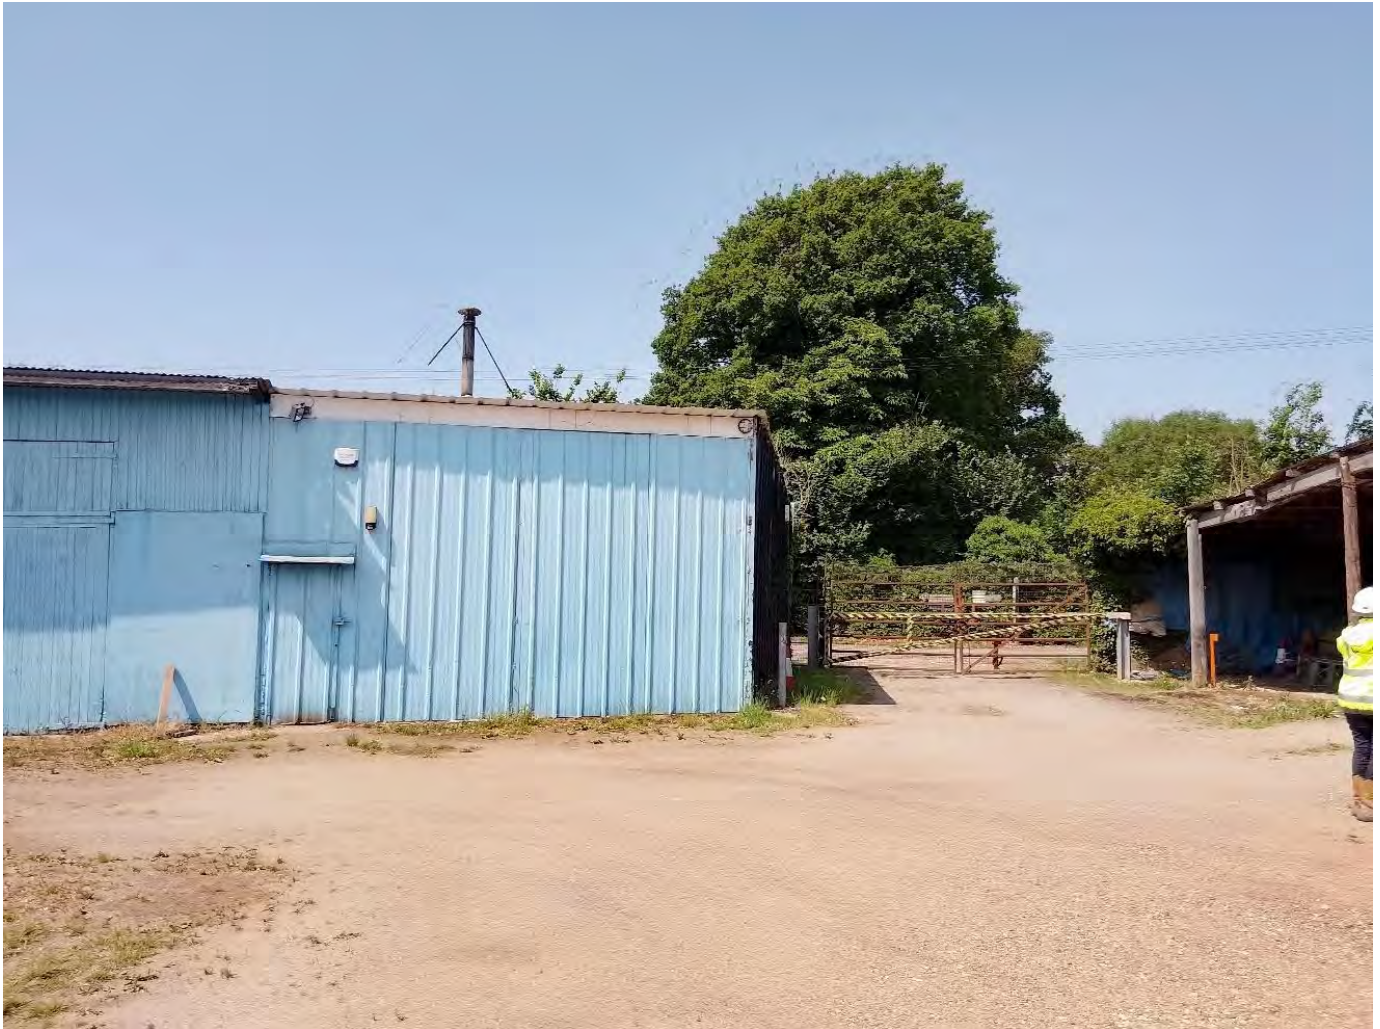
## Photo 18

View of the vehicle access gate off Whitehouse Farm (road) on the right of the image and a corrugated metal and wooden structure of unknown purpose in the west of the site looking west. Overhead cables are present crossing the site north/south in the background. Surface covering is poured concrete/concrete slabs and compacted gravel with overgrown vegetation.

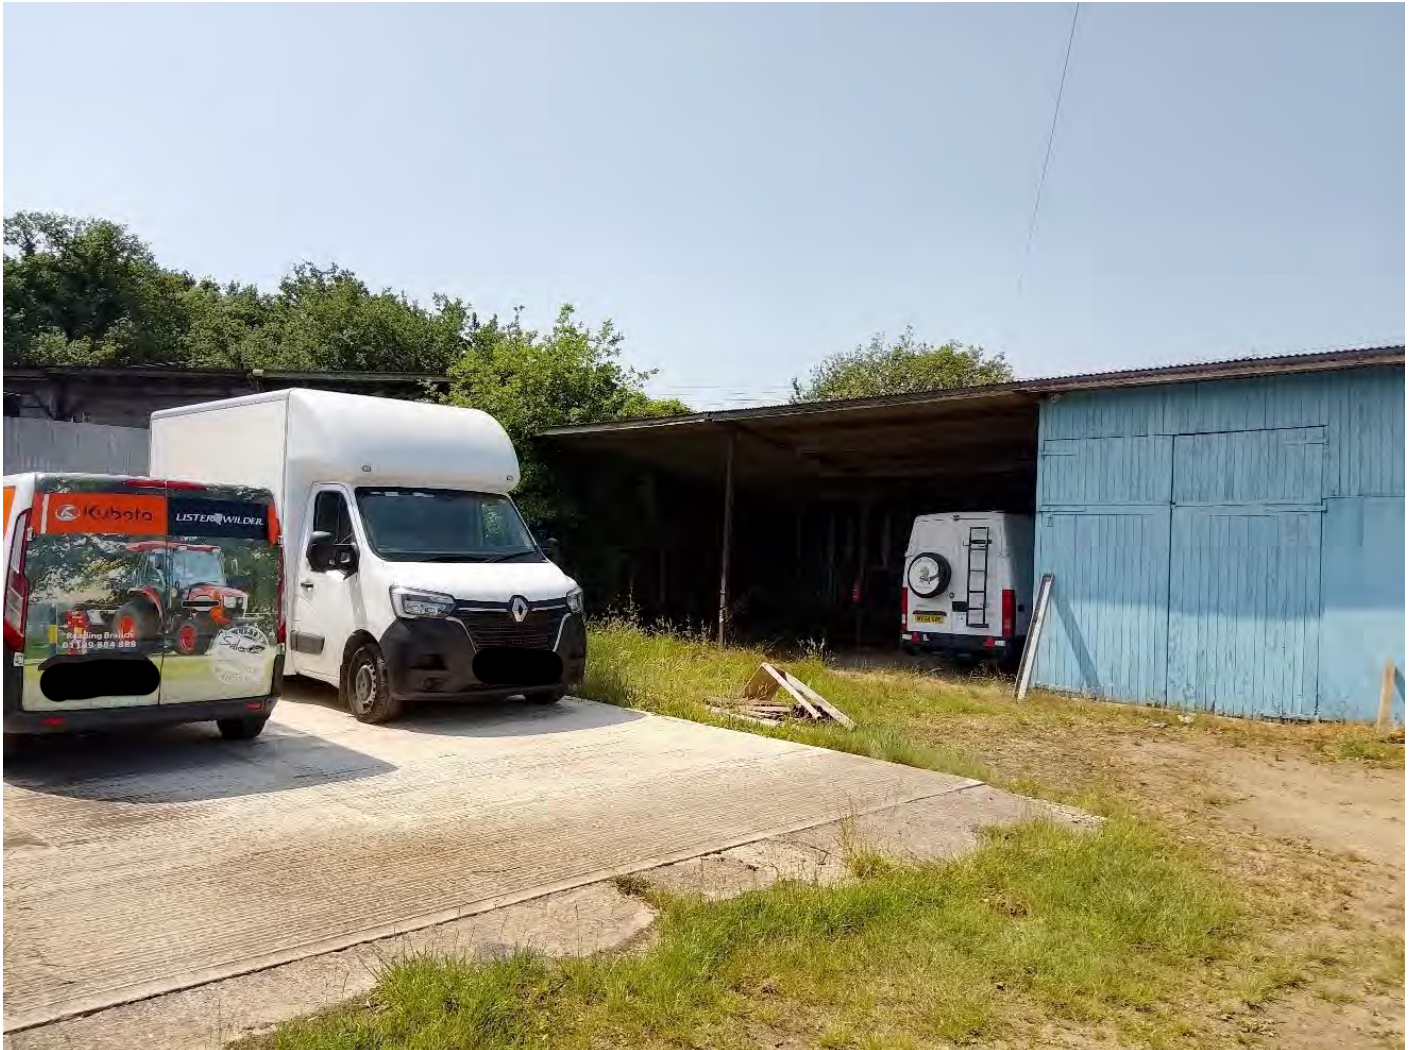
## Photo 19

View of a corrugated metal and wooden structure, including a covered vehicle bay and parking area in the west of the site looking southwest. Surface covering is poured concrete/concrete slabs and compacted gravel with overgrown vegetation. Photo 19 was taken in the space between the parking area and the covered vehicle bay.

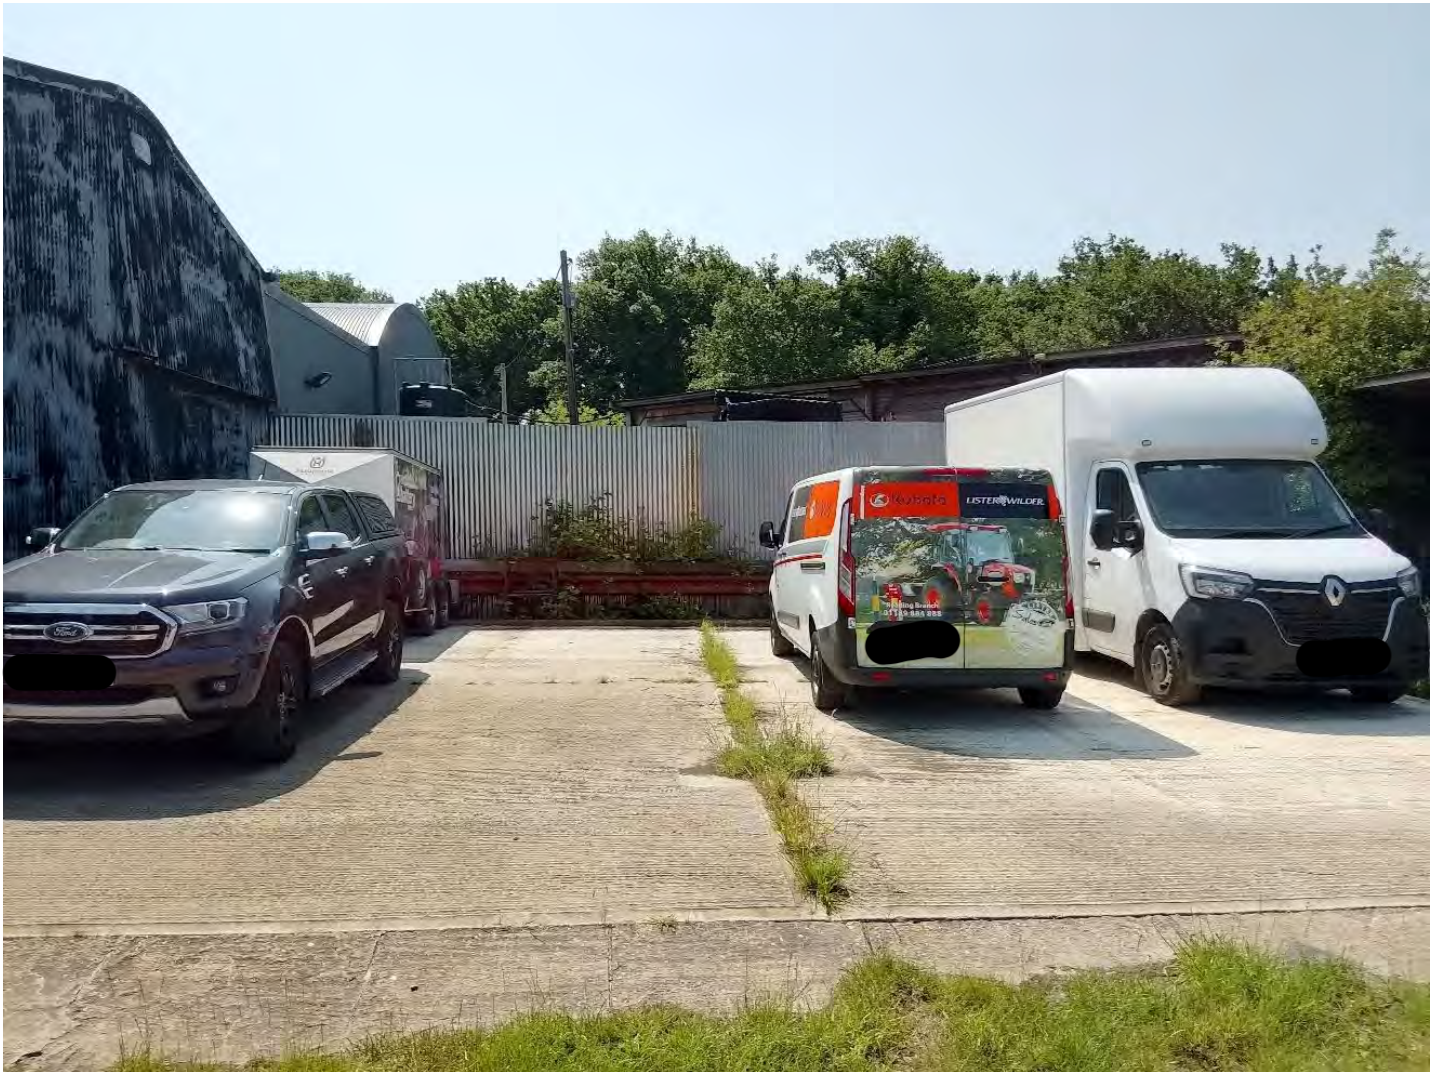
## Photo 20

View of parking area on the west of the site looking south. A corrugated metal fence and metal vehicle barrier prevents access to the south of the site. Surface covering is poured concrete/concrete slabs and compacted gravel with overgrown vegetation.

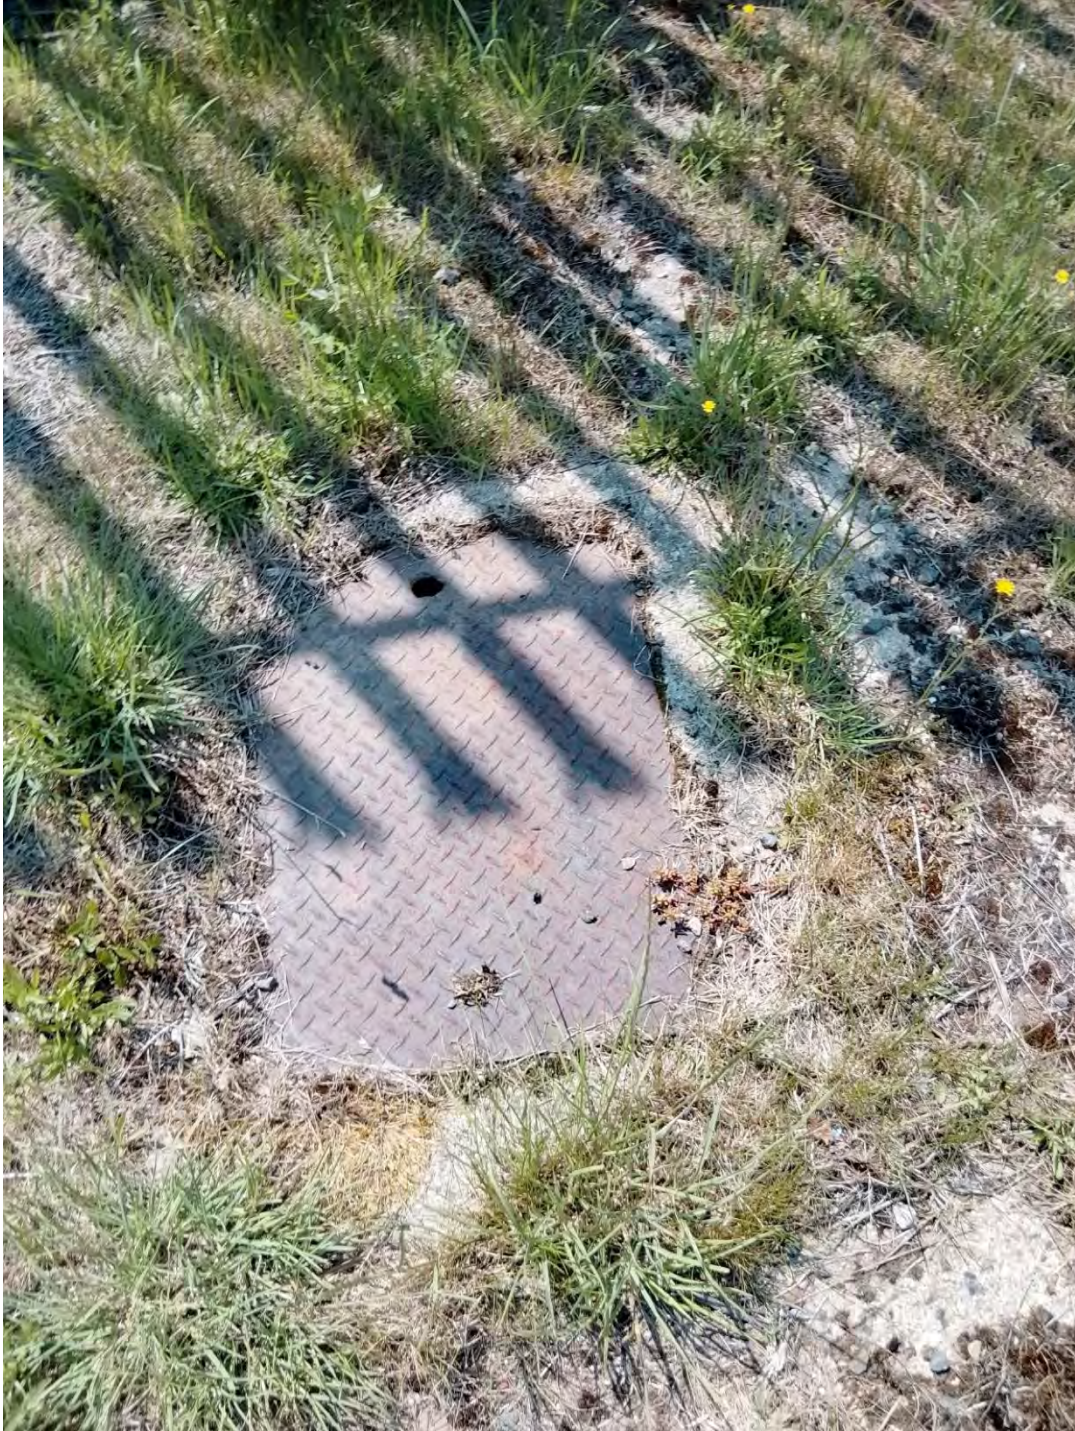
## Photo 21

Photograph of a cover, below which is a possible underground structure or tank.

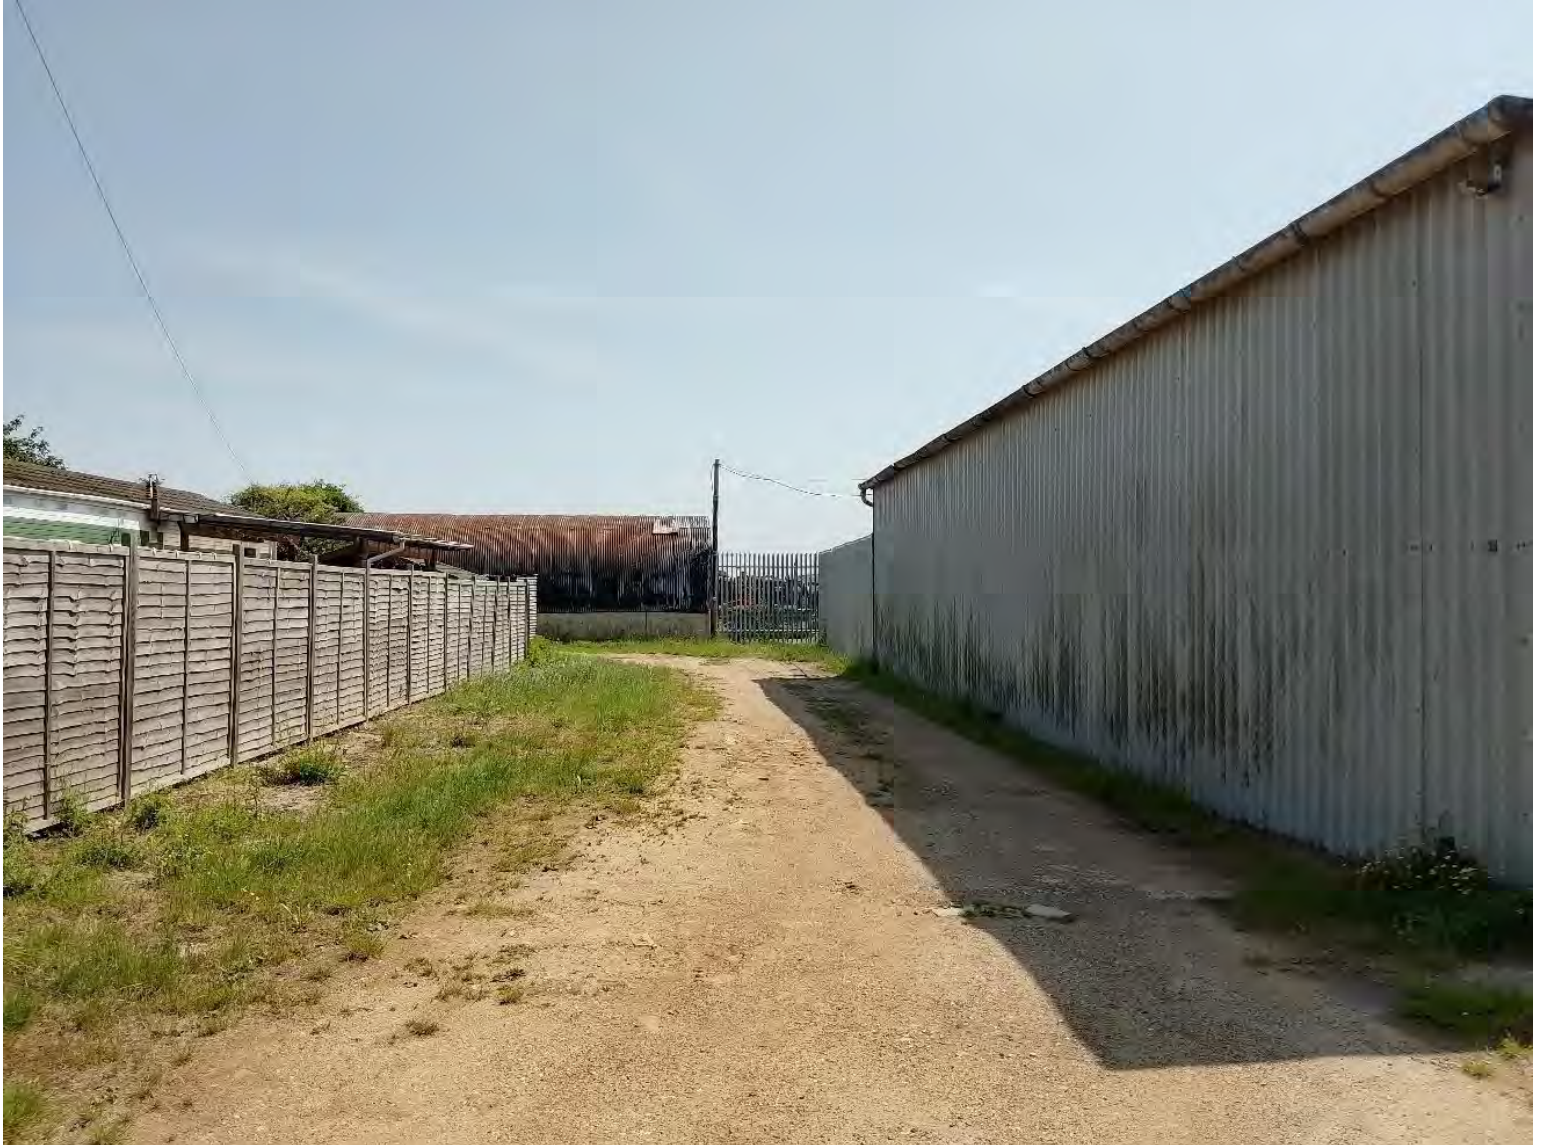
## Photo 22

View of vehicular access road running east/west through the west of the site looking east. A corrugated metal structure for vehicle and machinery storage is present on the right of the image. The wooden fence on the left of the image forms the northern boundary in this part of the site. Overhead cables are present in the background. Surface covering is poured concrete/concrete slabs and compacted gravel with overgrown vegetation.

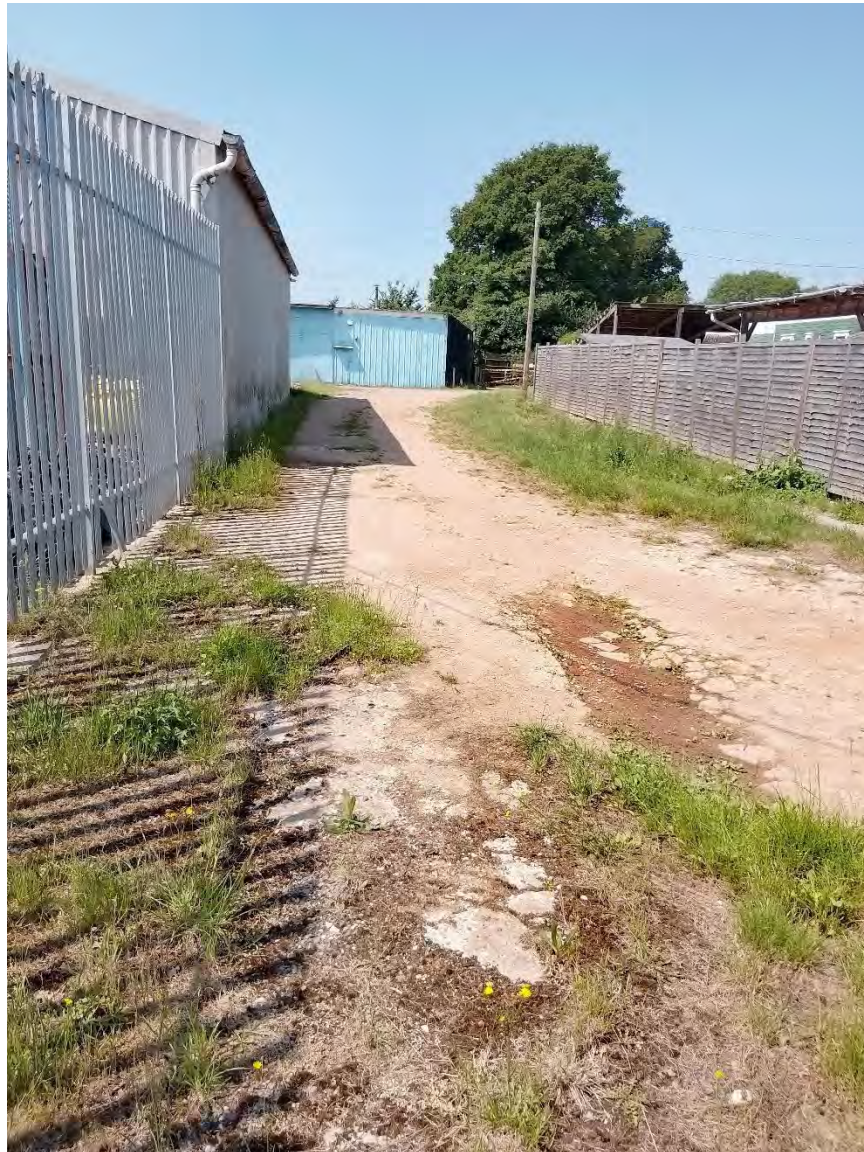
## Photo 23

View of vehicular access road running east/west through the west of the site looking west. The wooden fence on the right of the image forms the northern boundary in this part of the site. Surface covering is poured concrete/concrete slabs and compacted gravel with overgrown vegetation.

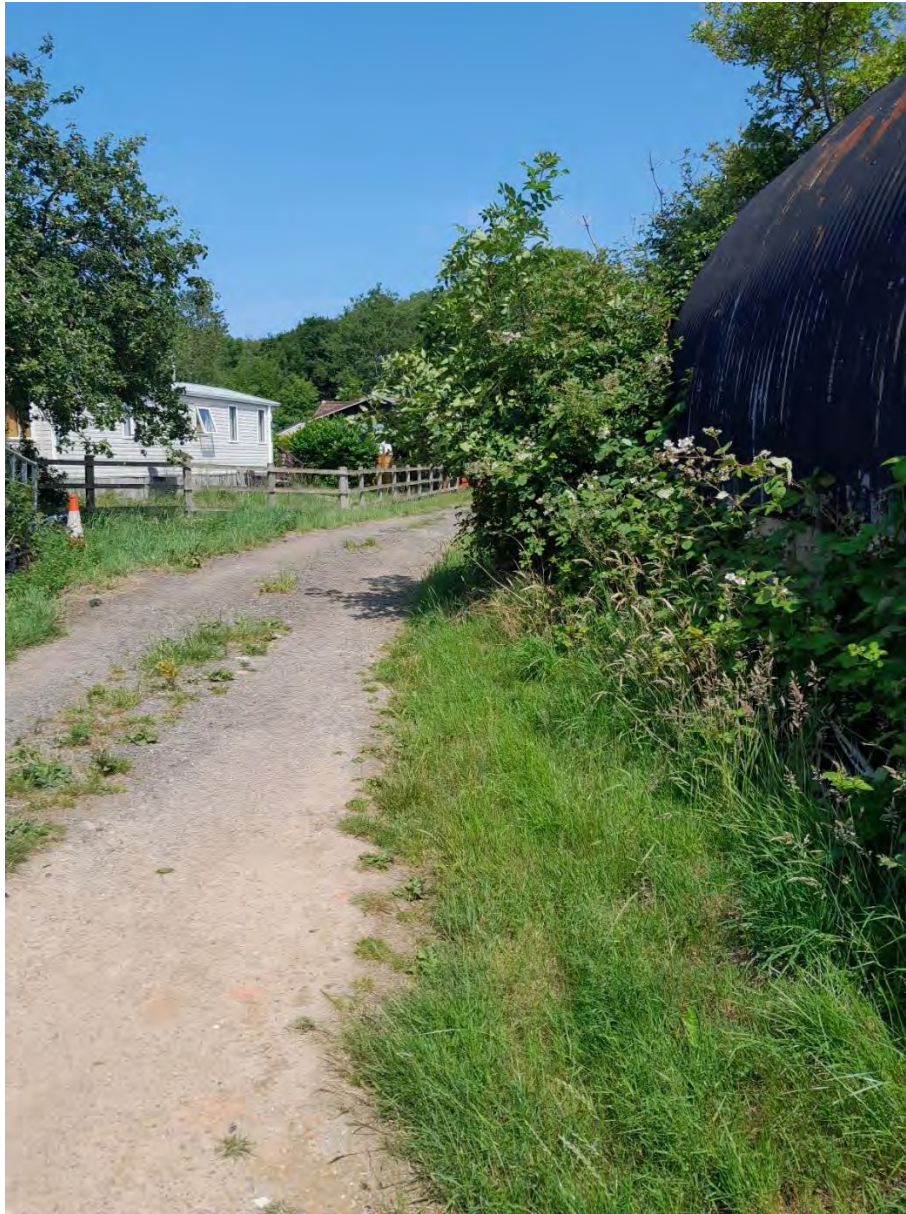
## Photo 24

View of the existing field access running north/south outside of the site boundary looking north.  
Surface covering is poured concrete/concrete slabs and compacted gravel with overgrown vegetation.

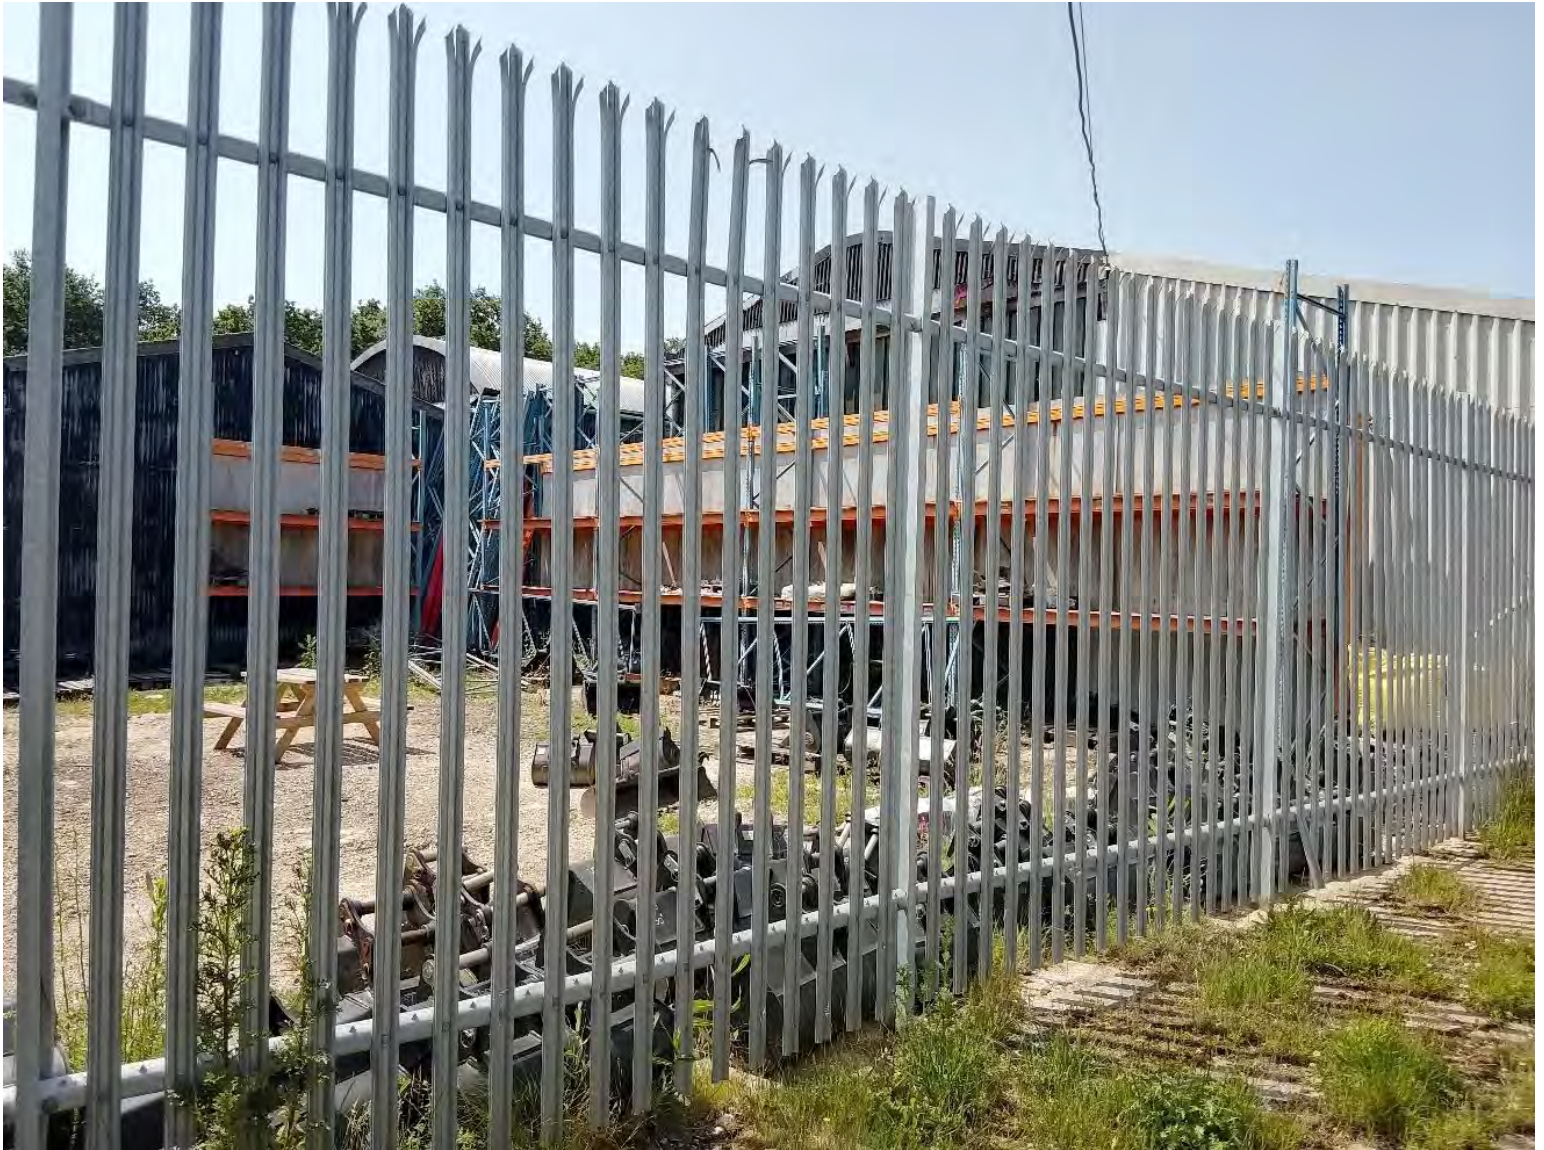
## Photo 25

View of metal palisade fencing with an external storage area beyond in the west of the site looking southwest. Surface covering is poured concrete/concrete slabs and compacted gravel with overgrown vegetation.

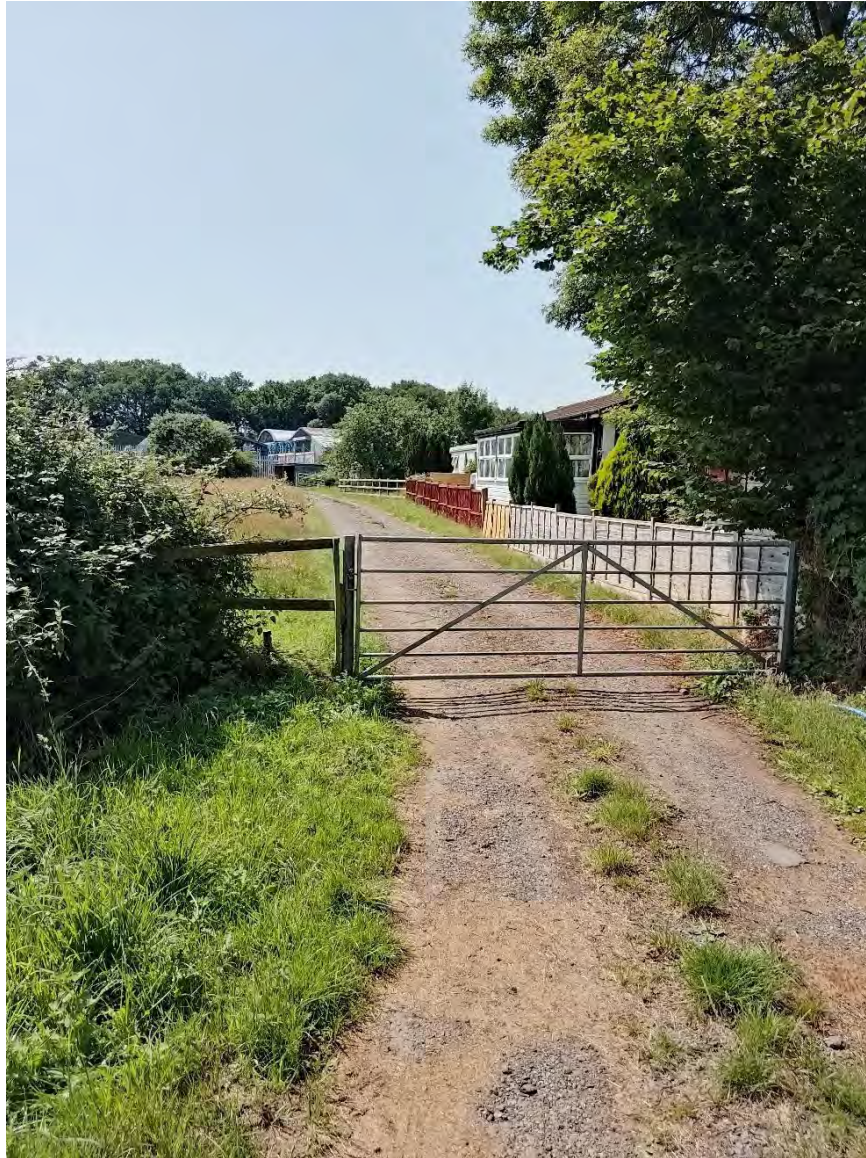
## Photo 26

View of the field access in the west of the site that is outside of the new site plan, running north/south. The image has been taken from outside of the site boundary looking south.

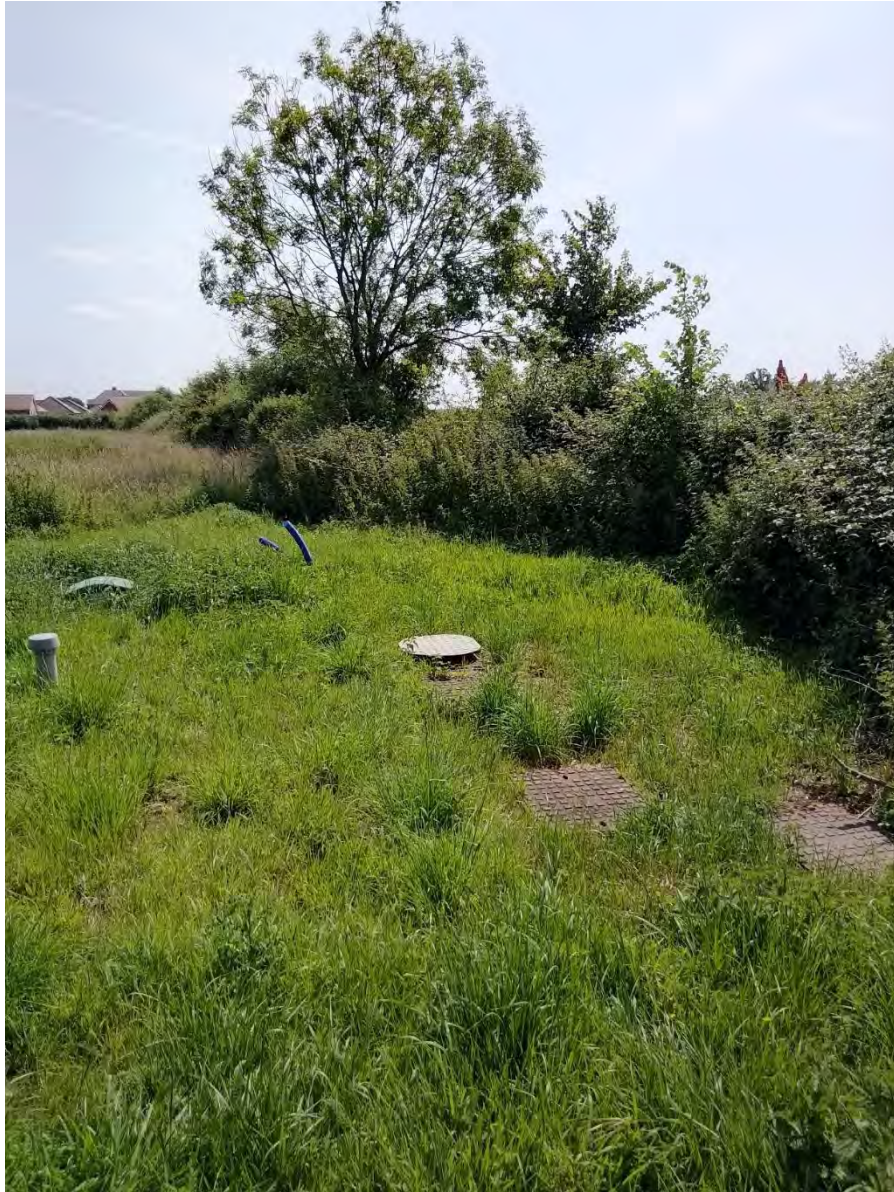
## Photo 27

View of existing drainage infrastructure with septic tank ventilation and inspection covers looking east. The image has been taken beyond the northern boundary, comprised of hedgerows with mature shrubs and scattered trees, in the field to the north of the site

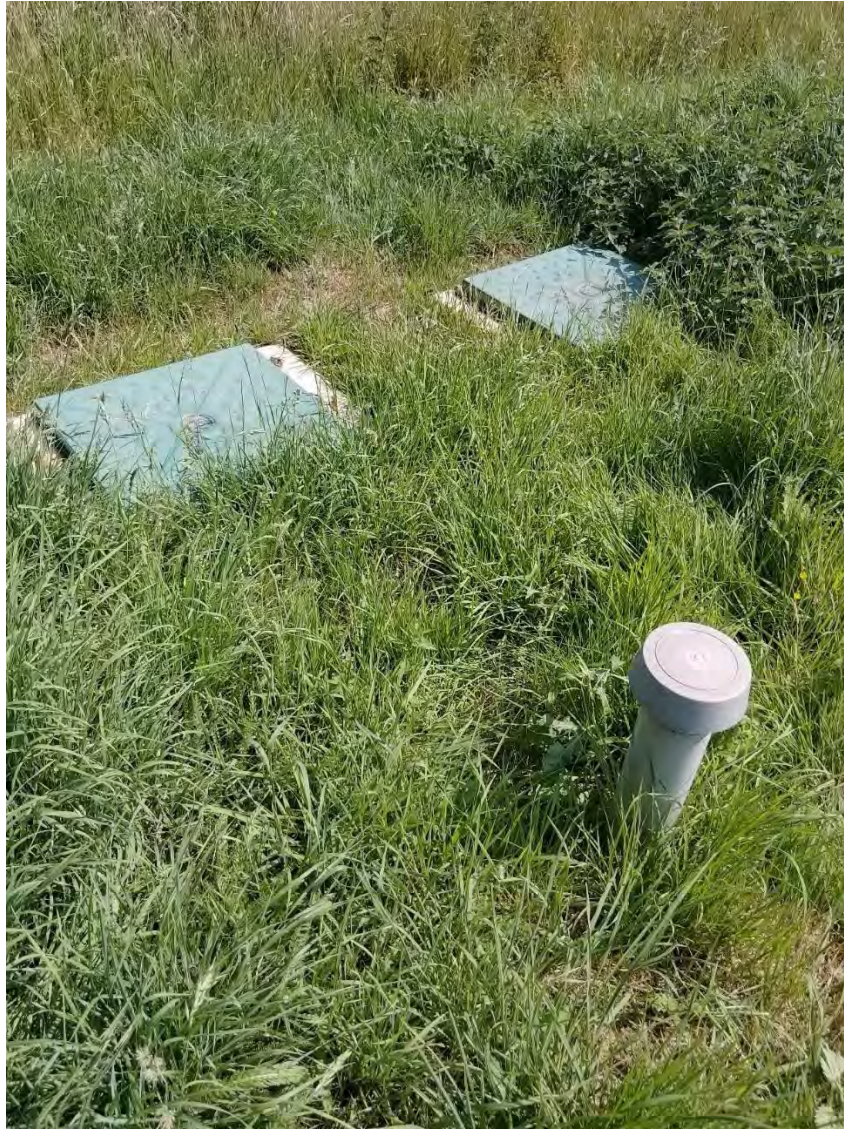
## Photo 28

Photograph of septic tank inspection and ventilation covers in the field beyond the northern boundary of the site.

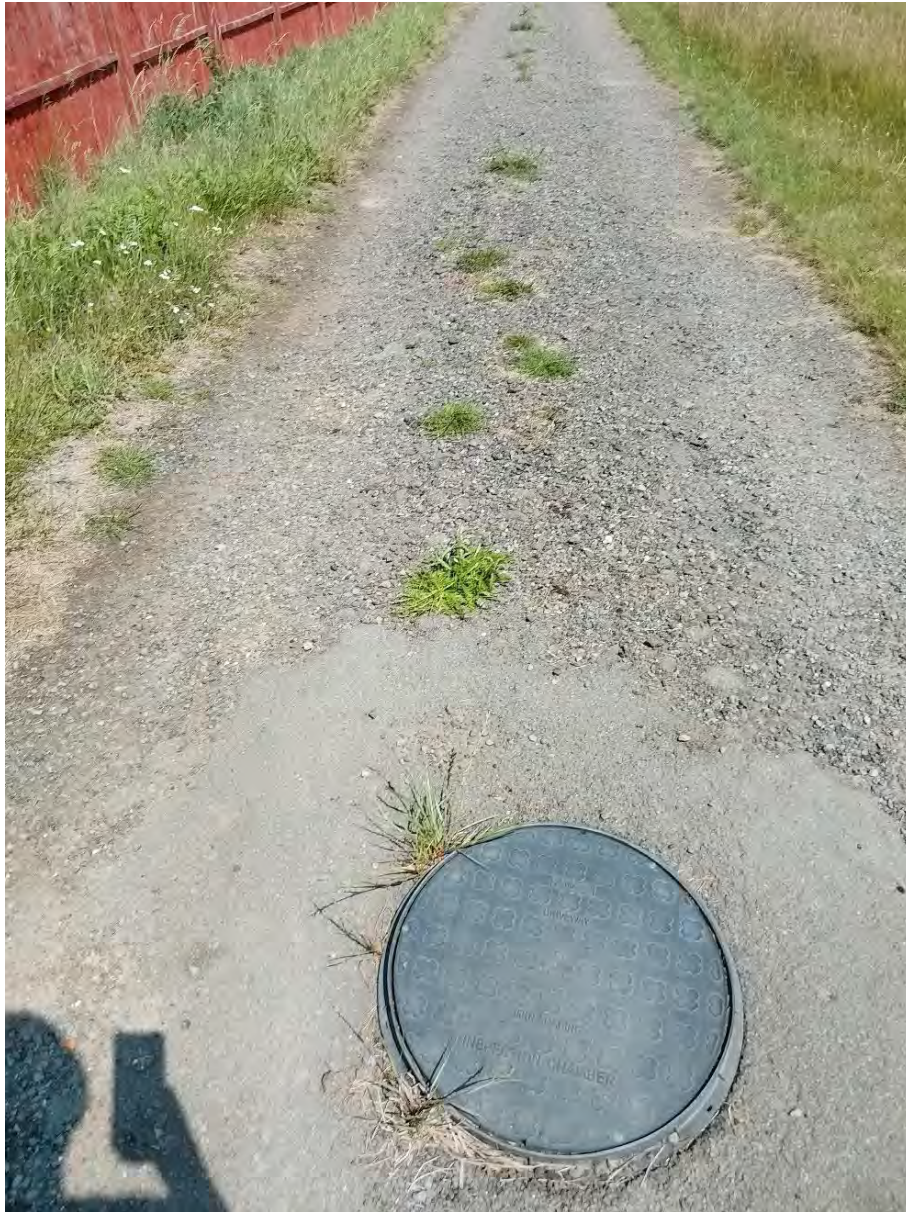
## Photo 29

Photograph of field access road surface and integrated manhole in the west of the site running north/south. Surface covering compacted and loose gravel with scattered vegetation.

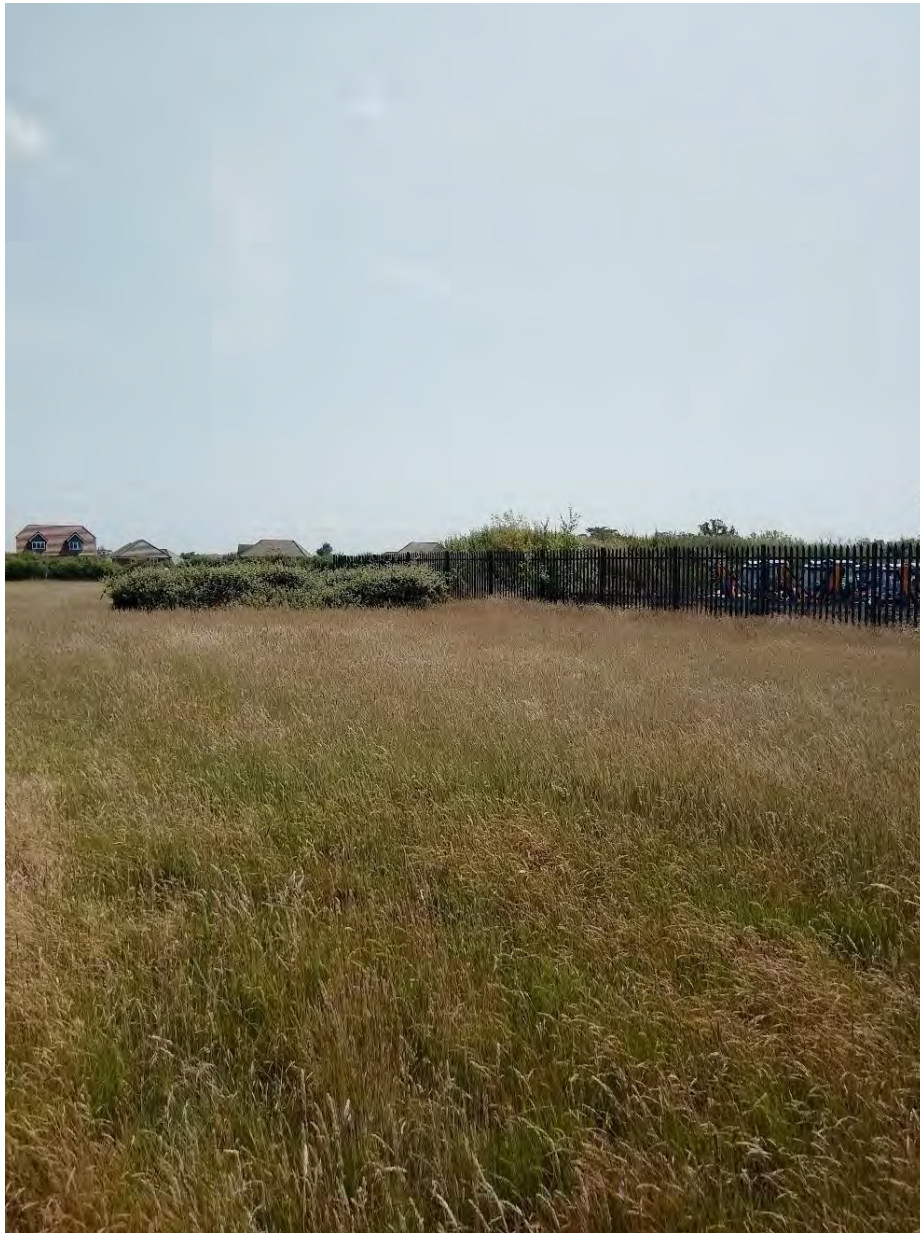
## Photo 30

View of open area of grassland in the north of the site looking east. Metal palisade fencing separating the northern area of the site from the centre of the site is visible. Also visible off center of the photo shows an overgrown area. Surface covering was topsoil.

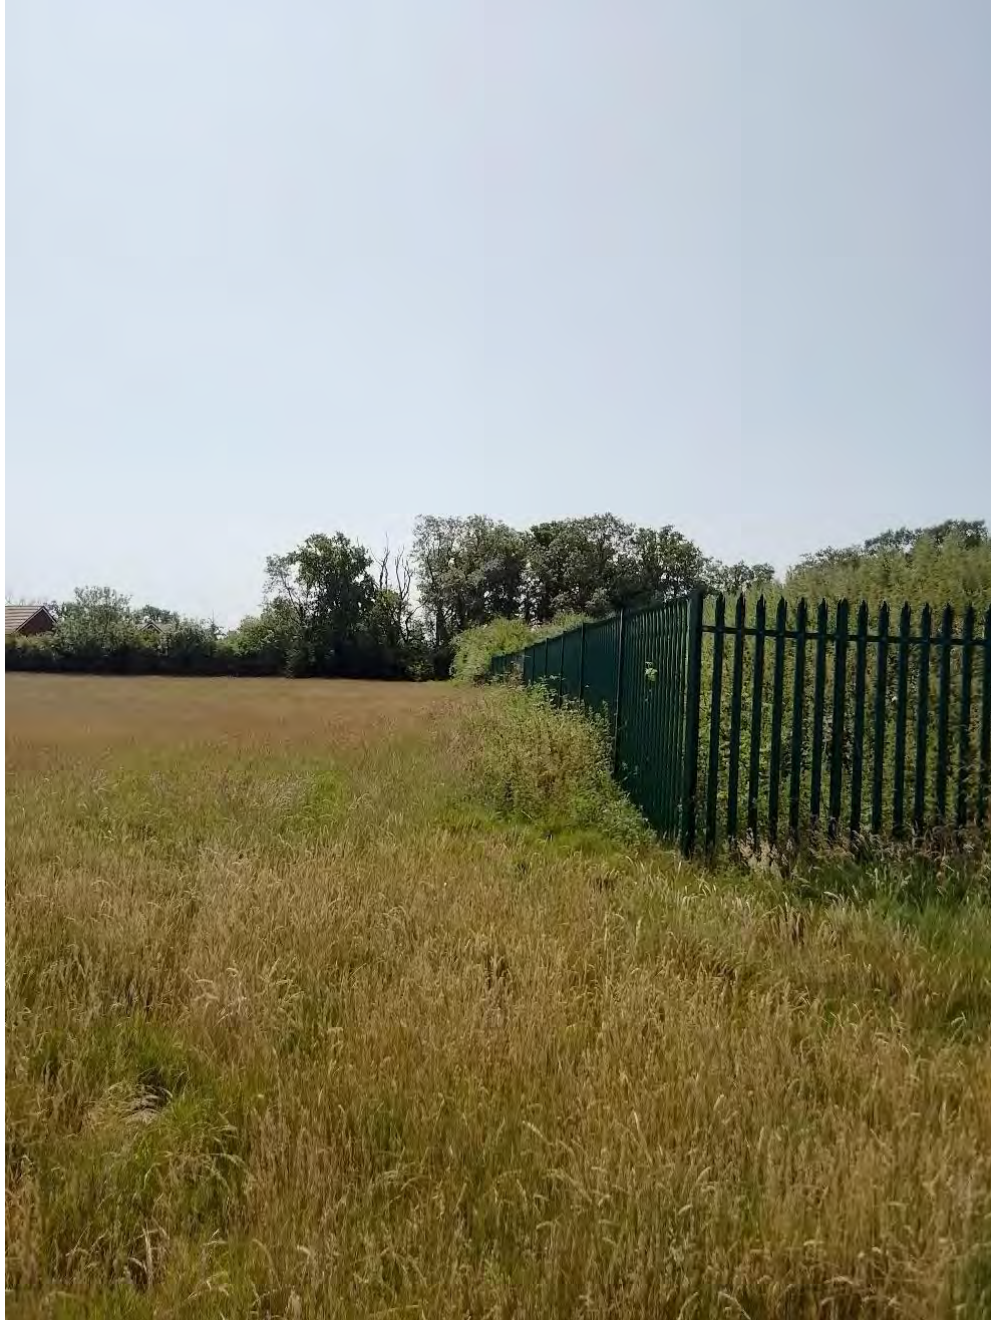
## Photo 31

View of open area of grassland in the north of the site, looking south, along the line of metal palisade fencing separating the site from the centre of the site. Surface covering was topsoil.

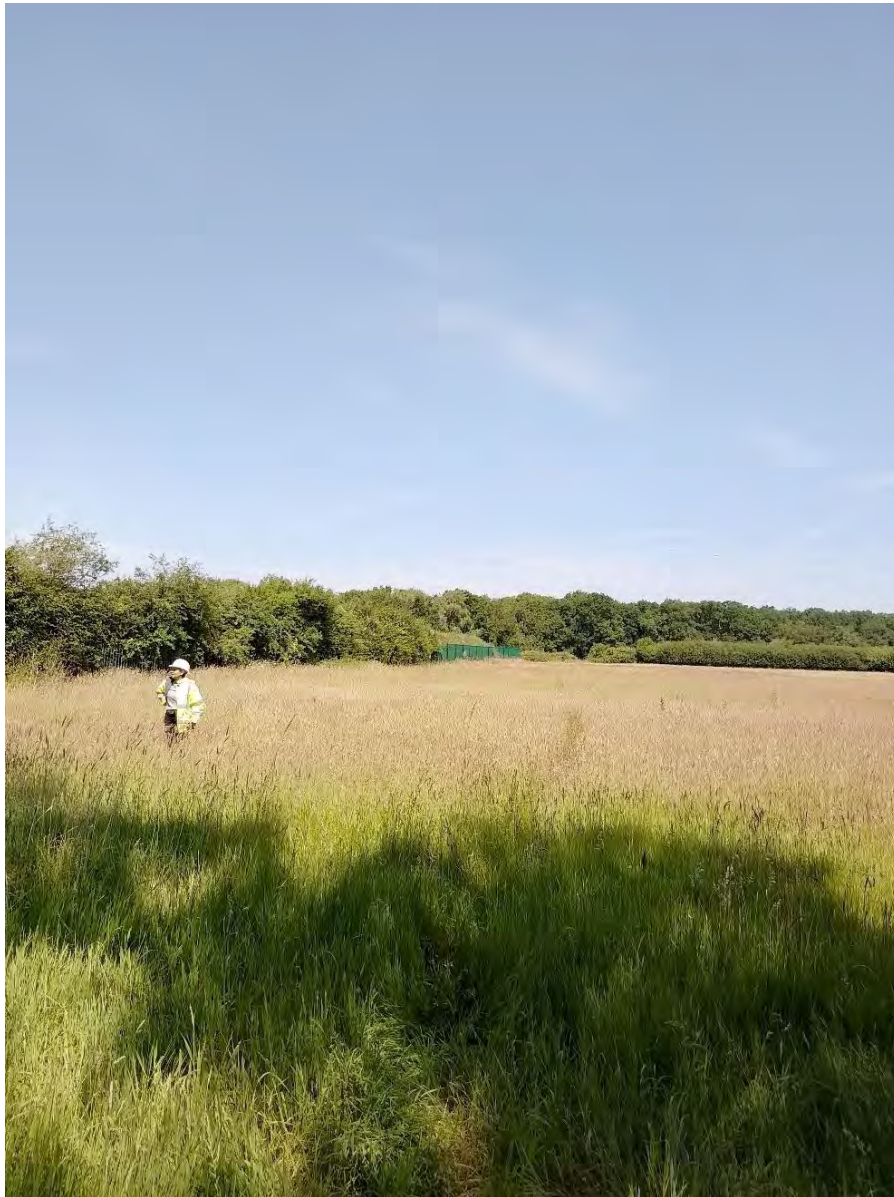
## Photo 32

View of open area of grassland in the southeast of the site looking northwest. Surface covering was topsoil.

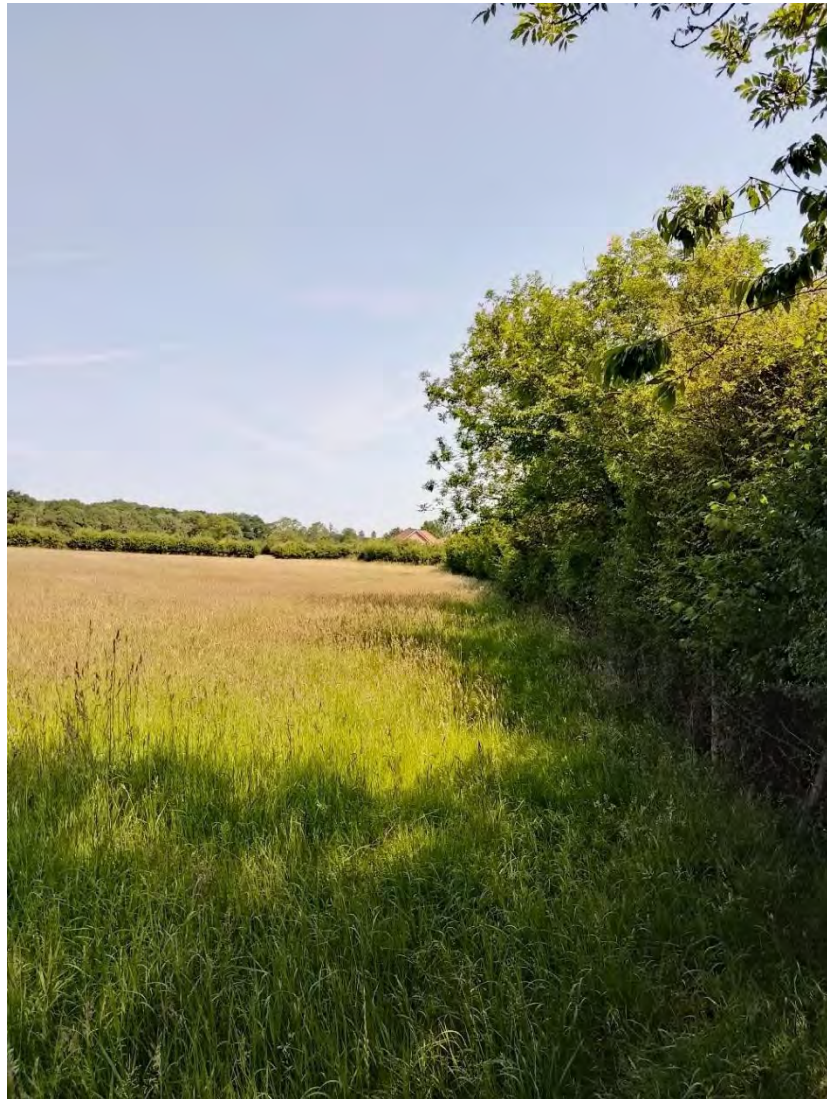
## Photo 33

View of open area of grassland in the east of the site looking northeast along the eastern boundary hedgeline. Surface covering was topsoil.
