## **APPENDIX A**

### **Photographic Record**

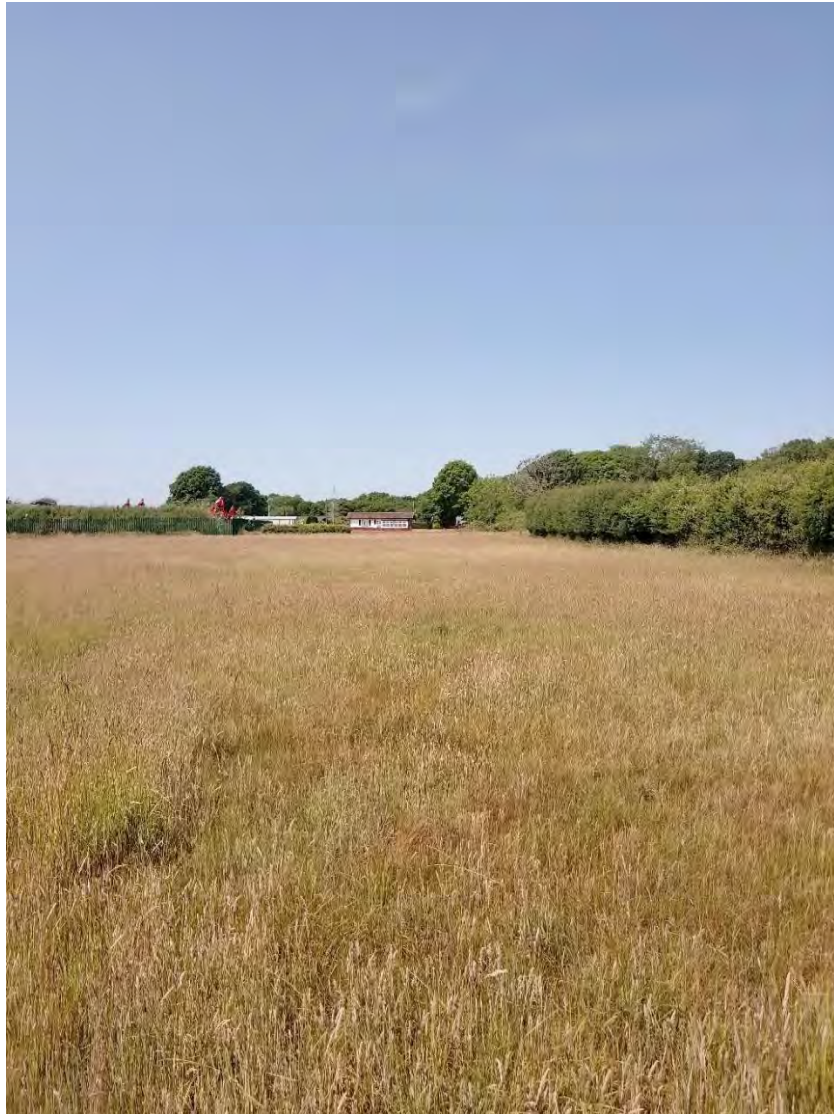
## Photo 34

View of open area of grassland in the northeast of the site looking west. Surface covering was topsoil.

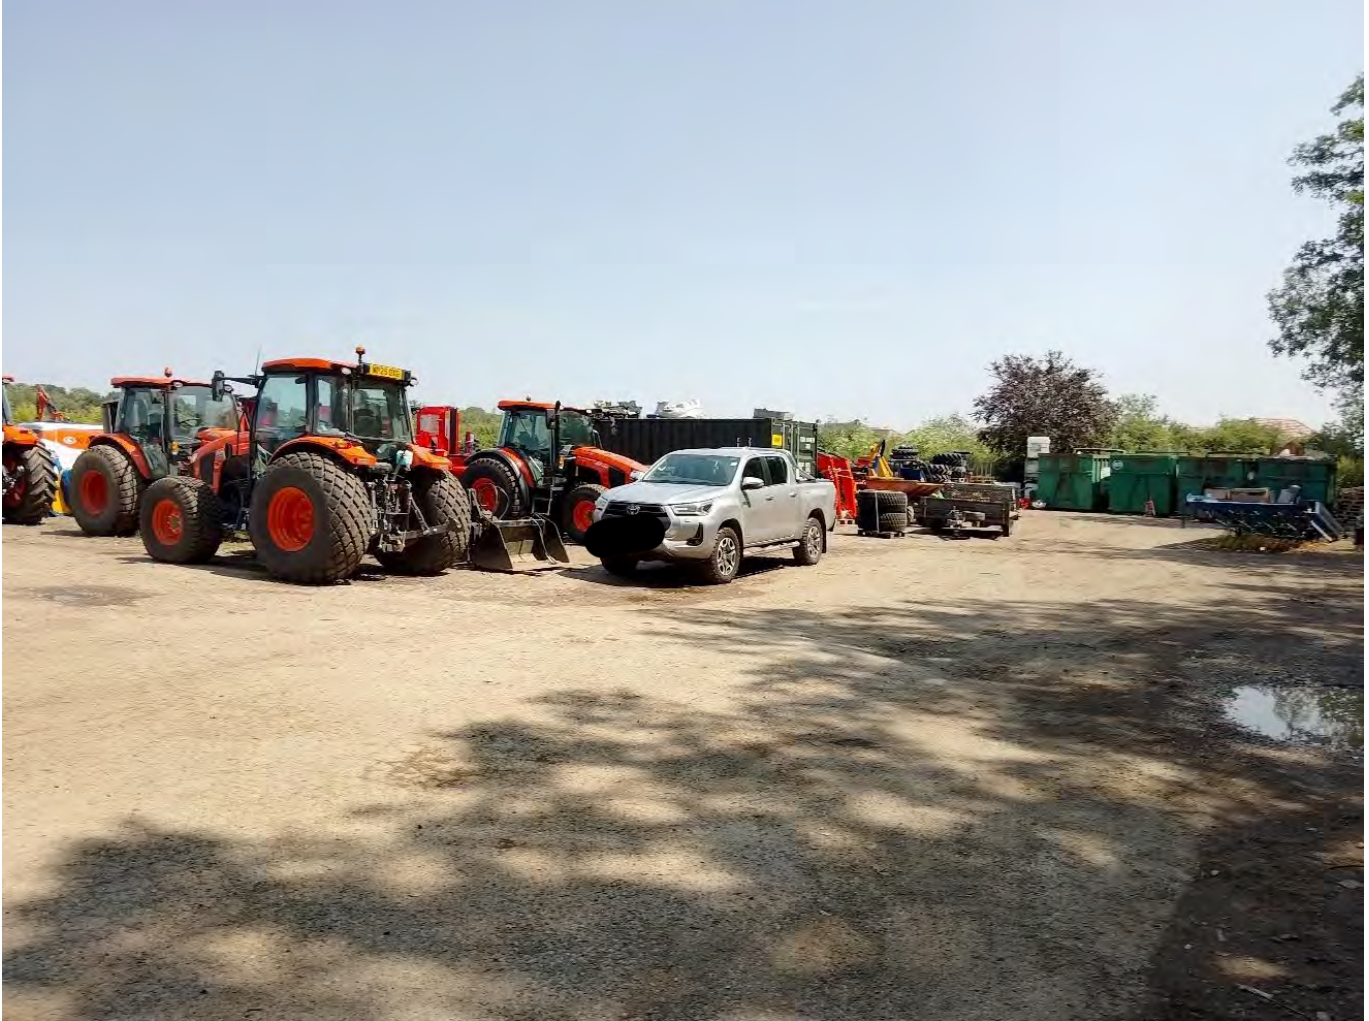
## Photo 35

View of the southern vehicle and machinery storage yard in the centre of the site looking northeast. Surface covering is poured concrete, cracking is visible.

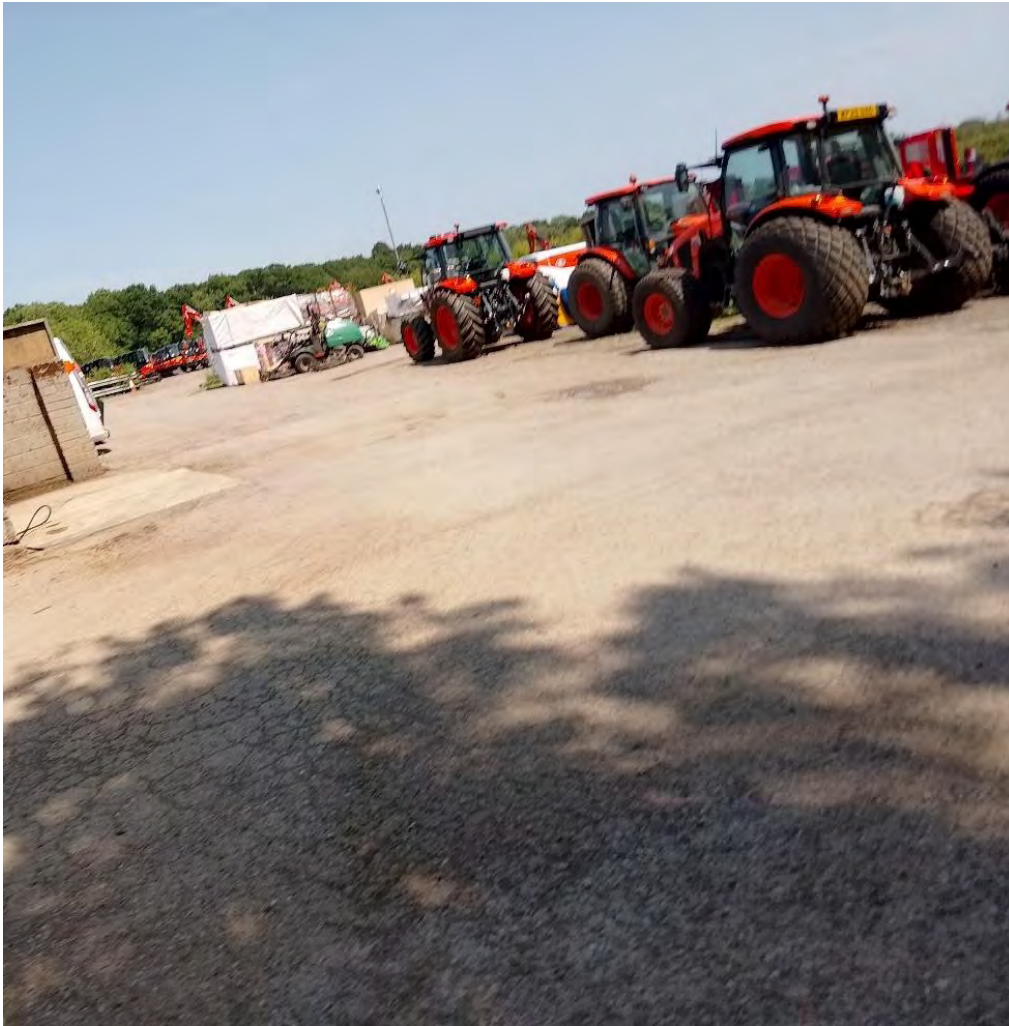
## Photo 36

View of the southern vehicle and machinery storage yard in the centre of the site looking north.  
Surface covering is poured concrete, cracking is visible.

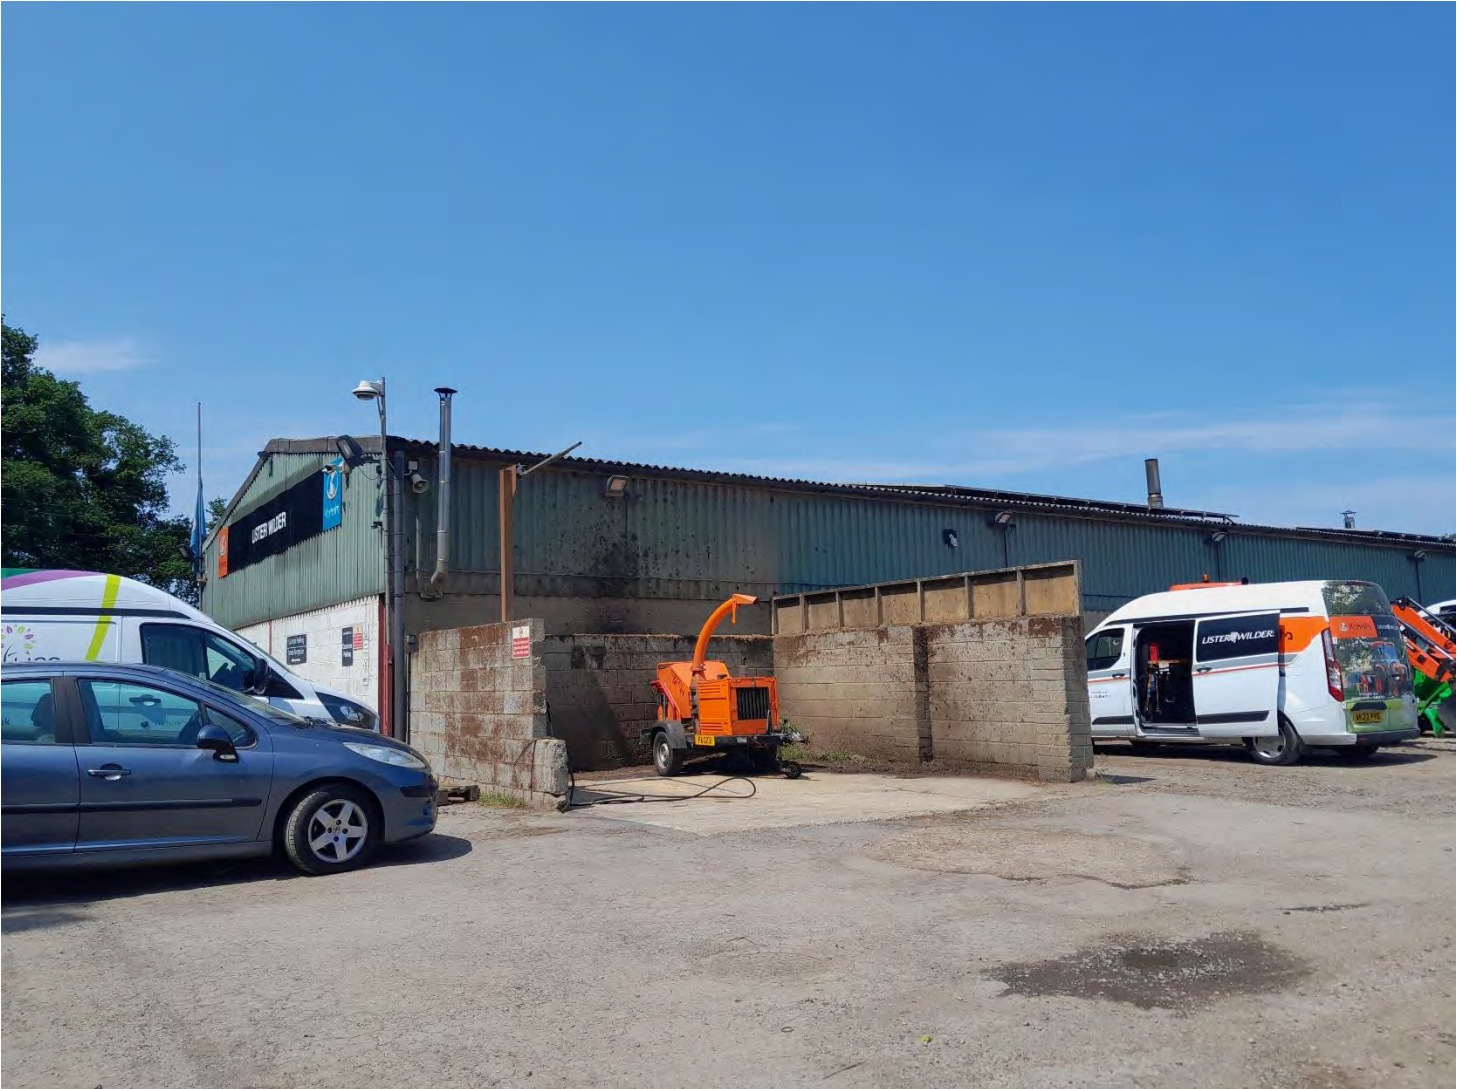
## Photo 37

View of vehicle washing bay at the southern end of the concrete brick and corrugated metal vehicle maintenance workshops in the centre of the site. Surface covering is poured concrete, cracking is visible.

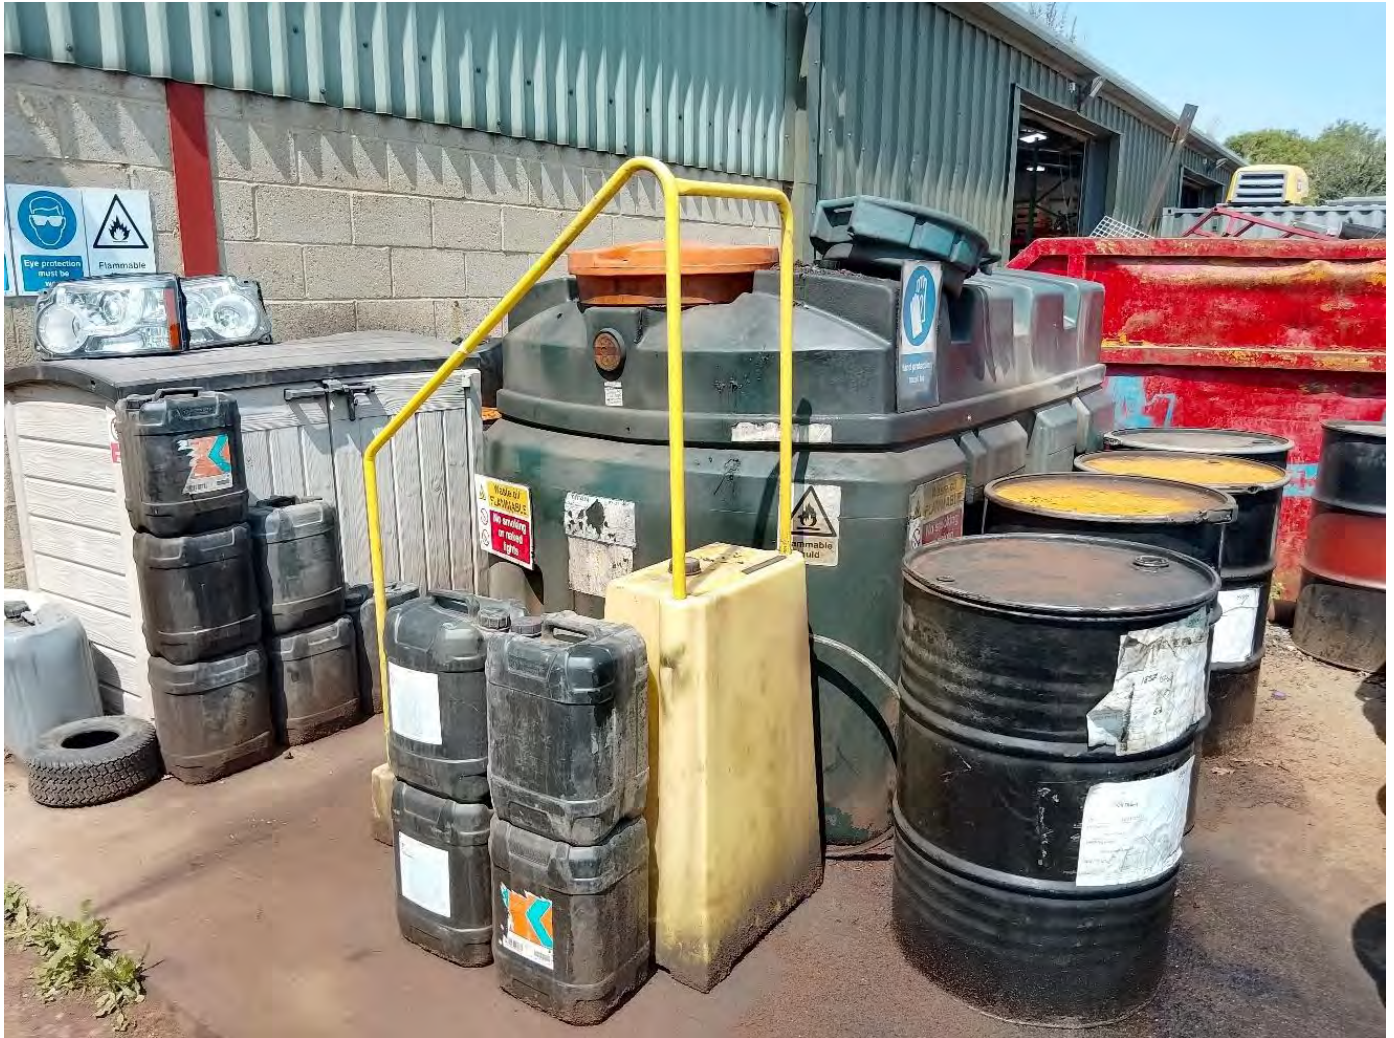
**Photo 38**

Photograph of oil storage facilities sited on a concrete slab with visible staining and discoloration in the center of the site. Concrete brick and corrugated metal vehicle maintenance workshops are visible in the background.

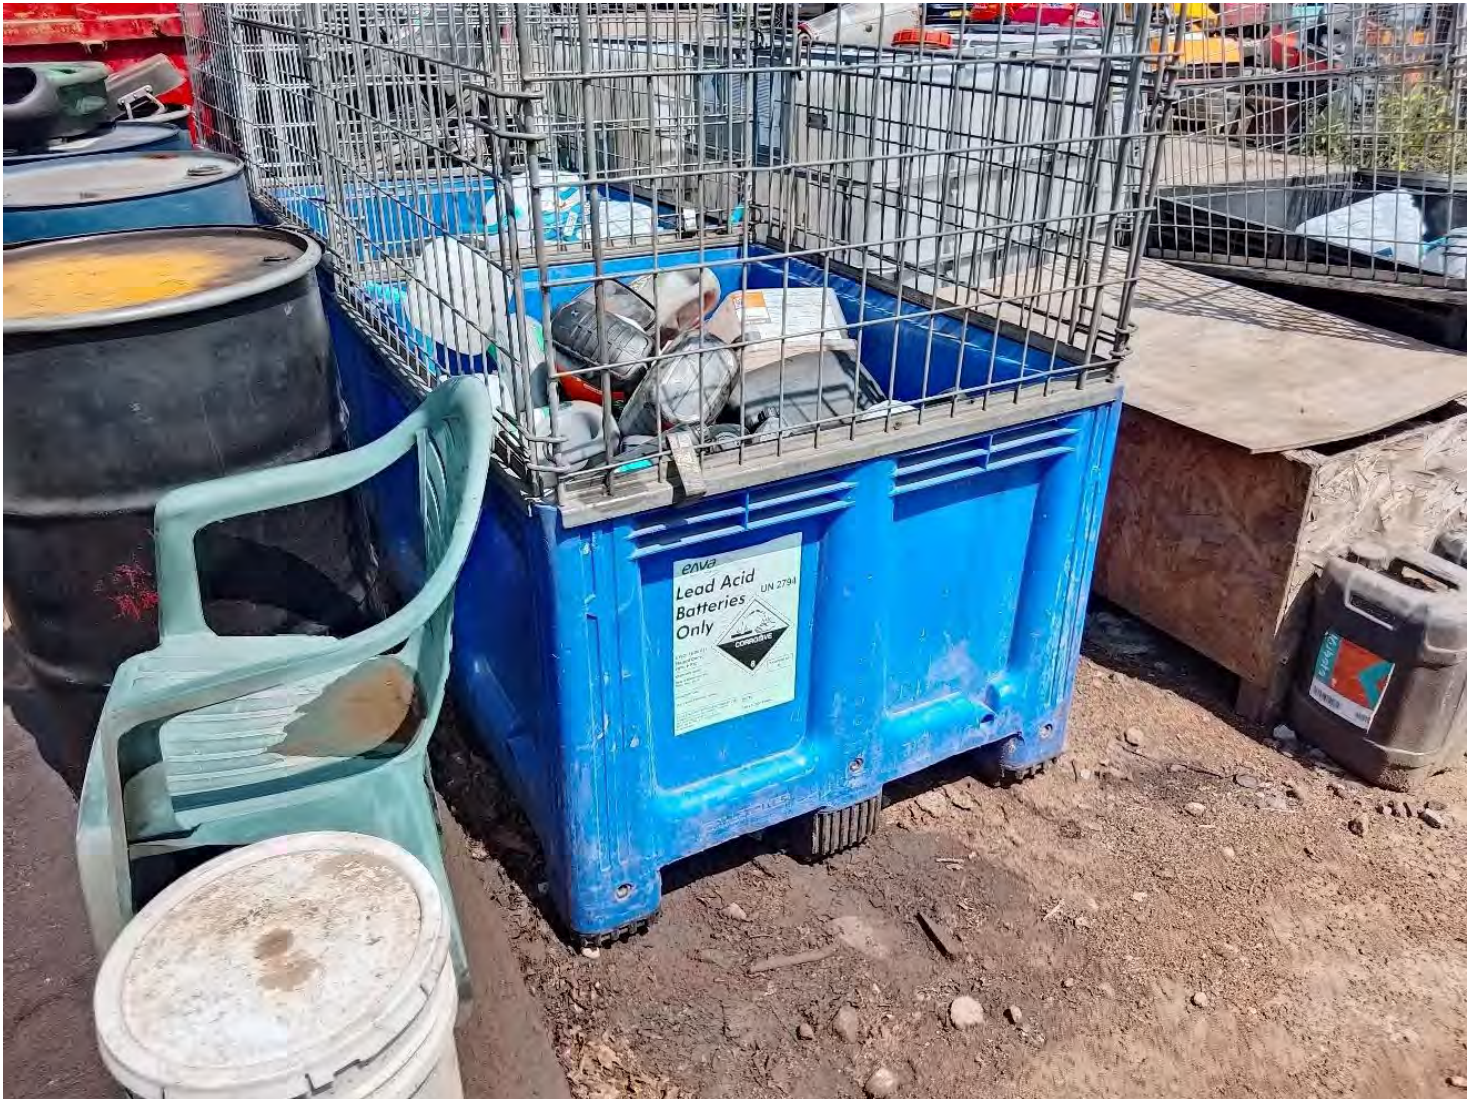
## Photo 39

Photograph of a used vehicle battery container sited on poured concrete in the centre of the site.

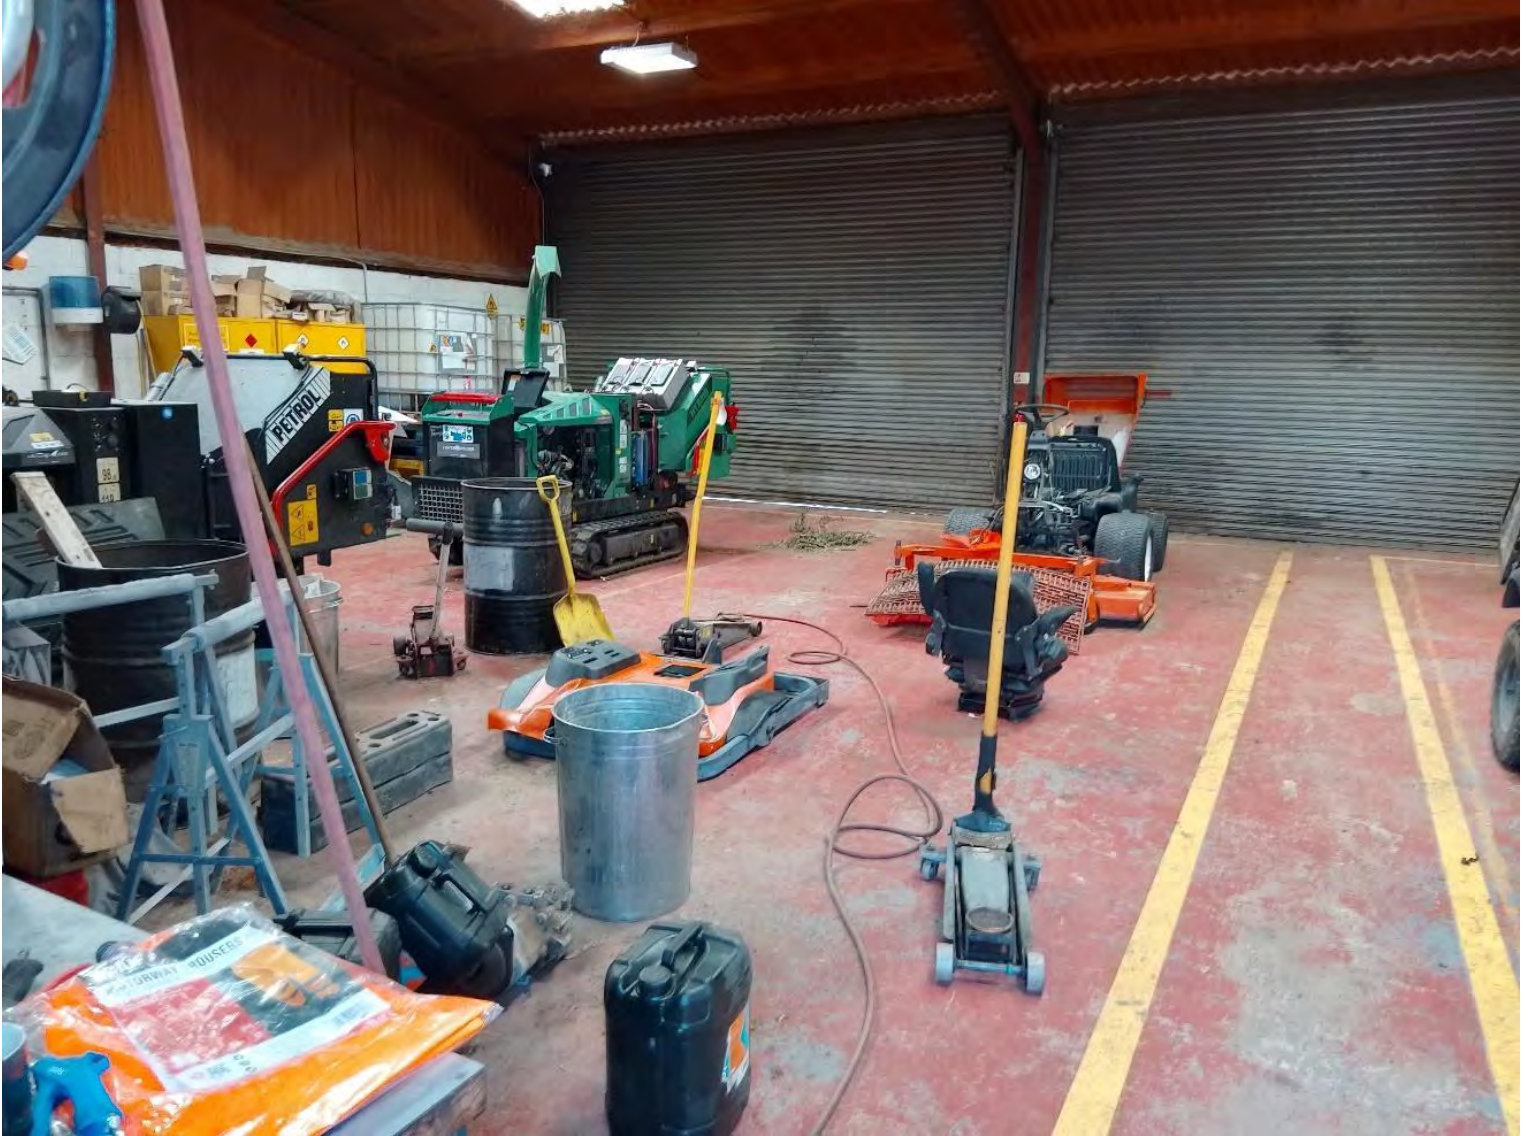
**Photo 40**

Internal view of a vehicle maintenance warehouse in the centre of the site. Surface covering is either poured concrete or concrete slabs.

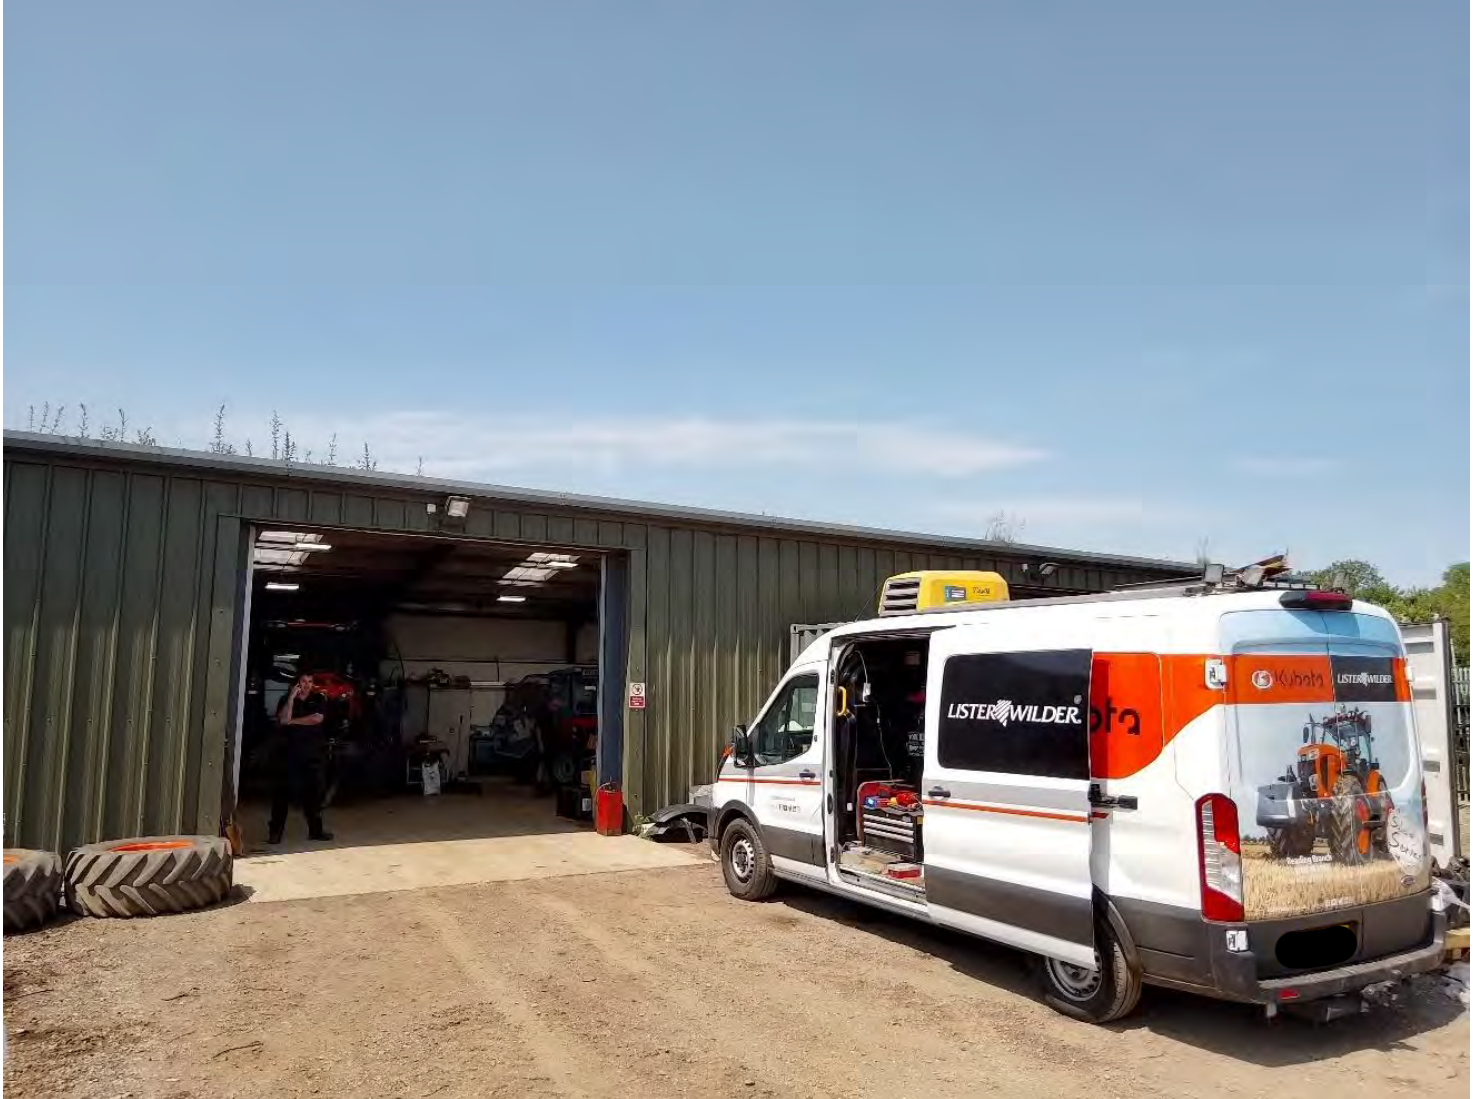
## Photo 41

View of access into a vehicle maintenance bay in the centre of the site looking west. Surface covering is compacted gravel and poured concrete.

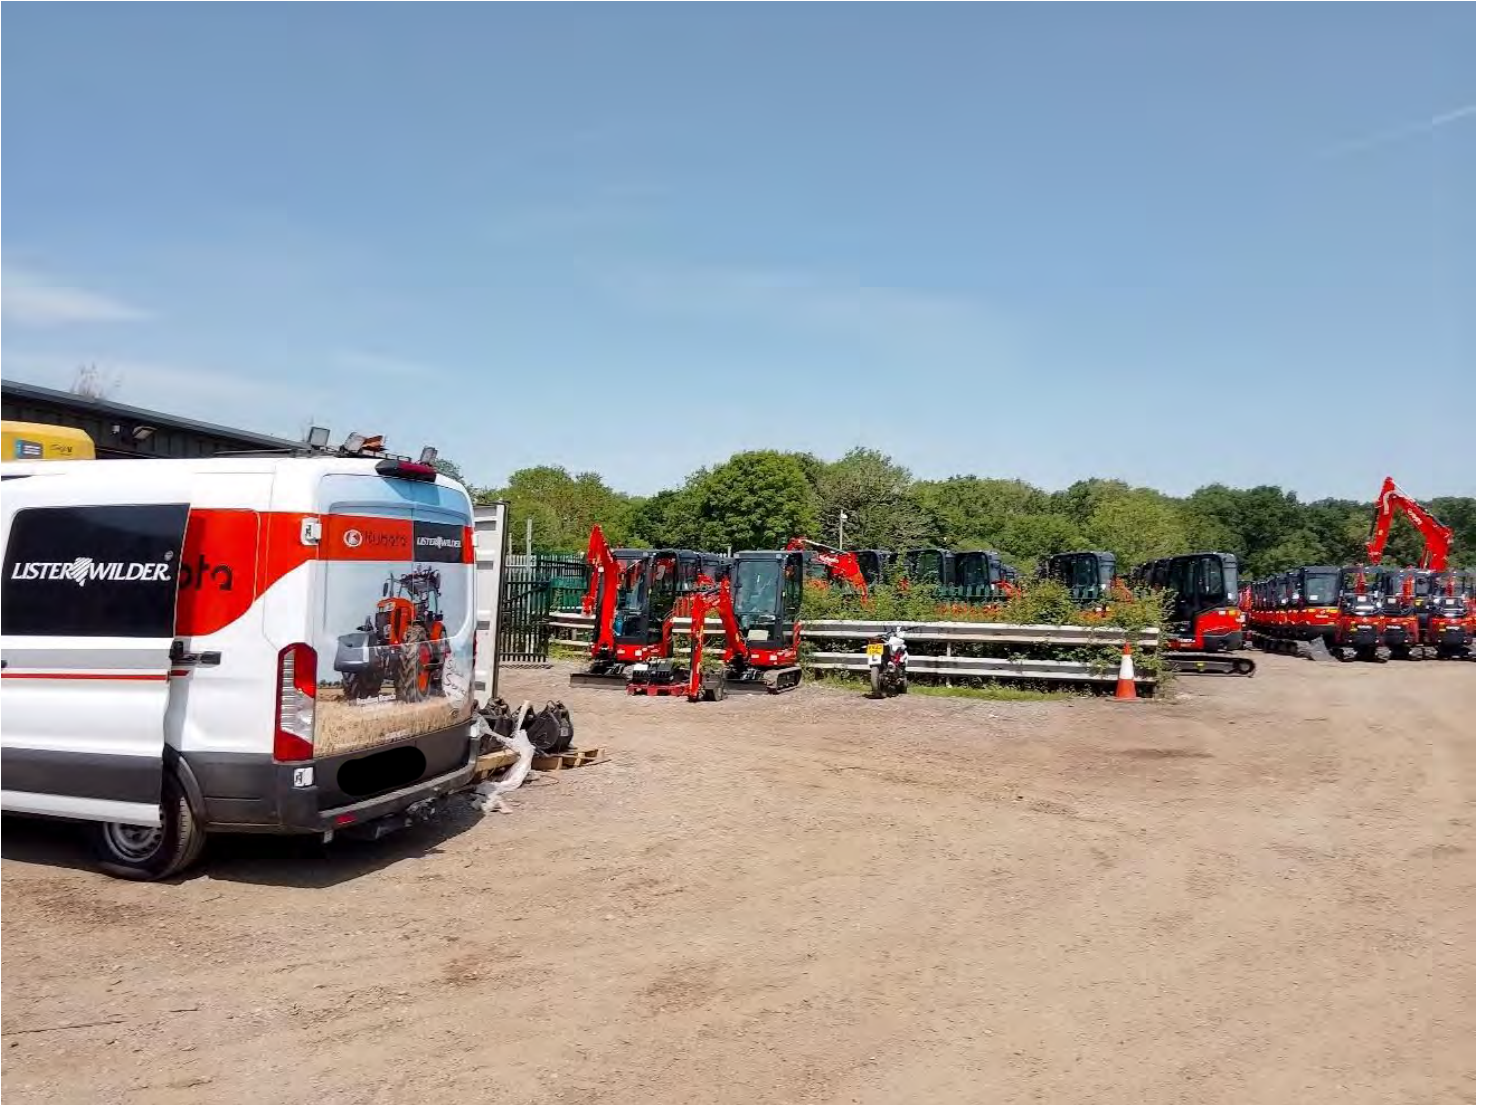
## Photo 42

View of vehicle and machinery storage compound, with access around to further areas on the left, looking north. The northern vehicle and machinery storage compound is visible. Surface covering is compacted gravel and poured concrete.

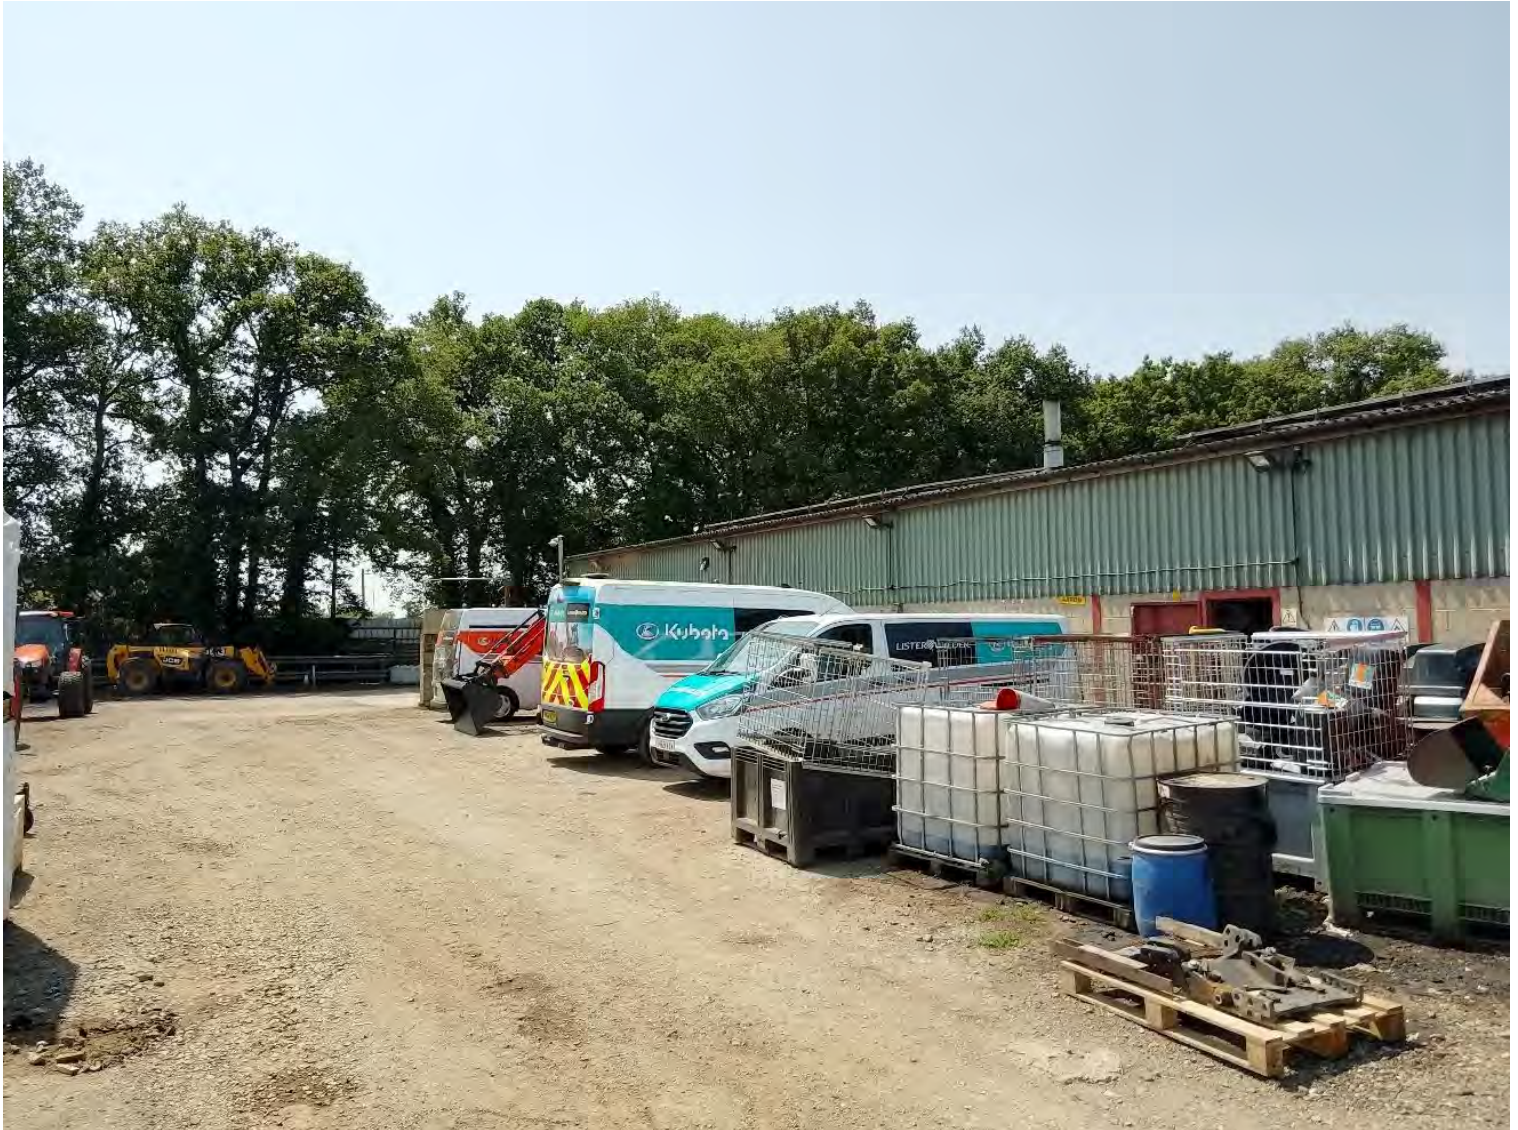
## Photo 43

View of concrete block and corrugated metal vehicle maintenance workshops in the centre of the site looking south. Surface covering is compacted gravel and poured concrete.

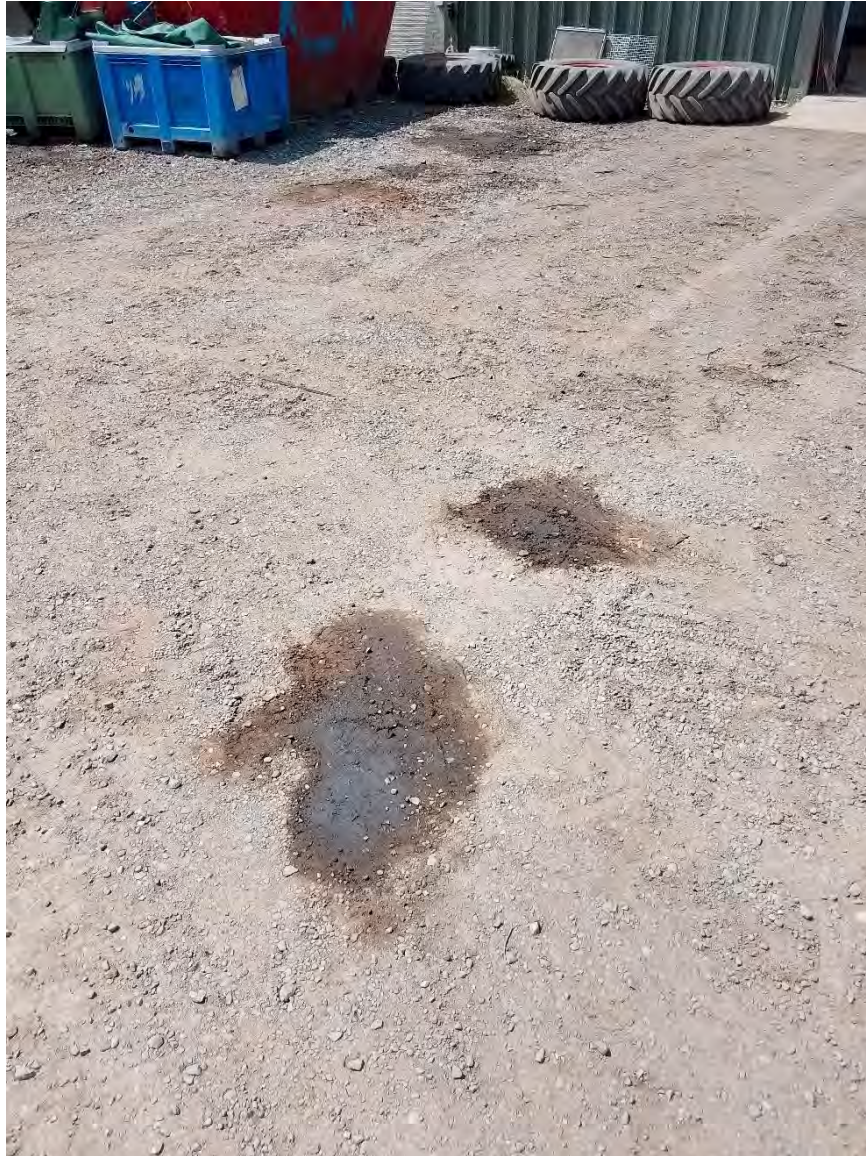
## Photo 44

Photograph of surface staining caused by unknown substances in the southern vehicle and machinery storage compound.

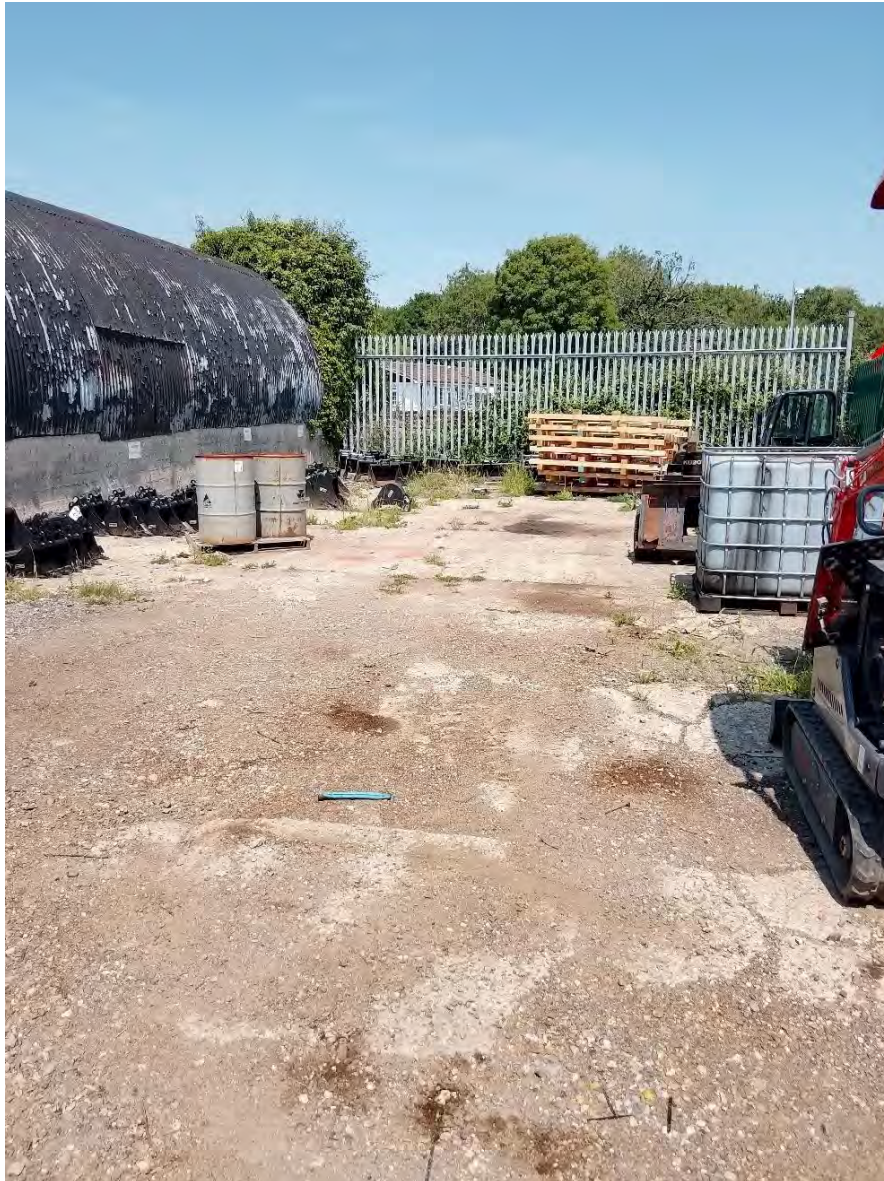
## Photo 45

View of external storage area in the western area of the site looking north. Also visible is a concrete block and corrugated metal structure and vehicle oil IBCs. Surface covering is poured concrete and concrete slabs.

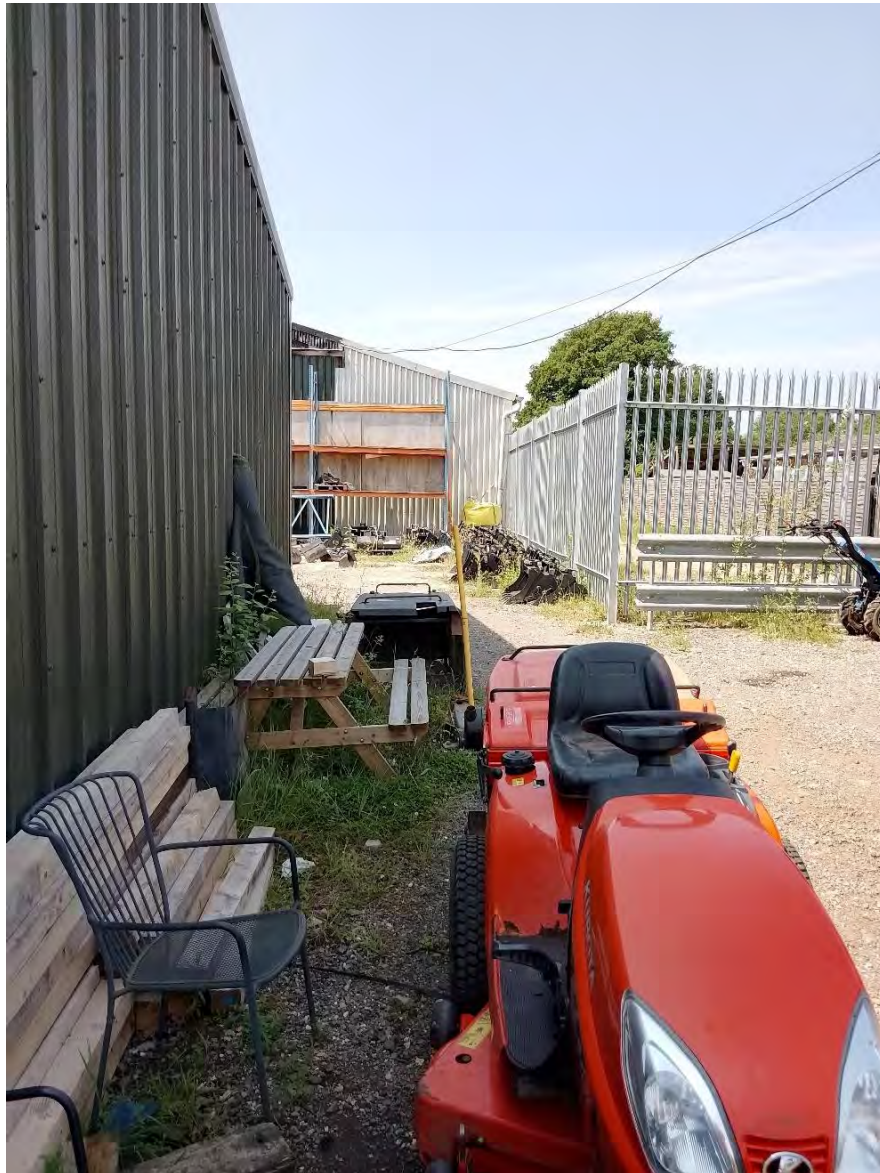
## Photo 46

View at the rear of corrugated metal vehicle maintenance workshops to further external storage areas in the western area of the site looking west. Surface covering is compacted gravel and poured concrete.

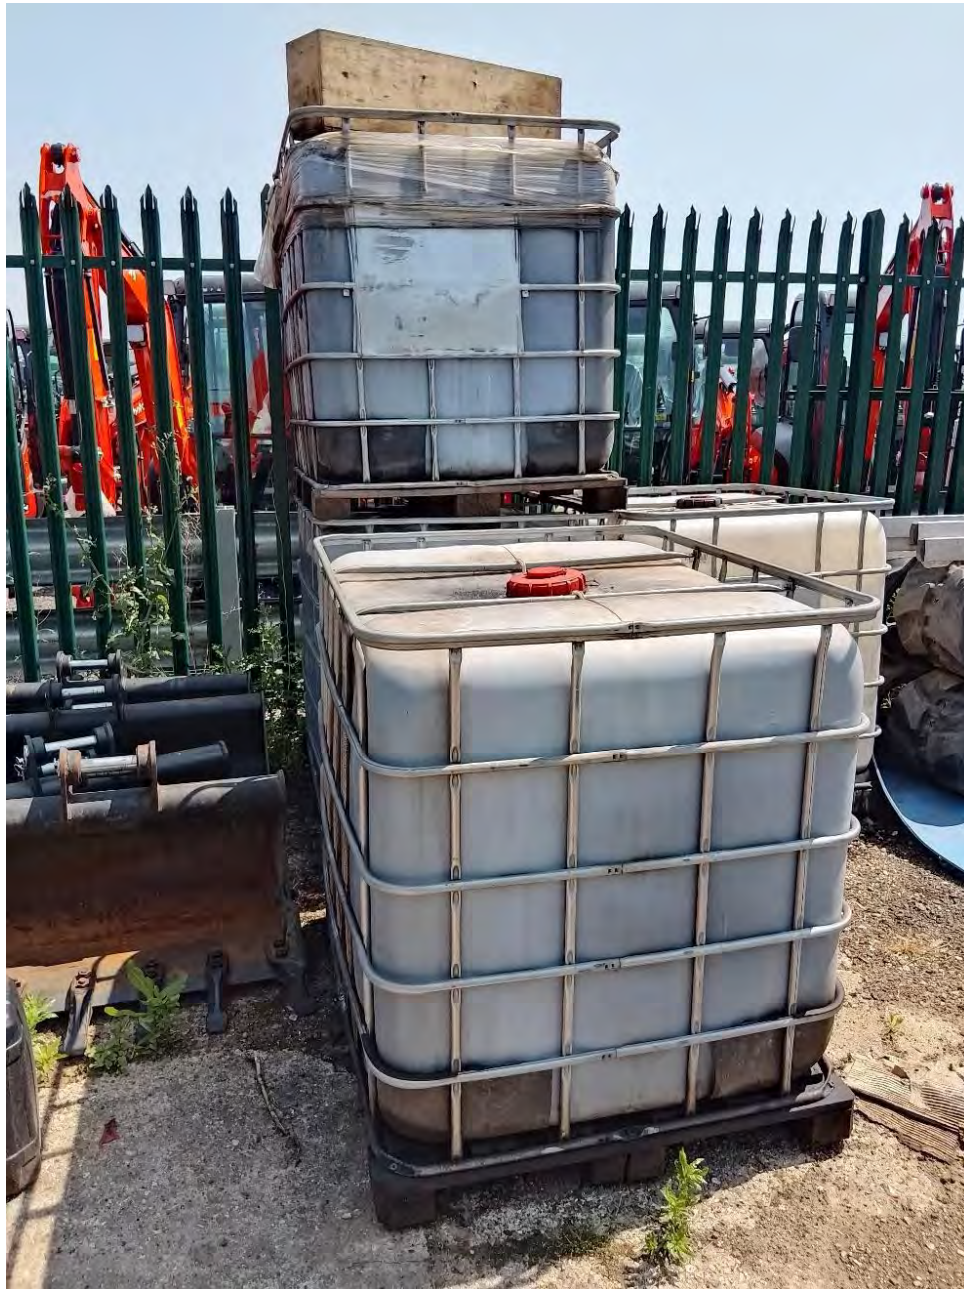
**Photo 47**

Photograph of vehicle oil IBCs in the western area of the site, sited on poured concrete.

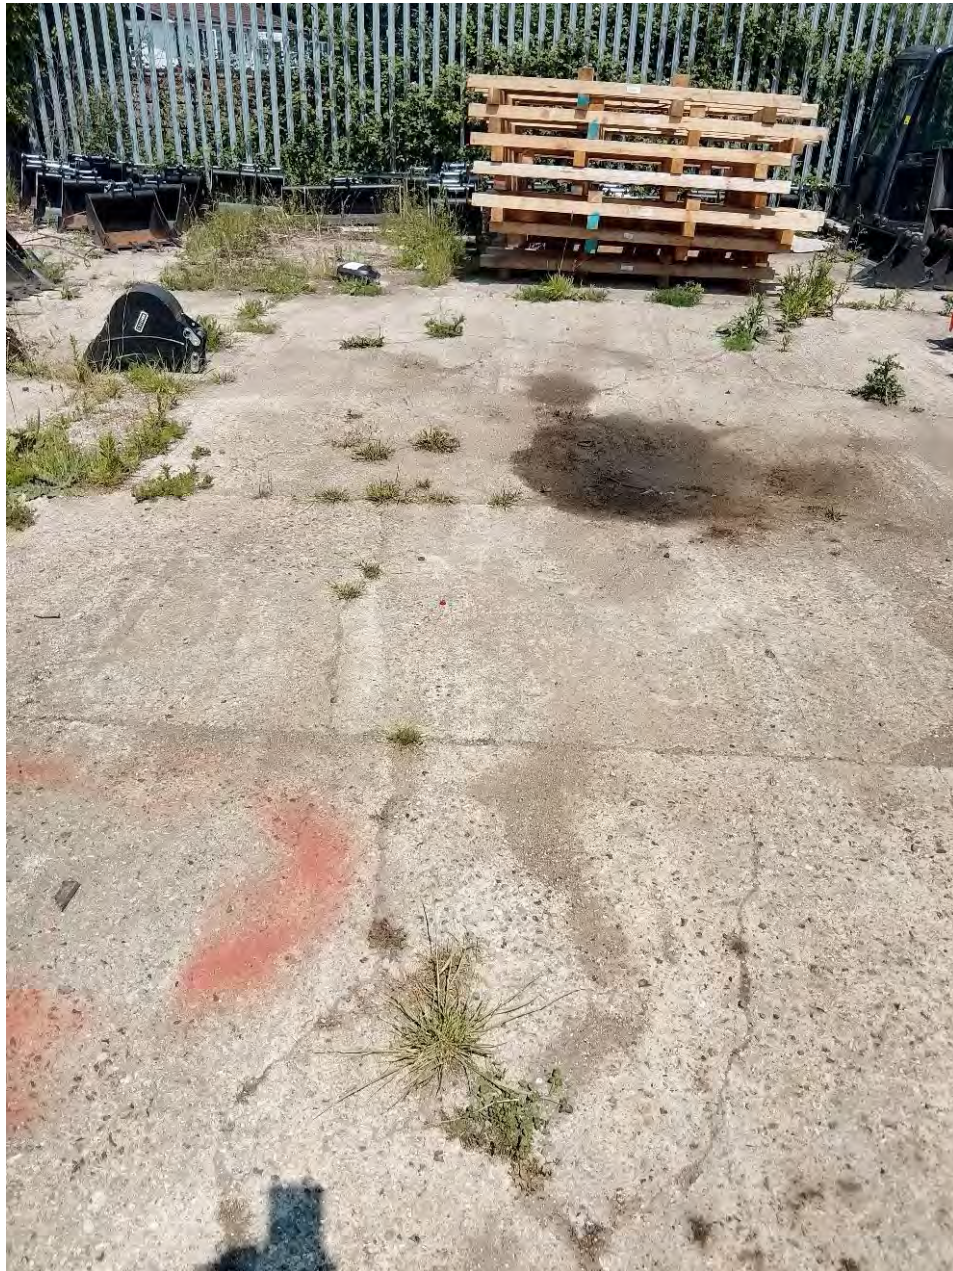
## Photo 48

Photograph of external storage area with concrete slab surface covering with discoloration and cracking visible in the centre of the site.

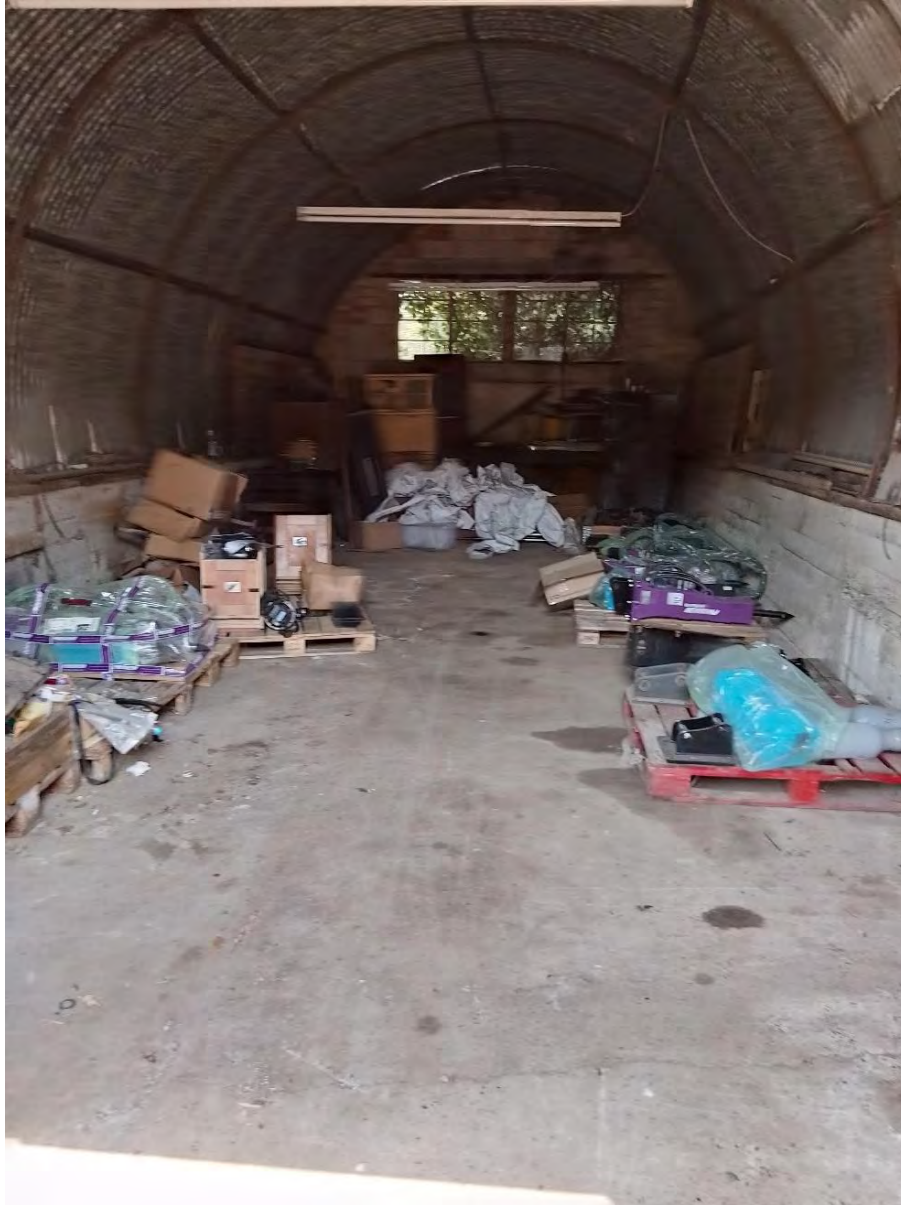
**Photo 49**

Internal view of concrete block and corrugated metal structure with concrete slab flooring in the western area of the site looking north.

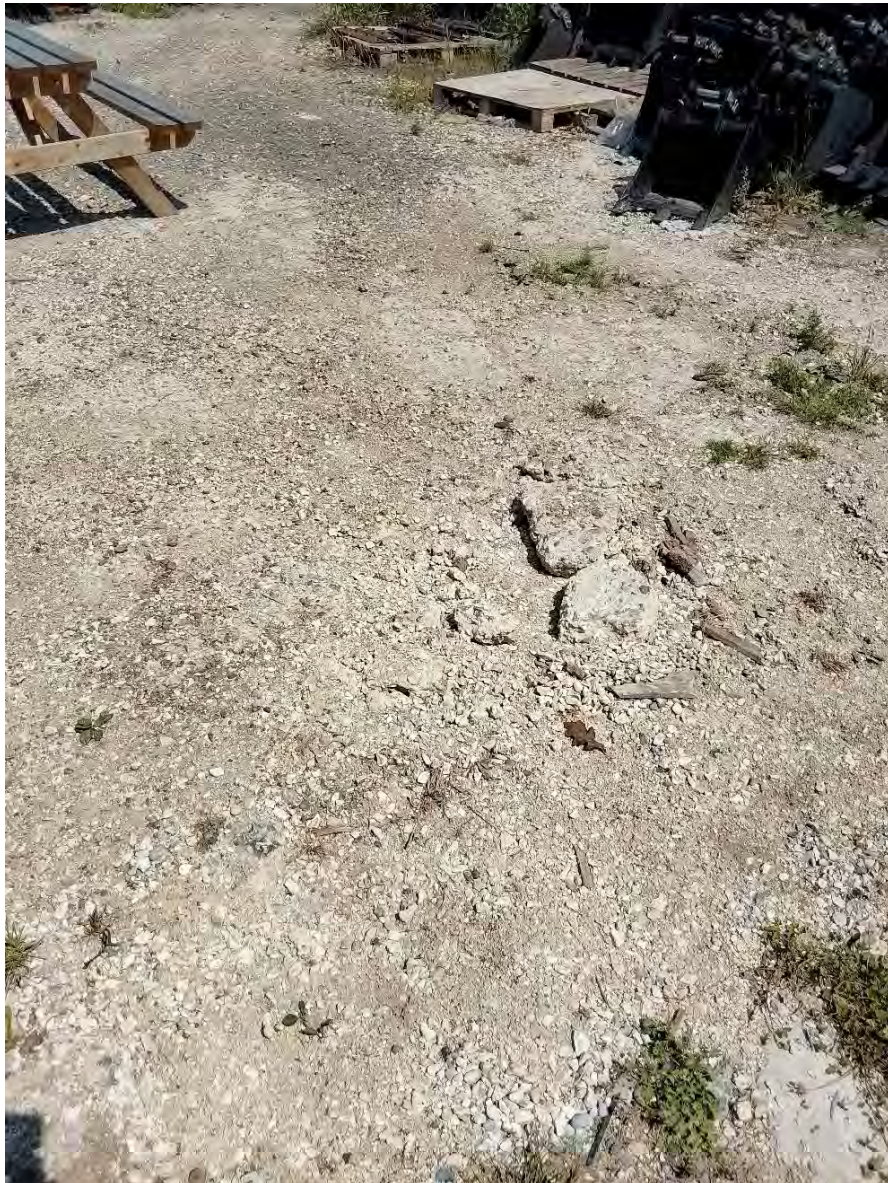
## Photo 50

Broken concrete slab in external storage area in the western area of the site.
