## **APPENDIX A**

### **Photographic Record**

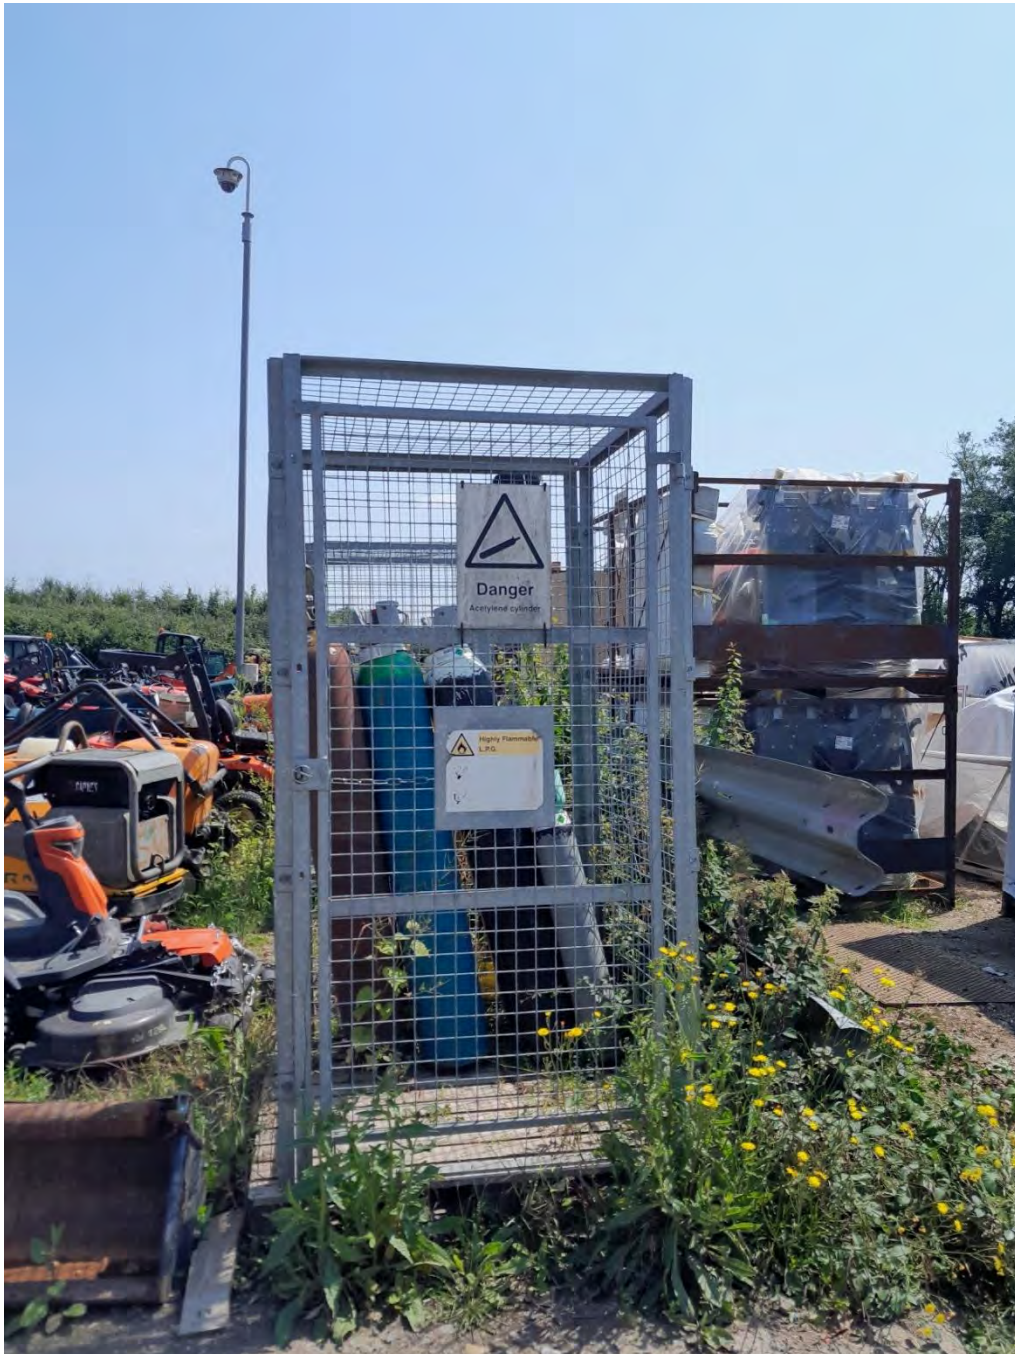
## Photo 51

Photograph of gas cylinders within a storage cage in the southern vehicle and machinery storage compound.

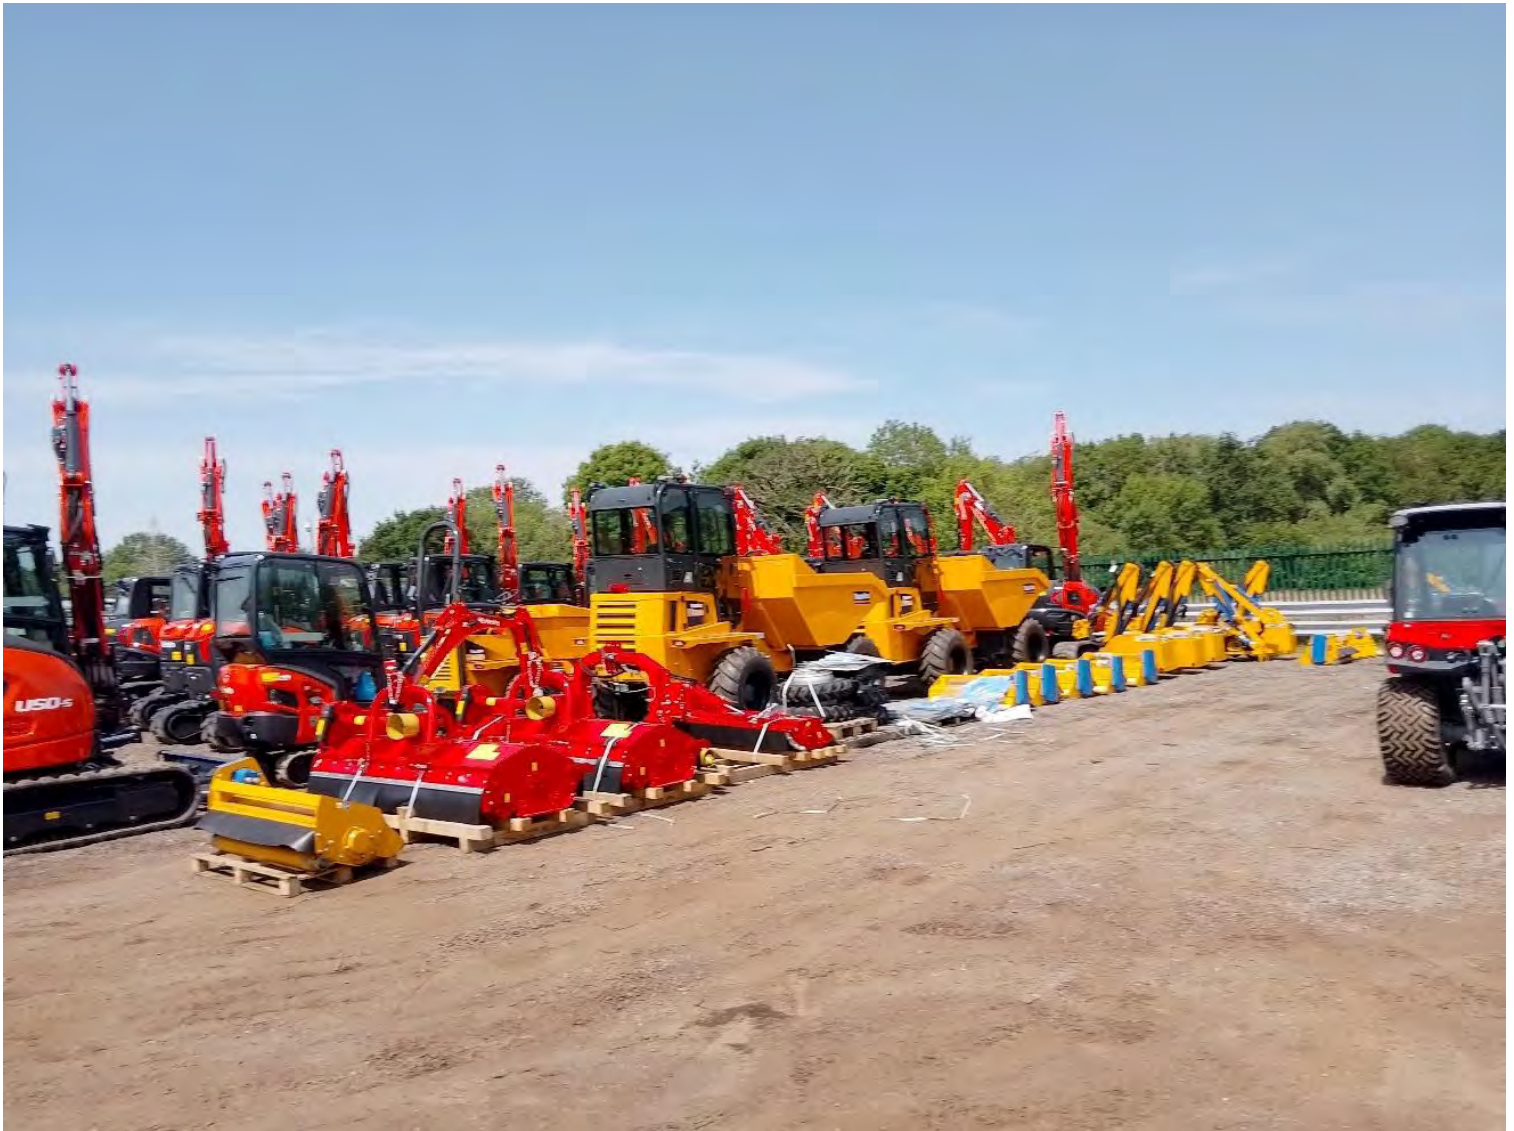
## Photo 52

View of northern vehicle and machinery storage compound in the centre of the site looking north.  
Surface covering is compacted gravel.

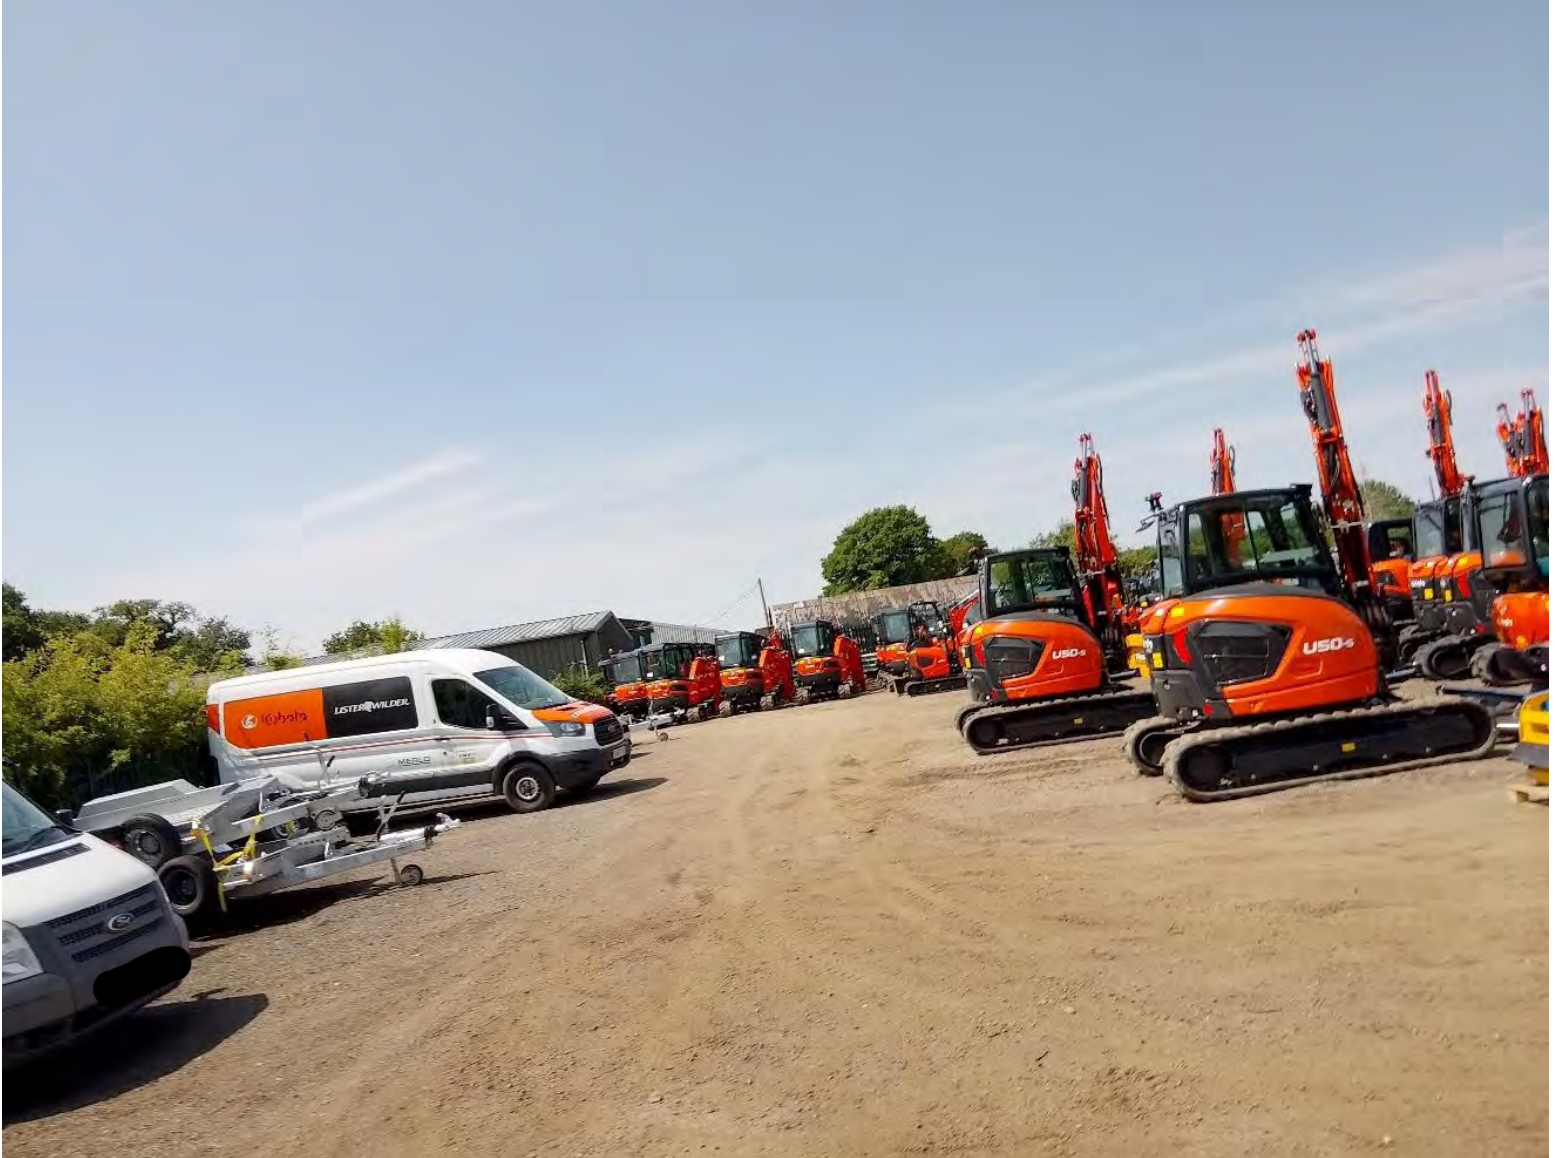
**Photo 53**

View of northern vehicle and machinery storage compound in the centre of the site looking east.  
Surface covering is compacted gravel.

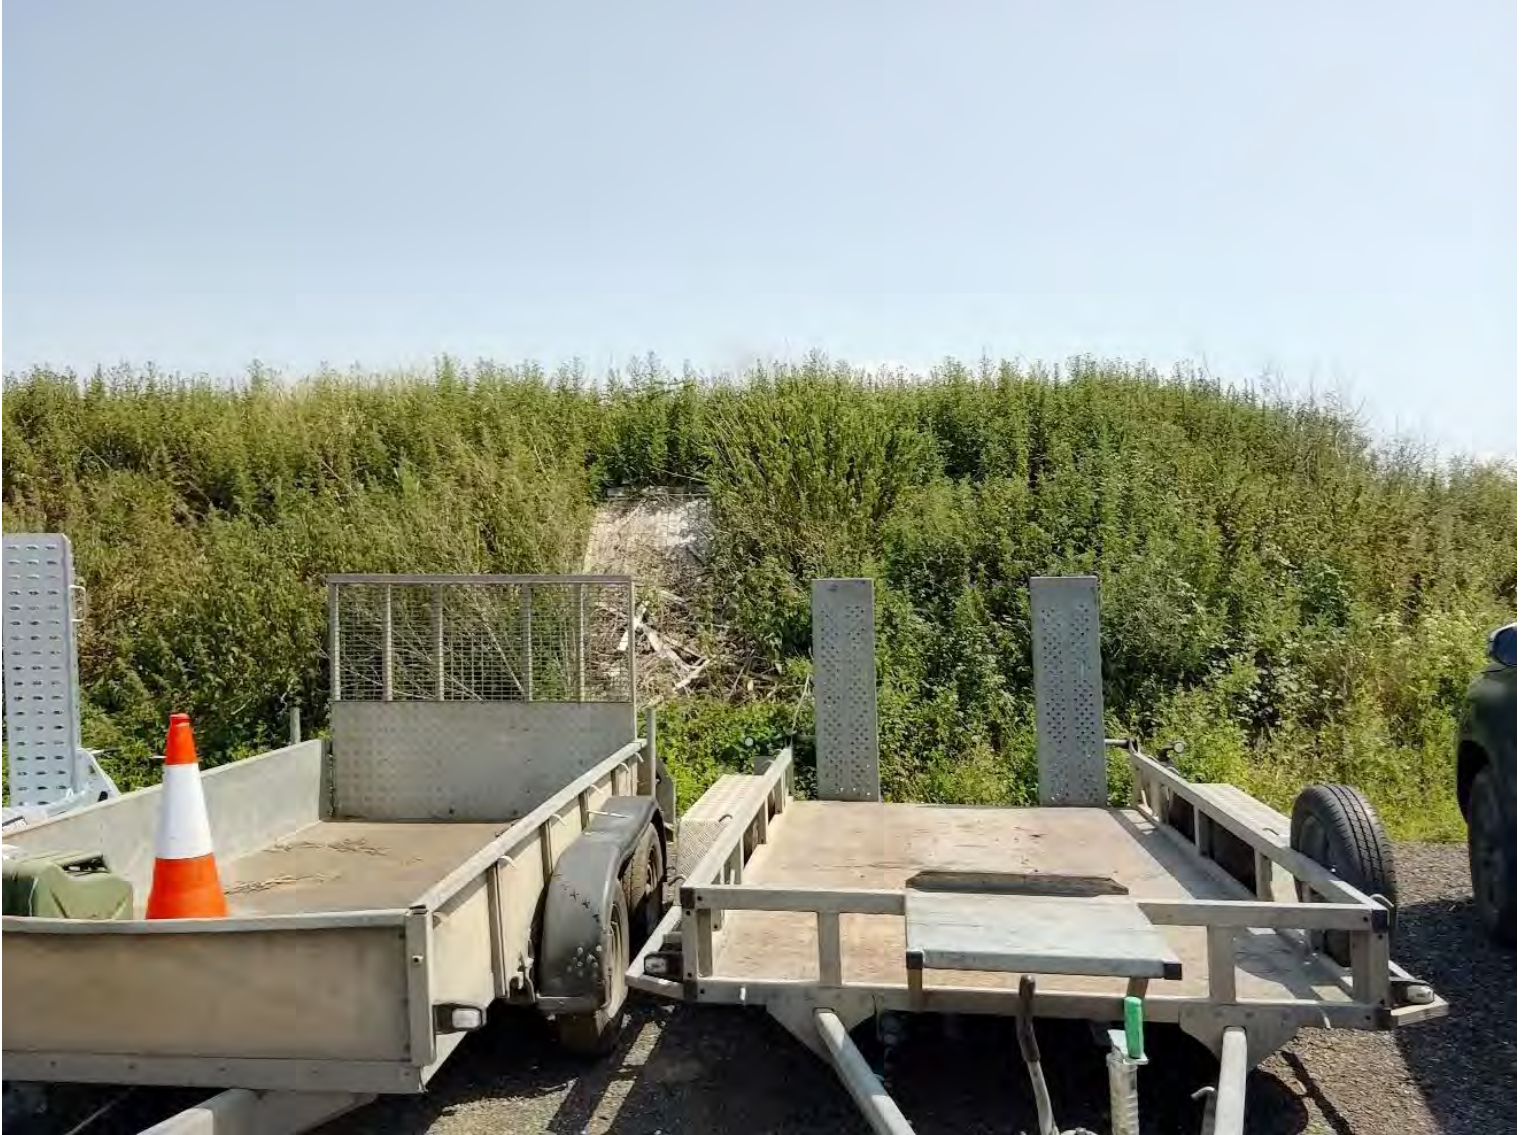
## Photo 54

View of a bund of unknown material to the west of the northern vehicle and machinery storage compound in the centre of the site looking west.

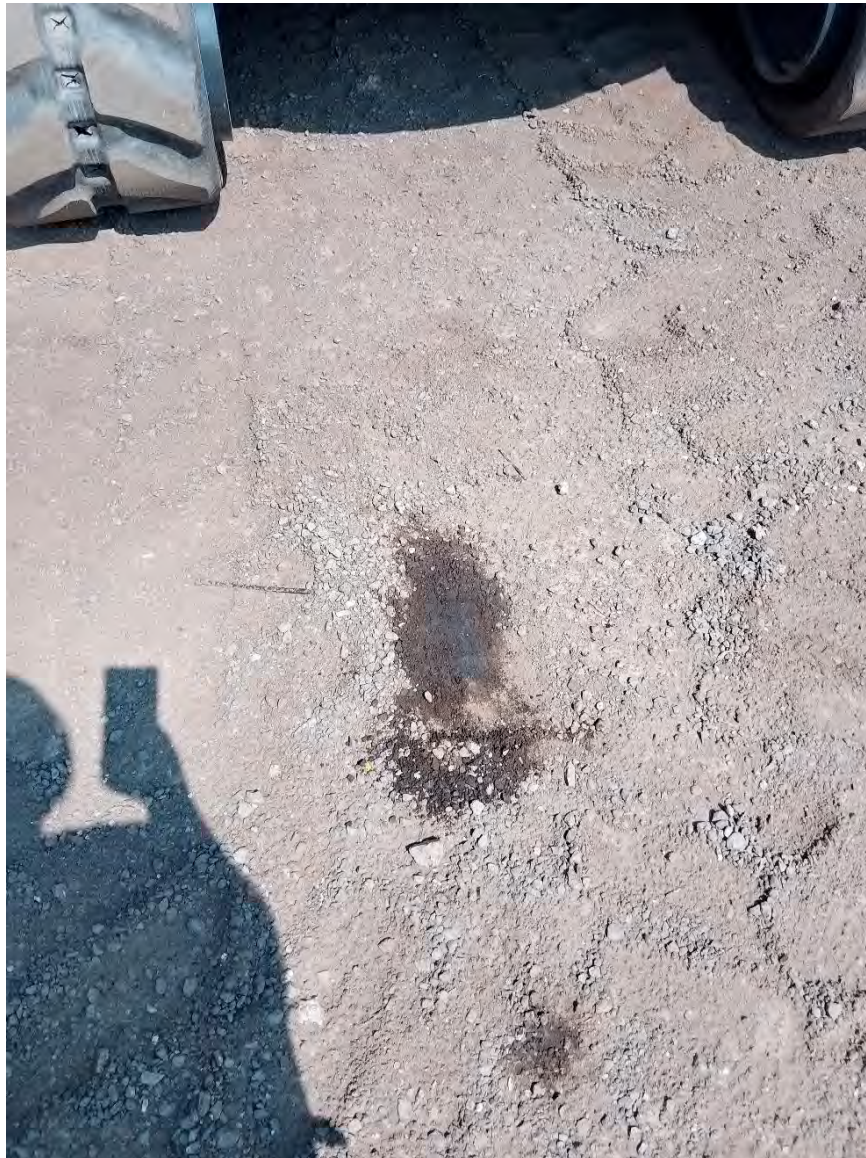
## Photo 55

Photograph of minor surface staining caused by an unknown substance in northern vehicle and machinery storage compound in the centre of the site. Surface covering is compacted gravel.

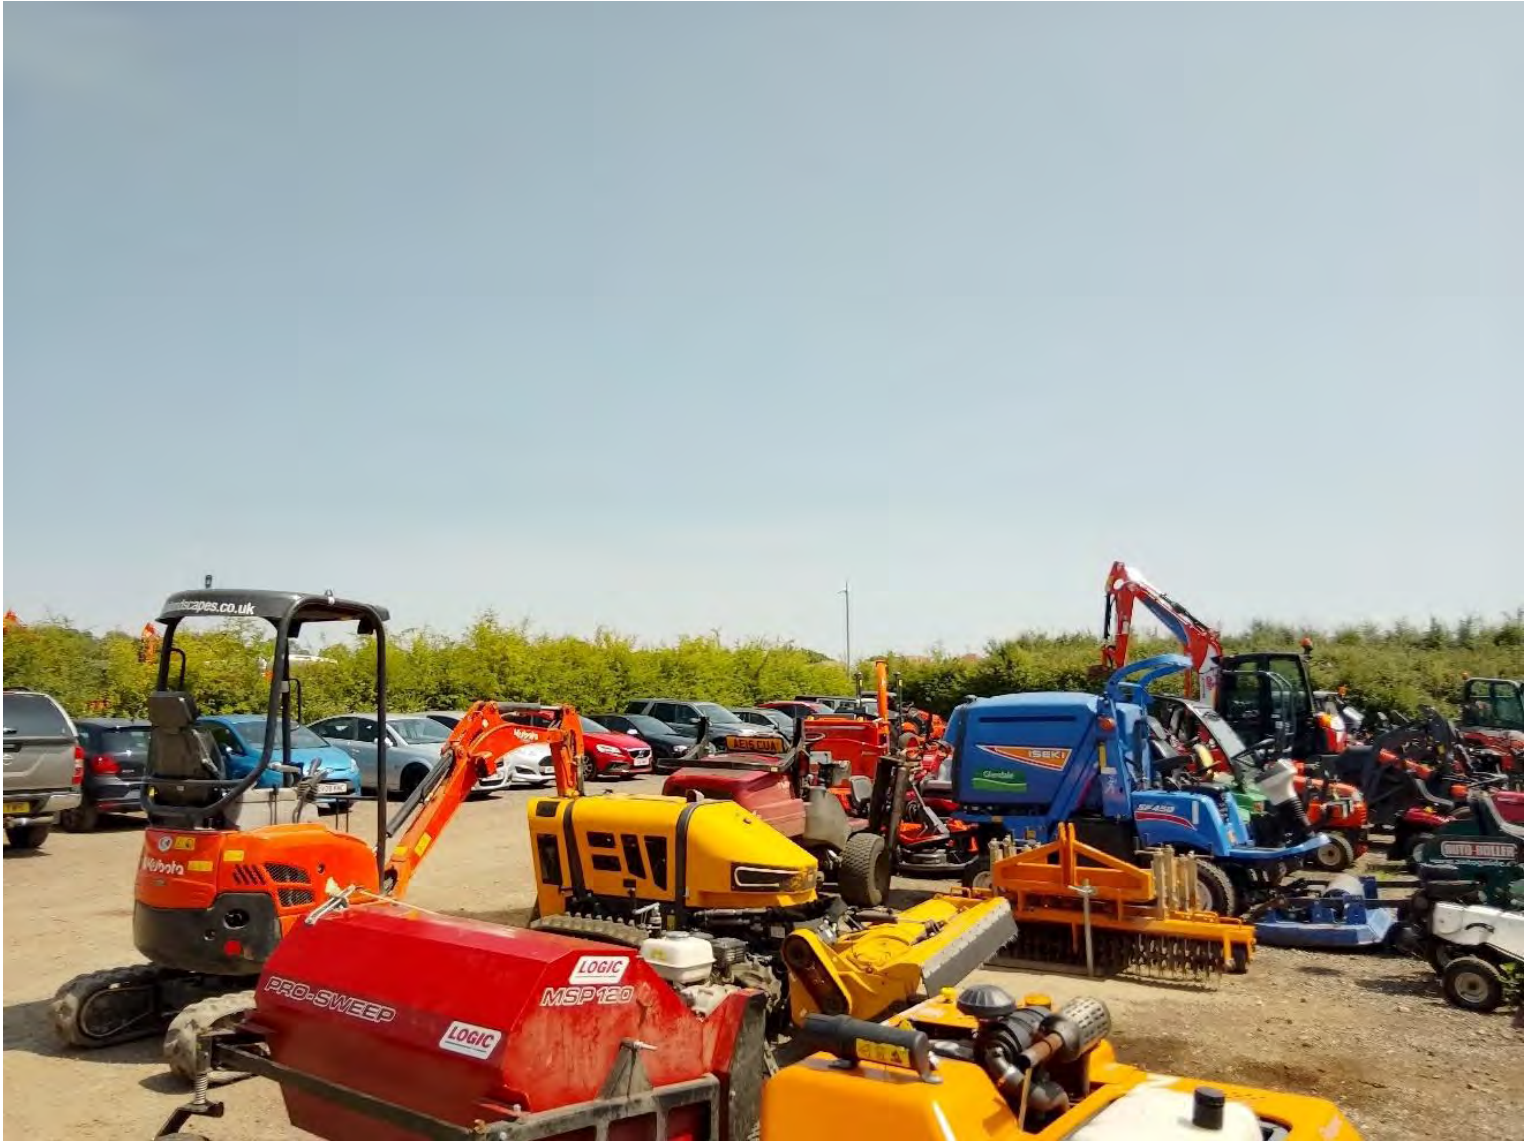
**Photo 56**

View of southern vehicle and machinery storage compound looking east. Surface covering is compacted gravel.

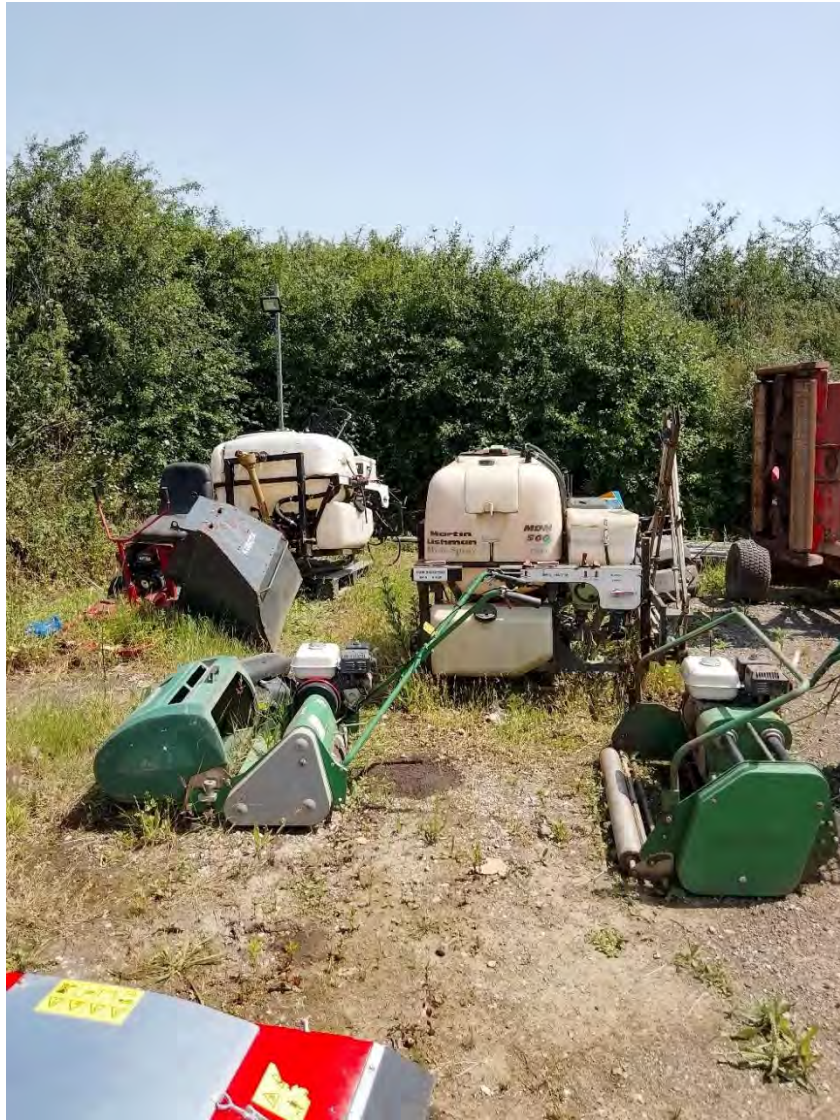
**Photo 57**

View of miscellaneous machinery with empty fertilizer tanks in the east of the southern vehicle and machinery storage compound looking east. Surface covering is compacted gravel.

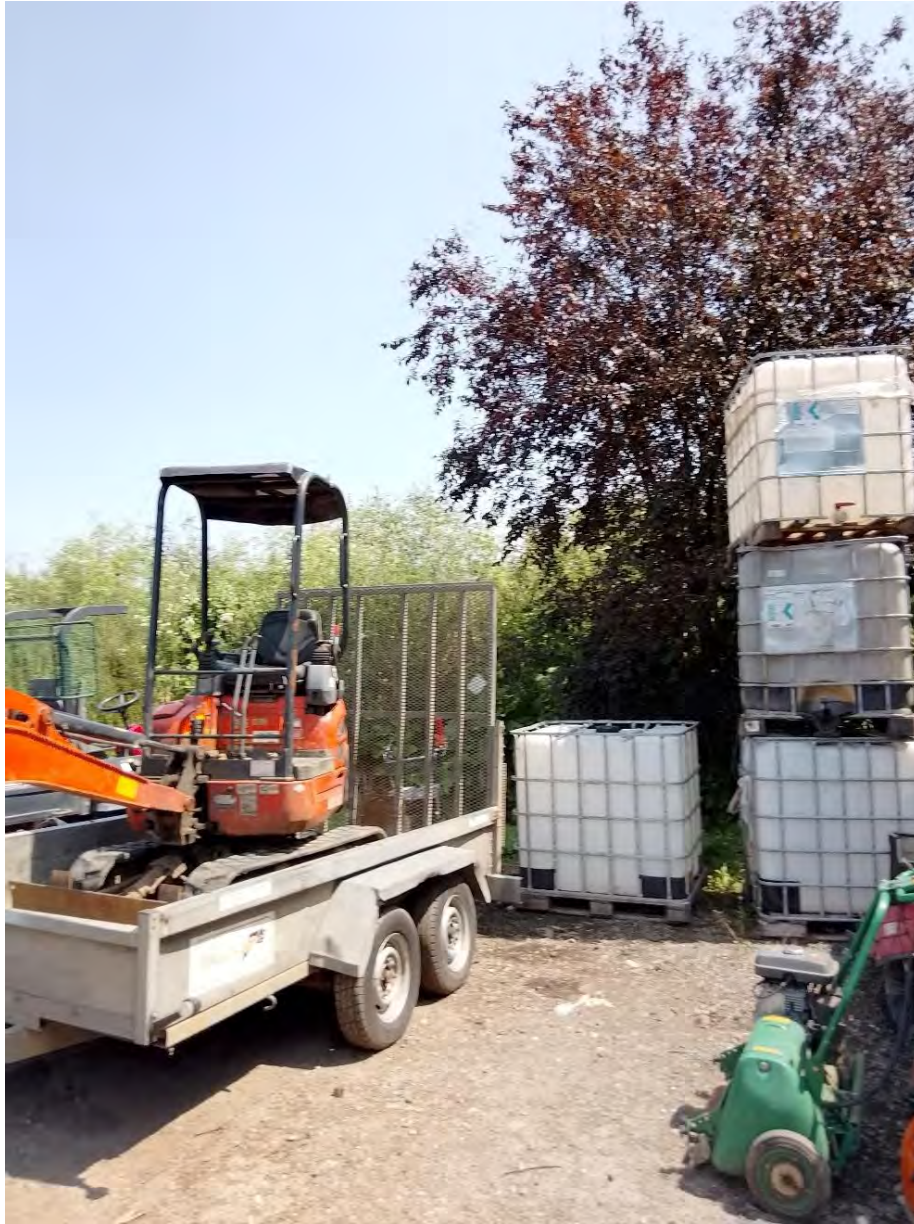
## Photo 58

View of IBCs and machinery in the east of the southern vehicle and machinery storage compound looking east. Surface covering is compacted gravel.

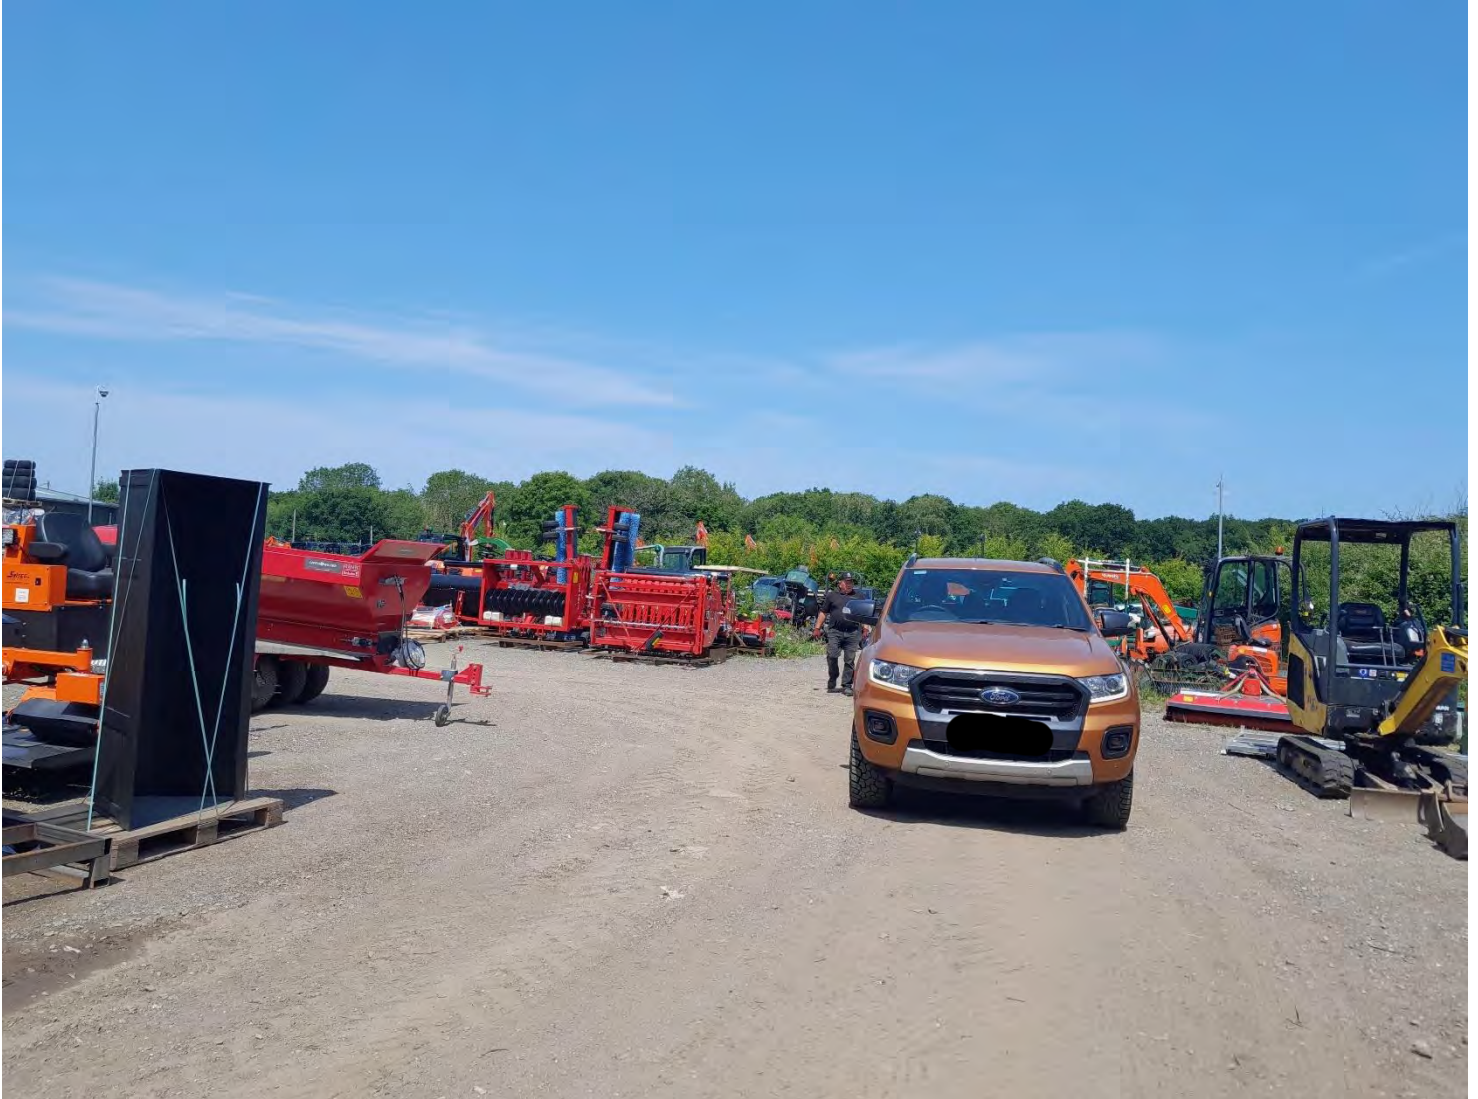
## Photo 59

View of the southern vehicle and machinery storage compound in the east looking north. Surface covering is compacted gravel.

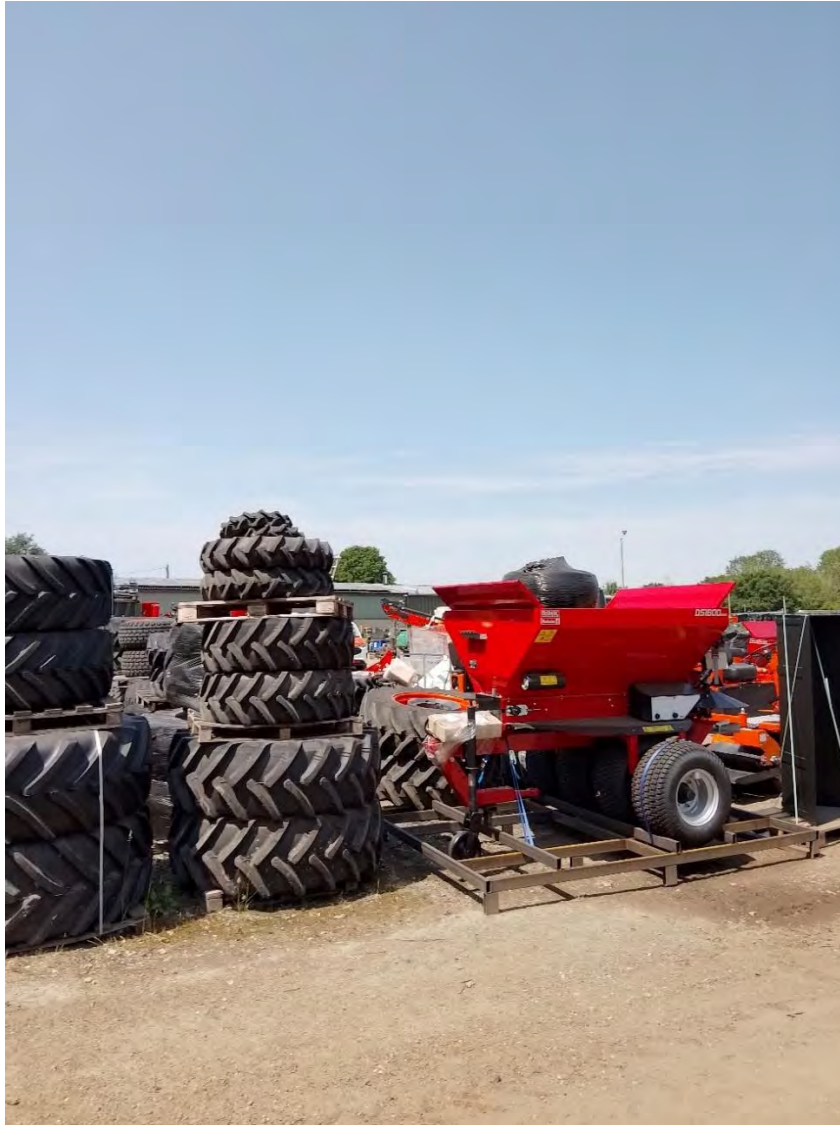
## Photo 60

View of the southern vehicle and machinery storage compound in the east looking west. Surface covering is compacted gravel.

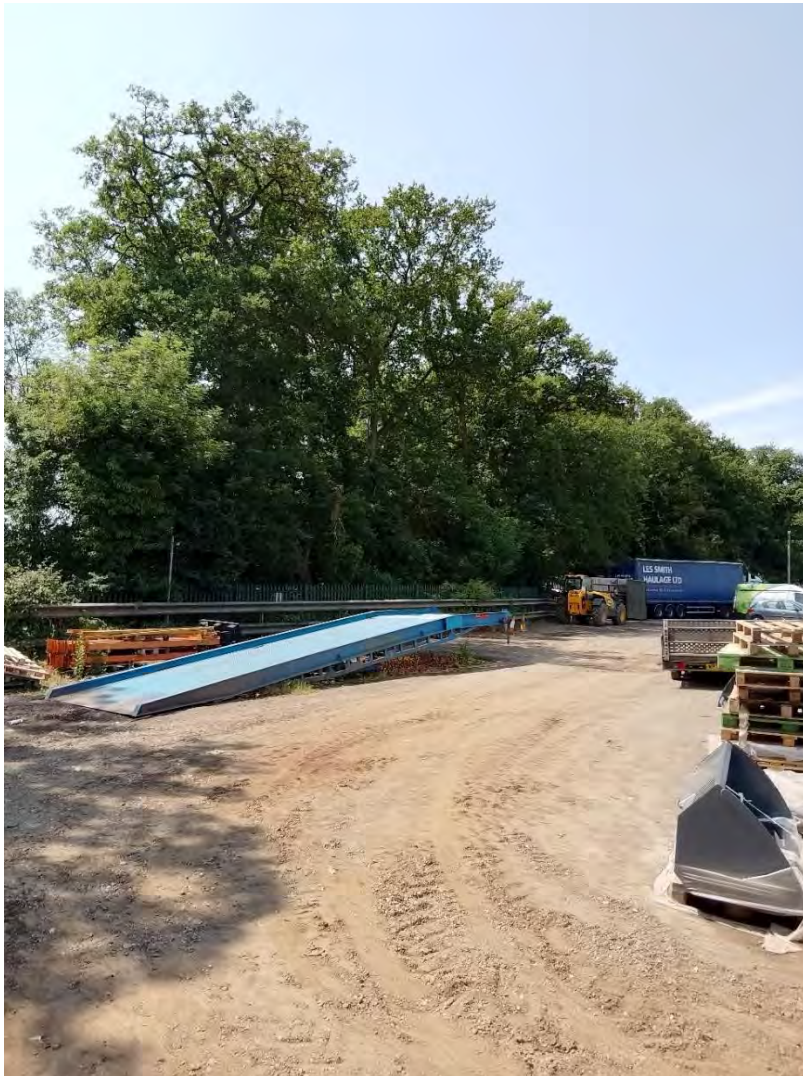
## Photo 61

View of the southern vehicle and machinery storage compound in the east looking south. Surface covering is compacted gravel.

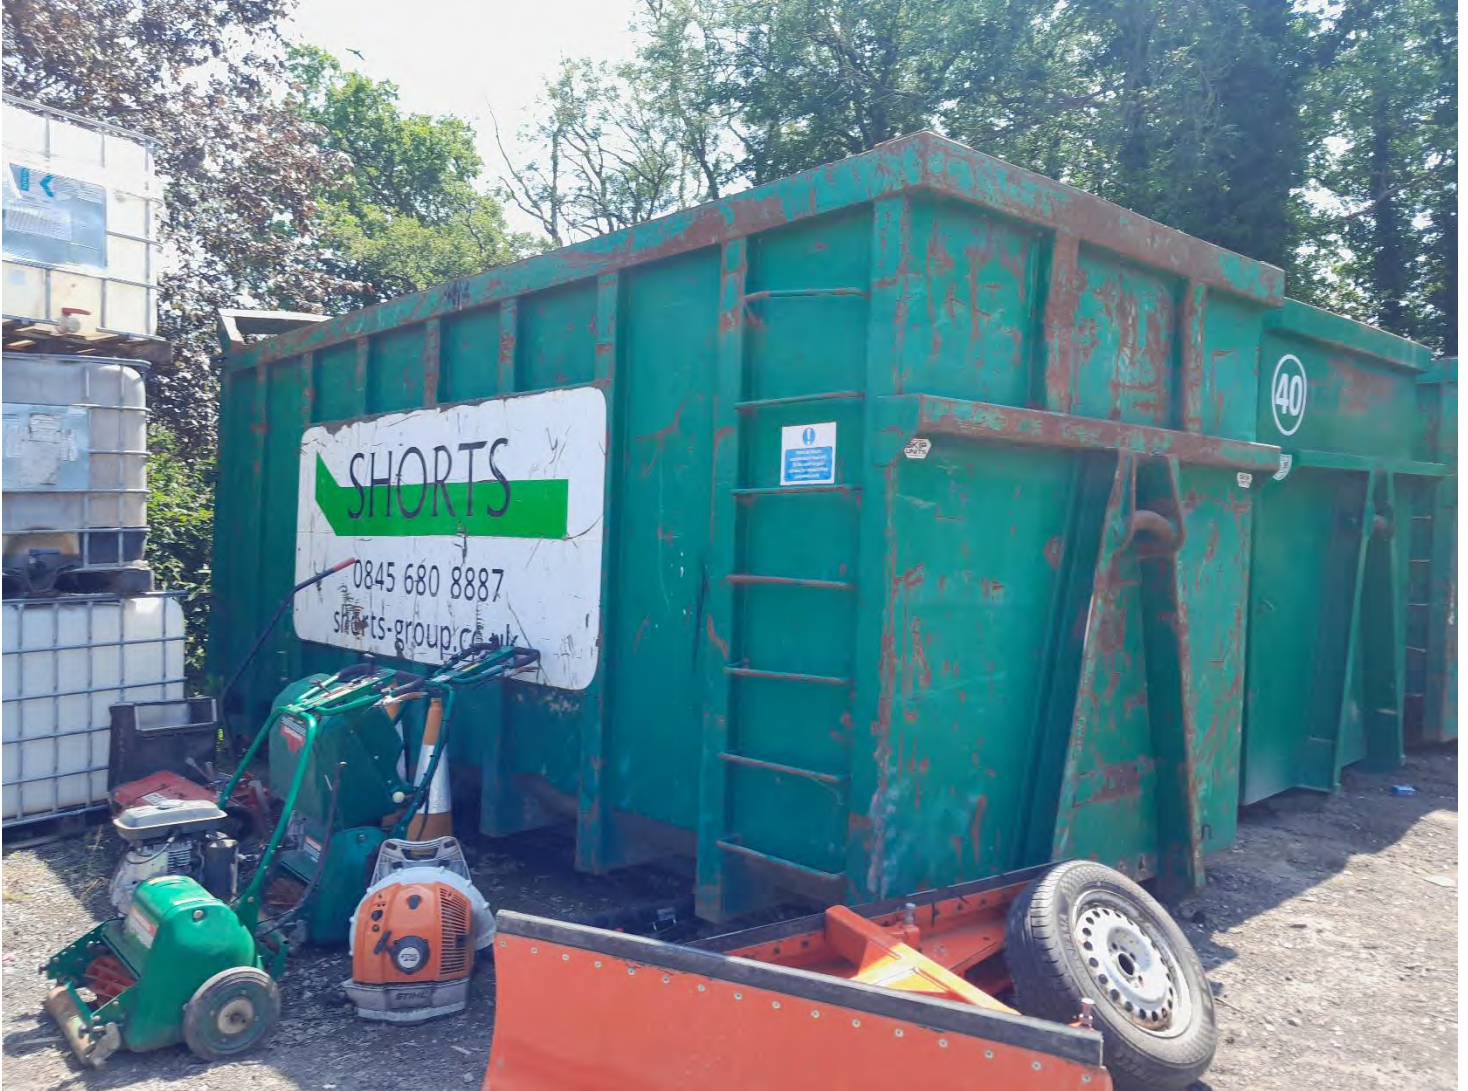
## Photo 62

Photograph of large industrial skips in the southeast of the southern vehicle and machinery storage compound.
