## ENGINEERS SITE INSPECTION REPORT

**SITE:-** South Lodge  
Stanbury Park  
Wellington Court  
Spencers Wood  
Reading  
Berkshire, RG7 1BN

**JOB No.:- 15144**

**Date of Inspection:-** Thursday 16 July 2015

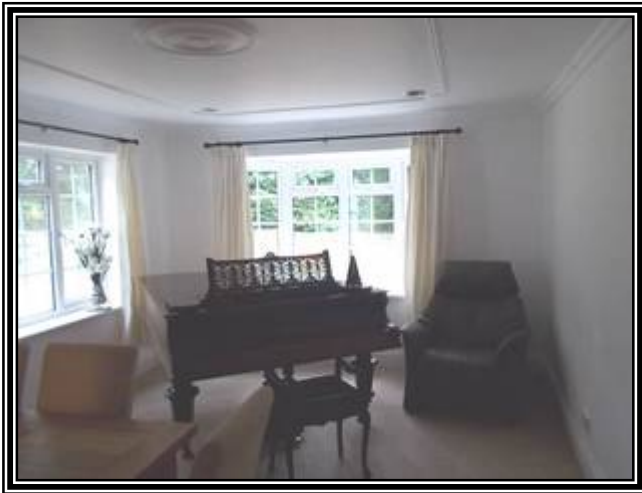
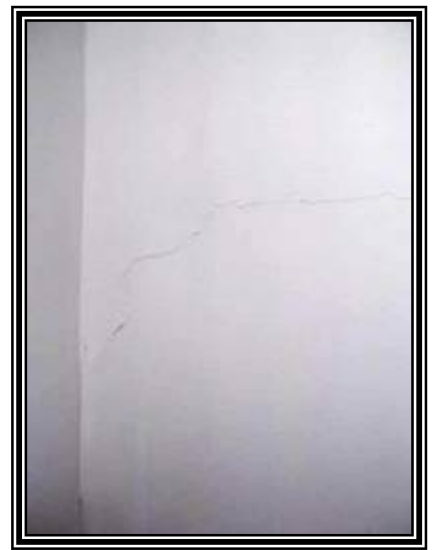
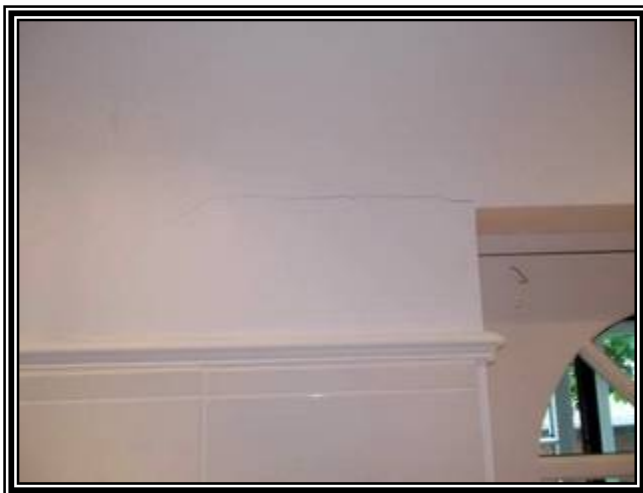
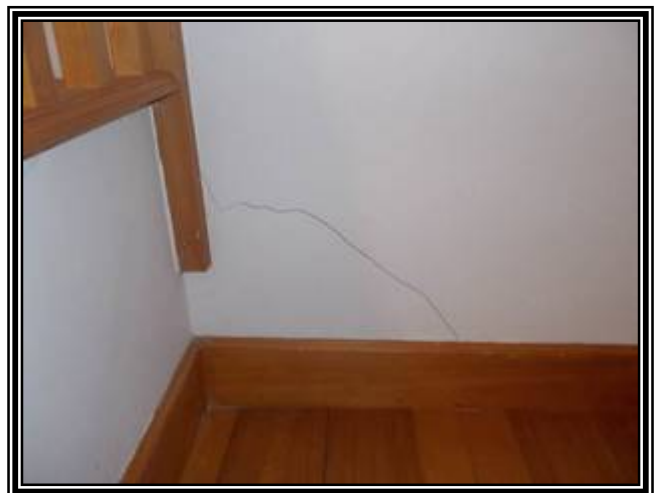
- The attached drawing indicates the site layout, together with locations where cracking was noted to the internal and external walls.
- Slight signs of movement were noted internally in several locations, and in particular to the Music / Dining Room partition walls adjacent to the Kitchen annex and adjacent to the mezzanine, the Kitchen annex wall adjacent to the Porch, and the partition between the mezzanine and Boiler Room.

- These cracks were generally not noted externally, except for a light vertical crack adjacent to the porch. This crack however had been painted over.

- d) The cracking to the internal walls particularly in the Music / Dining Room area should be investigated further by initially carrying out a monitoring exercise to check for progressive movement, followed by appropriate remedial works, preferably via stitching using masonry reinforcement. The monitoring should also include the floor slab and gap evident below the Bedroom skirting.
- e) It is likely that the 102mm thick brick boundary wall will need partial reconstruction, possibly on new foundations. Cracks in other boundary and retaining wall locations could be re-stitched or movement joints incorporated.
- f) We also recommend the below ground drainage around the building be checked via CCTV survey.

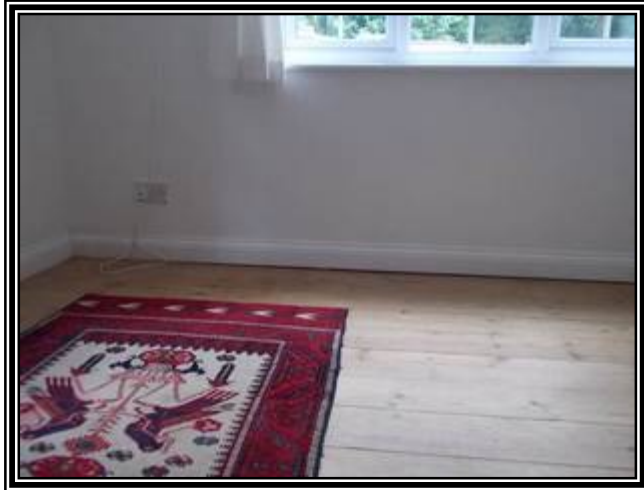
- Walls generally appear to be plumb and bed joints level. Floors also appear to be reasonably level and without gaps below skirting's except to the skirting in the North West corner bedroom, which showed a slight gap.

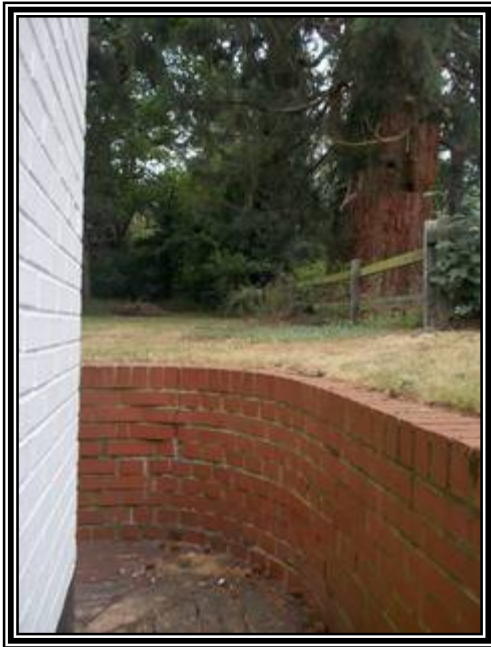
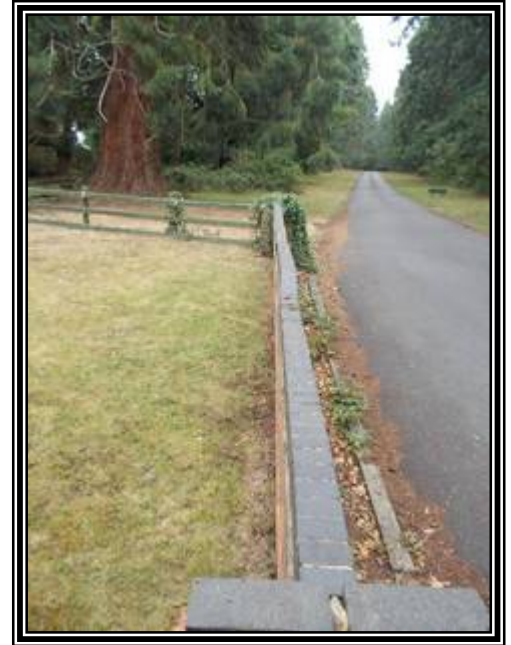
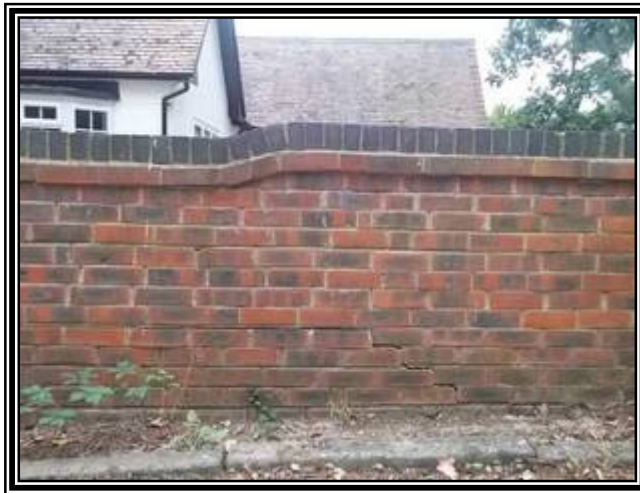
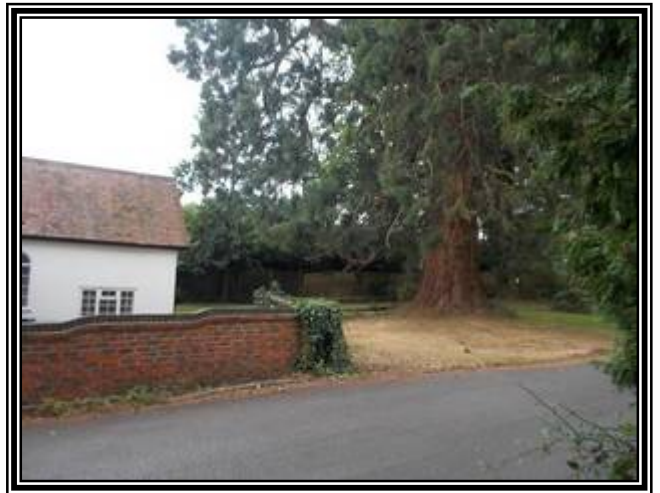
- Cracking was also noted to the curved section of retaining wall nearest to the giant Redwood, and also to the brickwork boundary walls, particularly the 102mm thick pierced wall nearest to the giant Redwood.

- b) A copy of the underpinning warranty should be obtained.
  - c) It has already been established that the giant Redwood cannot be removed, however to reduce the risk of further movement as a result of moisture abstraction by other nearby trees, we suggest that trees nearest to the house are either removed or regularly maintained at a height not greater than their distance from the building. Arboricultural advice should be sought particularly with respect to potential heave following removal of these trees.

Details of the previously installed root barrier should be obtained if possible and consideration given to installing a further more effective root barrier. We recommend that Arboricultural advice first be sought with regard to the extent of the root protection area, and therefore the location, depth and form of construction of the root barrier.

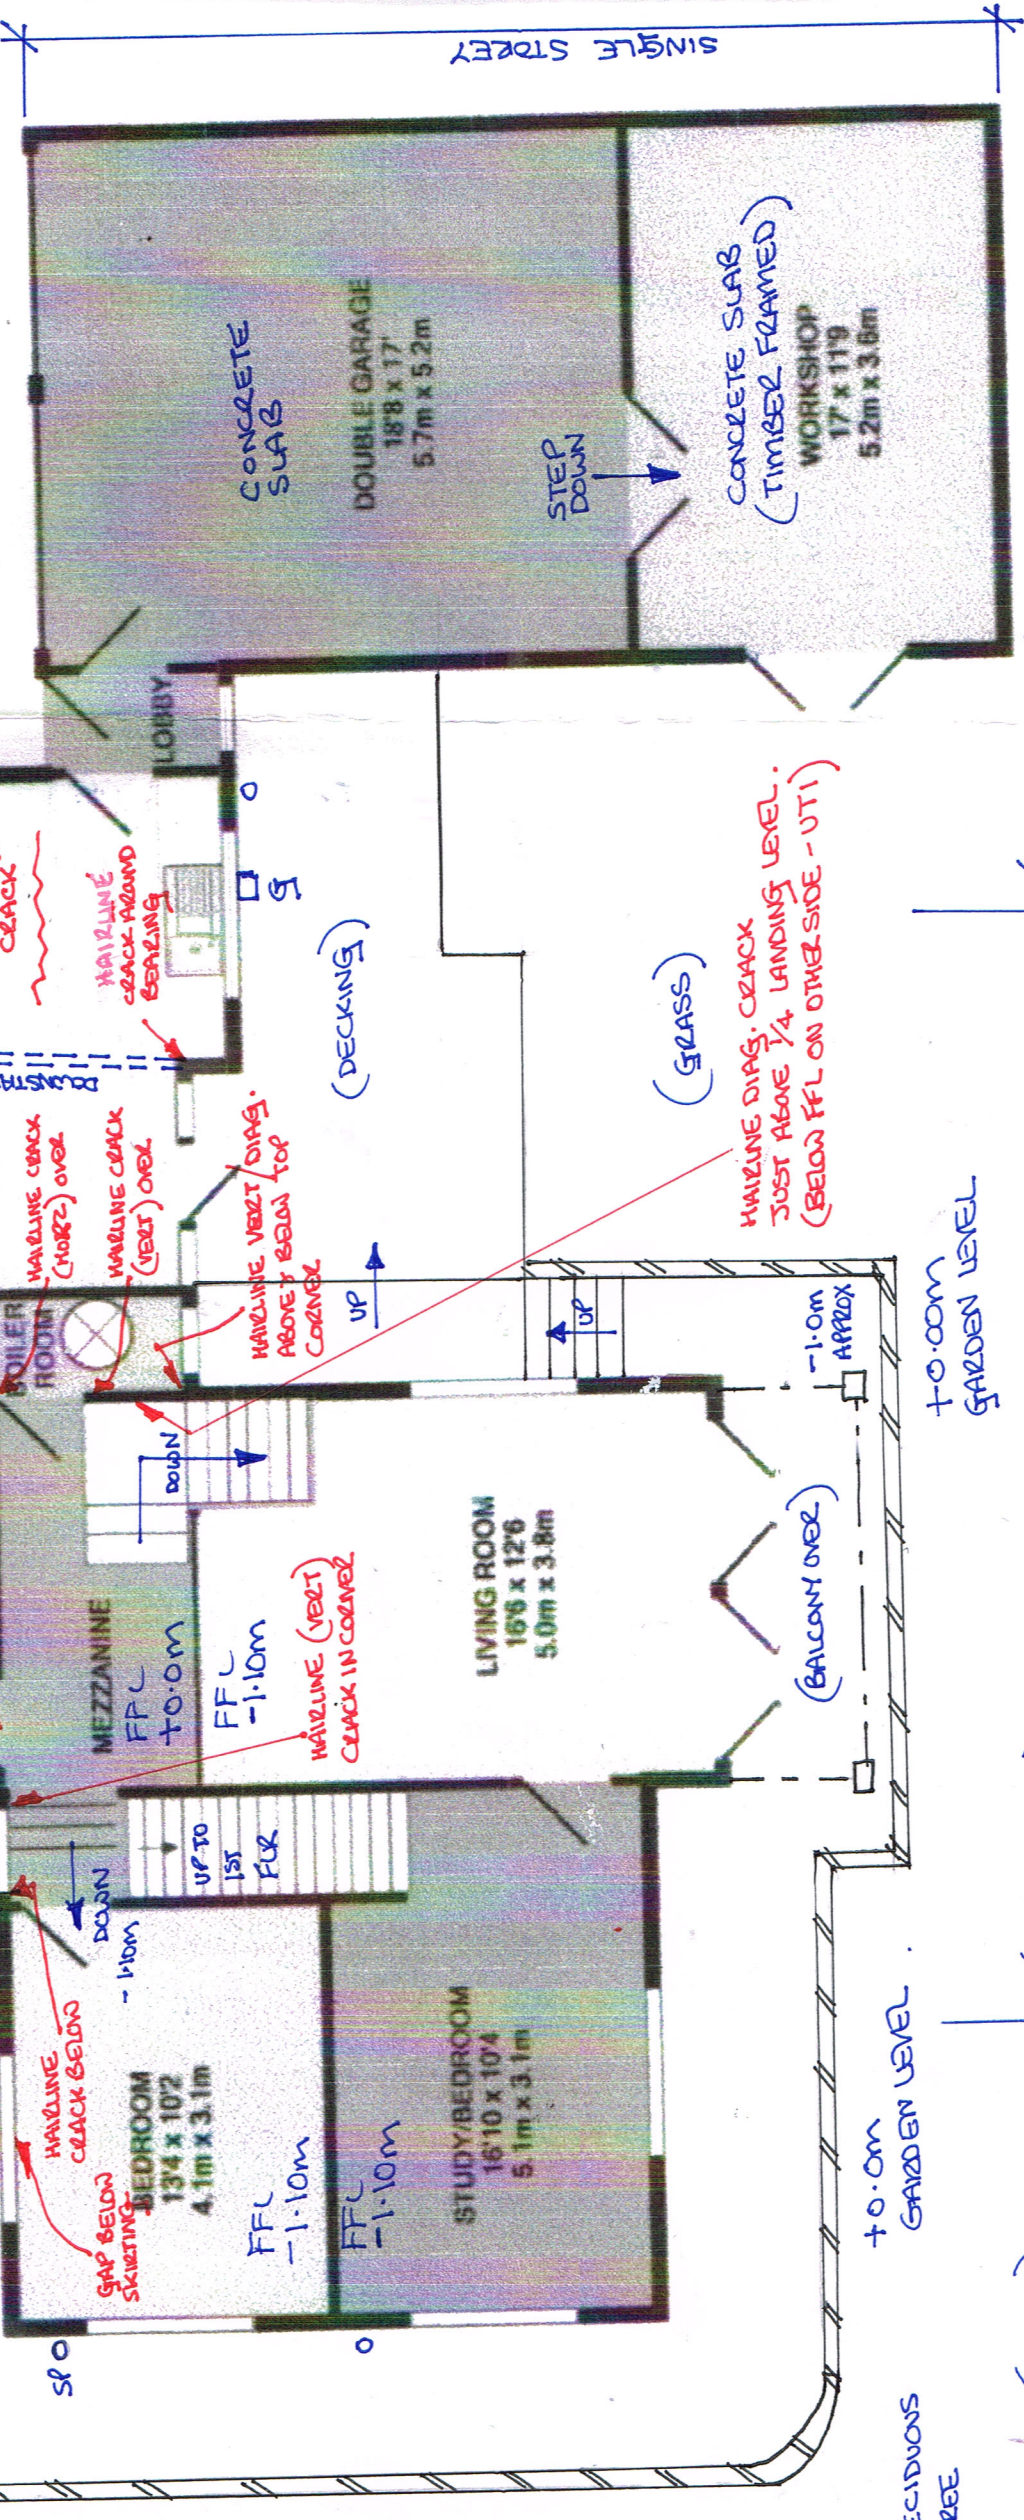
Floorplan

(HORIZ) & STOPPED CRACKS  
(HORIZ) DISPLACEMENT AT LAP  
LEVEL CRACK.  
WALL LEANS TOWARDS HOUSE

(HORIZ) CREASE  
AT APPROX 0.7m  
UP FROM FFL

HAIRLINE (VERT) CRACK  
PREVIOUSLY PAINTED OVER

HAIRLINE - 0.5mm (HORIZ) & DIAG.  
'STRESS' CRACKS - OFF DOOR HEAD.  
(NOT VISIBLE EXTERNALLY)

(VERT) CREASE / CRACK  
IN CORNER

DIAG. / (HORIZ) CRACK  
AT 1.6m UP FROM FFL  
(NOT VISIBLE ON OTHER SIDE)

HAIRLINE (HORIZ)  
(VERT) CRACK AT  
DOOR HEAD

HAIRLINE DIAG. CRACK OVER  
(NOT VISIBLE EXTERNALLY)

HAIRLINE (VERT) CRACK BETWEEN  
SOLID & STUD WALLS.

HAIRLINE DIAG. CRACK  
JUST ABOVE 1/4 LANDING LEVEL.  
(BELOW FFL ON OTHER SIDE - UTI)
