DUCKWORTHS
ARBORICULTURE

Arboricultural Supervision & Site Inspection

Location: Carnival Place, Wellington Road, Wokingham, Berkshire RG40 2AF

Date of visit: 4th March 2025

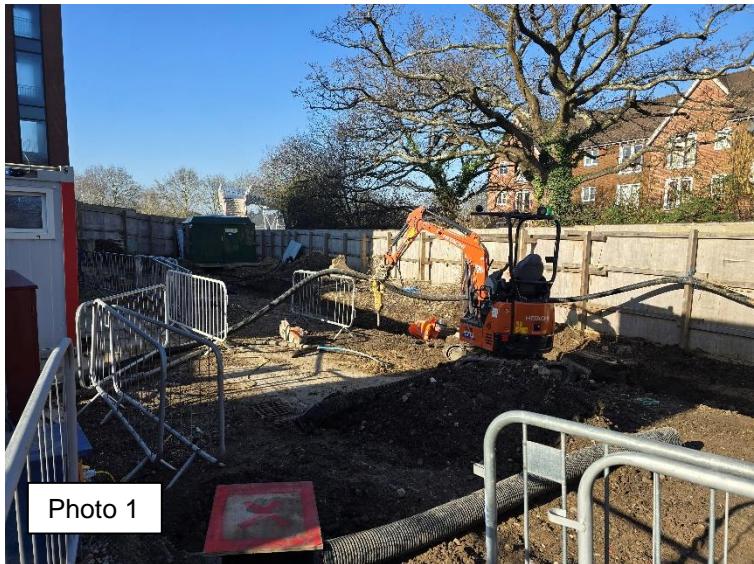
Photo 1

I also note that there has been uncontrolled mechanical excavation within the root protection area of TPO tree T4 (Oak). This area was designated as a precautionary dig zone 'A' and any work in this area is required to be undertaken with Arboricultural Supervision. Unfortunately, I was not informed about the work.

- 1) Mechanical excavation within RPA of T4 (Oak)
- 2) Tree Protection Fencing not present and needs to be reinstated
- 3) Storage of materials within the designated 'Construction Exclusion Zone' to be removed
- 4) Spoil infill within RPA of trees.

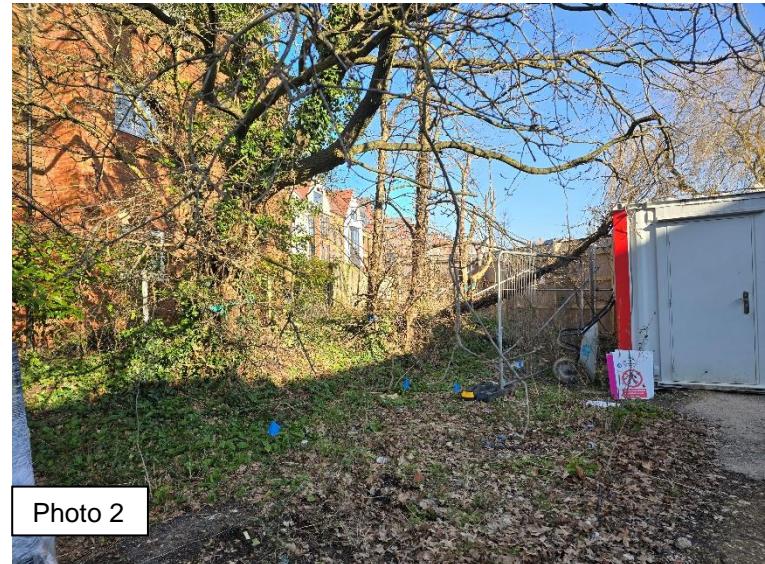
Photo 2

- Tree Protection Fencing has been removed along the northwest edge of the site but not reinstated as agreed in my previous report. In some areas the Heras fencing has been removed and replaced with crown barriers. These barriers do not meet the requirements of BS:5837 and The needs to be rectified within 7 days.

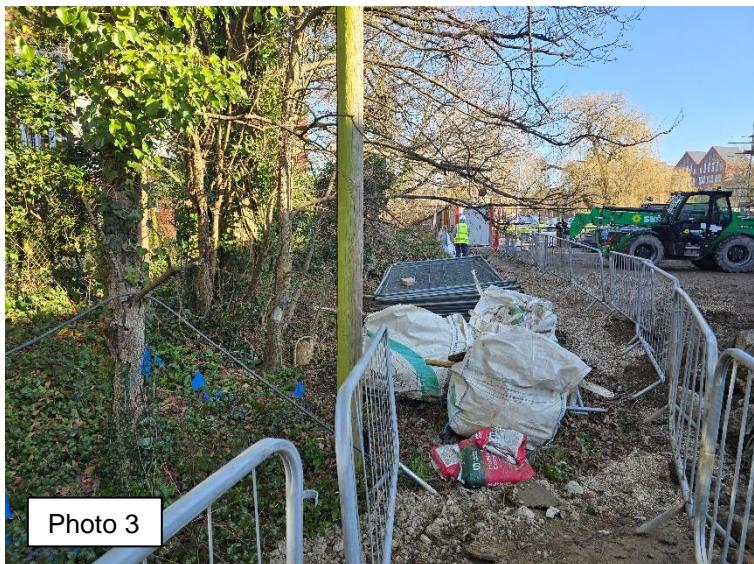
Photo 3

- Storage of materials and spoil within the Construction Exclusion Zone needs to be removed.
- Temporary ground protection within the pedestrian footpath should be removed
- ‘Temporary’ soil infill of the boundary ditch needs to be removed.
