DUCKWORTHS
ARBORICULTURE

Arboricultural Supervision & Site Inspection

Location: Carnival Place, Wellington Road, Wokingham, Berkshire RG40 2AF

Date of visit: 11th September 2025

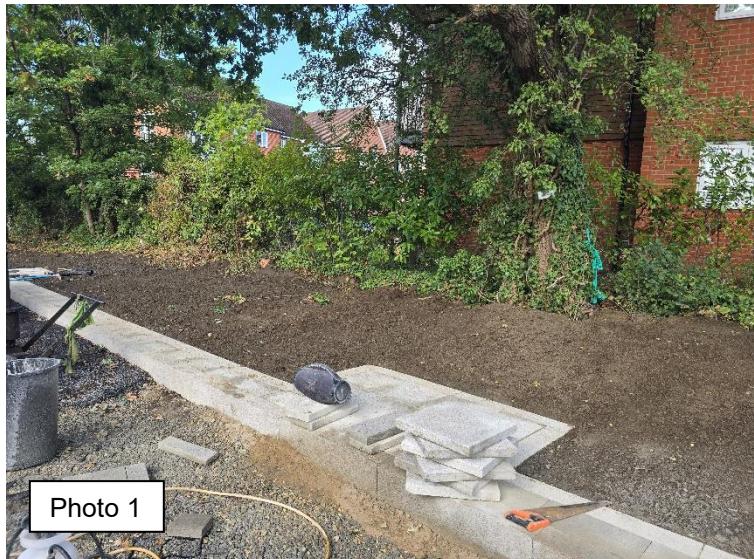
- 1) New landscaping / topsoil within the treed area
- 2) Storage of materials within the designated 'Construction Exclusion Zone' to be removed & Tree Protection Fencing reinstated
- 3) Broken branches of trees where struck by construction vehicles
- 4) Protected Sycamore in decline

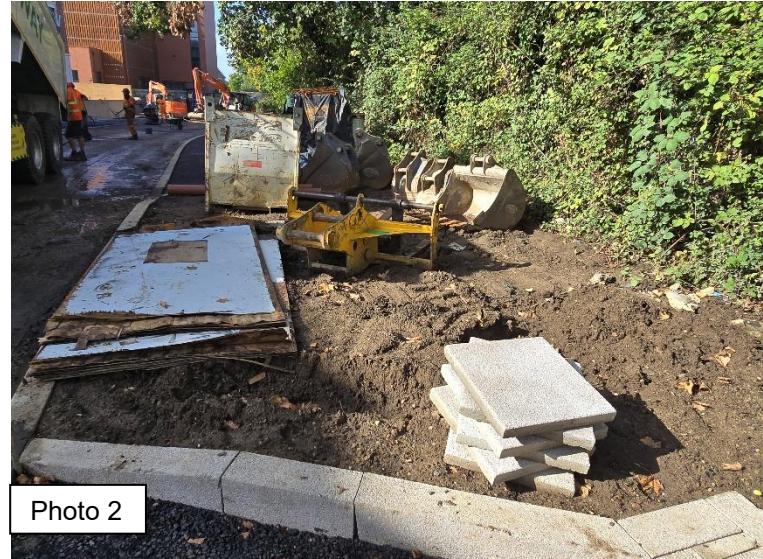
Tree Protection Fencing along the eastern end of the site has been removed and / or breached and is not fit for purpose.

Landscape materials are currently being stored within the root protection areas of retained trees causing compaction of the soil. Soil compaction can severely damage trees by restricting root growth, limiting water and nutrient uptake, and potentially leading to decline or even death. Compaction reduces the pore space in the soil, which is essential for oxygen and water to reach the roots. This can lead to a cascade of negative effects, including reduced growth, increased susceptibility to pests and diseases, and decreased stability.

- Hardcore within the no-dig roadway extension should be removed ahead of the road construction with a cellular-confinement subbase and porous surface.
- Tree Protection Fencing should be reinstated along the northern boundary in accordance with the agreed Tree Protection Plan.
- Storage of materials and spoil within the designated Construction Exclusion Zones need to be removed. These areas are sacrosanct and should be excluded from all works in relation to the build in order to protect tree roots.
- Care should be taken to prevent further damage to the low crowns of TPO trees. Broken / cut branches should be pruned out of damaged trees (a TPO application is required for these works).
- Consideration should be given to the removal of TPO Sycamore (T2 of TPO 1716/2020) and planting a replacement tree as part of the enhanced landscaping scheme.

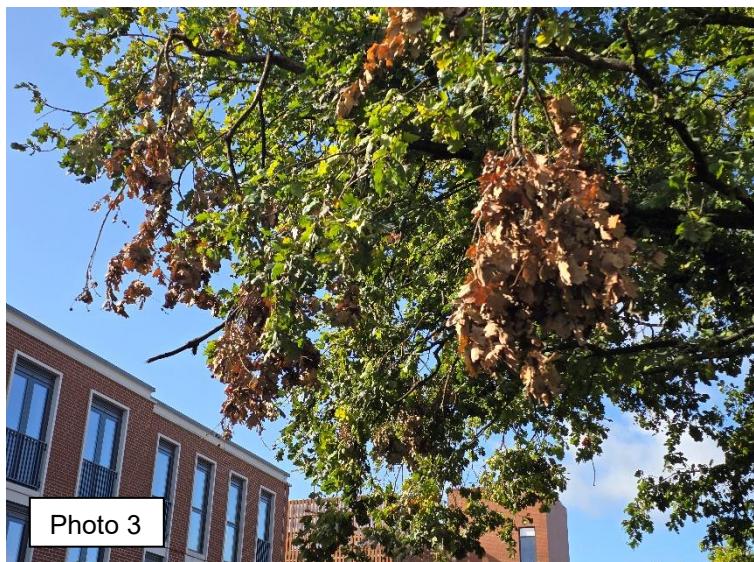
Low canopies of trees including trees subject of the TPO are being struck by passing vehicles causing dead and broken hanging branches.

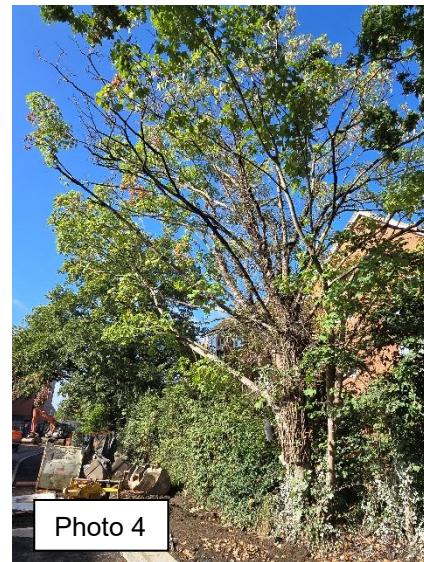
The canopy of a TPO Sycamore (T2 of TPO 1716/2020) is showing symptoms of physiological stress and decline.
