# ARBORICULTURAL REPORT

## TREE CONDITION SURVEY

93 READING ROAD  
WOKINGHAM  
BERKSHIRE  
RG41 1EN

DECEMBER 2024  
Ref: 06596 / 2024

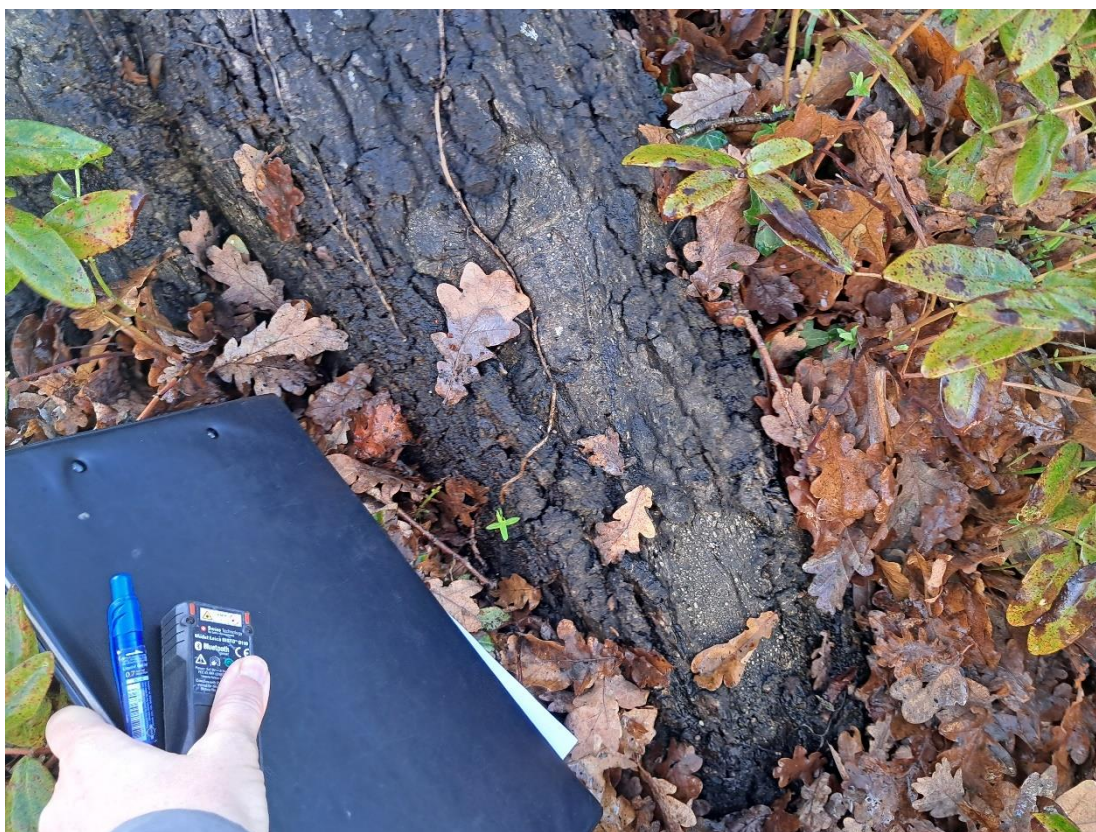
Photo 2 – Old, occluded wound on buttress root

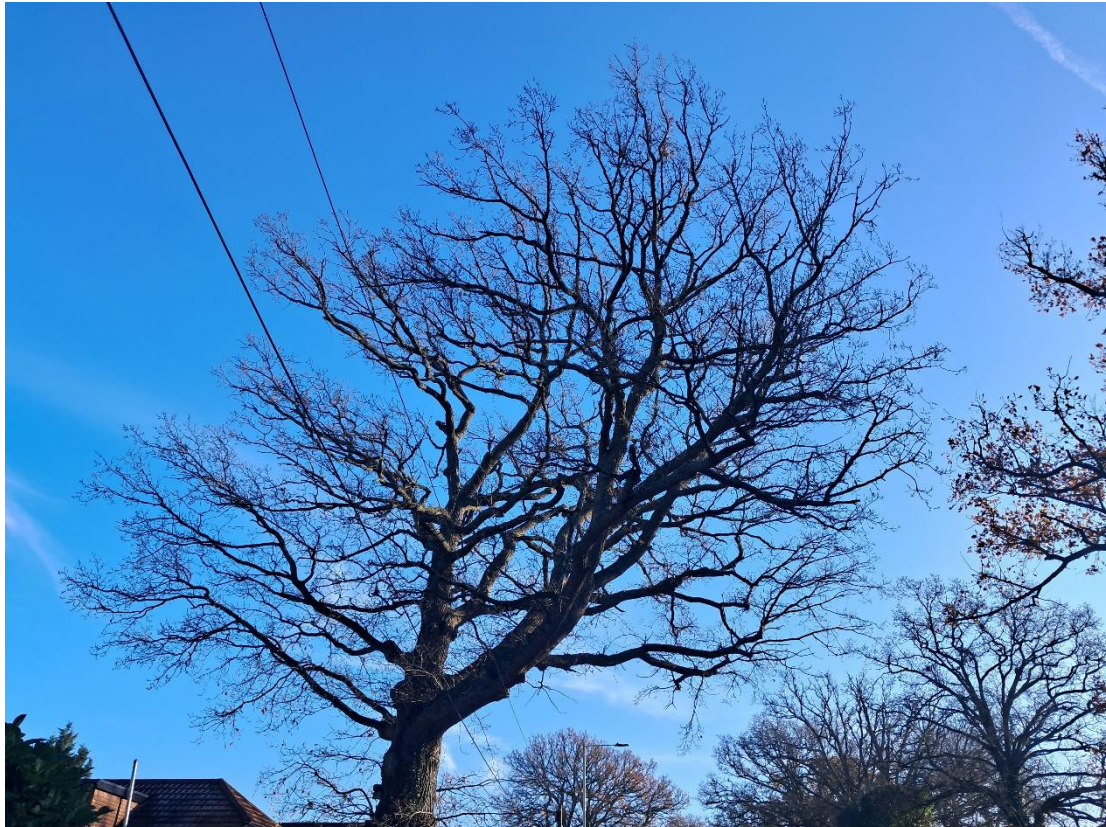
Photo 3 - Asymmetrical canopy - west side of tree

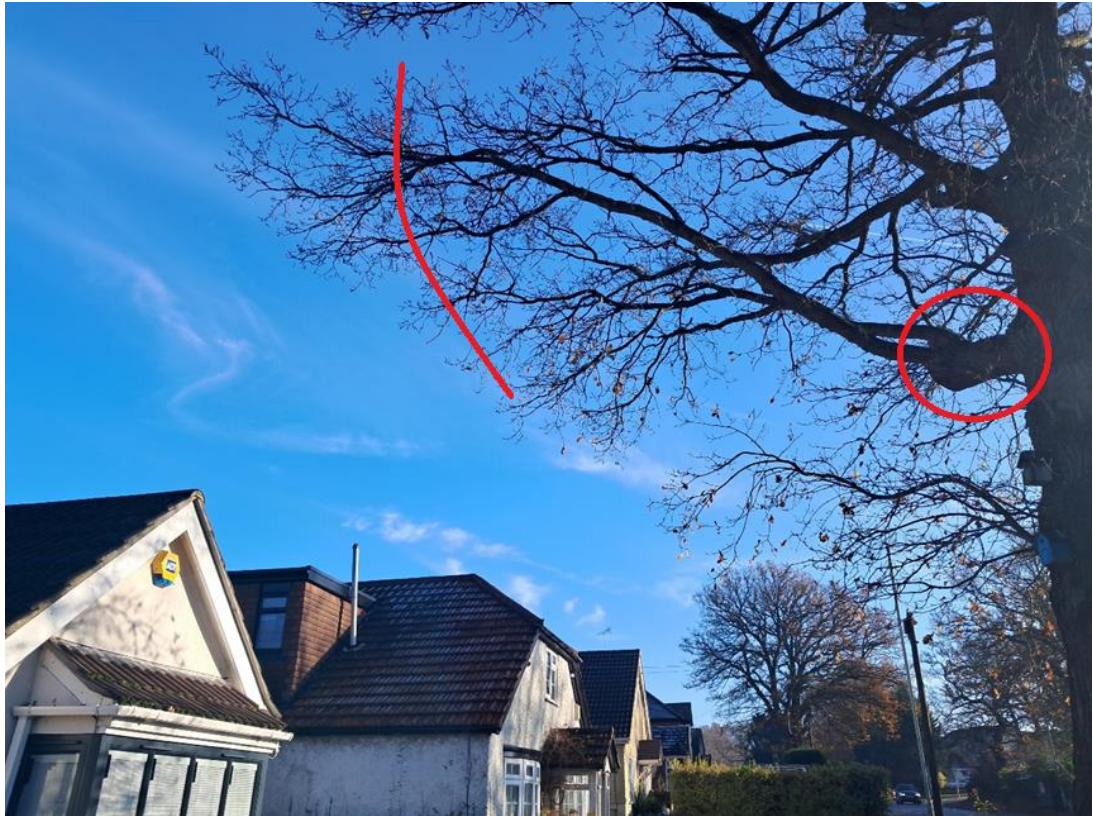
Photo 5 – Indicative line of proposed reduction of regrowth from decayed stump on north side of crown (circled)

| <b>Recommended Tree Works:</b> <ul style="list-style-type: none"> <li>Remove deadwood.</li> <li>1. Reduce lateral spread of lower branches on the north side towards dwelling by 1-1.5m to 1) Reduce weight of new growth beyond previous decayed pruning stump &amp; 2) create reasonable clearance to dwelling</li> <li>Remove epicormic shoots on the northeast side of the canopy only over parking/drive to create 4m canopy clearance above ground level.</li> </ul> | | | | | Priority | | Within 6 months | |

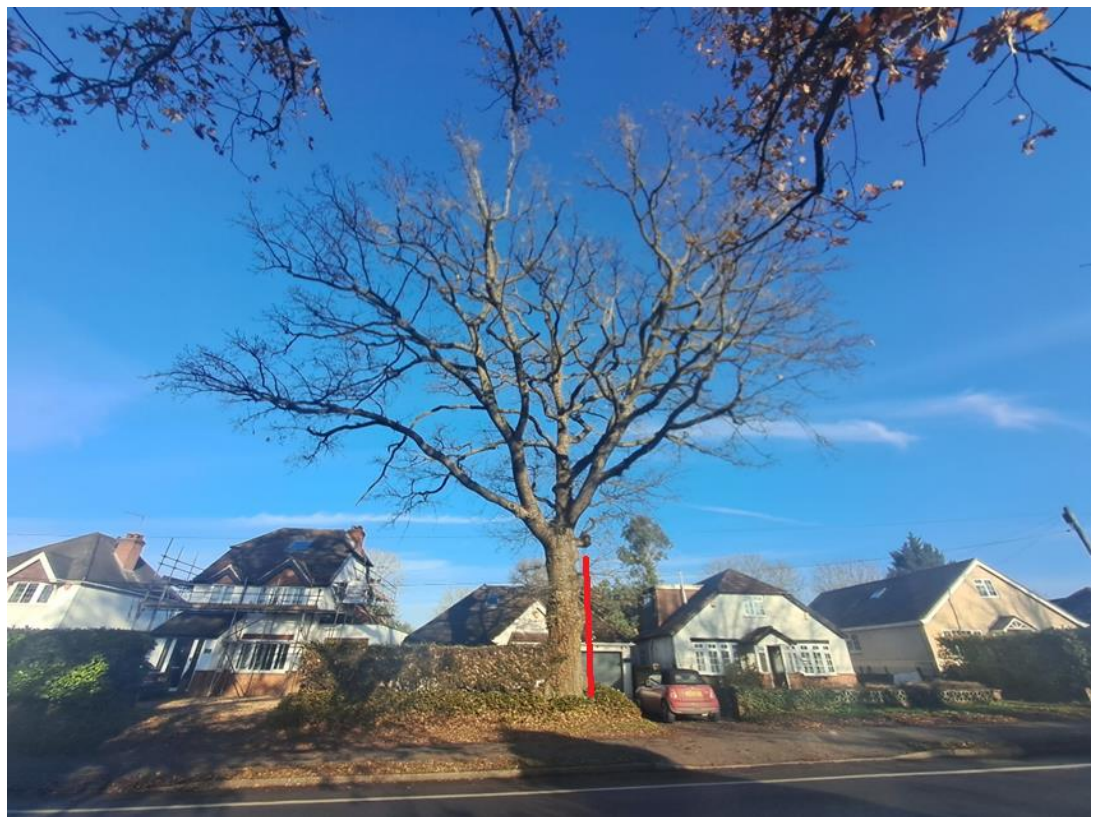
Photo 6 – T2 (Oak) viewed from southwest with line showing extent of epicormic growth removal over property access.
