# Engineers Report

**Risk Address** West Wood  
Lower Wokingham Road  
Crowthorne  
Berkshire  
RG45 6BY

**Date Notified** 5 September 2022  
**Date Instructed** 5 September 2022  
**Report Date** 14 October 2022

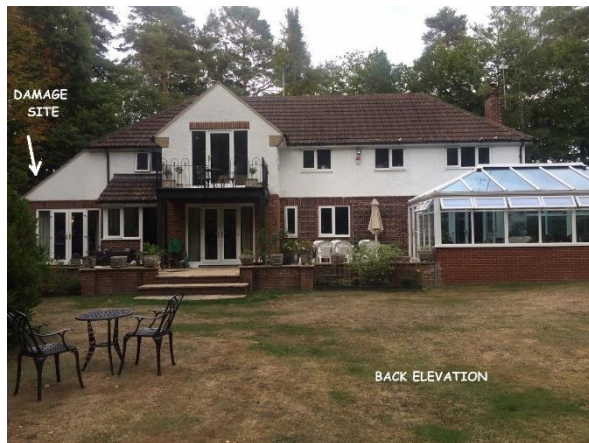
General view of the rear of the property

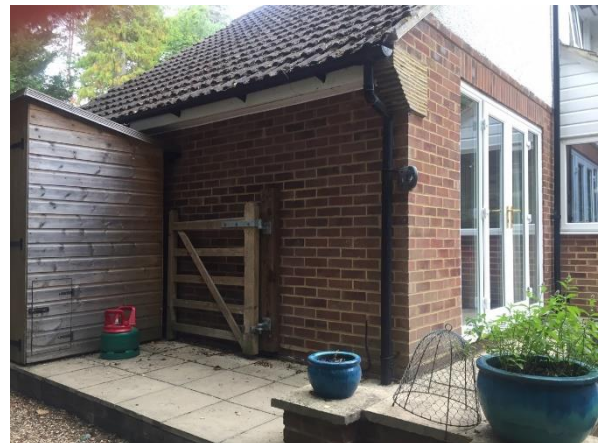
General view of the right-hand extension

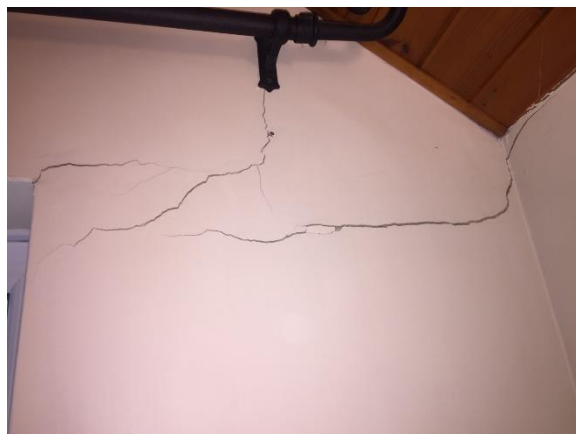
There are 3nr main diagonal cracks located to the right-hand side of the rear wall. The cracking is approximately 2-4mm, with the worst crack being approximately 2-6mm. The double doors to the rear wall are difficult to open and close successfully.

Diagonal cracking to the rear wall of the right-hand lounge

It is common practice to categorise the damage in accordance with B.R.E. Digest 251 "Assessment of Damage in Low-Rise Buildings". In this case, the localised damage to the property falls into Category 2 "Slight".

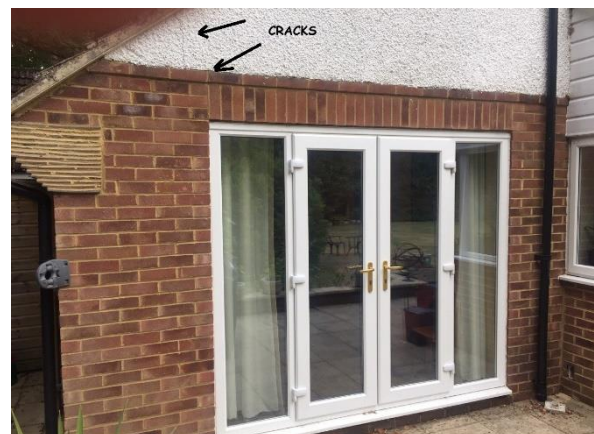
There is a vertical crack to the rendered section of the wall at high-level. The crack is located to the right-hand side of the wall, and is approximately 2-3mm. There is a 4-5mm horizontal crack at the junction of the high-level render and the adjoining brickwork located towards the right-hand side of the wall.

Cracking to the rear elevation of the right-hand extension

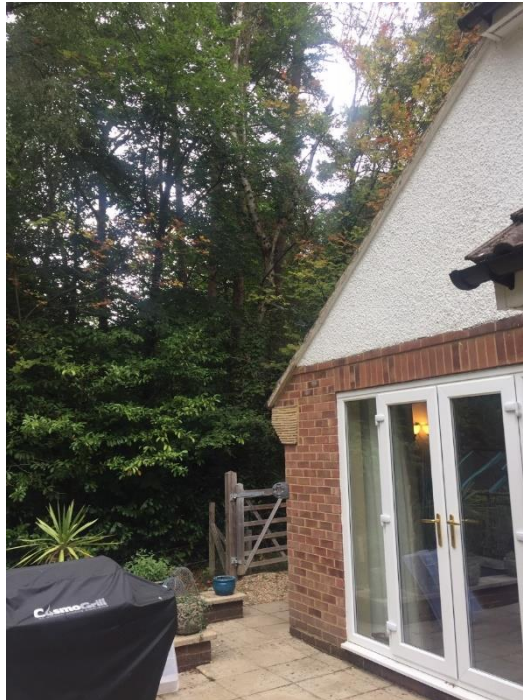
Close proximity of vegetation to the right-hand extension

We note the presence of multiple vegetation to the right-hand side of the property, of many differing species, believed to be solely owned by the next-door neighbour. In order to confirm which vegetation is likely to be having an adverse effect on the ground beneath the property, the advice of an expert arboriculturist is recommended.

All the indications from the evidence obtained suggest that the damage to the rear right-hand side of the property results from subsidence of the site upon which the property stands. Live roots in firm active clays have led to cyclical shrinkage and expansion below the foundations of the property, which together have led to consequent building movement and damage.

An arboriculturist will be appointed to confirm, in their opinion, which vegetation has caused the damage to the property. Upon receipt of the arboricultural report, pursuit of the recommended vegetation removal will be undertaken.
