**CCTV REPORT FOR: WEST WOOD  
LOWER WOKINGHAM ROAD  
CROWTHORNE  
BERKSHIRE  
RG45 6BY**

**Site Visit:** 30-Jan-25  
**Report Date:** 17-Feb-25

Address: **WEST WOOD, LOWER WOKINGHAM ROAD, CROWTHORNE, BERKSHIRE, RG45 6BY**

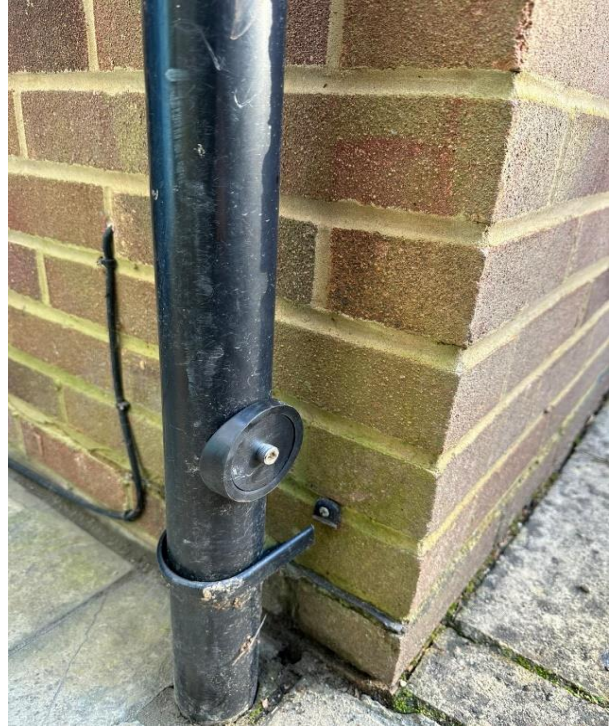
RWP1 access cut

Minor accumulation of debris. No visible pipework defects.

No recommendations are required.

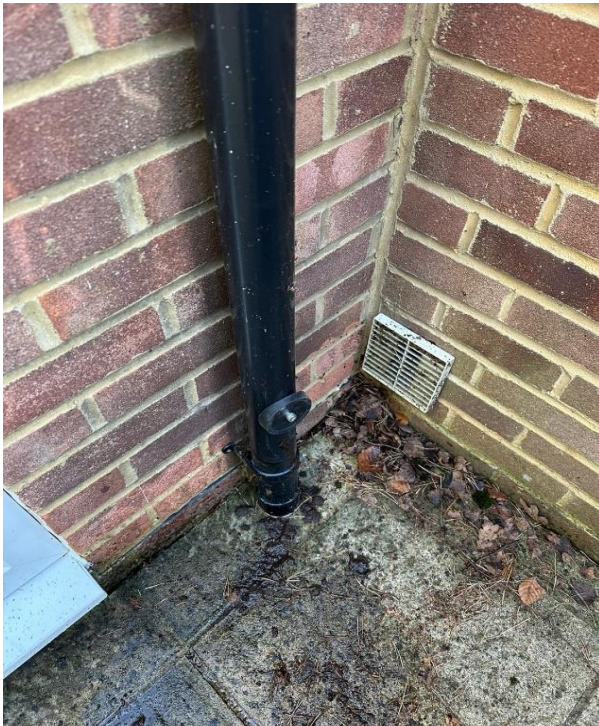
RWP2 access cut

Minor accumulation of debris. No visible pipework defects.

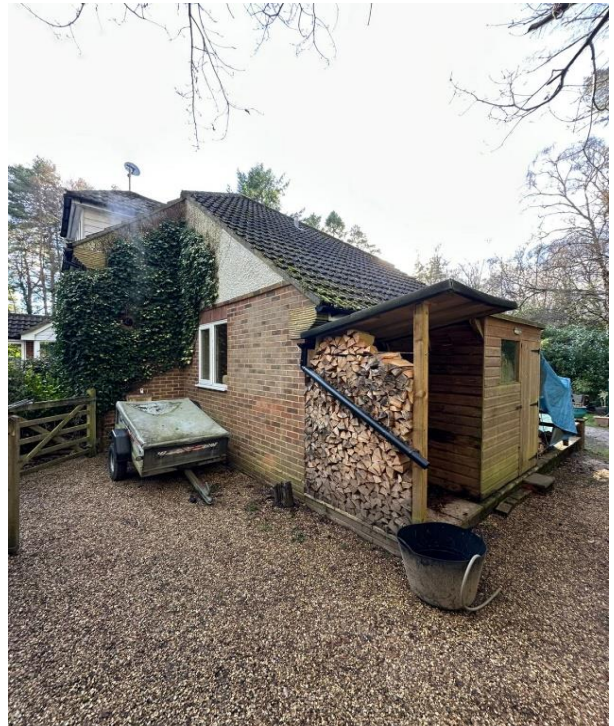
RWP3

There is a storm water down pipe on the front right corner of the main house. This runs above ground down the side of the wood store and discharges in to a large bucket.

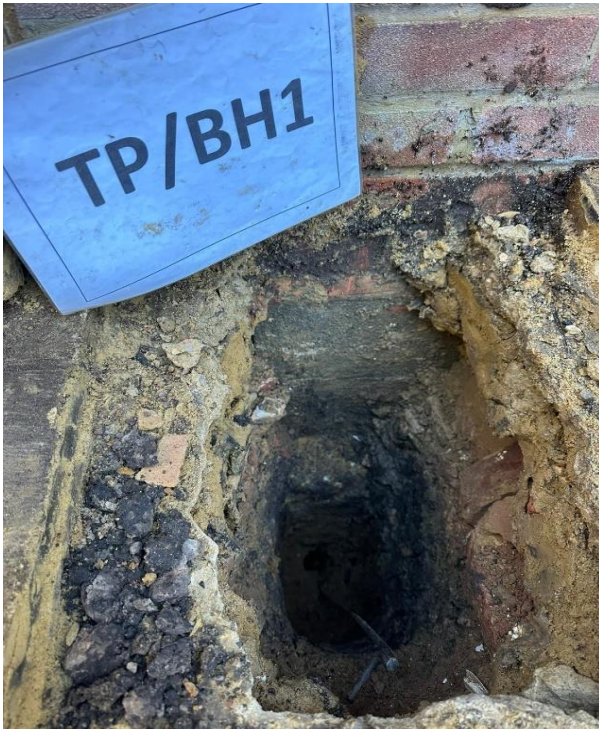
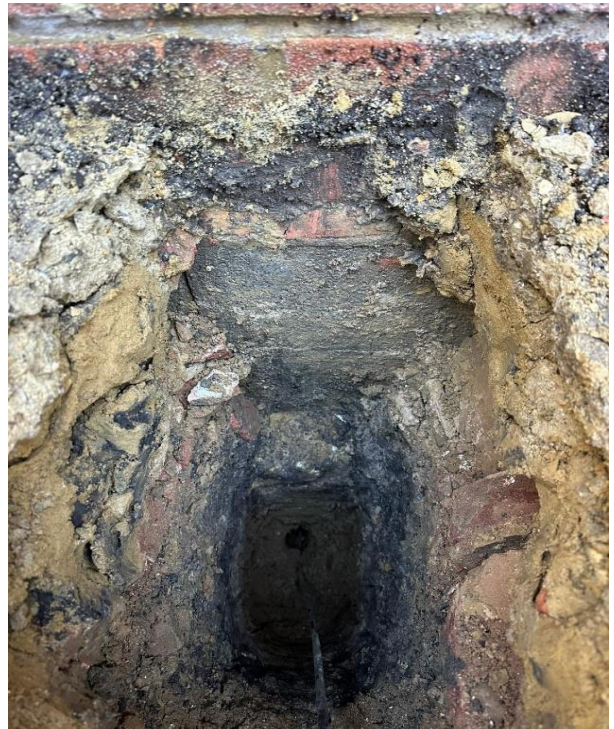
T/H1

| Depth T (m) | Depth B (m) | 1 - Rear right corner of single storey projection<br>Brief Soil Description | Plasticity (BS 5930) | Volume Change M.PI (BRE 240) |
|---|---|---|---|---|
| 1.4 | 2 | Firm light grey/brown slightly sandy CLAY with rare medium gravel | V. high CV | 46% High |
| 2 | 2.2 | Soft/firm light grey/brown sandy CLAY with occasional medium gravel | High CH | 38% Medium |
| 2.2 | 2.5 | Moist light grey/brown clayey SAND with occasional medium gravel | Low ML | 11% Low |

| TP/BH1, 1.4-1.5m | | |
|---|---|---|
| 2 no. | Examined root: although attempted, it was unfortunately too THIN and immature to identify (under 0.05mm in diameter). | |

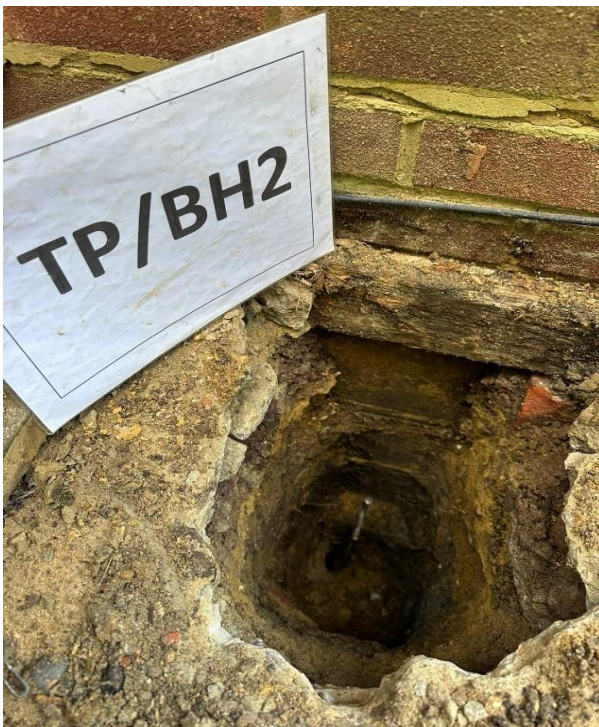
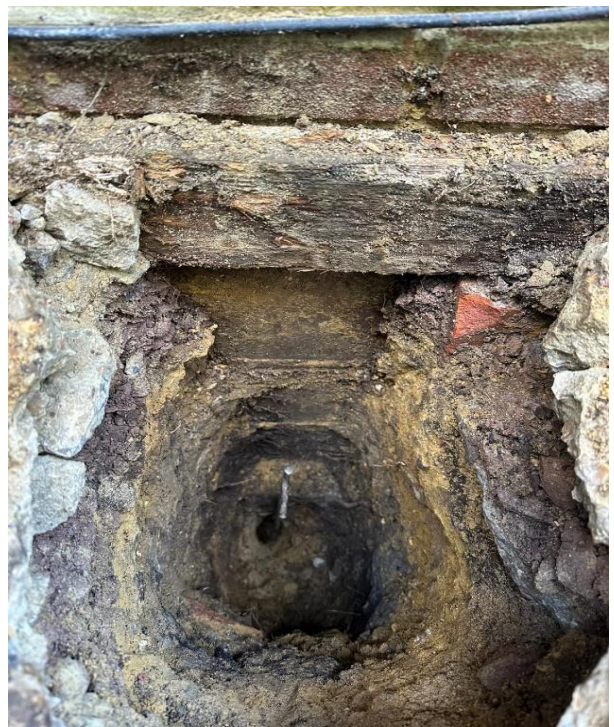
T/H2

| Depth T (m) | Depth B (m) | 2 - Rear right corner of main house<br>Brief Soil Description | Plasticity (BS 5930) | Volume Change M.PI (BRE 240) |
|---|---|---|---|---|
| 1.6 | 2 | Firm light grey/brown slightly sandy CLAY with rare medium gravel | V. high CV | 48% |
| 2 | 2.2 | Firm light grey/brown slightly sandy CLAY with rare medium gravel | V. high CV | 43% |
| 2.2 | 2.5 | Moist light grey/brown clayey SAND with occasional medium gravel | Low ML | 12% |

| TP/BH1, 1.4-1.5m | | |
|---|---|---|
| 2 no. | Examined root: PINUS (Pine). | Dead*. |
