## EXTERNAL TIMBER CONDITION INVESTIGATION

1 RADSTOCK COTTAGE

JOB NO. 159-77

13 OCTOBER 2023

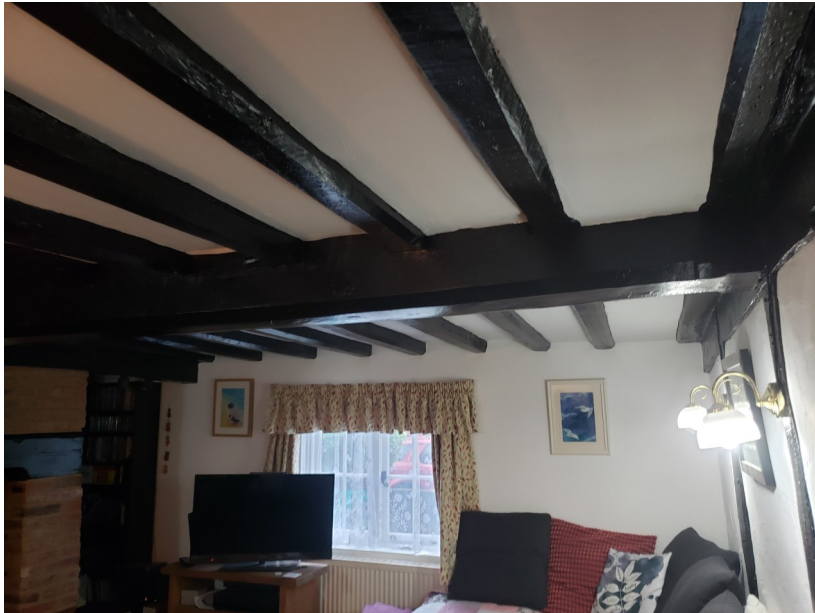
**Fig 5:**

Internal; showing a general view of the structural timbers forming the first floor from ground floor living room. Note that the historical movement in the structure was observed however this was not deemed to be due to the current decay issues seen externally

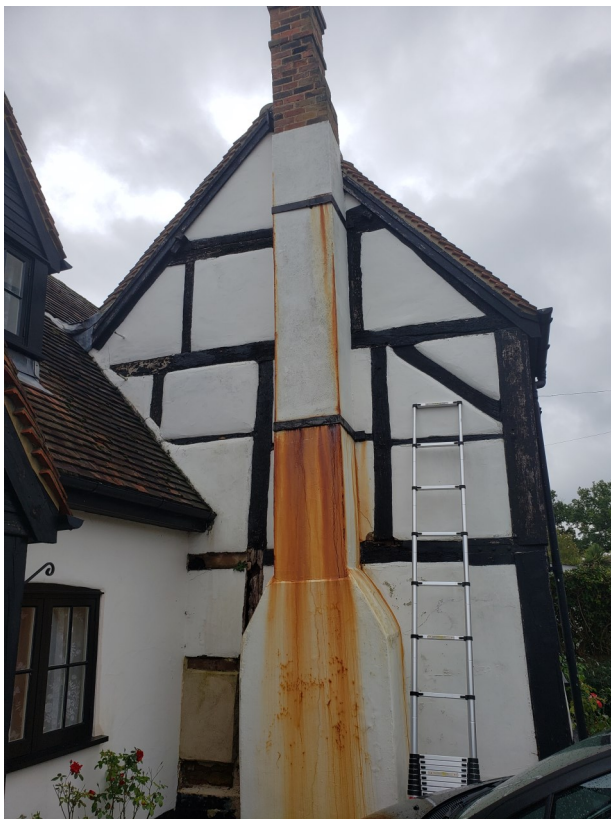
**Fig 6:**

External, north elevation; showing a general view of the structural arrangement and condition of the gable cross-frame. Note the positioning of the chimneybreast and stack over the external structural timbers, leaving certain timbers at particular risk of elevated moisture contents and decay

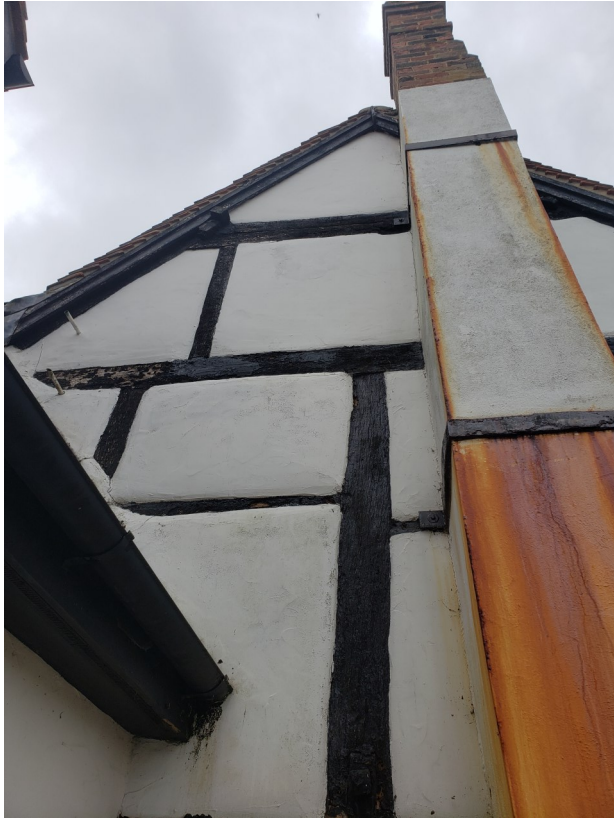
**Fig 7:**

External, north elevation; showing a general image of the structural timbers at this location. Note that several areas of decay were identified (see drawings in Attachment B for further details)

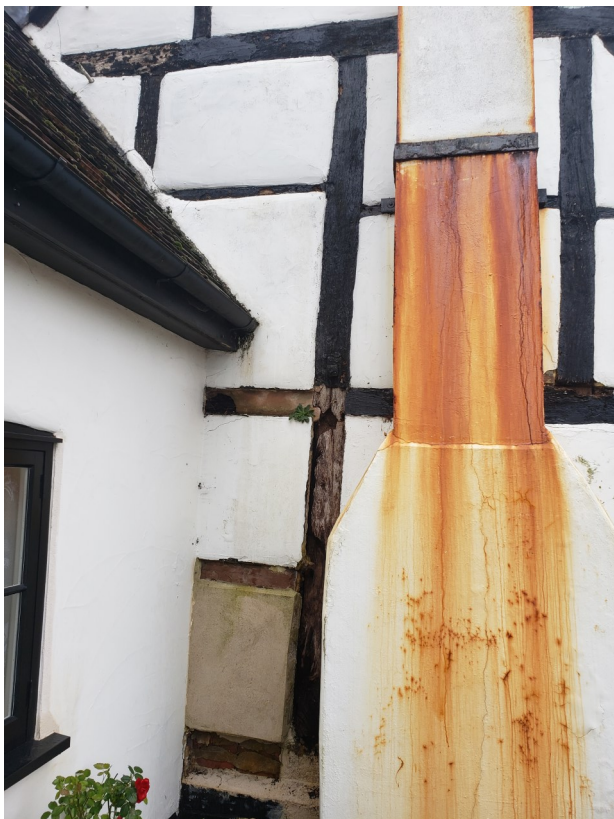
**Fig 8:**

External, north elevation; showing a general image of the structural timbers at this location. Note that several areas of decay were identified (see drawings in Attachment B for further details). Also note the visible cementitious render infill panel that had recently been installed

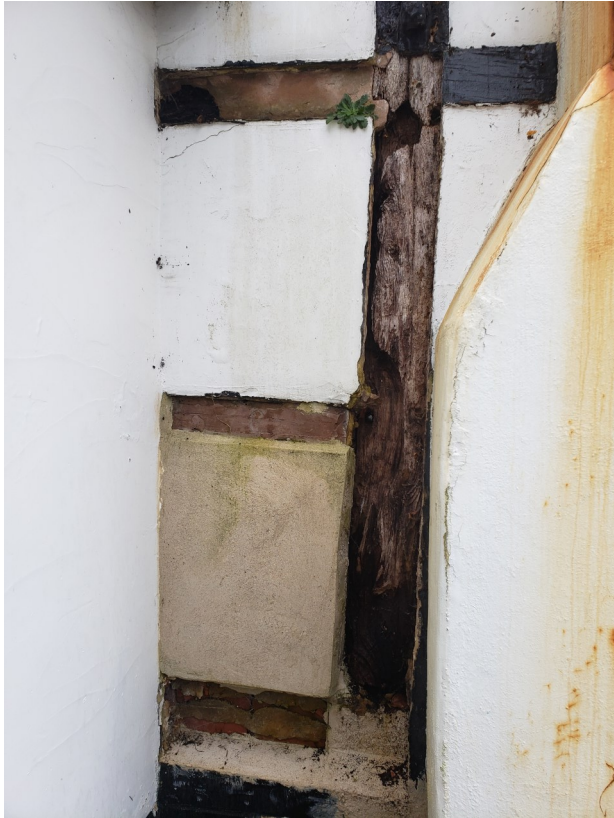
**Fig 9:**

External, north elevation; showing a focused view of the extent of decay to structural elements at this location. Urgent remedial works were deemed to be required

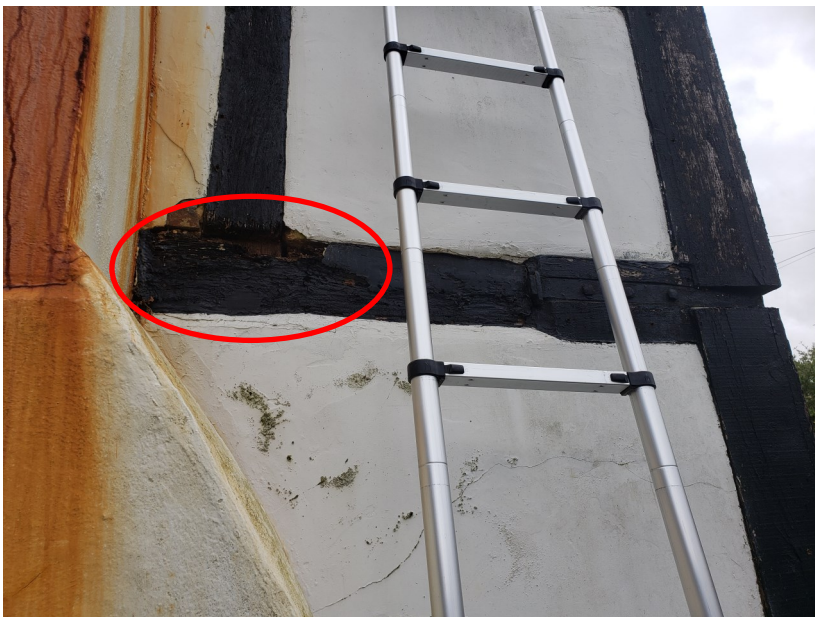
**Fig 10:**

External, north elevation; showing further decay to a mid rail at this location. Moisture pooling in the mortise or the joint had likely exacerbated decay issues over years

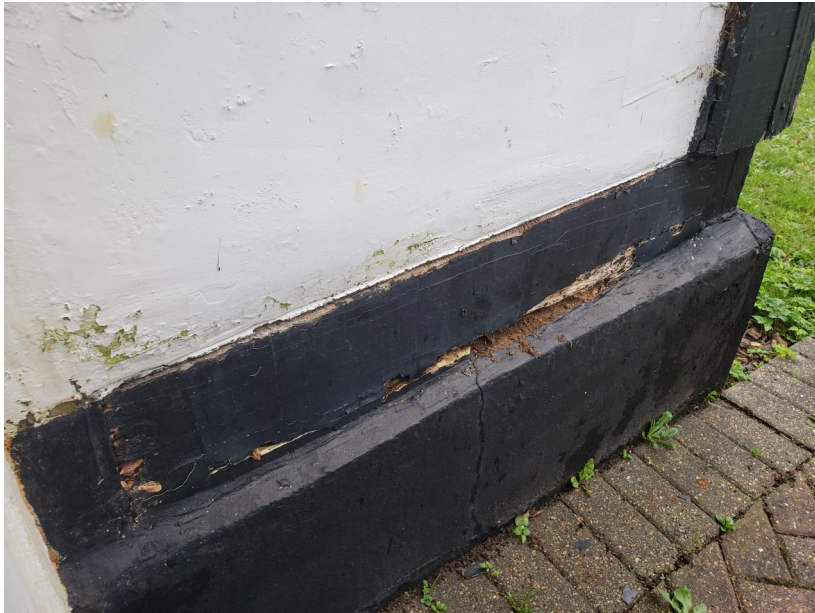
**Fig 11:**

External, north elevation; showing a contemporary remedial capping piece fitted over the cill beam at this location. Extensive decay was identified (see plans in Attachment B for further details)

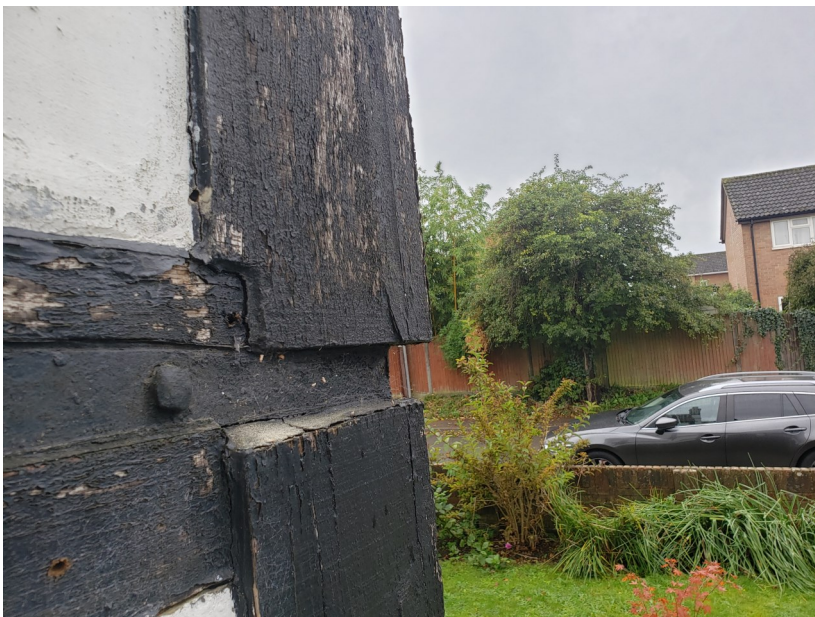
**Fig 12:**

External, north elevation; showing a focused view of metal strapping tying a mid rail to the corner post that had undergone significant repair works in the recent past

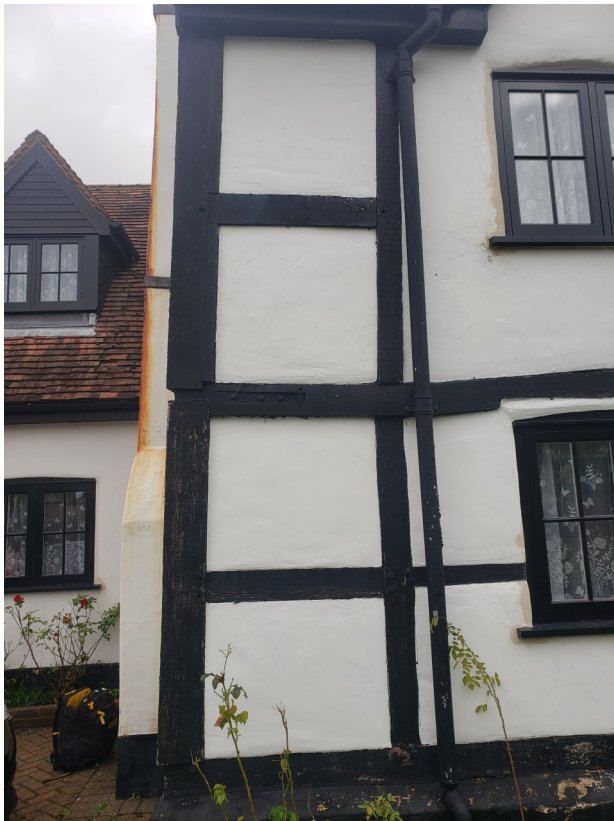
**Fig 13:**

External, west elevation; showing a general view of this section of the building. Note that all timbers had undergone significant remedial works in the recent past to combat chronic historical decay issues

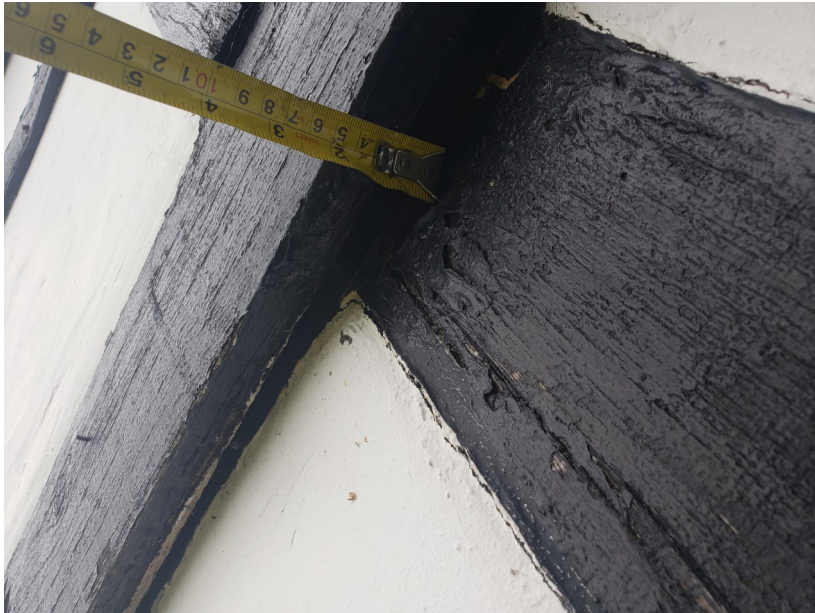
**Fig 15:**

External, west elevation; showing gaps between historical and contemporary remedial timbers, which would allow moisture ingress during inclement weather

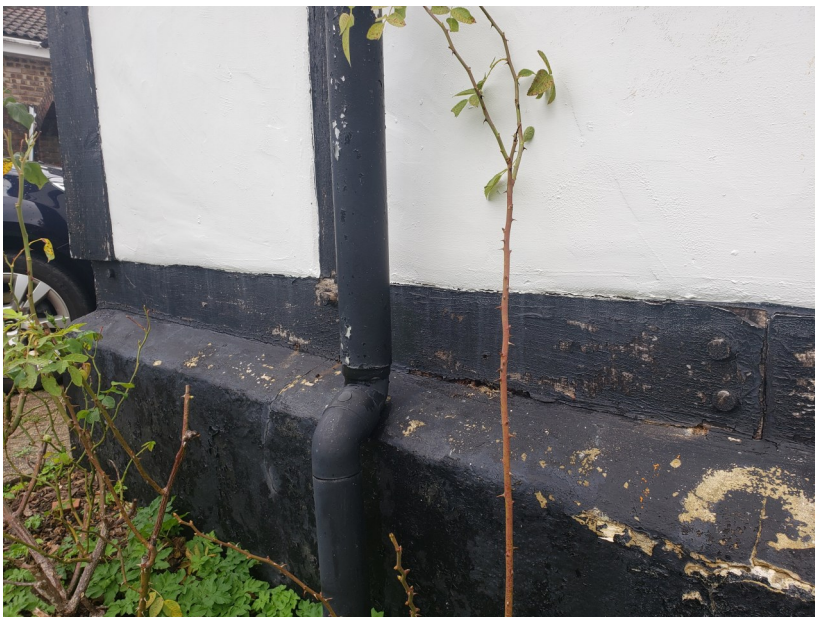
**Fig 16:**

External, west elevation; showing a focused view of the cill wall that had been rendered in cementitious materials and finished in film forming paints, this was inevitably exacerbating decay issues to the cill timbers and would continue to do so unless addressed

*Consideration should be made for all impermeable paints to be removed from exposed timbers and masonry, to be replaced with breathable, mineral based alternatives. All cementitious materials should be removed and replaced with lime-based alternatives to ensure all trapped moisture can escape*

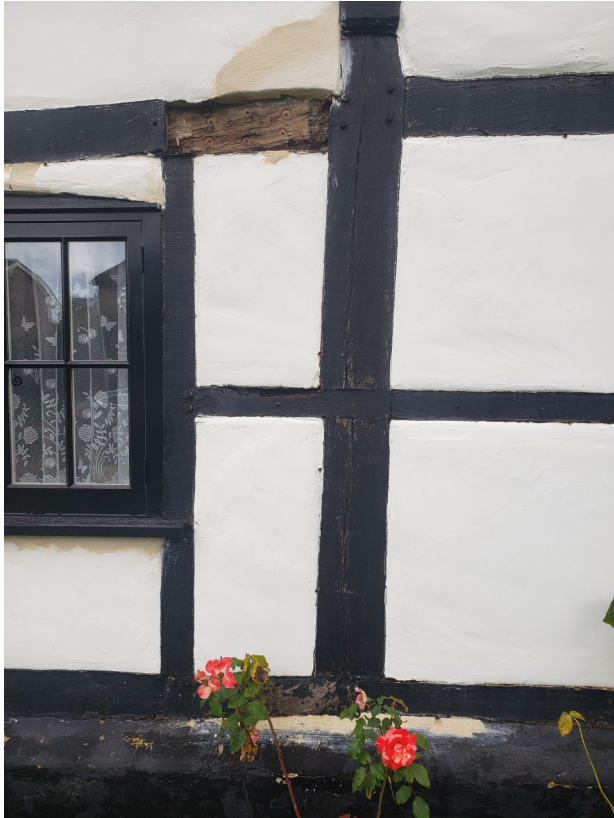
**Fig 17:**

External, west elevation; showing a section of mid rail that a missing section of contemporary remedial capping. This should be addressed to prevent further moisture saturation of the main historical structural timber

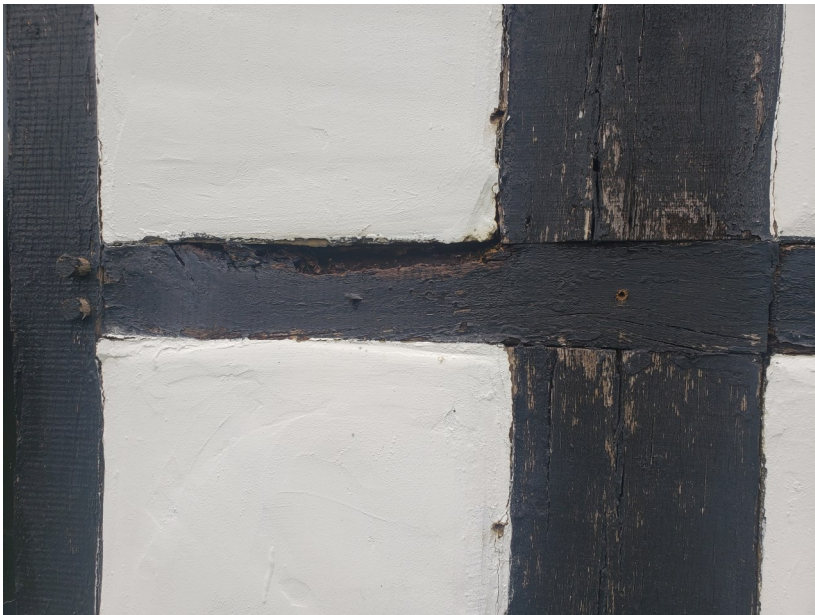
**Fig 18:**

External, west elevation; showing a significant pocket of decay to a later rail element

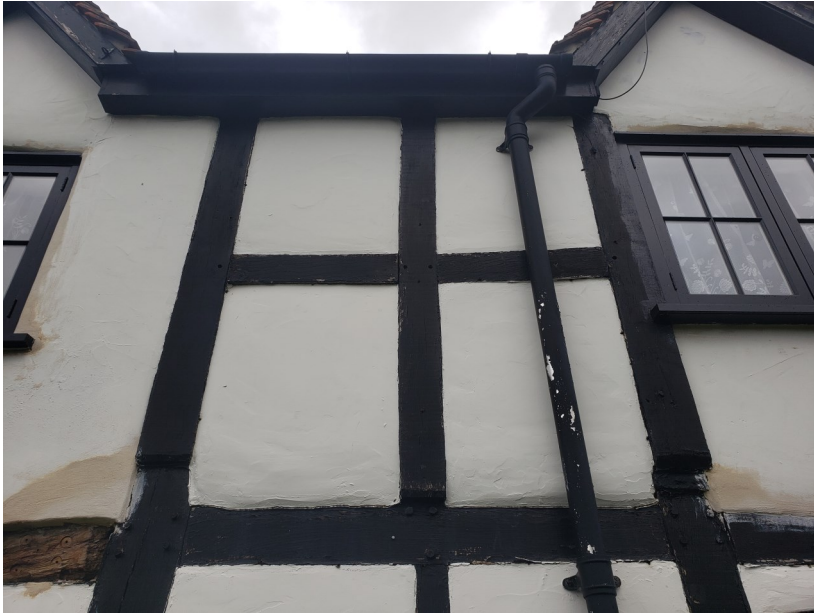
**Fig 19:**

External, west elevation; showing a general view of timbers at this location, as well as localised areas of repair to infill panels using a likely cementitious material

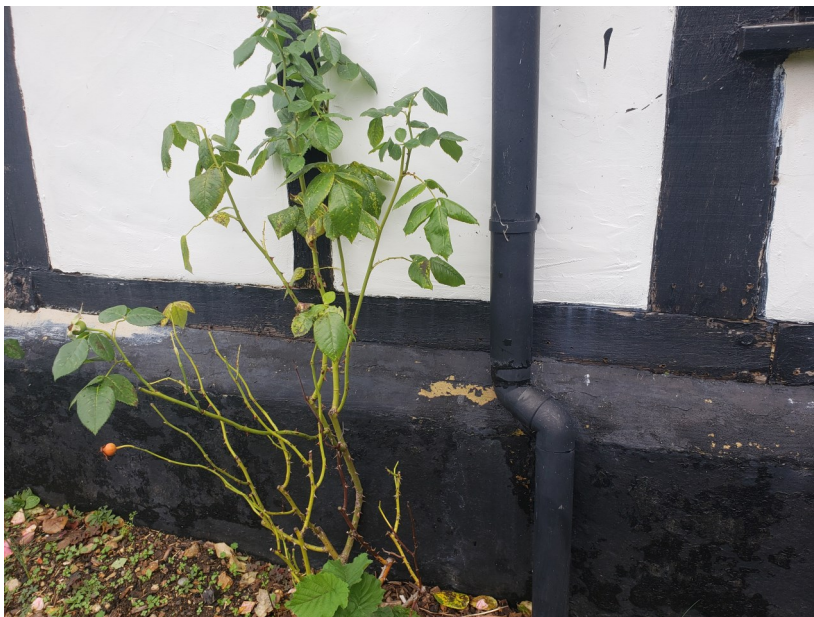
**Fig 20:**

External, west elevation; showing a focused view of the cill at this location. Note that decay was detected to the remedial capping piece and adjoining post (see plans in Attachment B for further details)

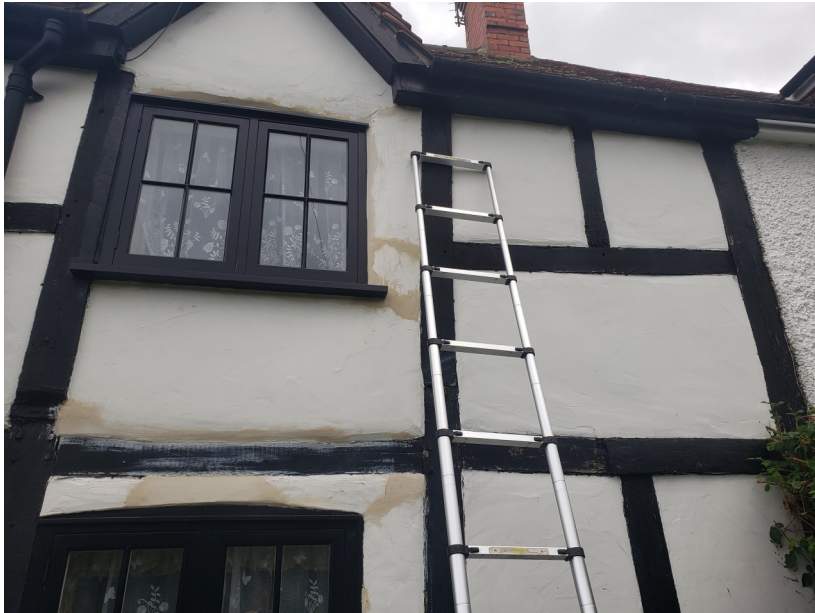
**Fig 21:**

External, west elevation; showing a general view of timbers at this location, as well as localised areas of repair to infill panels using a likely cementitious material

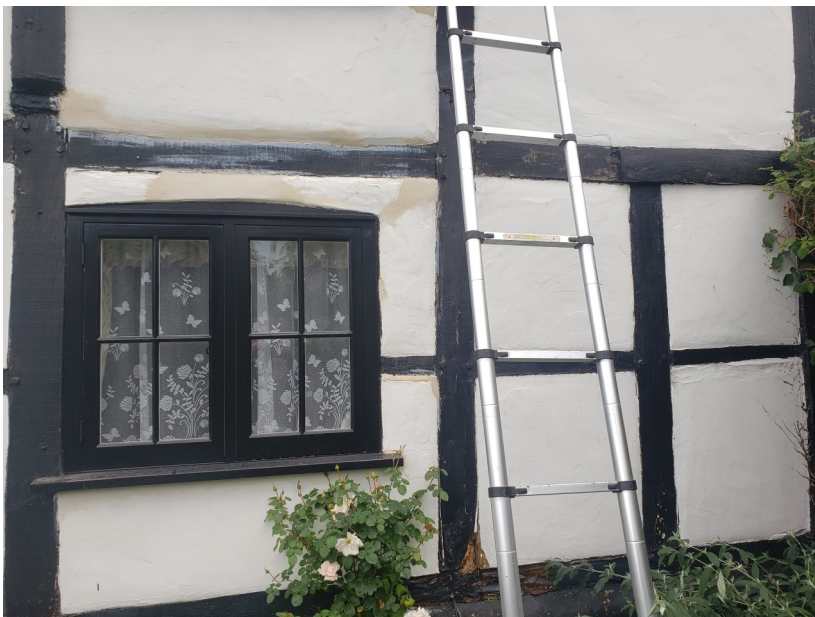
**Fig 22:**

External, west elevation; showing a general view of structural timbers and associated building materials at this location. Note that several areas of decay were detected to the lower sections of vertical elements, as well as cill members (see plans in Attachment B for further details)

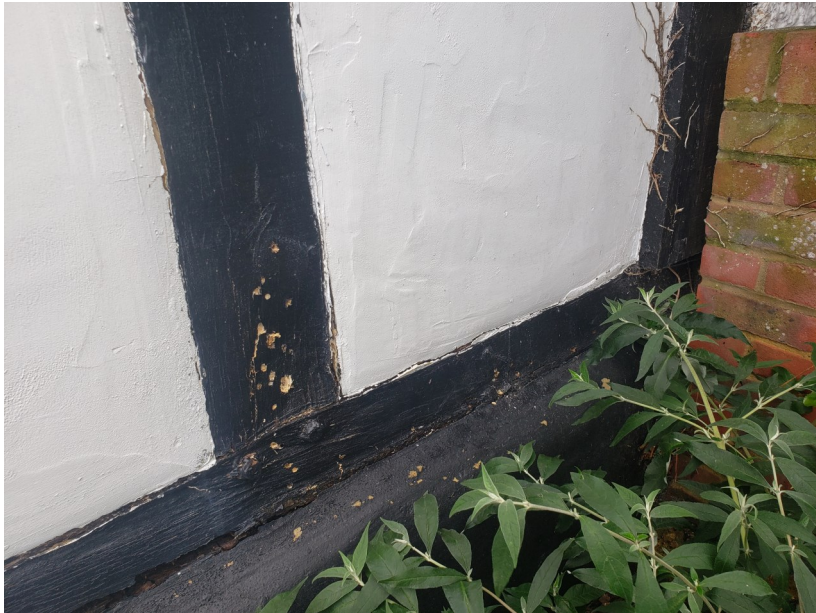
**Fig 23:**

External, west elevation; showing a focused view of historical and contemporary capping pieces that were found to be decayed upon investigation

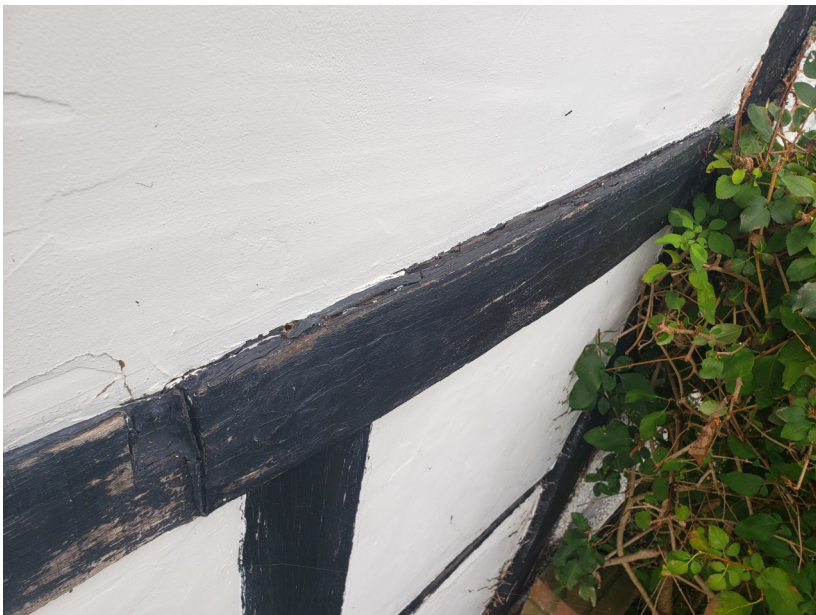
**Fig 24:**

External, west elevation; showing a capping timber that was projecting beyond the face of the elevation, resulting in a small shelf that was allowing moisture pool

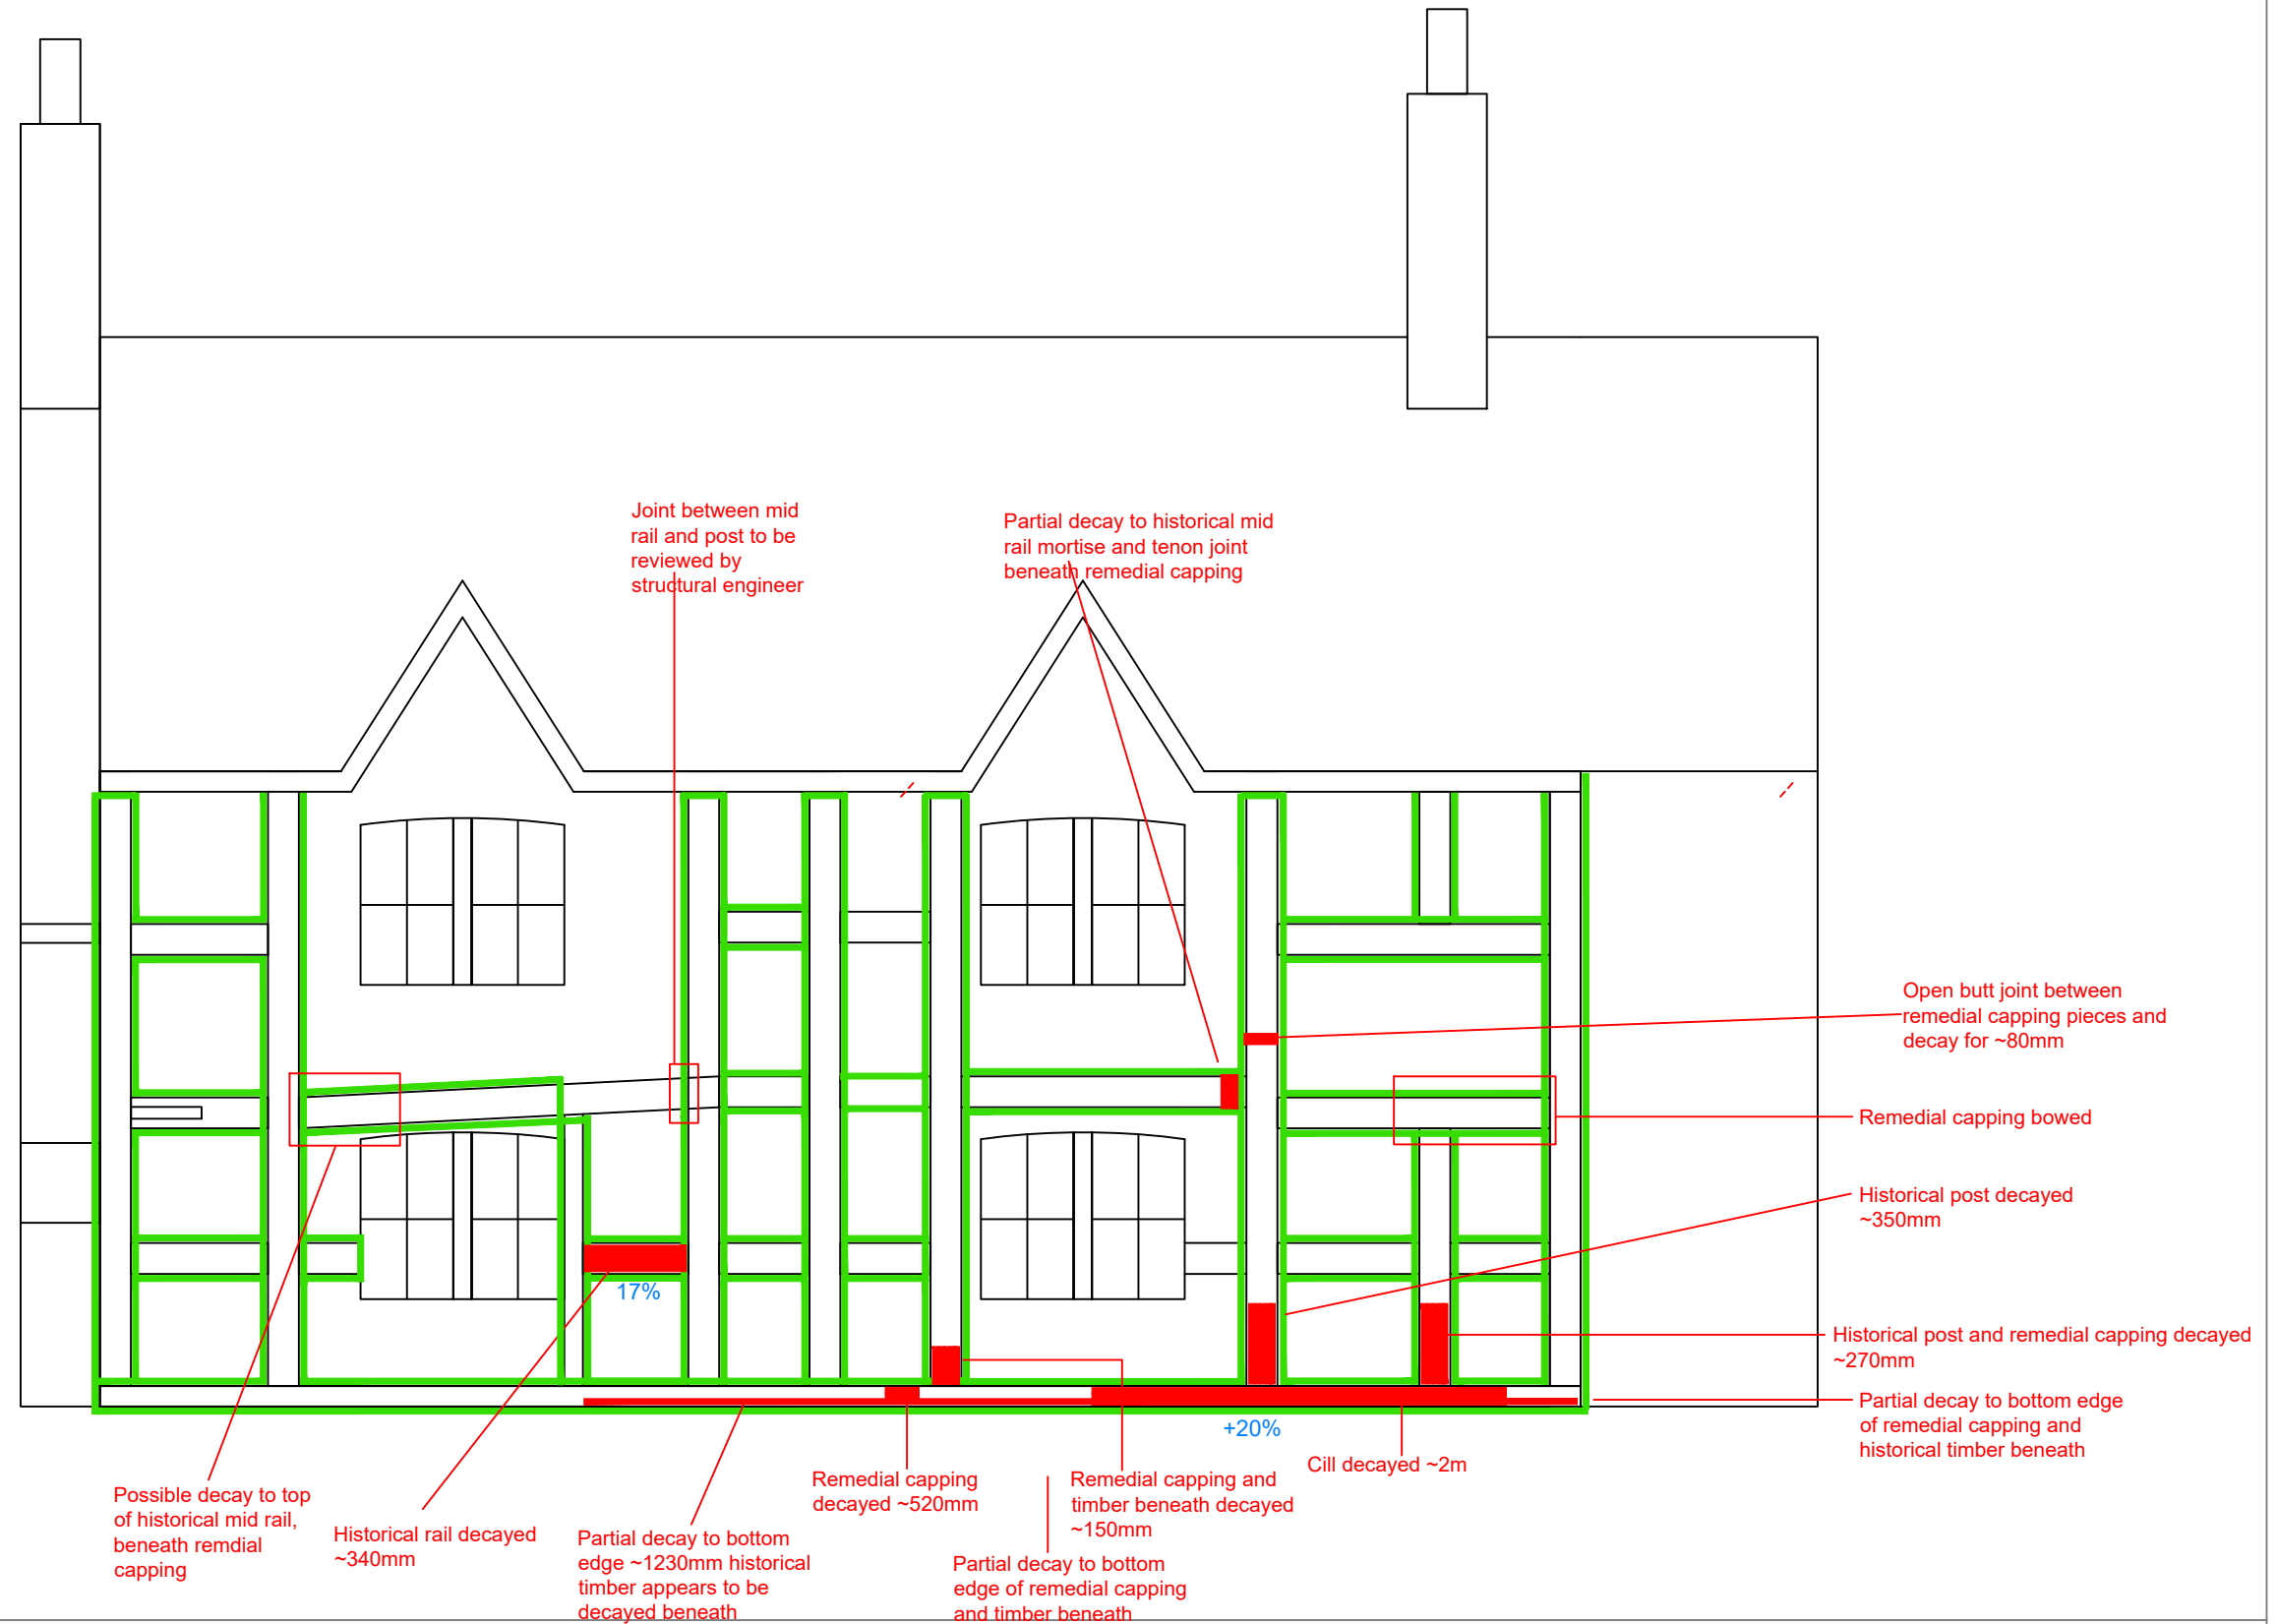
**1 Radstock Cottage, South-West Elevation**  
 External timber condition investigation  
 October 2023

Possible decay was identified to 1 no. historical mid-rail, beneath the remedial capping timber

1 no. lower historical rail was decayed for ~340mm

Partial decay to bottom edge of cill remedial capping ~1230mm historical timber appears to be decayed beneath

1 no. section of remedial capping to the cill was decayed for ~520mm

Partial decay to bottom edge of remedial cill capping and the historical timber beneath

1 no. section of remedial cill capping and historical timber beneath was decayed for ~150mm

1 no. section of the historical cill was decayed for ~2m

Further partial decay to bottom edge of remedial capping and historical timber beneath was identified

1 no. historical post and remedial capping were decayed at the bottom end for ~270mm

1 no. historical post was decayed at its bottom end for ~350mm

1 no. butt joint between remedial capping pieces on a main longwall post was seen to be open and decay for ~80mm was identified

1 no. section of partial decay to a historical mid rail mortise and tenon joint was identified, beneath remedial capping

1 no. mortise and tenon joint connecting an upper mid rail to a main longwall post was considered to be inadequate

*No chemical remedial treatments are required or recommended. All timber members in direct contact with or close proximity to damp affected masonry or other materials should be isolated using a damp-proof membrane and through ventilated air gap. Structurally decayed and/or defective timber elements (including all previous remedial capping elements) should be either replaced, partnered using suitable timber and mechanical fixings, or cut back to sound timber and repaired using a suitable scarf joint detail in air dried timber of a similar species. All new timber repairs should be secured using mechanical fixings such as stainless steel coach screws/bolts and timberloks, which should then be covered using timber grain pellets. Any failed jointing should be repaired and secured using traditional means such as draw-bored and pegged mortise and tenon joints*

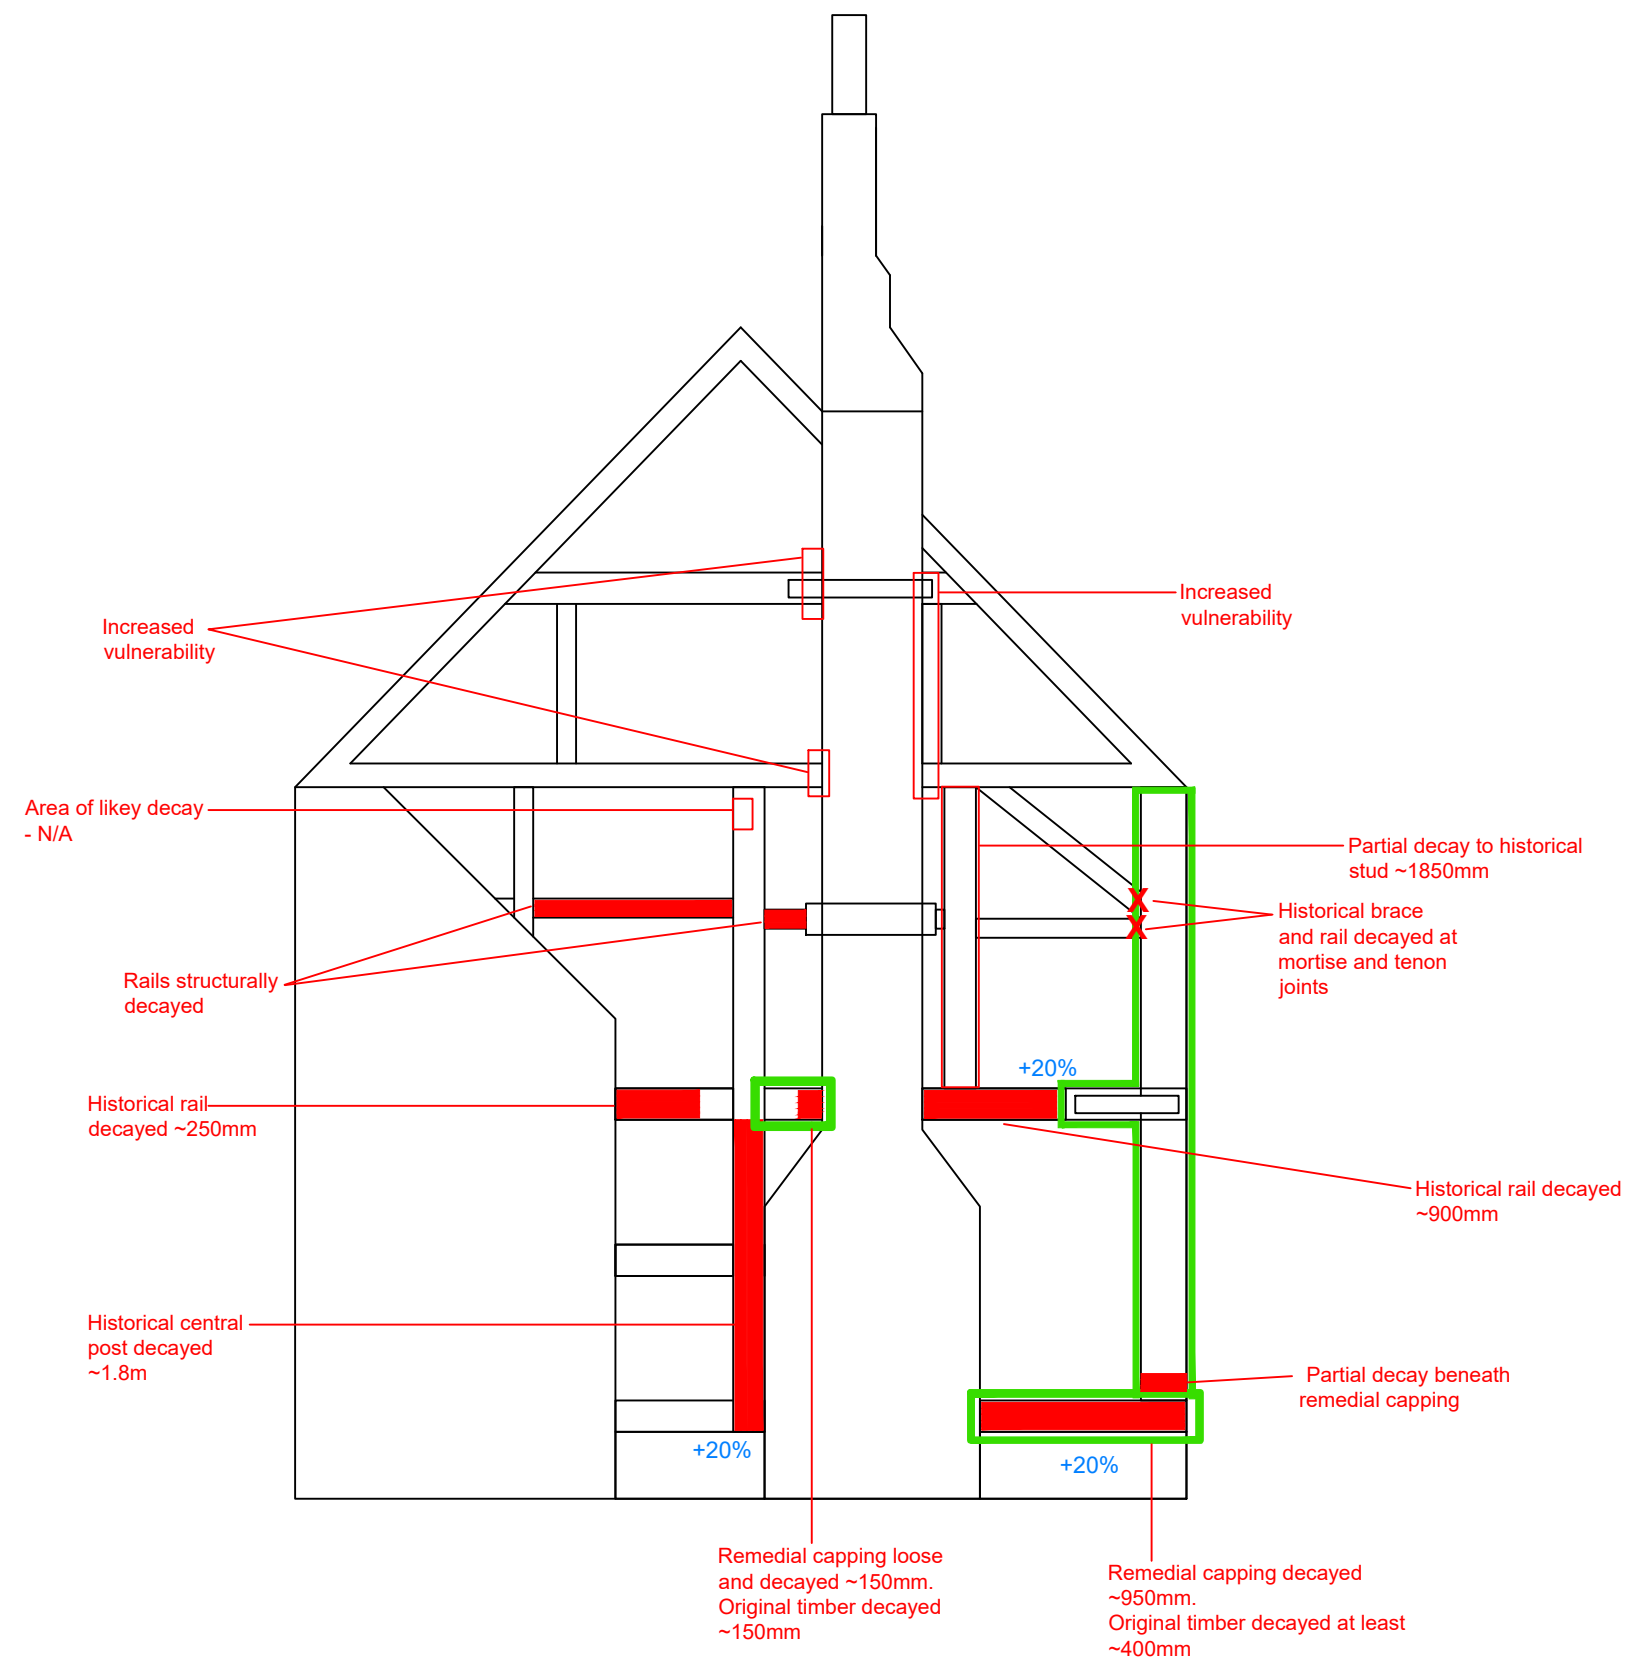
**1 Radstock Cottage, North-West Elevation**  
 External timber investigation  
 October 2023

The collar, tie beam and 1 no. truss stud that were in contact and close proximity to the chimneystack were visually identified as being at significant risk and likely decayed

1 no. section of the central cross-frame post was visually identified as being likely decayed

2 no. sections of historical rail to the left-hand side of the chimneystack were found to be decayed for their entire lengths

1 no. section of historical mid rail to the left-hand side of the chimneystack was decayed for ~250mm

The central cross-frame post was decayed at its lower section for ~1.8m

1 no. historical stud adjacent to the right-hand side of the chimneystack was partially decayed for ~1850mm

The historical down brace on the right-hand side of the chimneystack was decayed at its lower mortise and tenon joint

The historical upper rail on the right-hand side of the chimneystack, below the down brace was decayed at its mortise and tenon joint connecting it to the main corner post

The historical mid rail on the right-hand side of the chimneystack was decayed for ~900mm and a section visible on the left-hand side of the chimneystack was decayed for ~150mm, with the remedial capping also decayed for ~150mm

Partial decay was identified to the foot of the corner post, beneath the remedial capping timber

The historical cill section on the right-hand side of the chimneybreast was decayed for ~400mm and the remedial capping was decayed for ~950mm
