**Ashridge Farm, Warren House Road, Wokingham RG40 5QB**  
Historic recording of the farmyard buildings. Surveyed 30 06 2016.

## SUMMARY SHEET

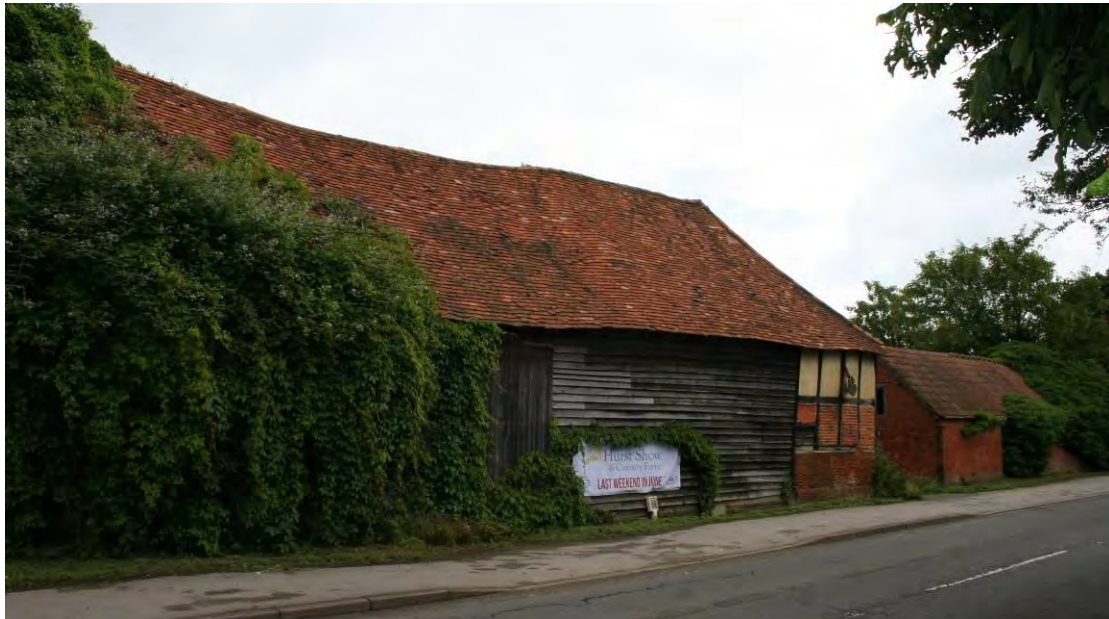
The southern elevation of the Timber-framed Barn. Looking NE.

The southern elevation faces the road and presents six bays clad with LC20th bandsawn and circular sawn weather-boards fixed with French nails. At the eastern end is an extended bay under a fully hipped roof with box framing infilled with brick noggin and render and stood on a 4ft 6in tall brick plinth. The plinth contains 2in Tudor bricks and many patch repairs of EC19th and C20th bricks. The roof is clad in plain clay tiles and was last retiled in the early 1990's when an asphalt membrane was inserted. (Owner –pers comm).

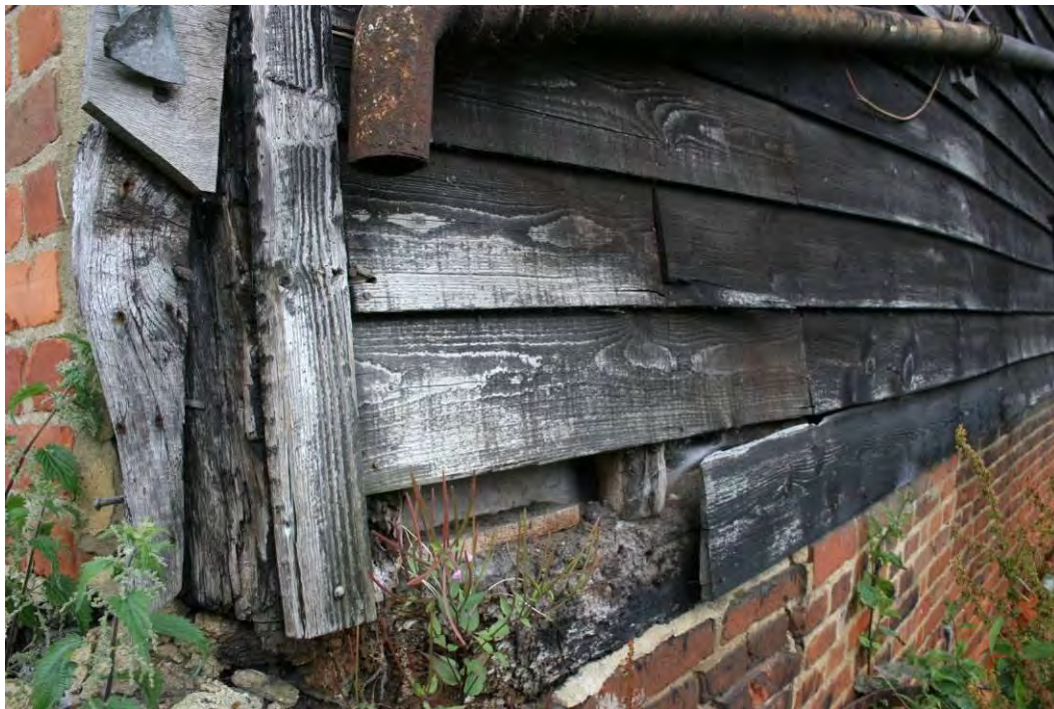
Detail of the C20th weather-boards and Tudor style bricks in the plinth.

The eastern elevation has been clad with C20th weather-boards with clear bandsaw marks. Only a few older boards remain on the barn high up under the eaves. These are hot-tarred – a practice that only ended in the 1960's. They are fixed with wrought iron nails.

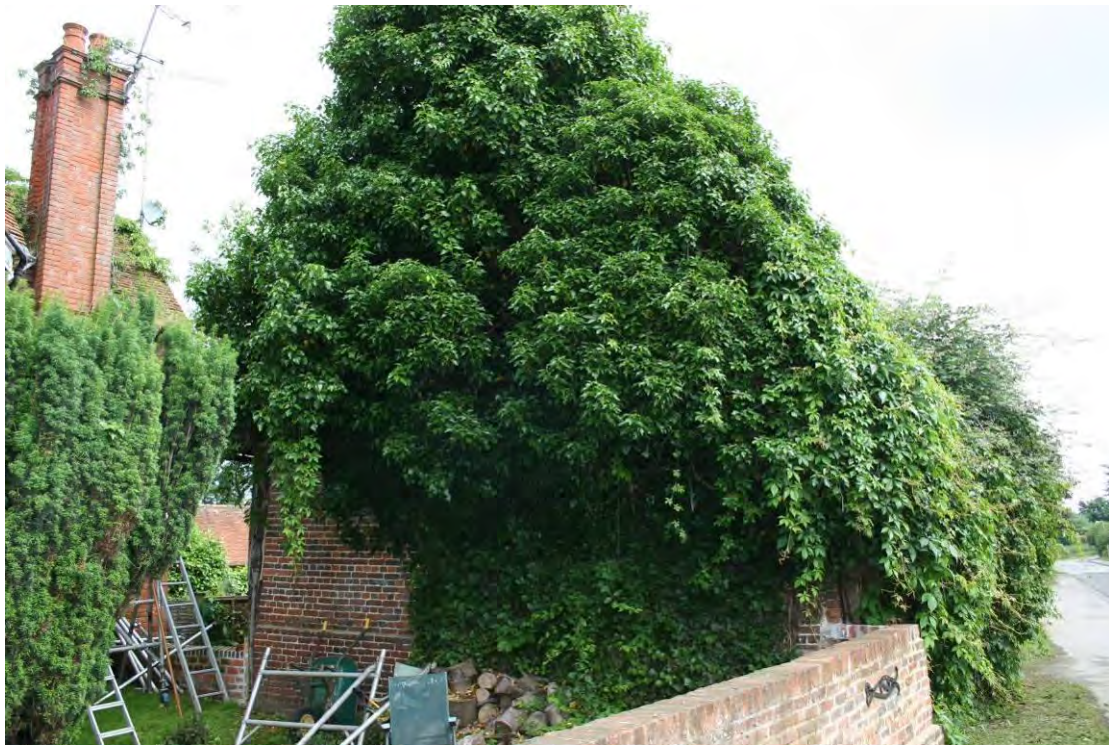
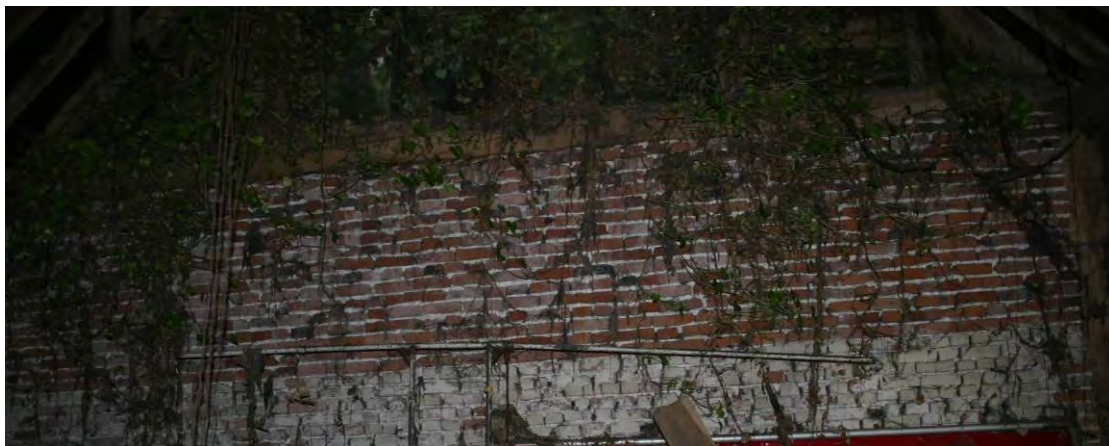
The western elevation of the Timber-framed Barn is made of brick.

Detail of the brickwork from inside.

The western elevation has the timber-frame replaced in C18th style brickwork, now mostly hidden by a Virginia Creeper. On the outside the brickwork is laid in English bond in lime mortar recently repointed. On the inside the bricks can be seen to be red with many overfired headers of 70x110x225-230mm as well as 2in Tudor style bricks. The interior is not finished and the lime mortar hangs over in snots implying it was built against an earlier wall before it was removed. This end of the barn is gabled.

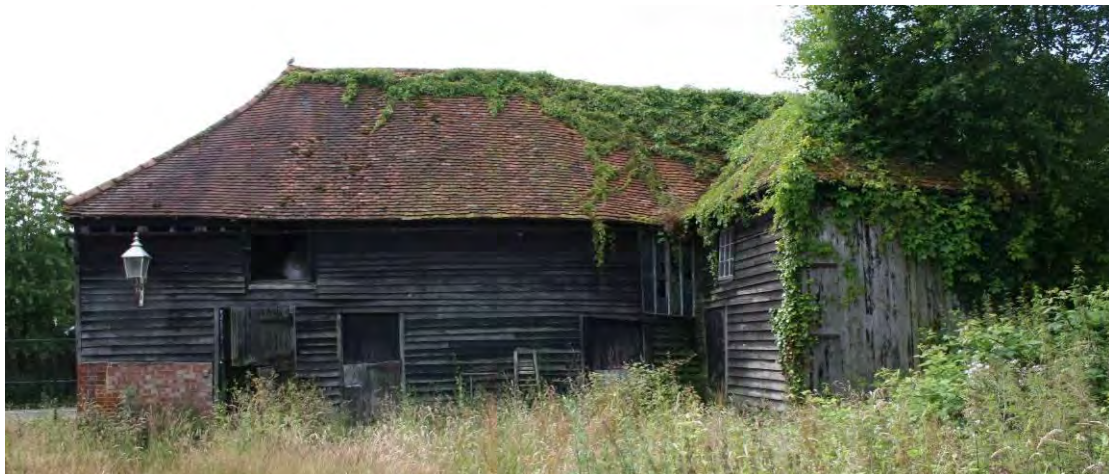
The northern elevation.

The northern elevation faces into the farmyard. The Barn has doorways for two stables with split stable doors which are lightweight C20th softwood doors. A single heavier C19th gate and ledger door remains near the porch but all of the other doors are MC20th hung on mild steel strap hinges screwed in place. The extended bay has a high level hatch door but the door is missing. There are two homemade casement windows. That above the main door has overlapping panes in the manner of a greenhouse and is likely to be LC19th or EC20th. The porch has a MC20th side door with a C20th casement above.

The porch doors are also MC20th copies in softwood and are hung on reversible hinges. The westernmost bay has been consumed by Virginia Creeper and hidden by brambles but there is a pair of two pane top hung MC20th casements high up in the frame.

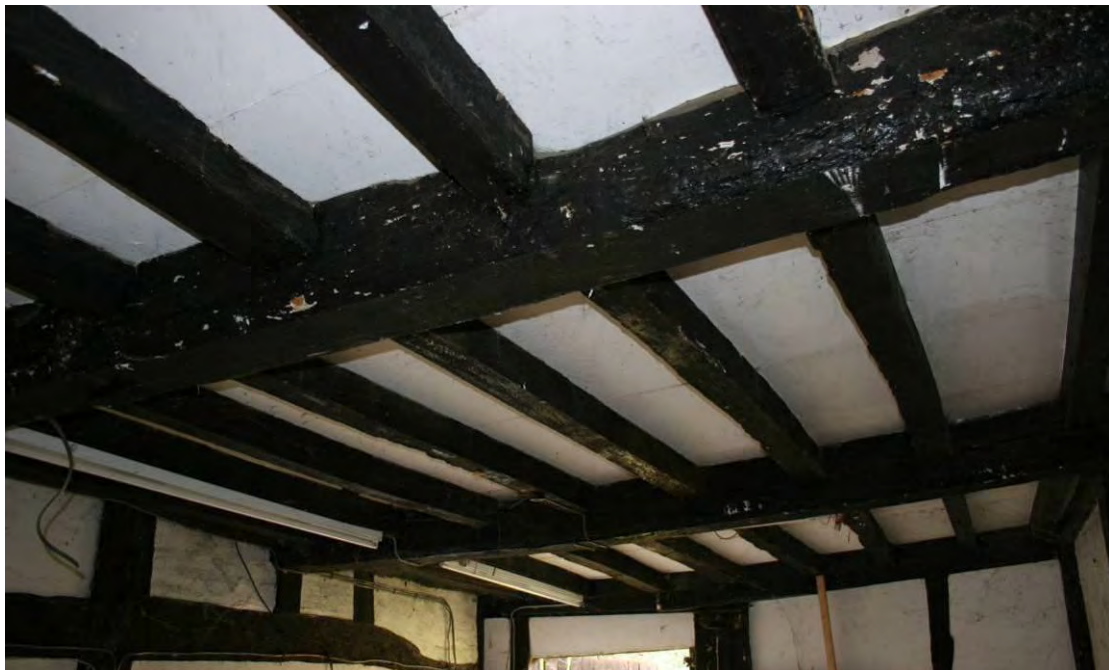
Framed granary floor in the western extension. Looking NW.

The two storey extension to the west of the Barn has a fully framed floor with a pair of axial main joists with chamfers and cyma stops. The heavy common rafters are set on edge in the style of the EC17th. The wall is box framed with added interstitial studs that can be seen in the upper storey. The plinth is of Tudor style 2in bricks except in the northern wall where it has been quoined with EC19th bricks and has a large section of C20th Flettons.

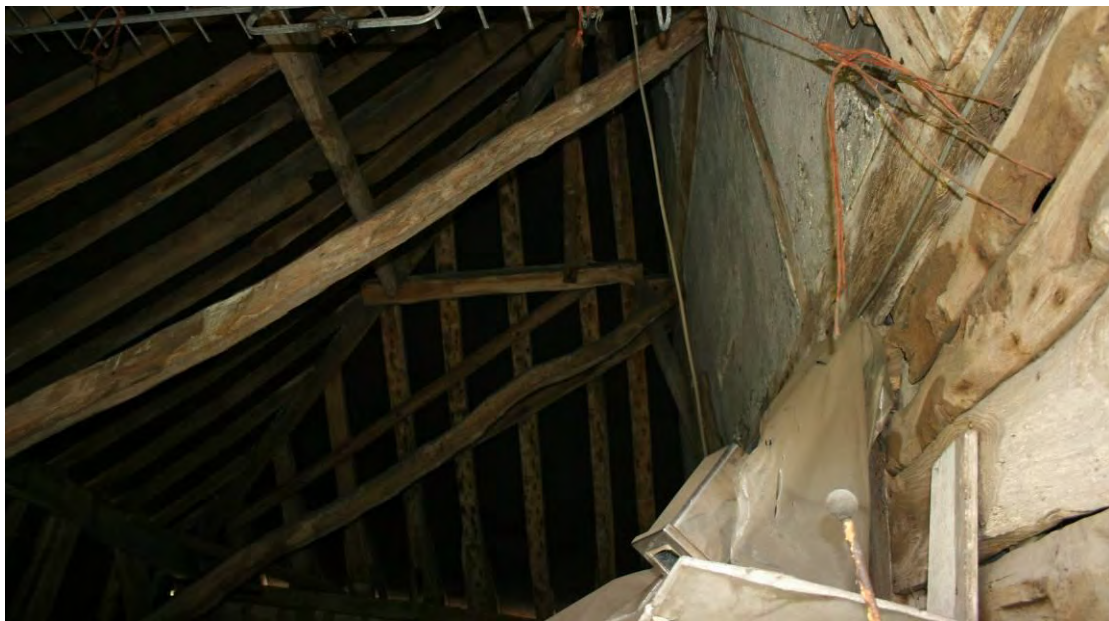
Looking up at the exterior wall of the Barn within the western extension.

The upper walls have added studs to support the weather-boards. The wall of the Barn has lath and plaster rendered box panels above hand hewn planks cut from round trunks. The top-plate has many round ended vacant mortices. The wall is shored with poles and it can be seen inside the Barn that the roof has been racked for a very long time. The roof above the granary is made from reused rafters, peppered with nail holes and some set on edge, the others on the flat. The granary floor can only be reached by ladder and there is no stair trap in the floor.

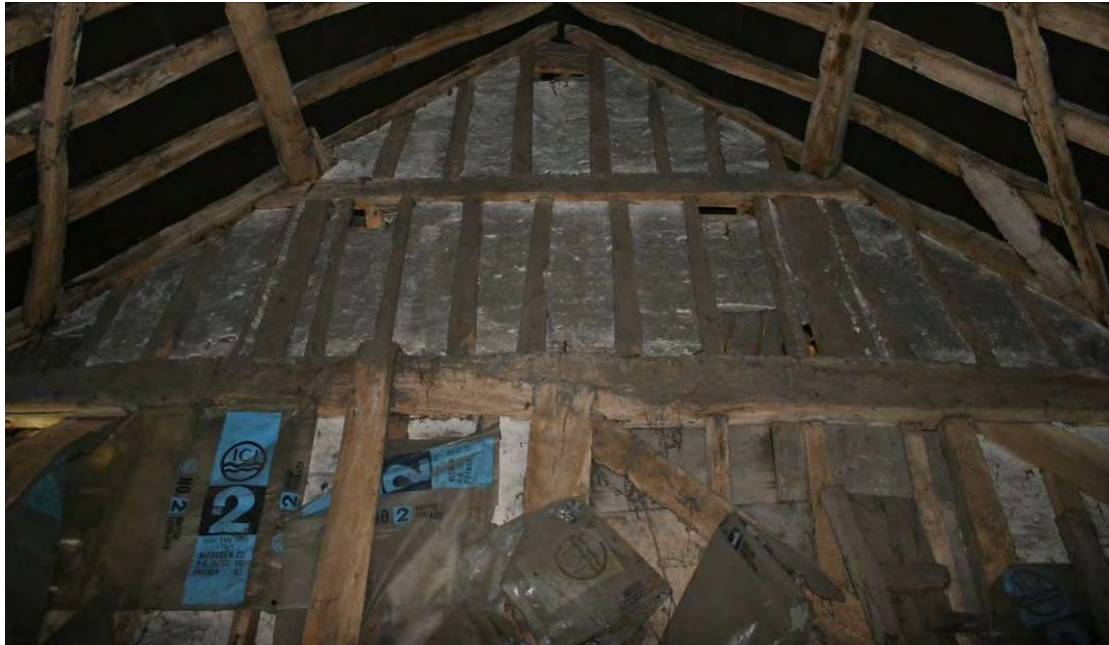
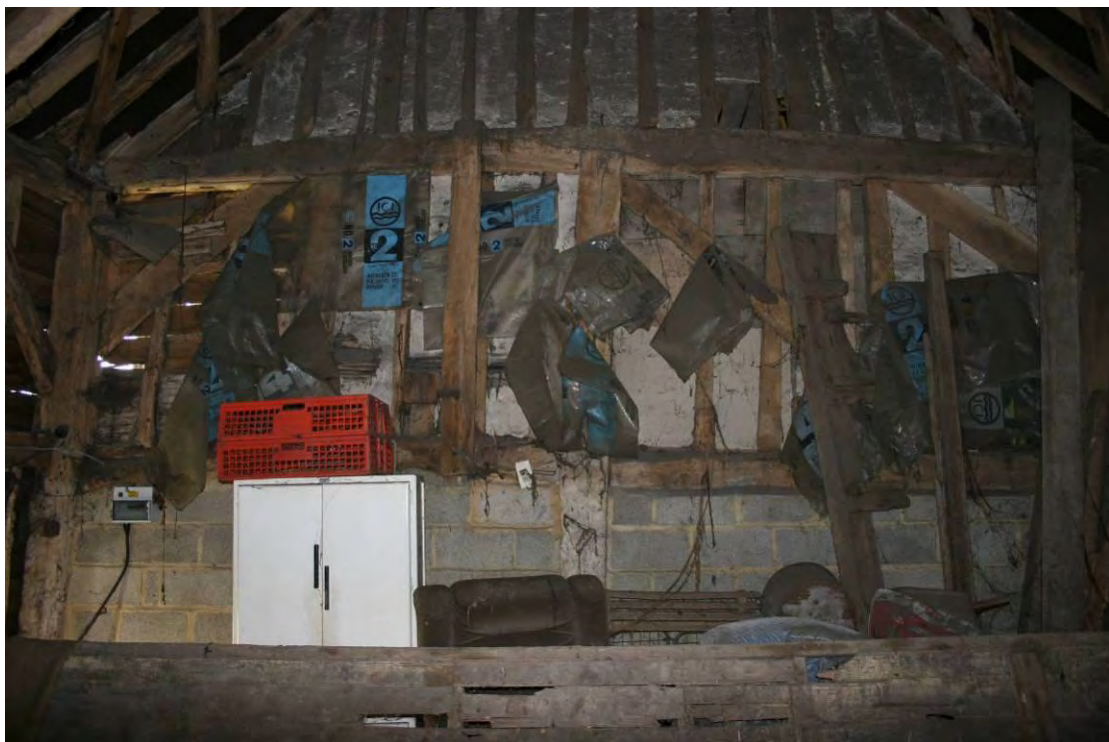
The upper section of the western wall frame.

The western wall frame common with the western extension appears to have been an open truss from an earlier structure that has been morticed for new studs with a large central post side nailed in place. An additional reinforcement has been nailed to the tie-beam and cill plate and a diagonal brace added. The plinth has been replaced with LC20th blockwork.

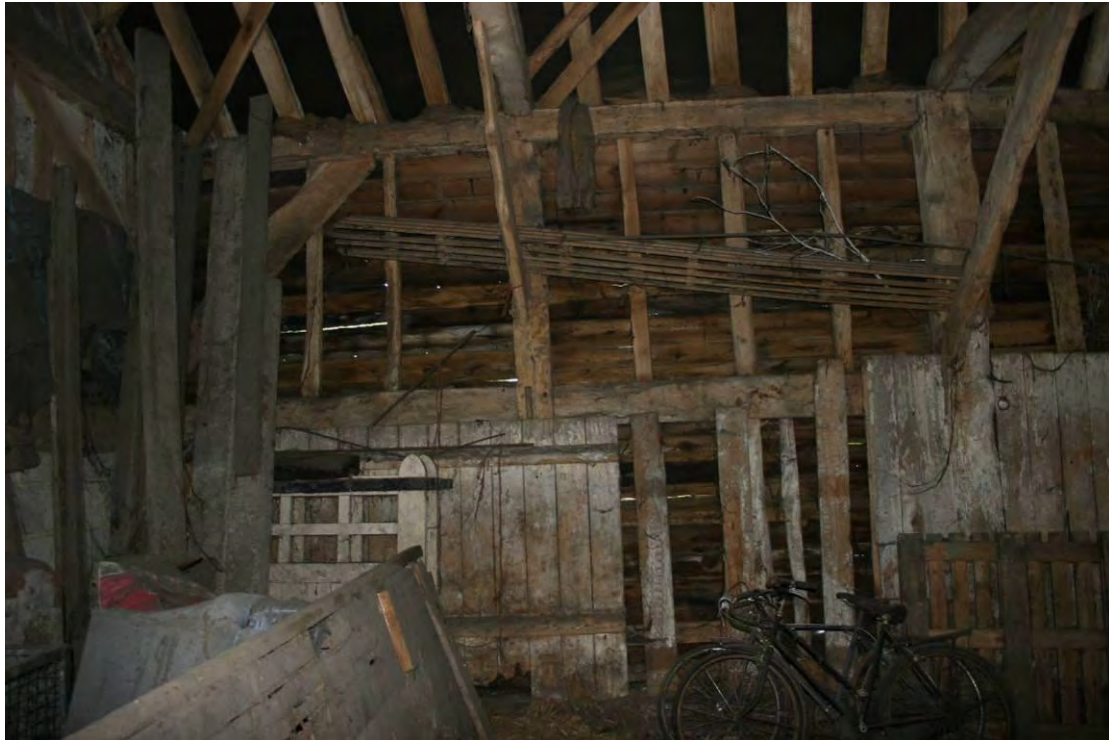
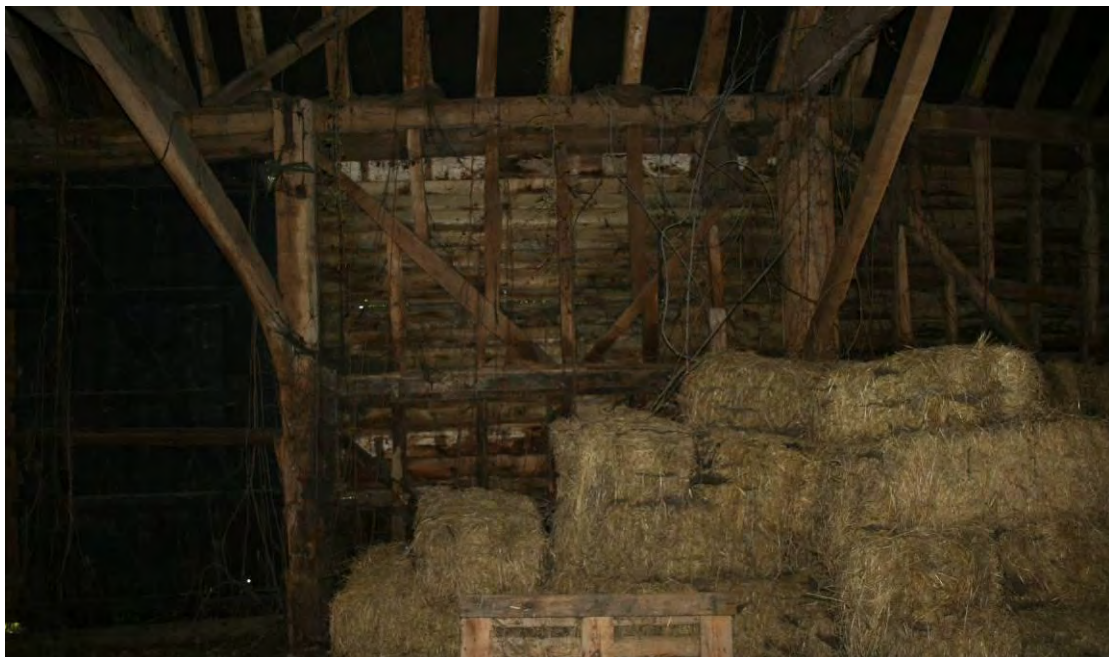
Wall frame in Bays 5 and 6, south side.

Wall frames in Bays 1 and 2, south side.

Very few of the 4-6in x 3-4in studs look as though they came from the earlier frame and the nailed studwork is of c.1800 in style and fabric. The 9x6in midrails, although more convincing in some bays where they are correctly pegged, are much more slender in others. Most of the timbers are grey with a reddish hue and are therefore elm – a characteristic that has been noted by several carpenter's while repairing the building. (Owner –pers comm).

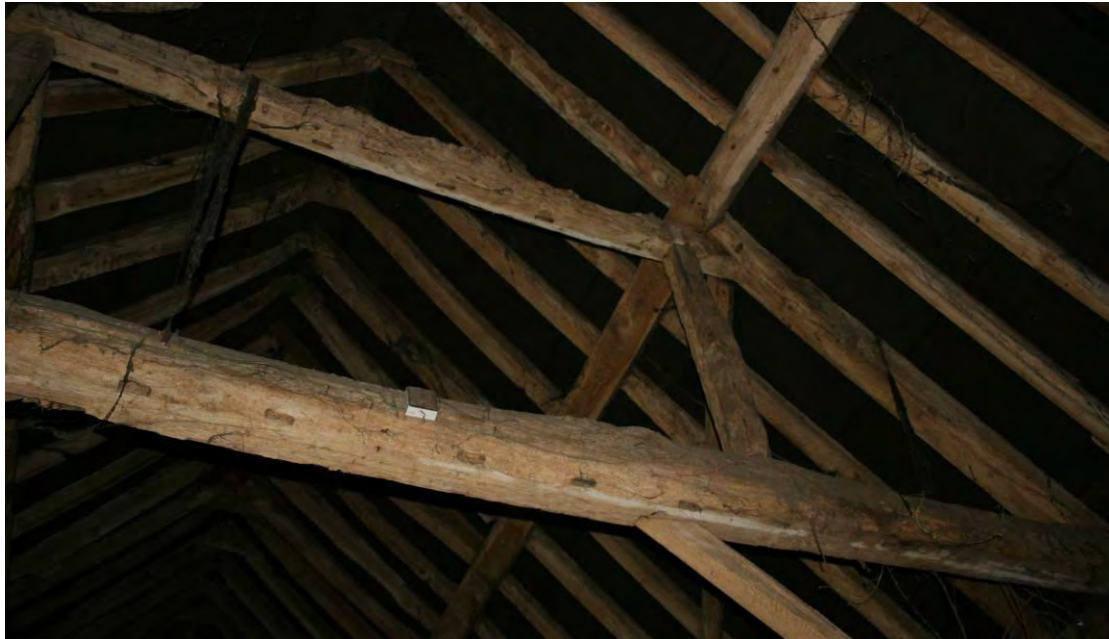
The Barn has 6 bays but it is immediately evident that Bay 1 (from the west) has been added. Truss 1 is morticed for studwork to form an end wall which has been removed to form the extra bay. The end wall is the brick wall described previously. The midstreys and porches are in Bay 3 giving an asymmetrical earlier building (i.e. the doors were not in the middle).

The frame of Truss 1 showing the mortices for an end wall. Looking SE.

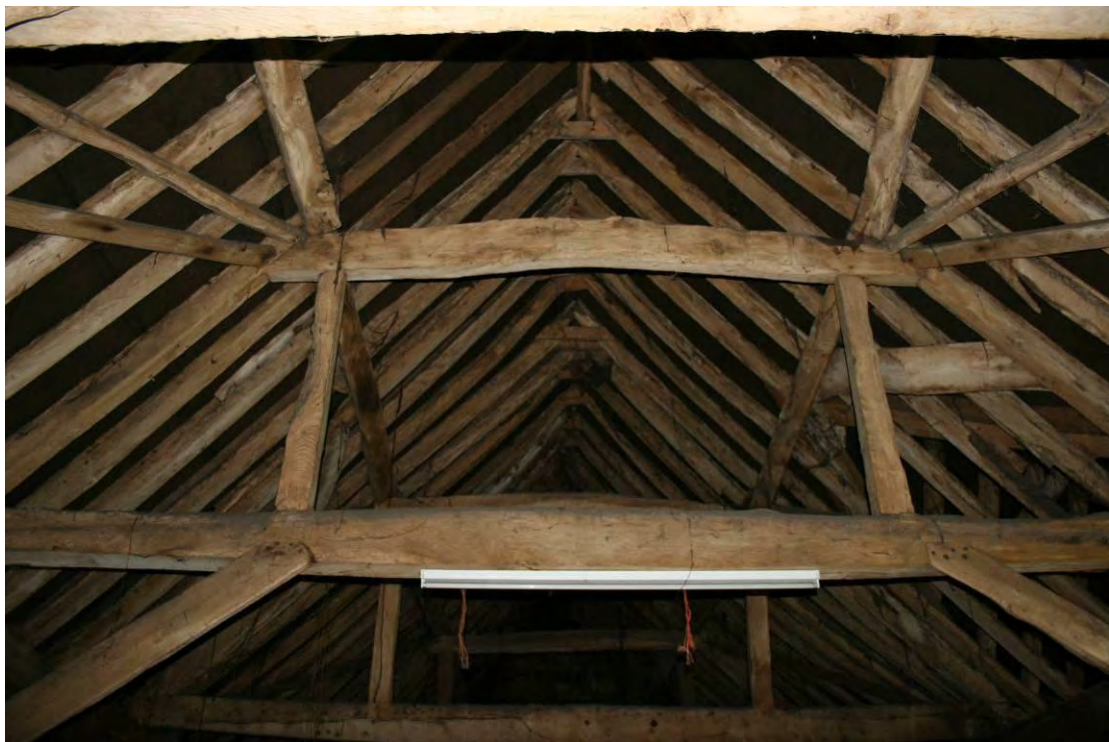
Truss 3 looking W.

The clasped side purlin roof is supported on five queen post trusses with cambered tie-beams with flat soffits. The 6-7inx3-4in flat rafters are paired with gussets and no ridgepiece. In places the queen posts are numbered with a race knife. The trusses have been altered by applying side nailed braces in place of the original curved and pegged spandrels of which only two appear original.

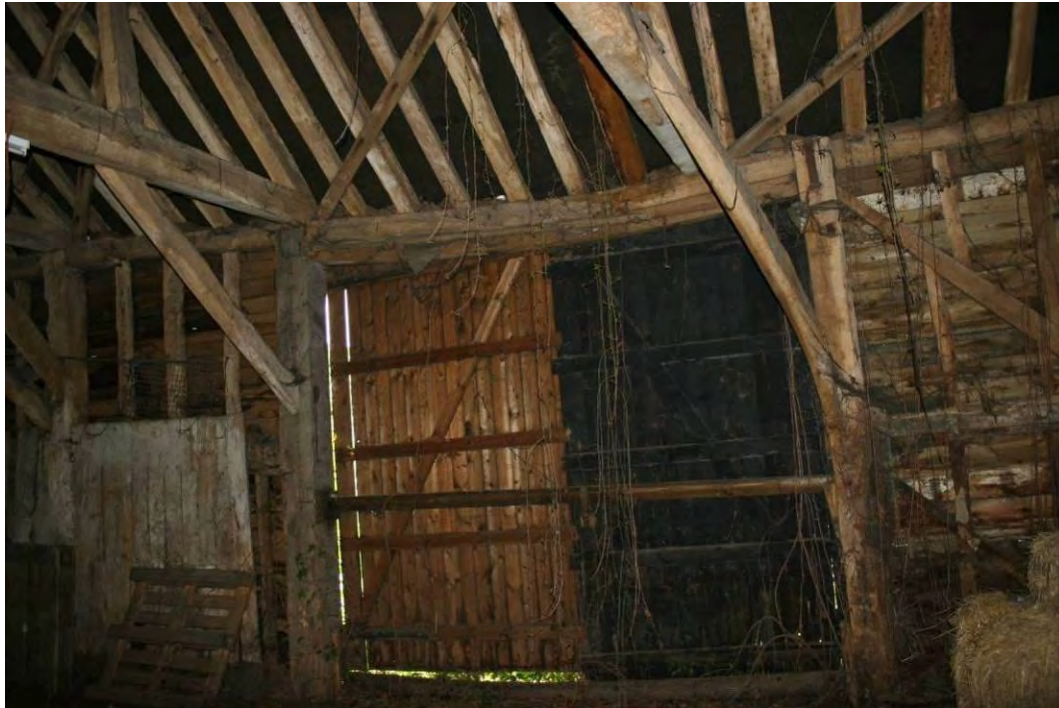
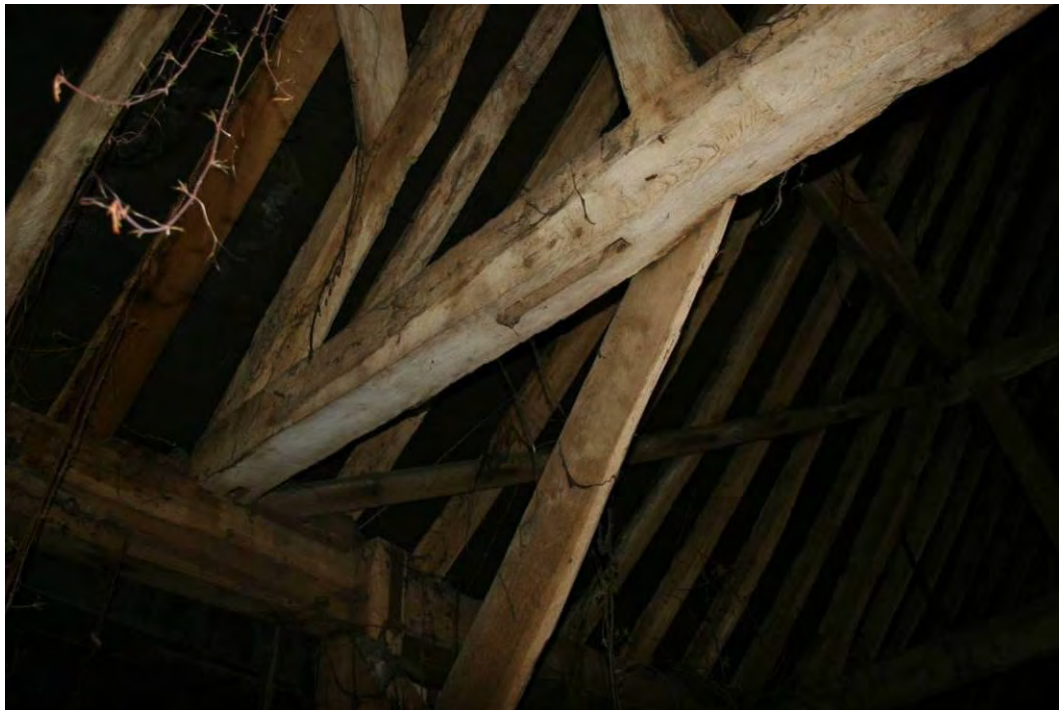
The trusses forming the midstorey. Note the displacement of the post. South doors.

Detail of the displaced storey post and tie-beam assembly.

Truss 2 storey post has been completely displaced. It appears the tie-beam is in its correct position while the storey post has been moved to increase the width of the double doors on the south side. The 10in square storey posts do not have jowls but rather are square posts, tapering upwards with upstands in the style of early medieval carpentry.

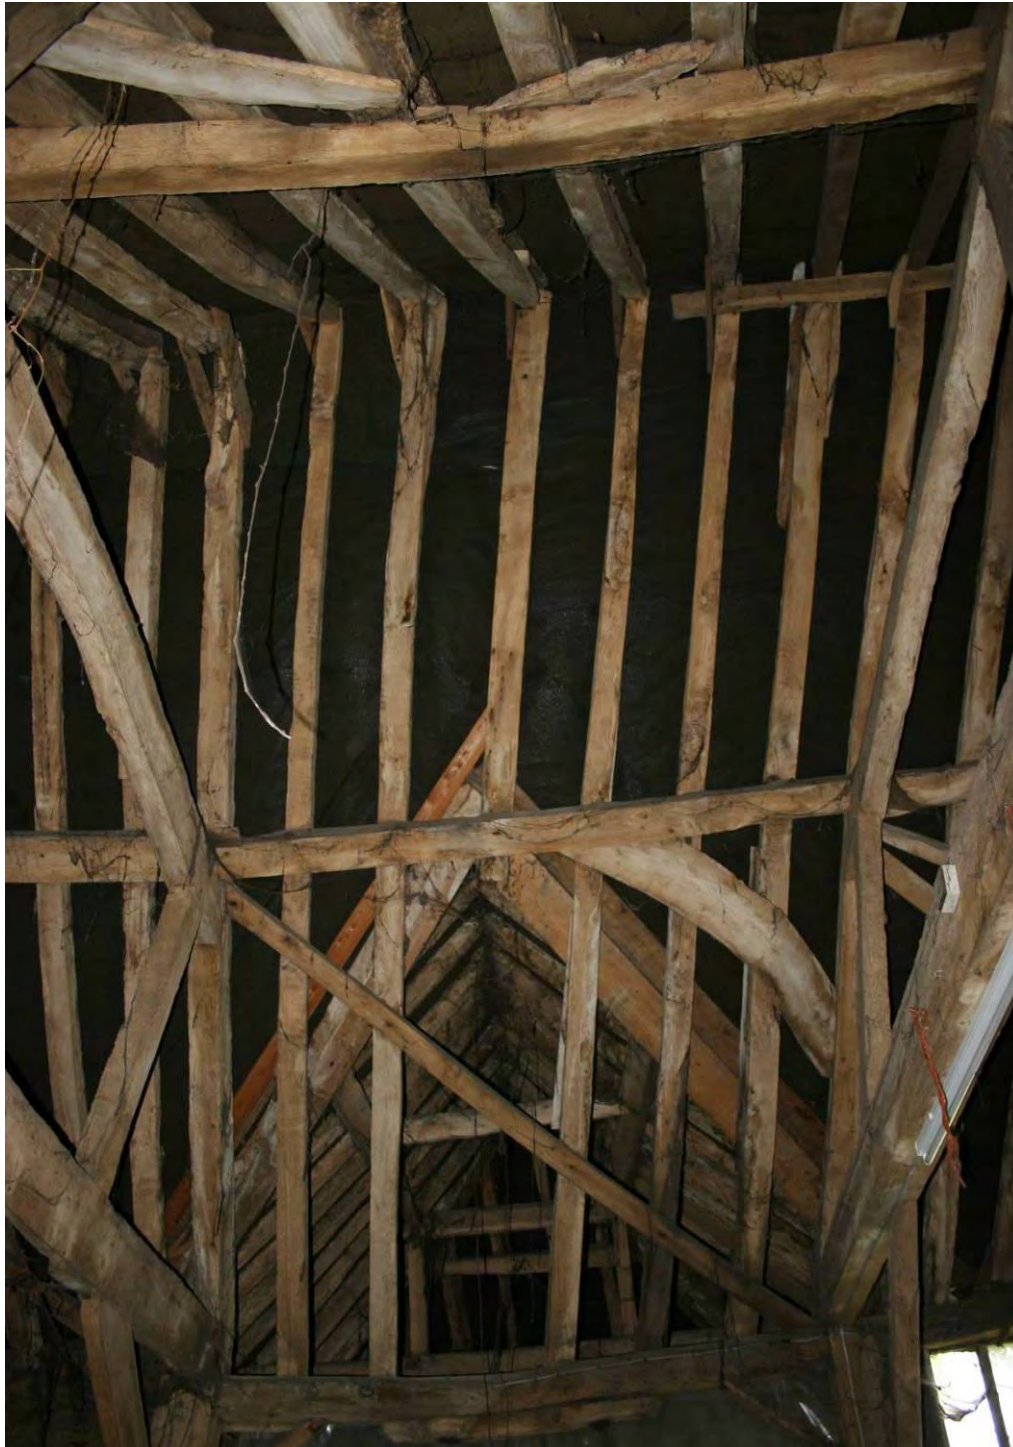
The northern side of the roof in Bay 3. Note the remnants of windbraces.

The roof has racked badly over the years and there are many inserted birdsmouthed struts and some C19th iron tie-rods put in to try to arrest the movement. There are remnants of four of the original curved windbraces that braced the principal rafters to the purlins but as they are only one inch thick they have otherwise failed. The roof was retiled in the 1990's and must therefore be braced through its battens.

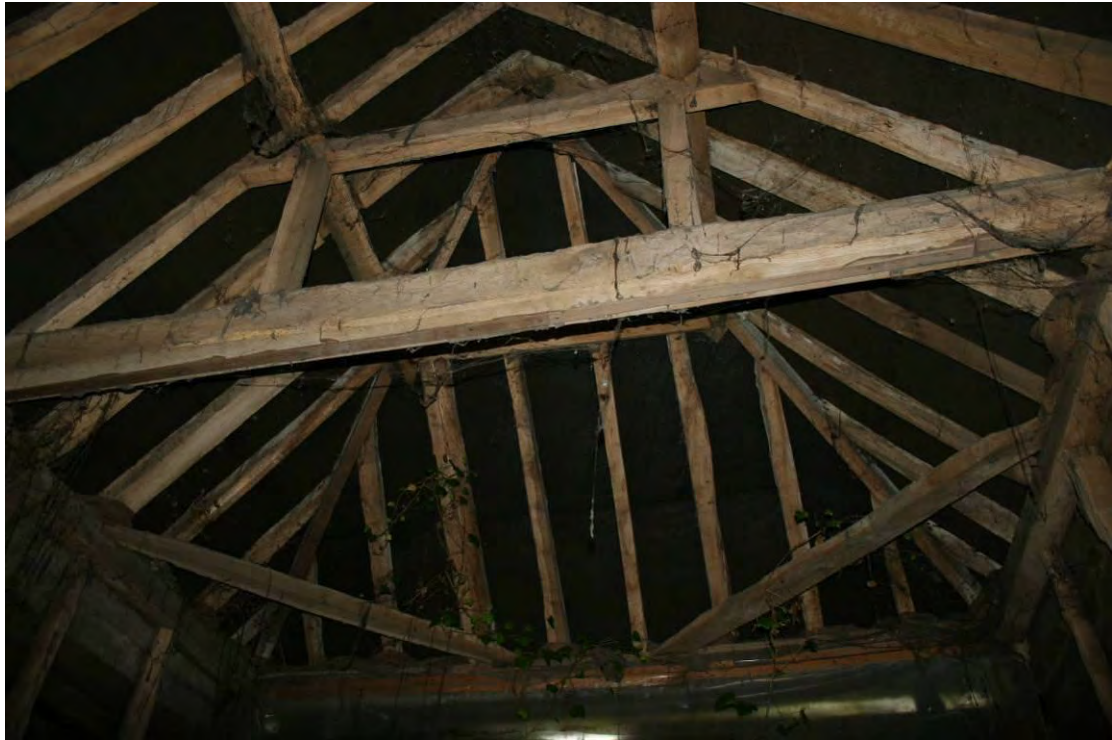
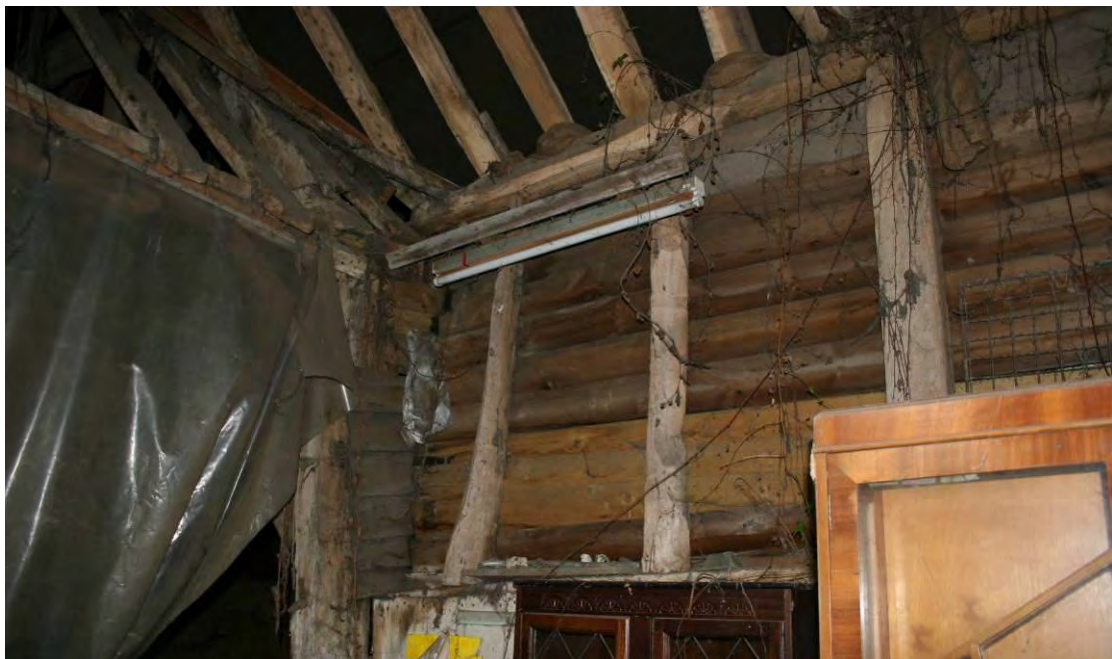
The roof of the midstrey. Looking NW.

The frame visible on the western wall of the midstrey.

The hipped roof of the midstrey has a queen post truss that mimics that of the main Barn but all the elements are slender and set on edge. The rafters are pitsawn except for the jack rafters that have been machined. The walls have very widely spaced roughly hewn studs and principal posts. The porch has been added to the Barn frame and there is a ragged join where the weather-boards meet.

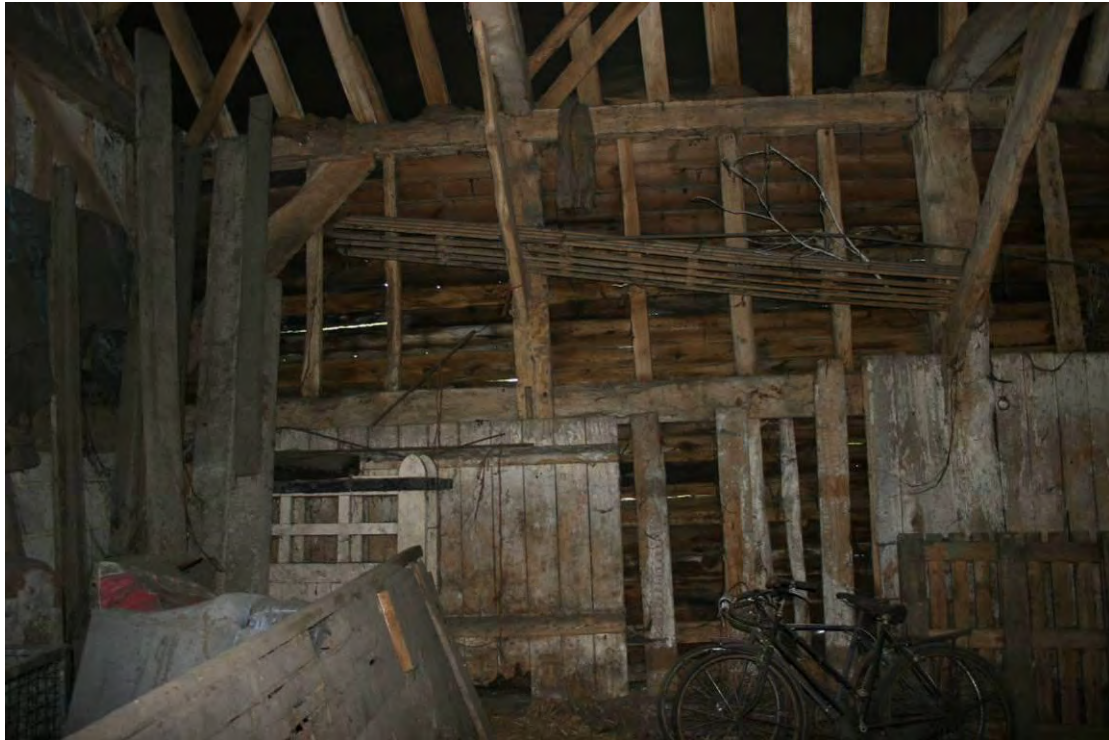
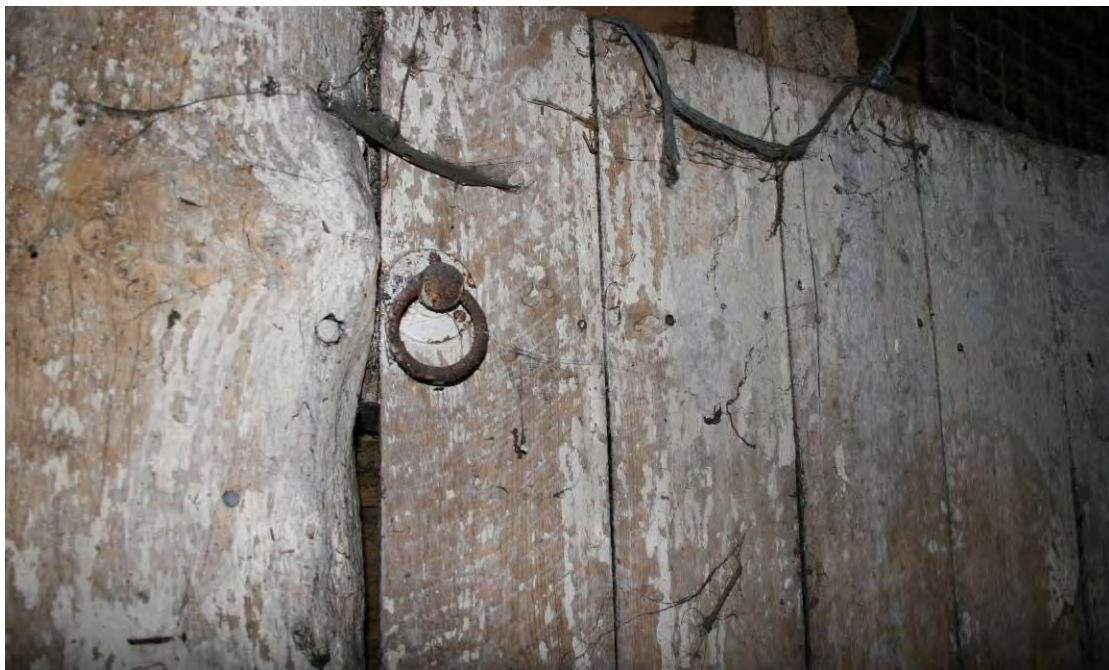
Kickboards lining the north wall.

The north wall of the Barn is lined with circular sawn boards fitted with tethering rings fixed with dome headed screws. It is evident the Barn was used to stable horses in the C20th but the boarding is LC19th in character.

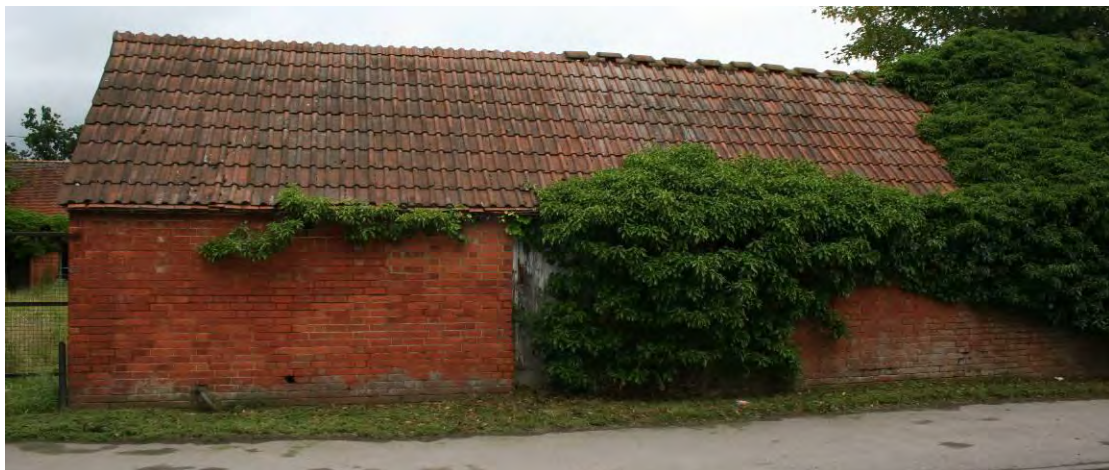
The southern elevation of the Processing Shed.

The Processing Shed was most recently used to process and pack potatoes but it was also a milking shed. Formerly open sided on the north side until at least 1966 (OS maps) it is built of Victorian style 65x110x225mm wire cut bricks, with smooth faces, crisp arrises, horizontal pressure marks, kiss marks and no frogs. They are laid in Flemish bond in lime mortar. While the quoins are finished with queen closers the doors and windows have none and are therefore C20th insertions. All the doors are MC20th. The roof is clad with C20th double roman clay tiles.

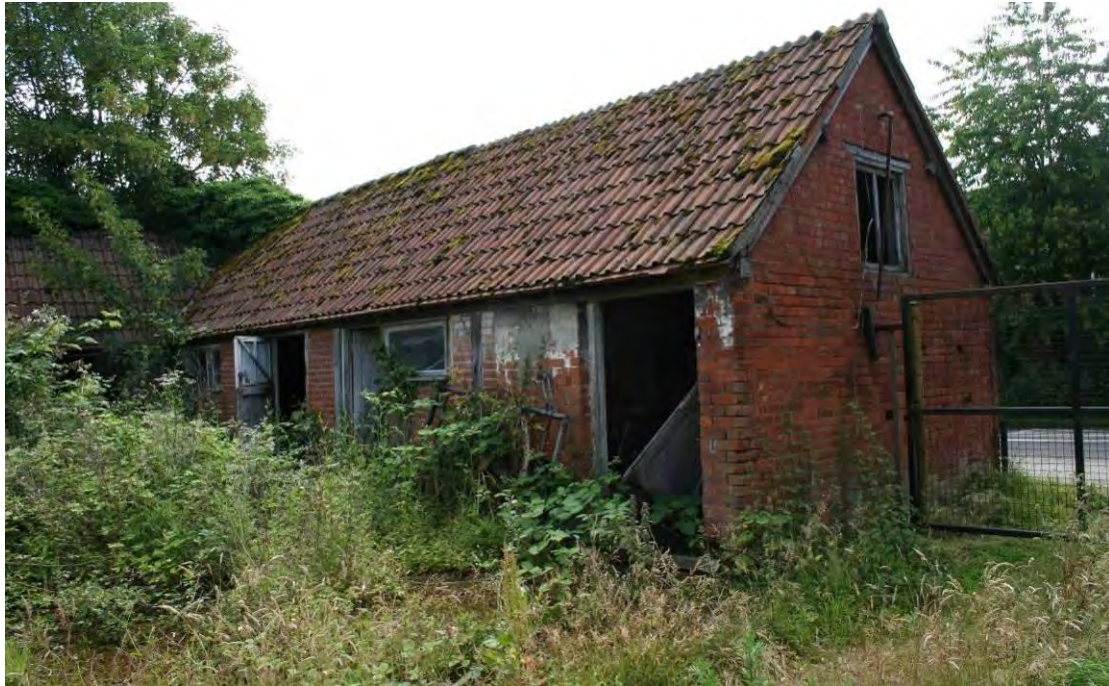
The western and northern elevations.

The northern elevation has inserted C20th brickwork, doors and windows to form small offices. That closest to the entrance way still retains the pumping equipment for the milking machines.

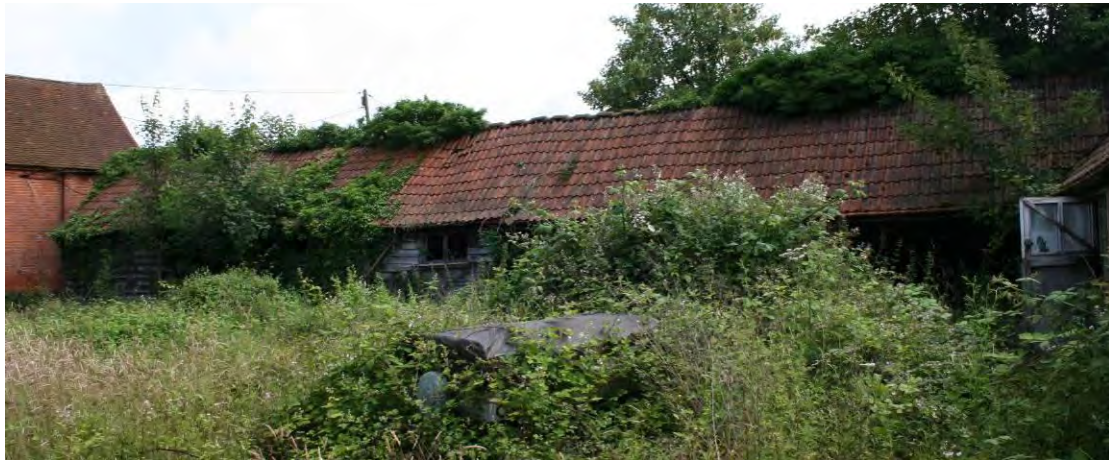
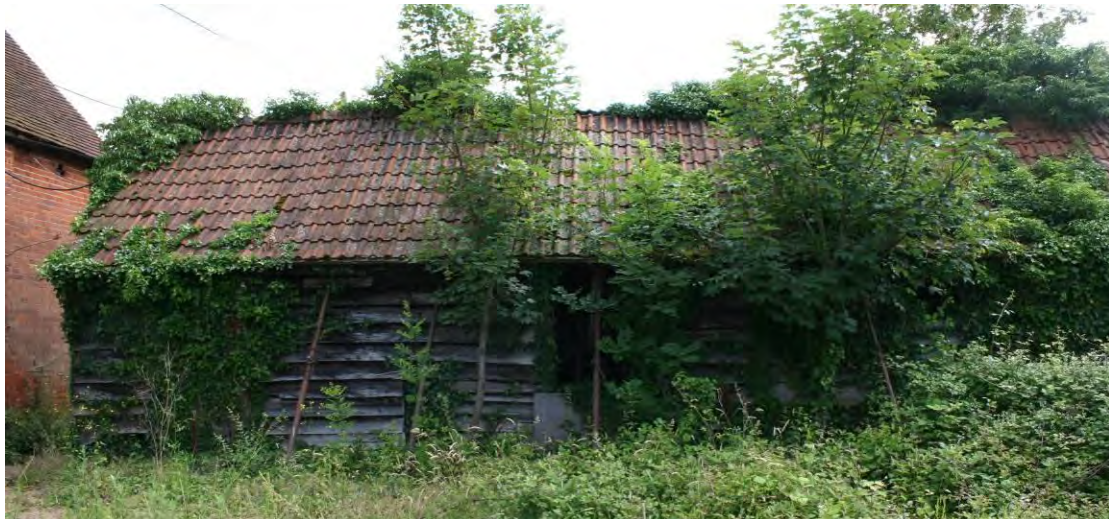
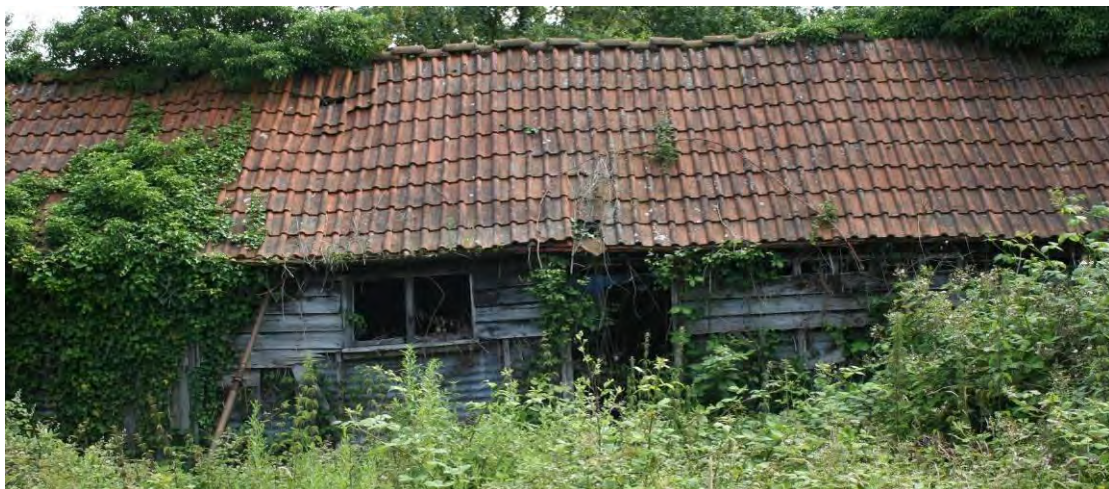
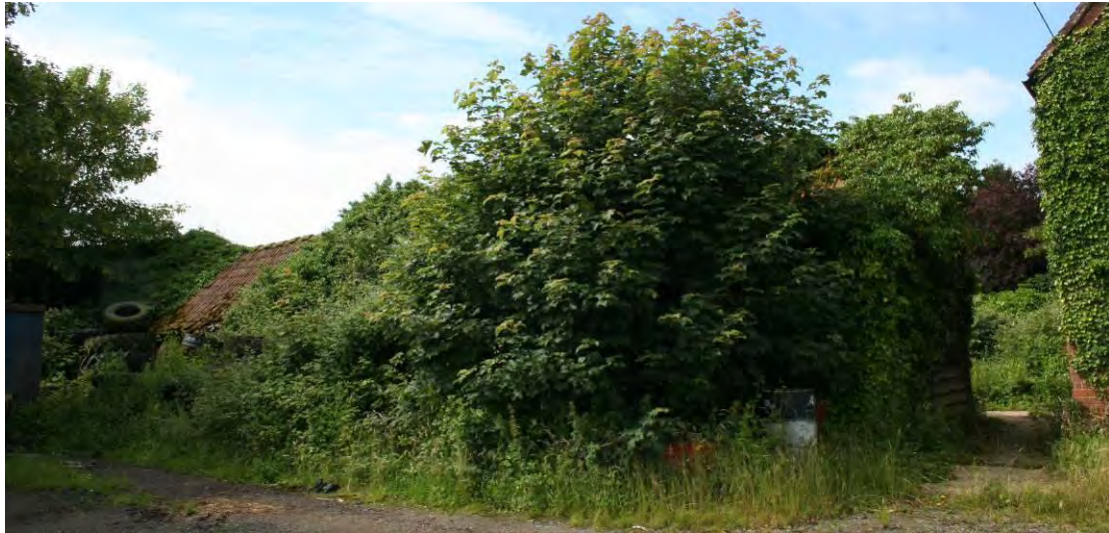
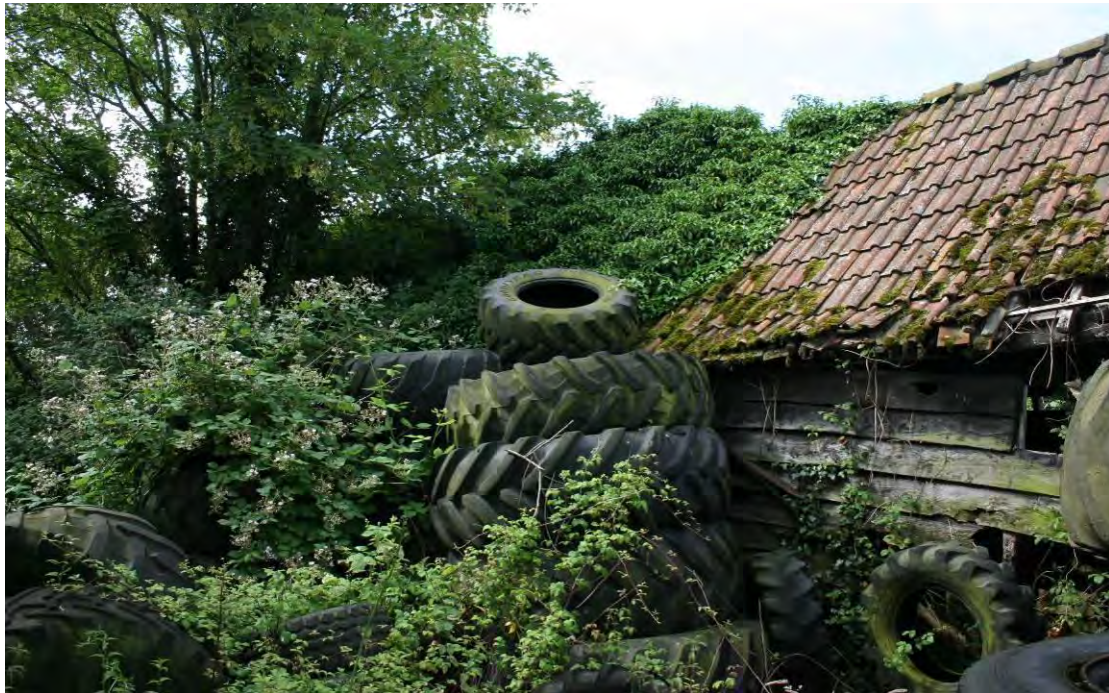
The western elevation of the Workshop.

The Workshop is in a parlous condition being supported by acroprops and large sections of it have been consumed by foliage. The building has timber-framed walls of 2x4in sawn softwood studs clad with C20th weather-boards. The casements are also MC20th and there is one basculating window of the type typically seen in Victorian era stable buildings. The doors and window glass are missing. The roof is clad with double roman tiles but the roof structure is E-MC19th in design and fabric.

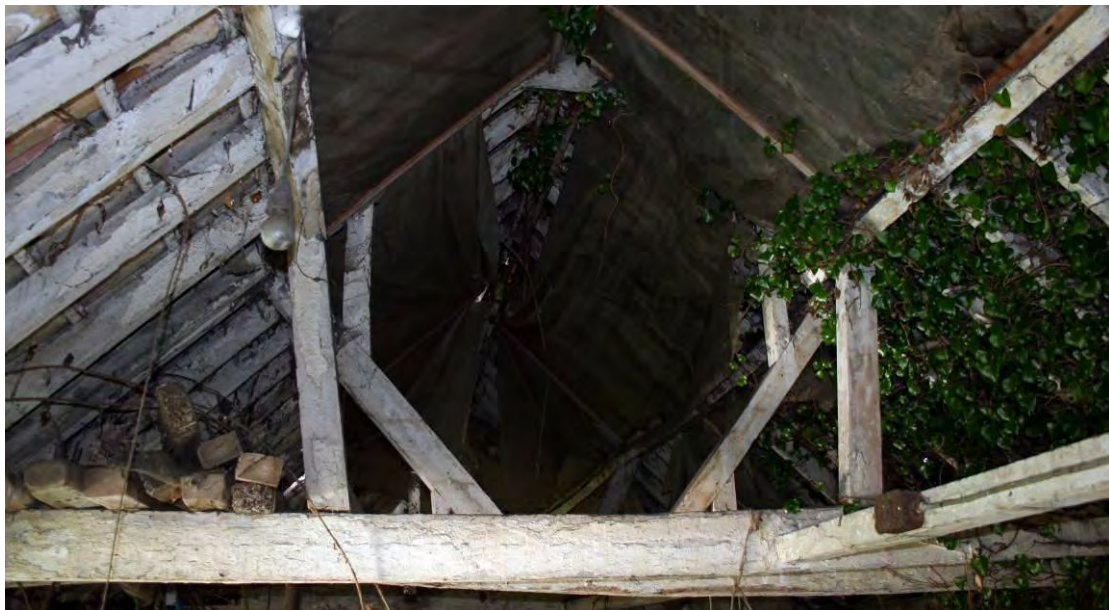
The roof structure in the southern half of the Workshop.

The Workshop has been formed by adjoining the Processing Shed with a LC19th timber link to a timber-frame with LC19th sawn softwood walls but an E-MC19th elm pitsawn roof structure with side purlins supported by raking struts. The southernmost bay has the common brick wall of the Processing Shed and a LC19th machine cut roof that meets the older roof at the first truss. Additional tie beams and struts have been added to improve the stability of the older roof of which many of the rafters are quarter poles.
