**Ashridge Farm, Warren House Road, Wokingham RG40 5QB**  
Historic recording of the farmyard buildings. Surveyed 30 06 2016.

## SUMMARY SHEET

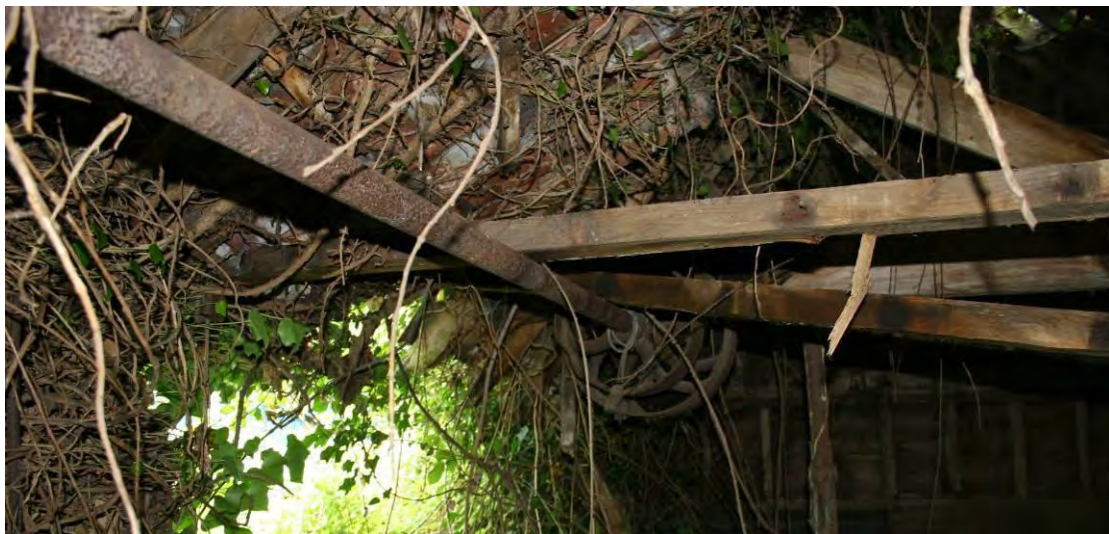
Machine drive shaft against the eastern wall.

Running along the eastern wall and hung from added tie-beams is a machine belt drive shaft of Victorian or Edwardian design. This would have been used to run workshop machinery with a small engine turning the shaft powering various machines. One such drilling machine is kept in the Brick Barn.

This part of the building is in parlous condition and the roof is collapsing due to the rotting of the main members.

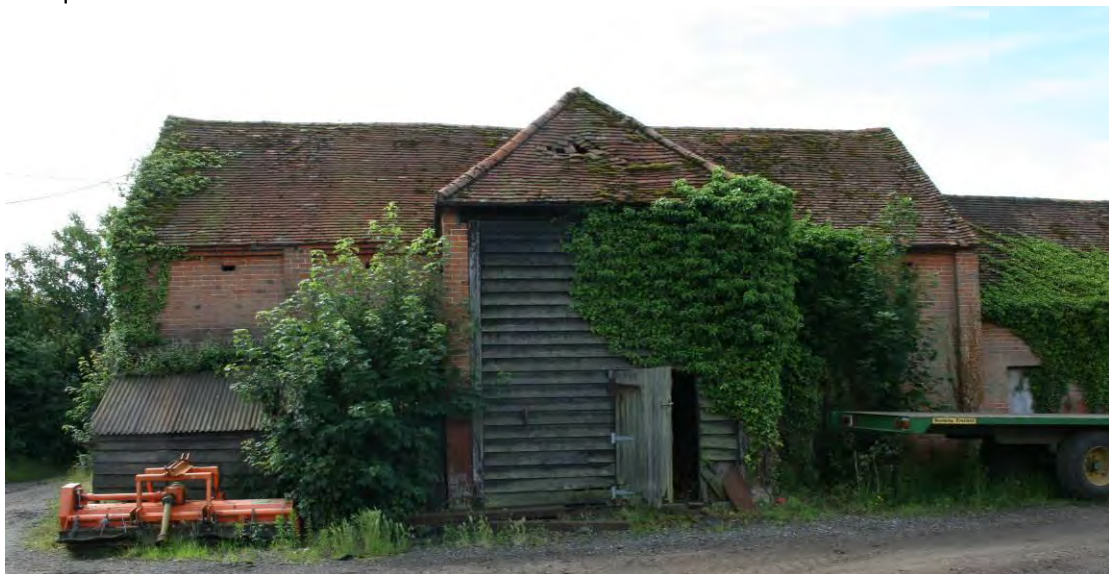
The northern elevation of the Brick Barn.

The northern elevation presents a symmetrical brick built barn of five bays with an integrated brick porch under a half hipped clay tiled roof. The main roof is gabled at both ends and also clad with clay peg tiles. The pilastered walls are built of 70x110x225mm red bricks with creased faces, sharp arrises and horizontal pressure marks. They are set in lime mortar tempered with crushed stone, lain in Flemish bond with closers for the openings and the brick pilasters. The doors have been replaced with LC20th studs and boards.

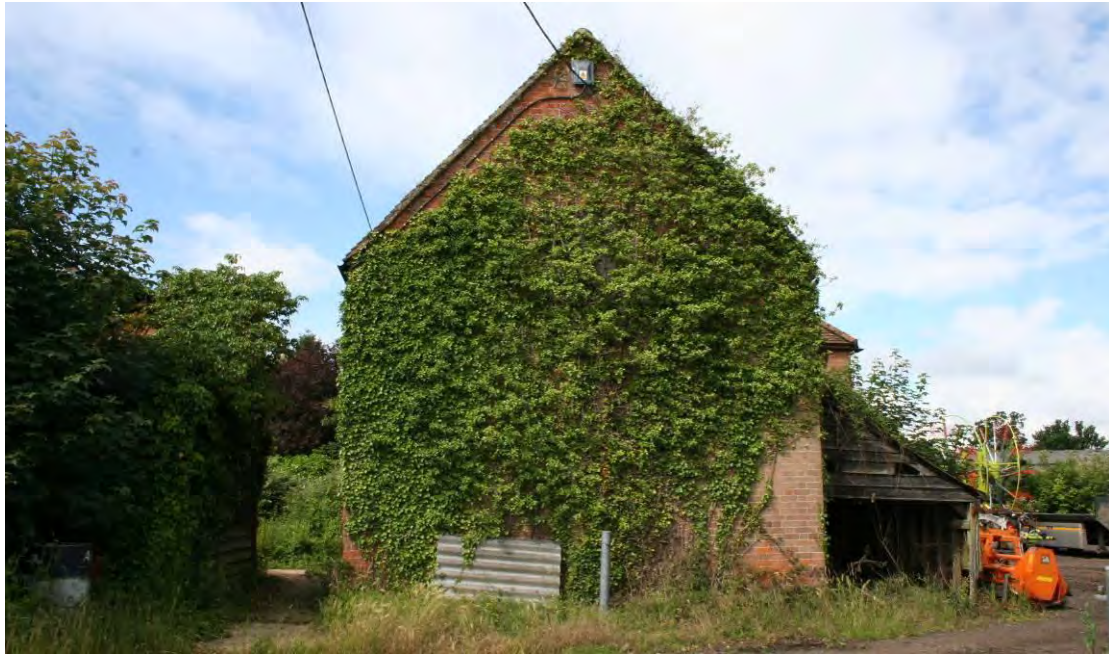
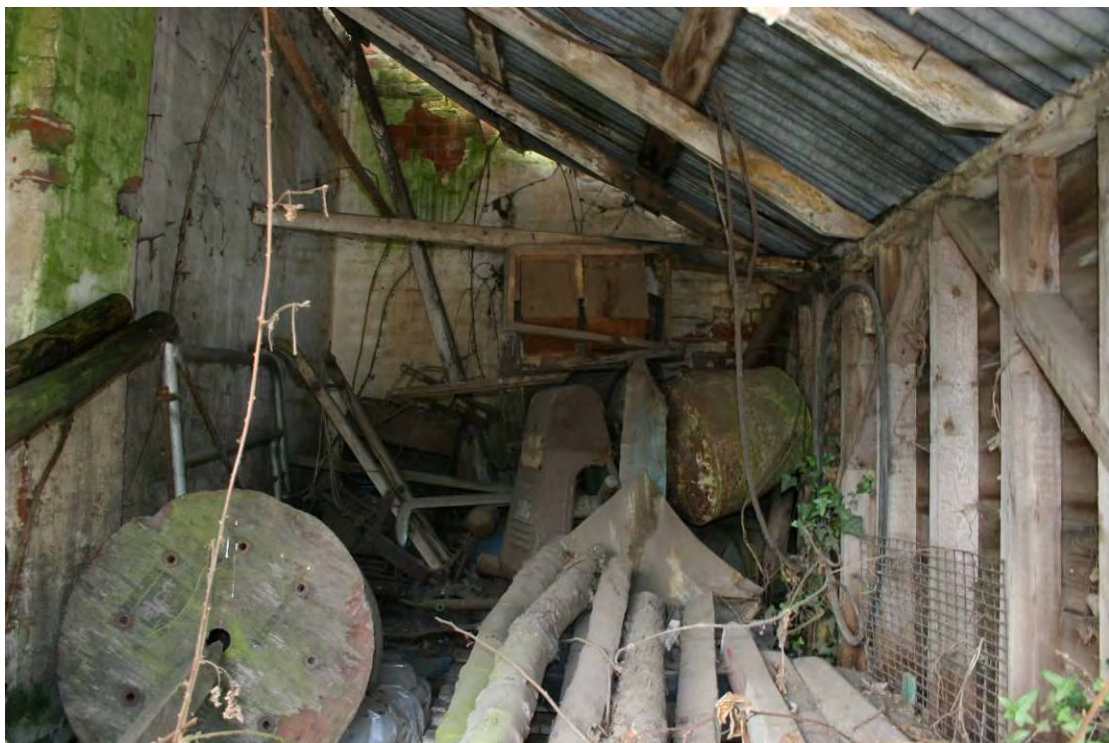
The eastern elevation of the Brick Barn.

The eastern elevation presents a gabled brick wall with a high level hatch door hidden by foliage. On the northern side is a MC20th timber framed shelter built of bandsawn softwood with a corrugated sheet roof and MC20th weather-boarding. The doors have been lost.
