#### Description – 4. Brick Barn – Internal.

## Description – 5. Brick Stables – External.

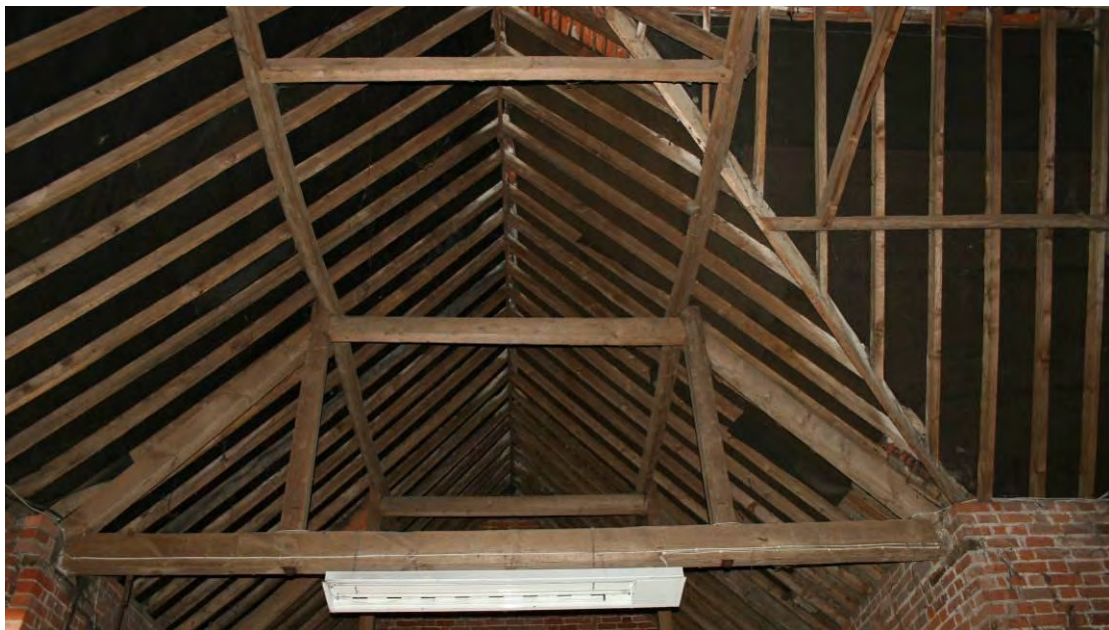
The roof mimics the style of the queen post roof in the Timber-barn.

The roof is made of machine sawn softwood and forms a side purlin roof. The truss has queen struts secured with large wrought iron bolts and collets. The principal rafters are shored into the sides of the queen struts which are connected with a collar. The collar supports the side purlins upon which are laid the 2x4in rafters. In this way the truss is independent of the rafters. The extensive use of standardised machine cut softwood timber indicates that the Barn was erected in the second half of the C19th.

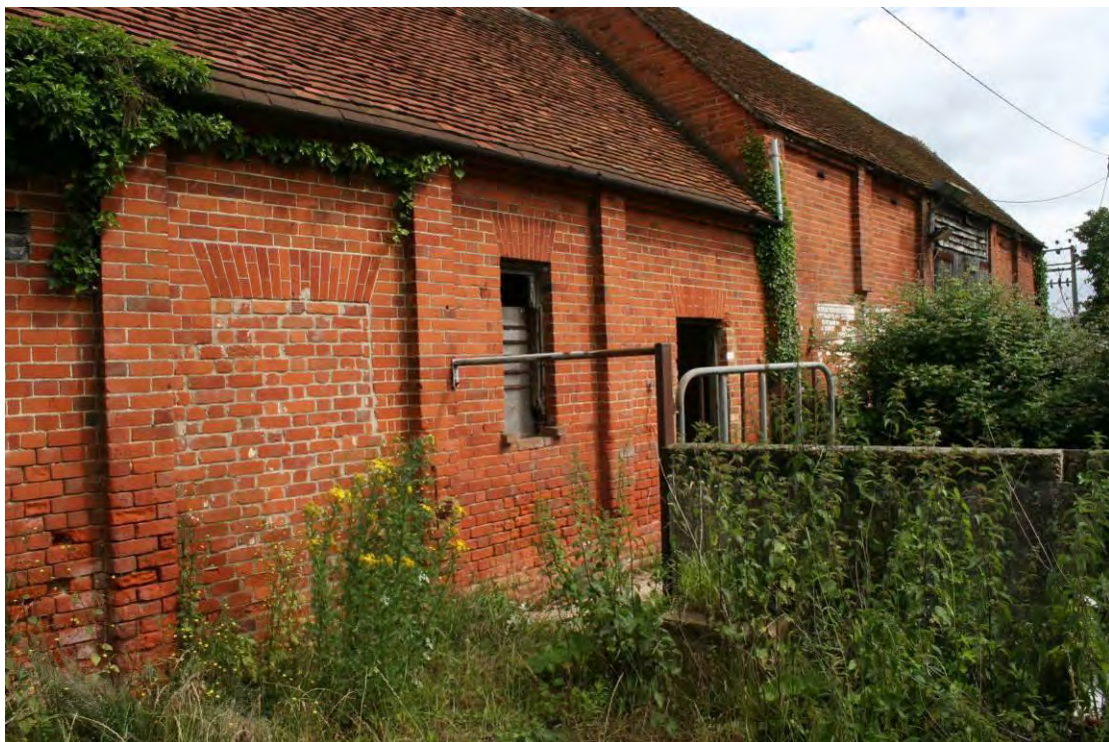
The southern elevation looking NE.

The southern elevation was originally built with two doorways and four windows under gauged brick arches. The elevation was remodelled in the 1960's, blocking one doorway and opening another up under a steel lintel to accommodate the cattle. A substantial bull pen built of reinforced concrete and steel railings was built around the doorway to the east and is notable for the damage to its jambs.

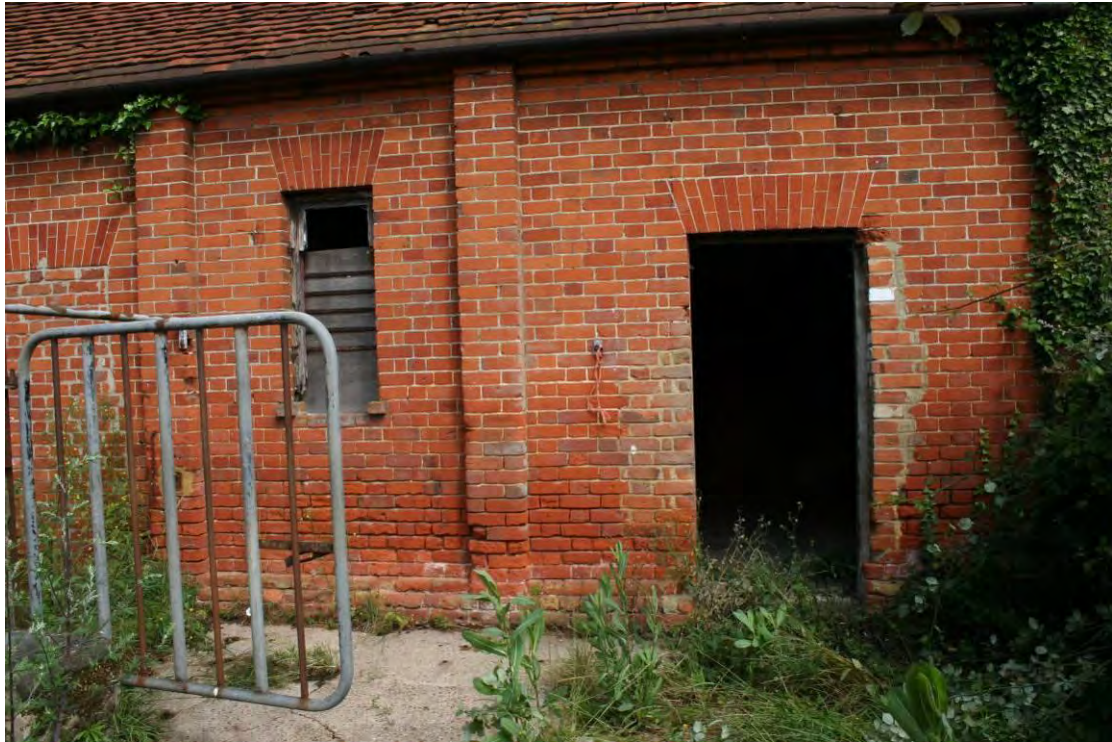
Doorway to the bull pen.

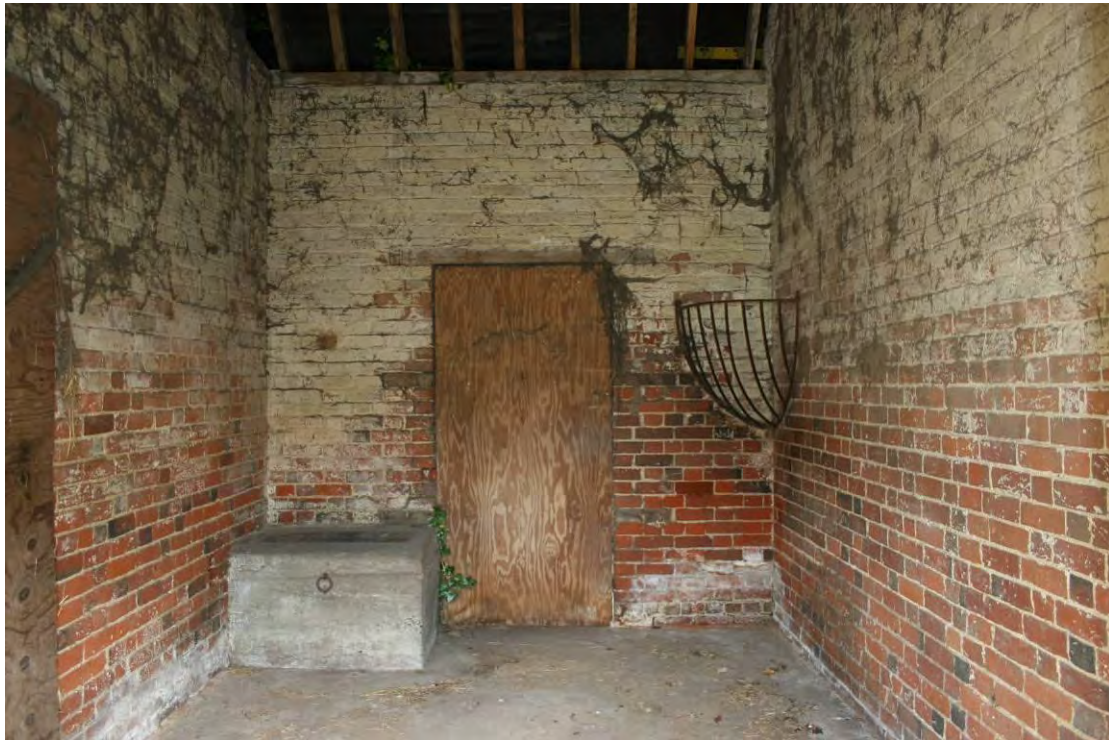
The stall used to house the bull. Note the blocked up door.

The stall last used to house the bull was most likely originally the tack room as it is the only room with two doors allowing exit to the north. The door has been blocked and covered with Sterling board and another opening broken through on the western side has also been covered. There remains a low level concrete water trough with a tethering ring and an elegant C19th style hay rack riveted to the brickwork indicating that horses were also kept here at one point.

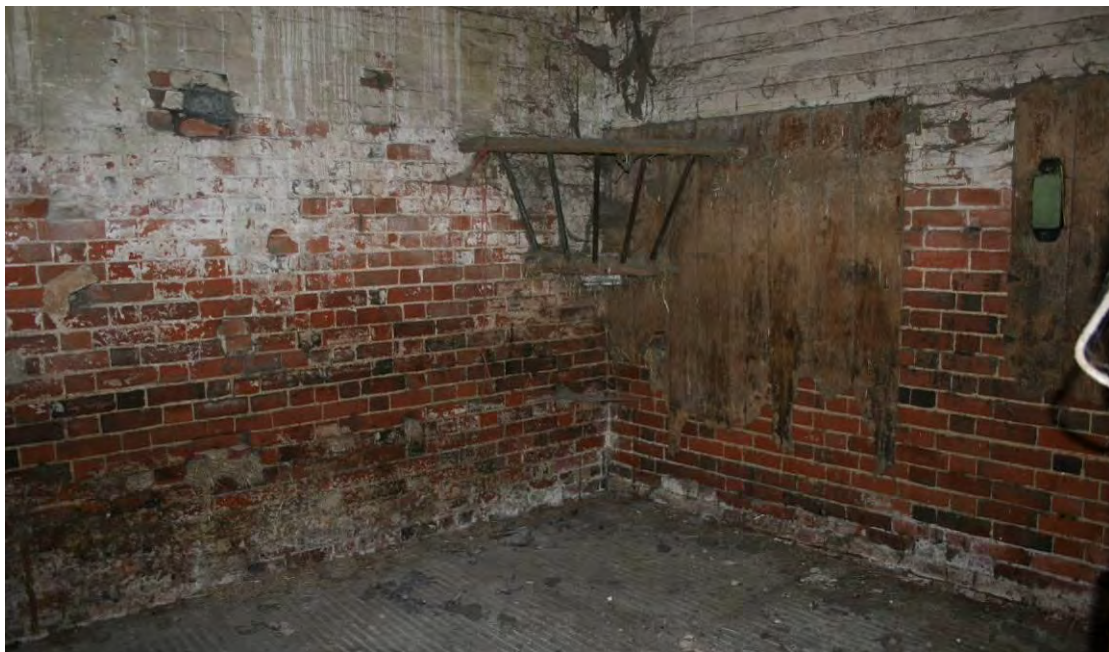
The eastern stall.

The main stable has been divided into two stalls using LC20th machined posts and Sterling board. That to the east of the room has a homemade hay rack of roughly cut timber and metal tubes. The western wall is lined with decaying kick boards nailed to battens fixed to wooden wedges inserted into the brickwork and these are likely to be original.
