# METHOD STATEMENT FOR REPAIR WORK TO BUILDINGS AT

## ASHRIDGE FARM, WOKINGHAM

Report by William Harrison

RED ROSE DEVELOPMENTS MARCH 2021

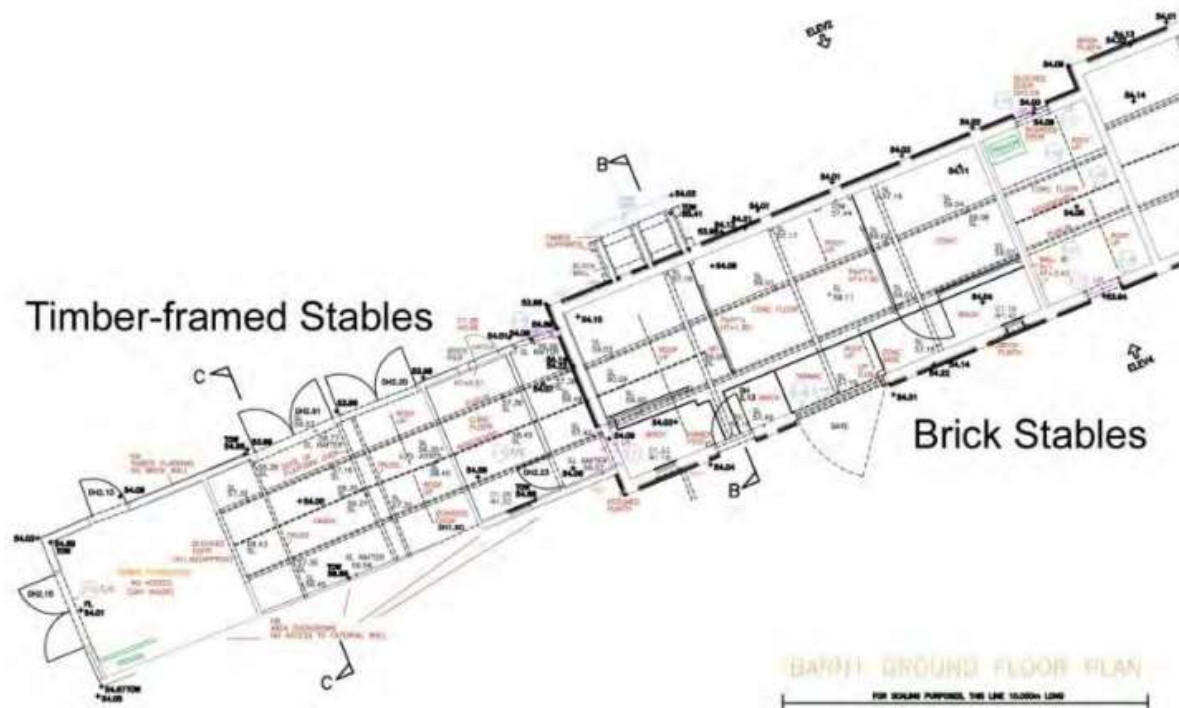
To the West lower section of Unit 1 there is a rough, partially broken up, concrete ground floor slab, previously used as timber framed stables and a garage. There is no sign of a visible damp proof membrane. The slab will have to be removed and replaced. The timber clad frame is sited on a small perimeter brick plinth that is partially collapsed in areas. It is unlikely that the structure has a much of a foundation due to the condition of the plinth. Tree roots around the building have destabilised much of the wall. Within the brick stables there is also a rough concrete slab which requires removing and replacing.

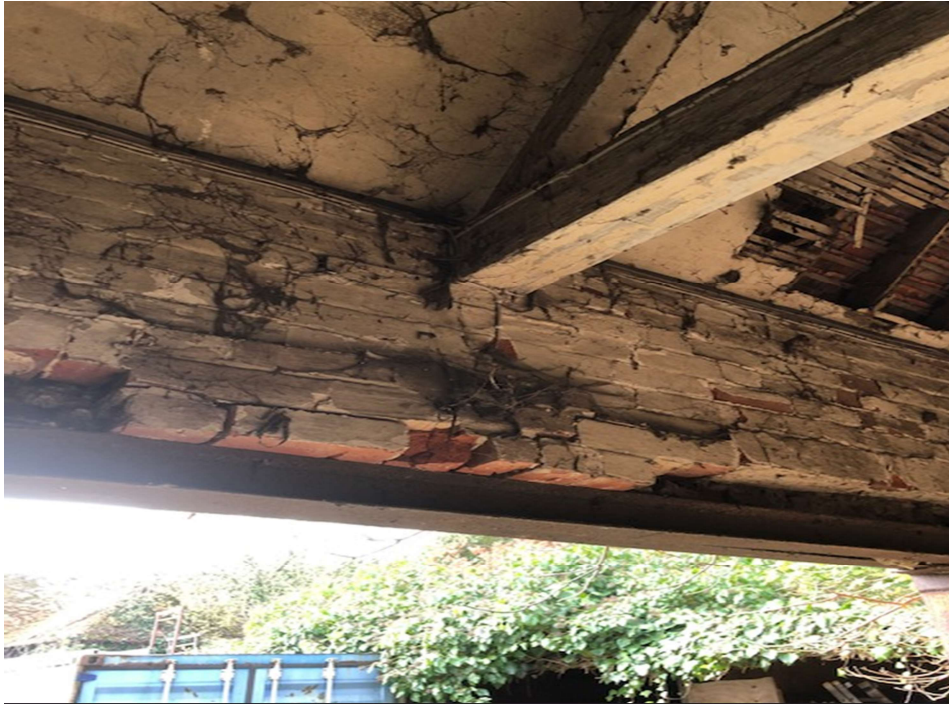
There are numerous spalled bricks that would need to be replaced locally, but in general the brickwork is in fair condition to the stables. All the brickwork will require repointing which will be completed in lime mortar, of matched colour and texture to the existing. There is structural cracking appearing where the external southern wall meets the eastern internal wall, likely due to the roof spreading. This will be repaired once the roof is repaired. The steel lintel over the main opening from the courtyard is not up to building regulations and has crudely been added in across two original windows, see image below, it has also been knocked causing a instability. The steel beam will be removed and replaced with a hidden lintel and brickwork made good above.

Figure 5: Brickwork collapsing and steel beam over entrance to unit 1

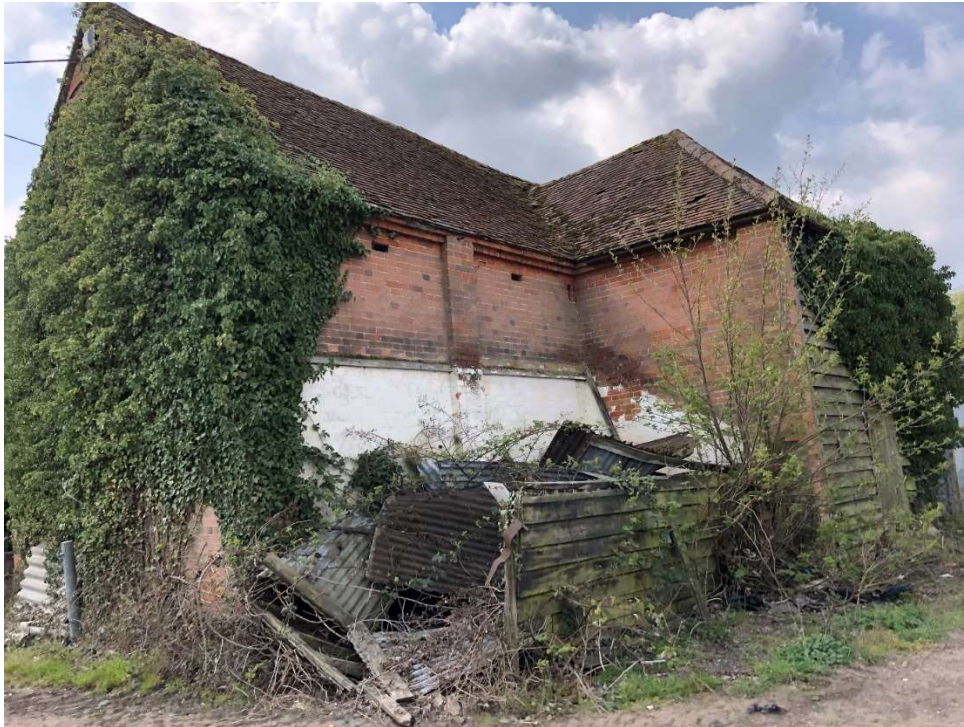
Figure 6: Exterior south elevation of unit 2

The brick barn forming Unit 1 is of the similar age and construction and Unit 1, a concrete ground slab had no sign of a damp proof membrane and was not level which will be replaced. There were a number of spalled bricks and some cracking to the brickwork visible over a number of the roof trusses, possibly from machine collisions. The external walls were overall in good condition, plumb and showed no evidence of subsidence although the roof is spreading over the northern and southern main openings which is pushing the wall outwards considerably and unrepaired would lead to collapse of the wall and roof. The external walls require repointing in some areas where the mortar has leached out. There was no damp-proof course in the wall.

The roof structure has received many patch repairs over time using unsuitable materials and a felt underlay has been added to areas. The large queen post trusses will be retained in situ and reused but the rafters and battens will need to be replaced. The roof tiles look to be in sound condition so will be reused.

The current porch doors and surrounding cladding are in poor condition and have decayed beyond repair.

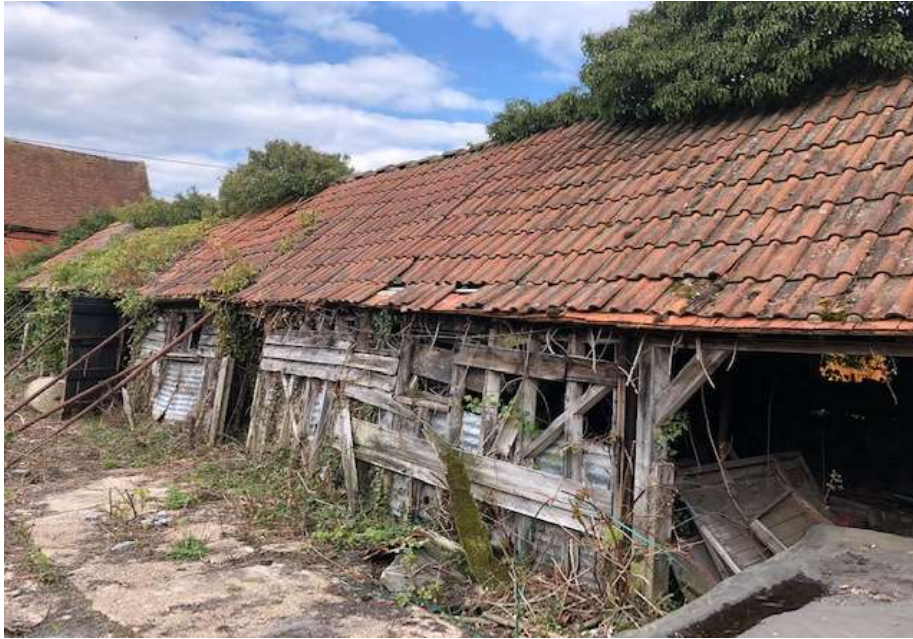
The former workshop forming Unit 3 has timber-framed walls with softwood studs clad with C20th weather-boards. The doors and window glass are missing. The roof is clad with modern double roman tiles, but the roof structure is C19th in design and fabric. A thin concrete slurry partially covers the floor. The building is held up using several acrow props on all sides due to all of the structure being in a state of decay. Most of the structural timber posts are rotten or missing. Metal sheeting has been added internally which is tying some of the timber together. Undergrowth,

particularly ivy, is currently holding much of the structure together. Overall, there is no fabric of this building that can be retained.

Figure 7: Courtyard view of unit 3 in state of collapse and temporarily propped

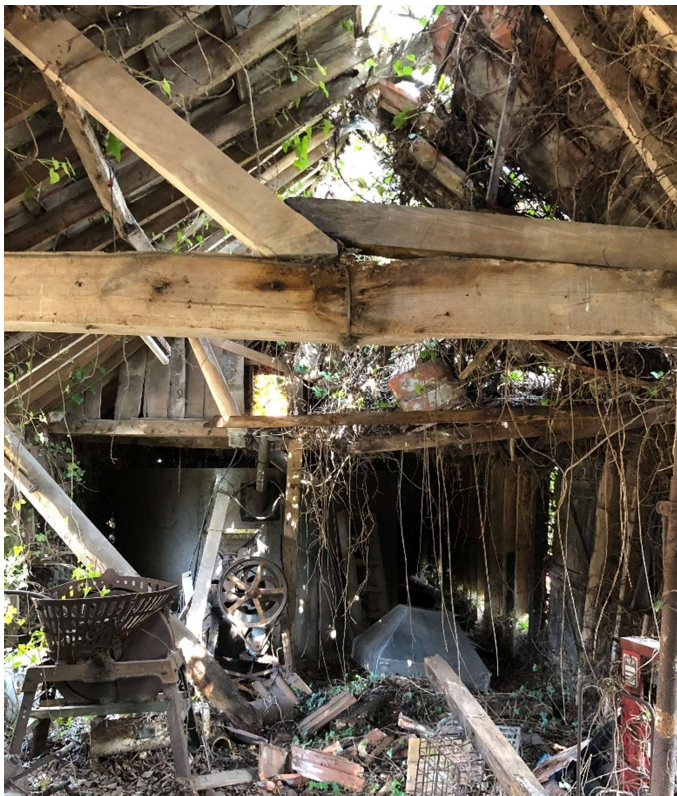
Figure 8: Internal view of Unit 3 showing decay and overgrowth

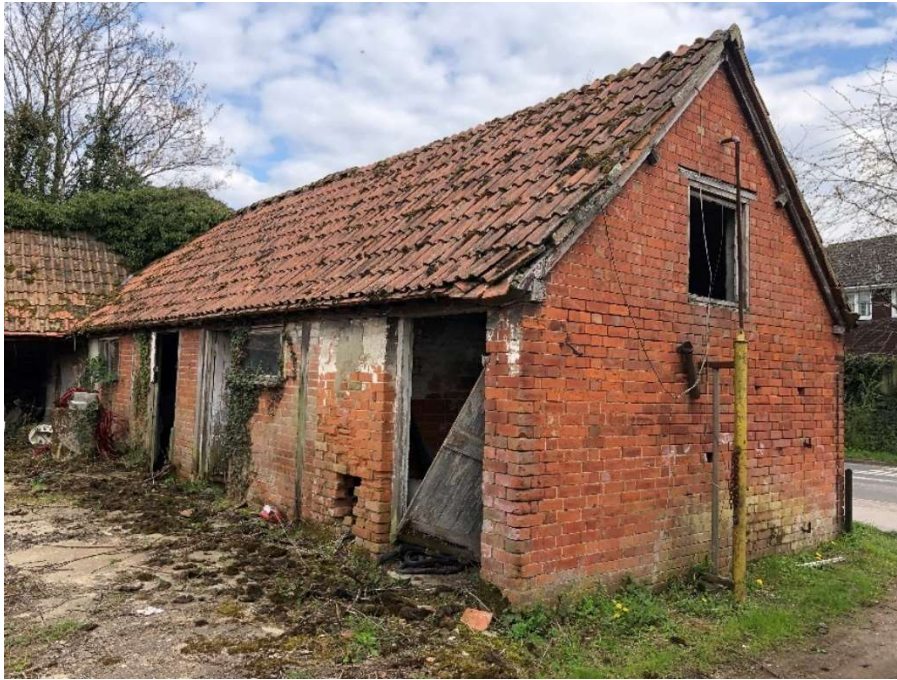
Figure 9: Courtyard view of unit 4

The thin concrete ground slab is cracked in areas and had no sign of a damp proof membrane and was not level, which will be replaced. To the southern elevation and gable ends the solid brick wall is in fair condition and can be repaired. To the North courtyard elevation that was open until post 1966, according to historical plans, there were a number of spalled bricks and modern cement repairs that infilled the rotting timber sections. It is proposed that this section is removed in order to replace it, matching it with the original brickwork on the other sides of the building. The roof structure and roman tiles are of modern construction and will be replaced.

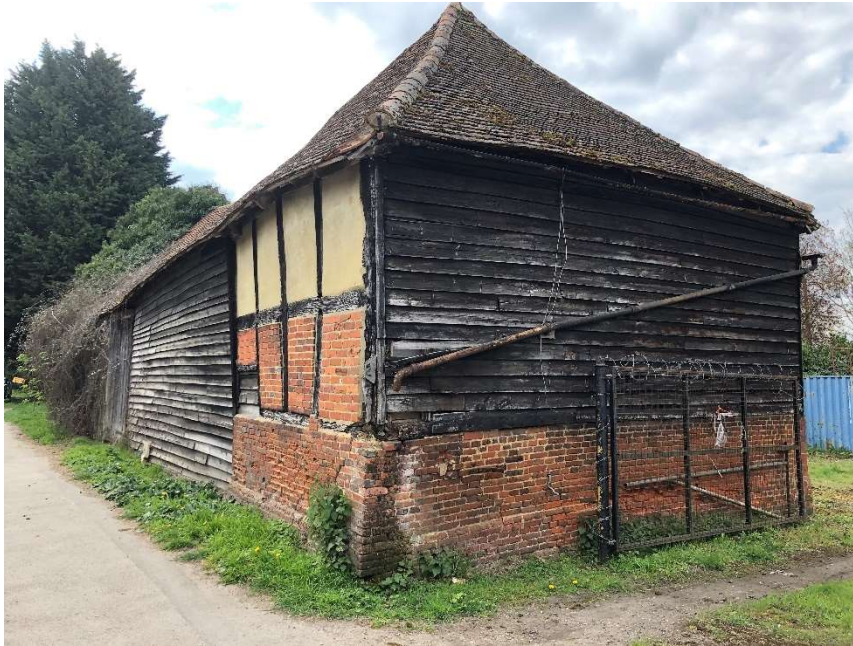
The roof is tiled in a mix of old and new clay tiles due to being re roofed with under felt added in the 90's. Due to the structural movement underneath it is in need of major repair works, although mainly water tight there are some missing tiles causing water damage internally. Some of the internal roof timbers have deflected excessively or broken. The tiles of modern manufacture will all be replaced with a tile to match the older style. The guttering and downpipes are in poor condition and will need to be replaced as water is currently draining onto the original timber frame causing significant damage, especially seen on the south east corner, photo below.

Figure 11: South eastern corner of unit 5

Where subsidence has taken place on the southeast corner a localised footing may be required on the corner to avoid this happening in the future. As the corner has cracked away approximately 0.5m in each direction this will be removed and rebuilt. Crack stitching may also be used, subject to the engineer's approval, in order to strengthen the corner and keep it aligned with the surrounding brickwork. This is done by inserting small metal rods into the joints, then covered by lime mortar.

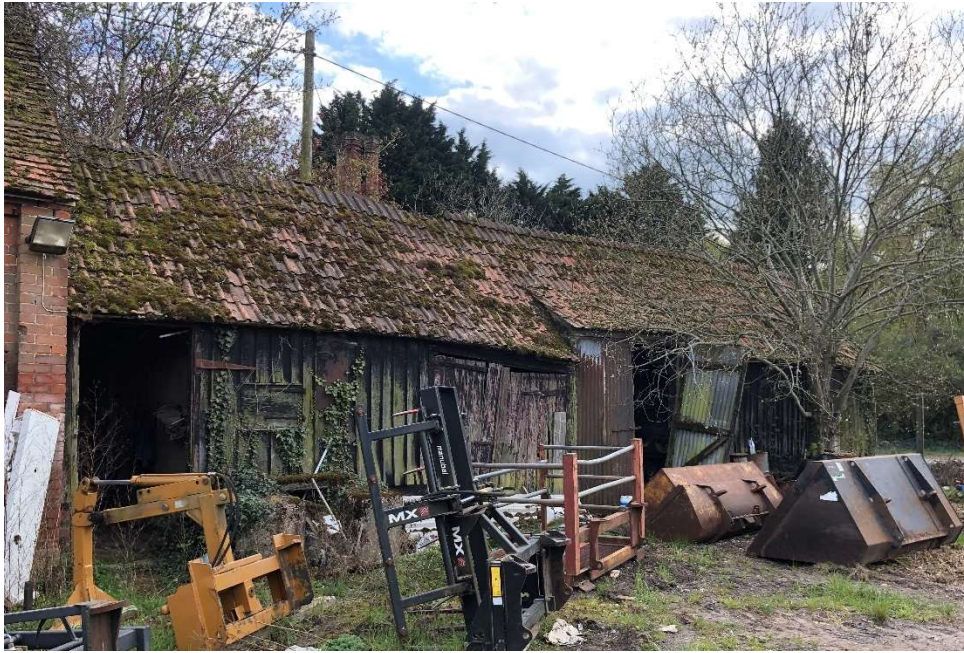
Figure 17: Unit 1 west lower timber section to be replaced

To the western lower section of unit 1 as well as Unit 3, as noted in the MLM structural report and BJHC historic reports, the softwood 20<sup>th</sup> century timber has been allowed to decay to an unsafe and unrepairable state. These sections of the buildings will be rebuilt using standard modern construction methods, to engineers' details, but keeping the same external form and appearance. Both buildings will be timber clad and have heritage clay tiles to match the adjoining roofs. Any roof trusses that are able to be preserved will be set aside and cosmetically reinstated once the new structures have been installed.

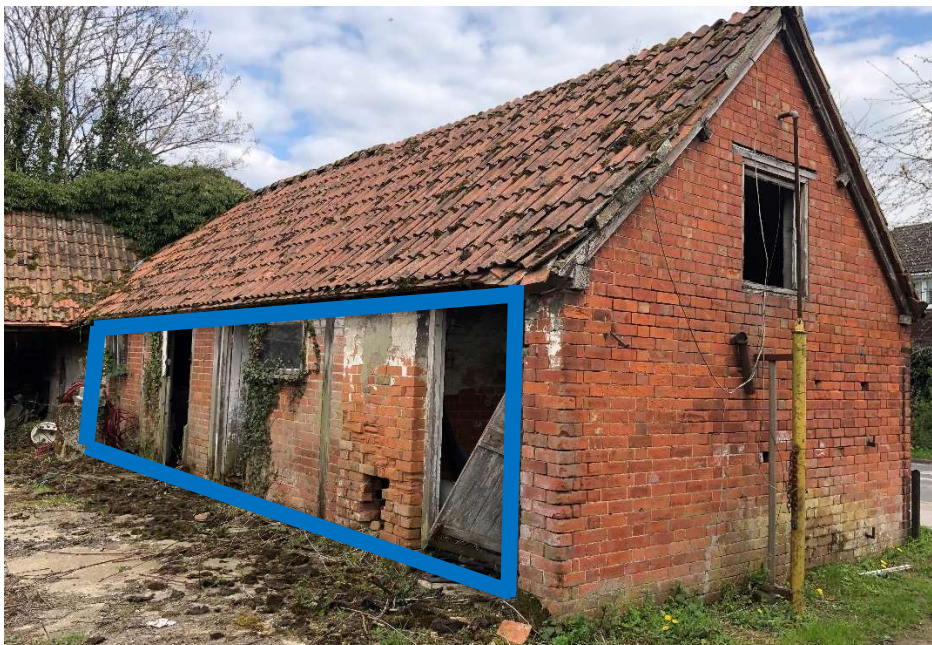
As noted in BJHC's report the courtyard side northern wall to unit 4 was originally an open cart shed style that was later infilled in patched cement brickwork with a range of different style bricks. The section is single thickness brickwork rather than the traditional solid brick wall surrounding it. This will be removed and replaced with bricks to match the surrounding solid brick wall in lime mortar with new openings to suit the approved plans. Area noted in blue on the photo below.

Figure 18: Unit 4 North elevation to be replaced

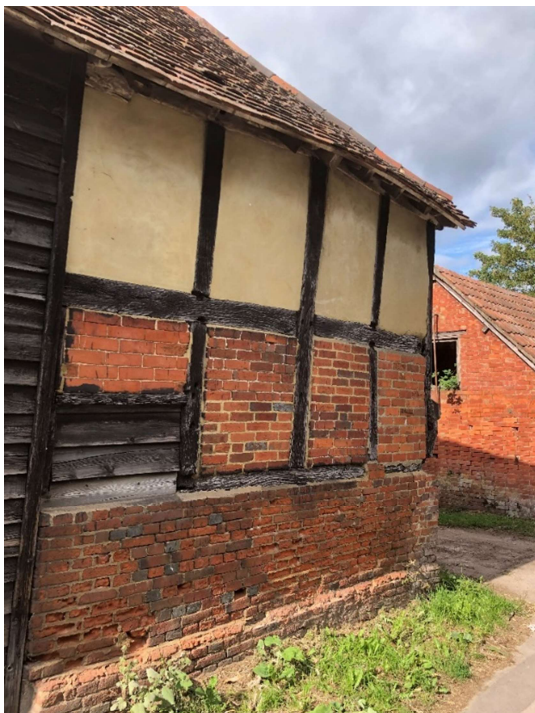
Below is a photo of the southern elevation where the lime render has been replaced with cement render panels. It is proposed that the four brick panels below are replaced back to their original wattle and daub make up so that the surrounding timber frame can move and breath better.

Figure 29: Photo of unit 5 south east corner panels

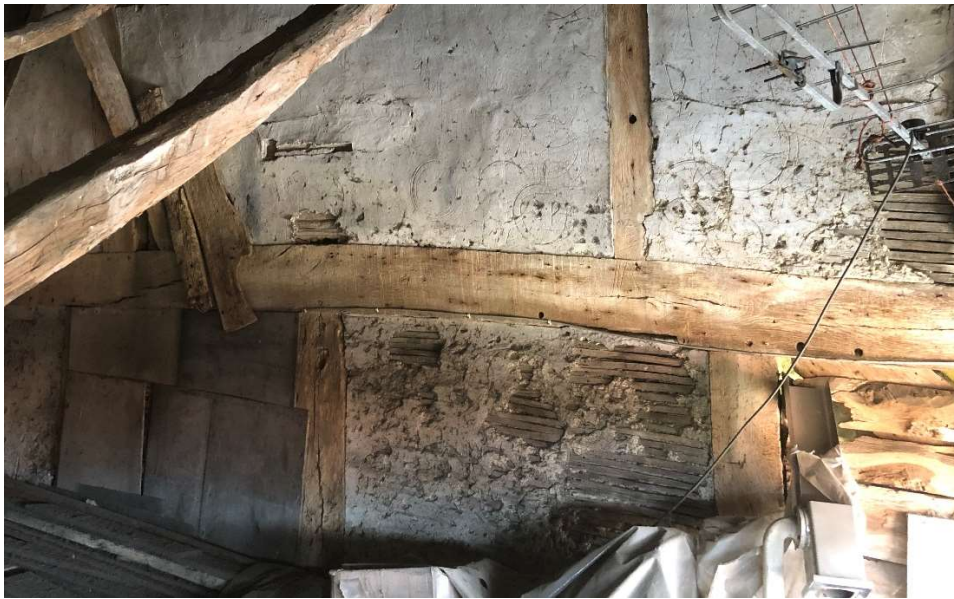
Below is a photo of the area on the first floor, eastern bedroom side of the wattle and daub plasterwork to be repaired and then encased for protection. The lower panel is in a poor condition.

Figure 30: Photo of unit 5 bay 7 internal lime plaster

Internally there are also wattle and daub panels to the first floor over the mezzanine between bays six and seven. These will be sympathetically repaired where they are in poor condition in lime plaster in order to preserve as much historic fabric as possible. The western face will remain exposed and limewash applied as a finish. Due to the Eastern face being close to ground level on the first floor and having apoptotic witch marks in the areas in poor condition will be repaired and recorded and then a new timber stud wall will be installed in front of the wattle and daub so that it is encased and protected.

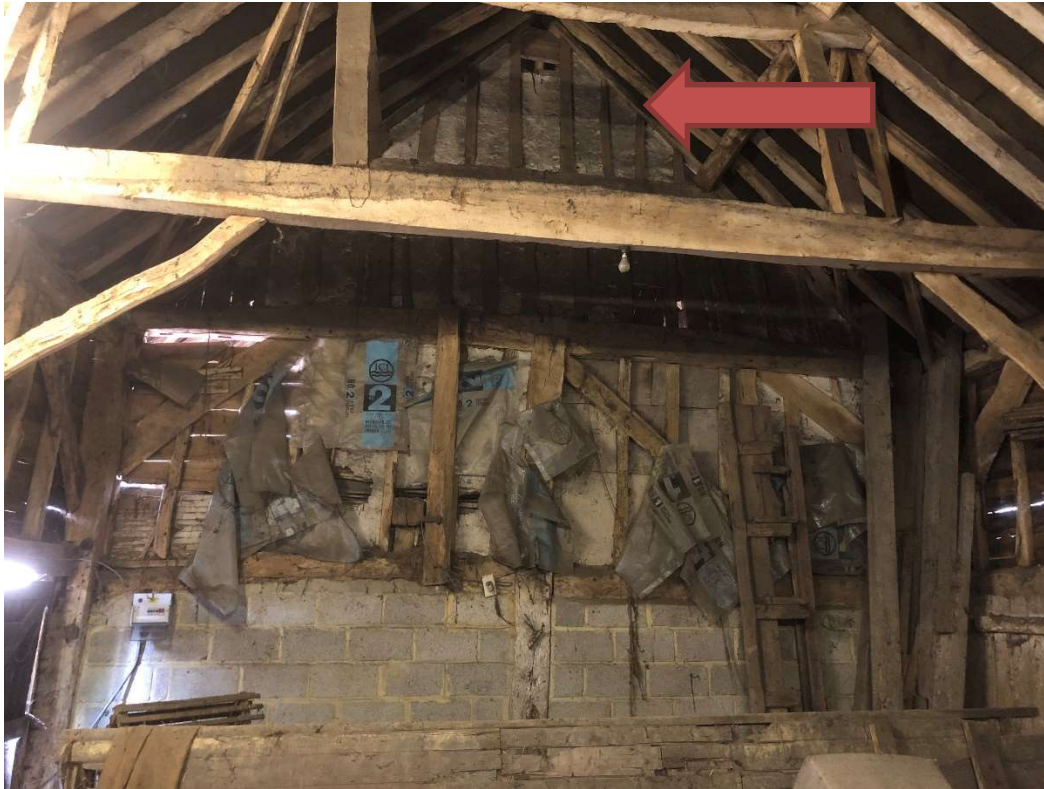
The photo below is of the internal western wattle and daub panel that will be repaired in lime and left exposed.

Figure 31: Photo of unit 5 Bay 7 internal wall to remain in situ

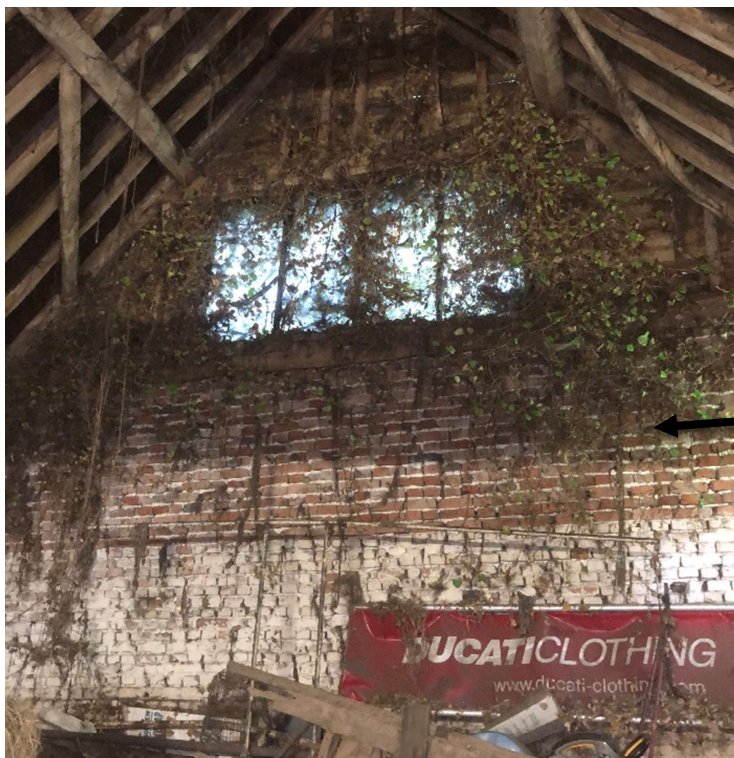
The photo below shows the western elevation brick wall from the inside of the barn, this is where the temporary braces will be installed whilst the timber frame structure is removed.

Figure 33: Photo of unit 5 western brick wall as existing

Structural studwork and racing to existing brick wall being left in situ.

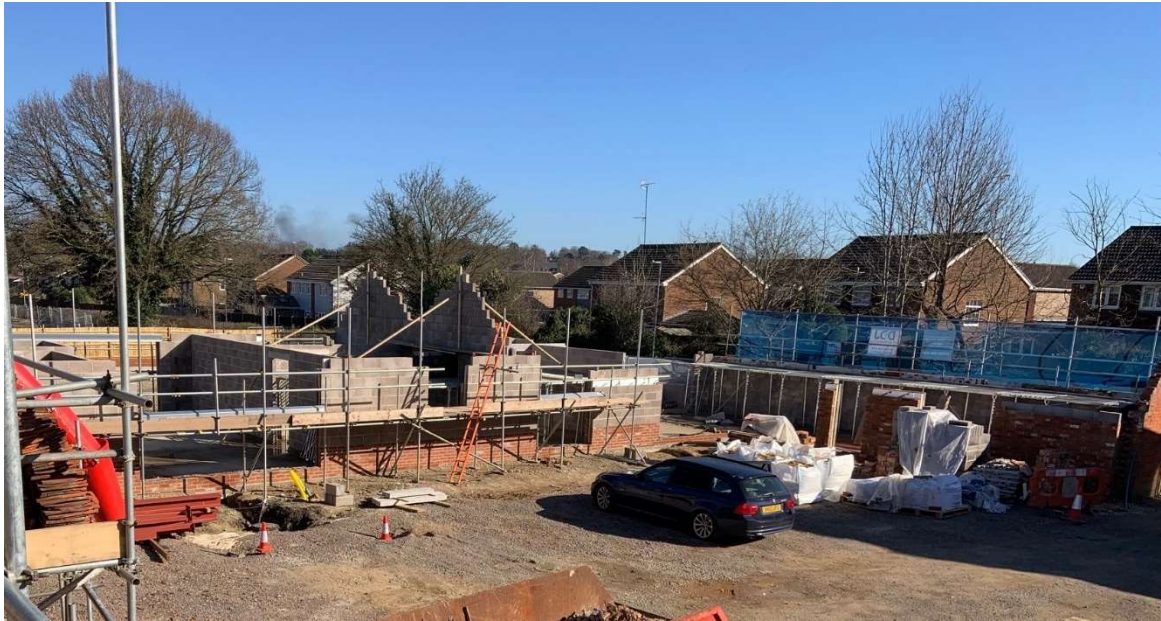
The timber structure of Unit 3 has been removed, replaced and extended as per the plans. As can be seen on the photo below the new block walls are up to roof height, ready for the new roof to be installed, in the same profile as the previous structure. As modern fluted tiles had been used as the roof covering these have not been saved and will be replaced by a heritage plain clay tile to match the surrounding historic roofs. Once the windows and doors are installed the blockwork will then be clad in feather edge timber as originally intended.

Figure 36: Units 3 and 4 current photograph

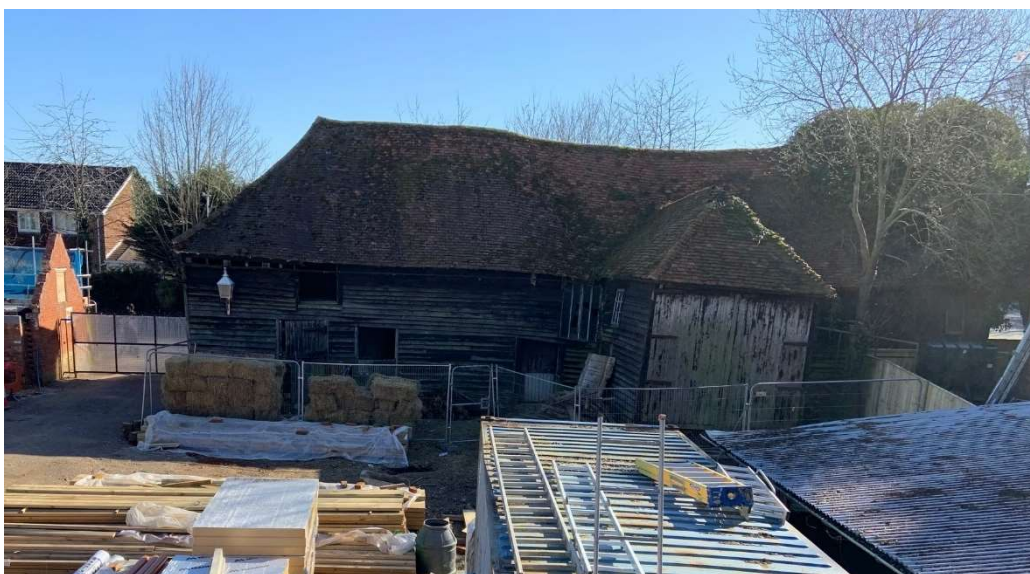
The structural timber studwork lining has been installed to the existing brickwork wall internally on the West elevation in order to protect the brickwork whilst the timber frame repairs are completed.

Figure 37: Unit 5 current photograph
