**Structural Survey**

**Ashridge Farm**

**Warren House Road, RG40 5QB**

**Document Ref:** NA/667422/RP  
**Revision:** 2  
**Date:** 26 July 2016

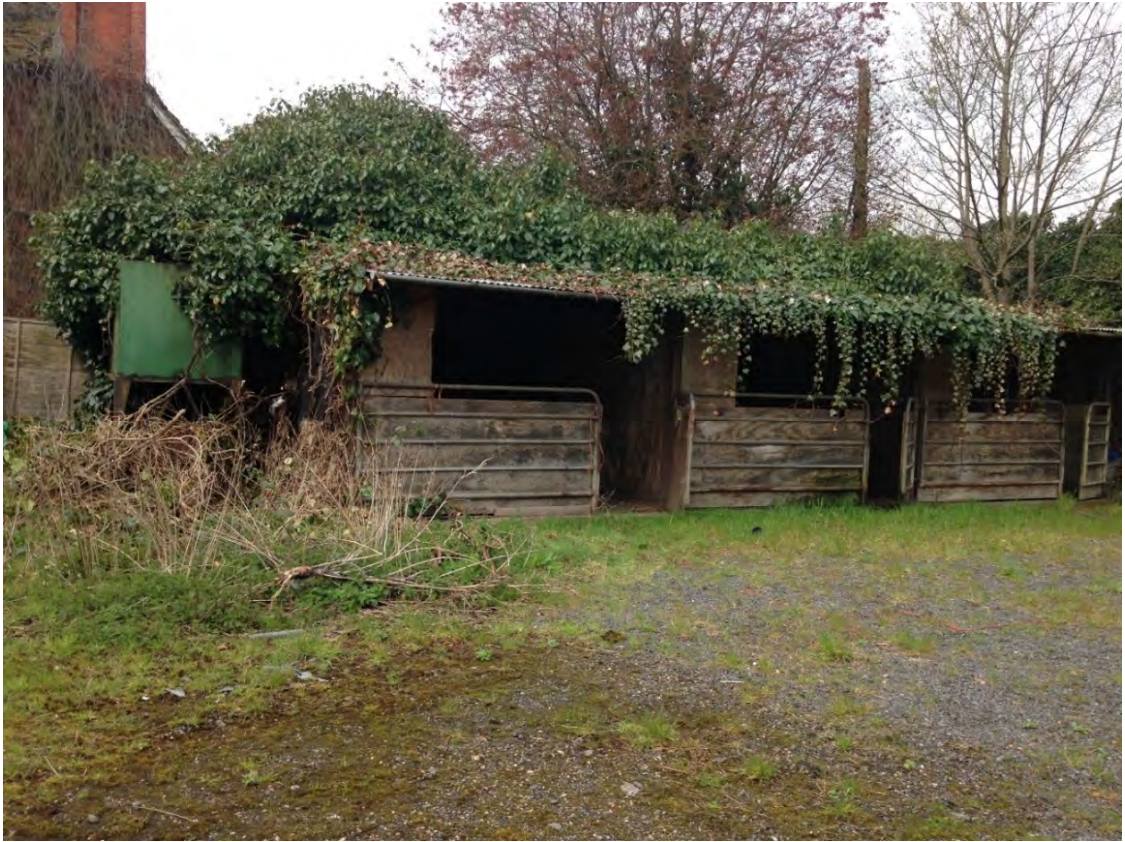
**BUILDING 'B'**

Walls: blockwork dado walls – approximate 1350mm high with timber studs over to the underside of roof level, the walls are covered with bituminous type corrugated sheets. The wall cladding / covering is in very poor condition and requires to be replaced to ensure the building is watertight. Due to either vehicular impact or vegetation around the external perimeter of the building the masonry walls have severely cracked and dislodged from their original position. The walls do not appear to have damp proof course.

Roof: Steel rafters to create mono pitched roof. The roof is covered with a galvanised corrugated metal sheet covering. The steel rafters and posts show signs of weathering as they are exposed to the elements and the steelwork requires a suitable protective coating applied in order to maintain the structural integrity over time. We would normally expect all 'external' steelwork or that exposed to the elements to be hot dip galvanised.

Other: The guttering to the building is in a poor condition, generally leaving the water to drain on the fabric of the building.

In summary the fabric of the building is considered to be in a poor condition.

Due to the form of construction used and the condition of the building we would not recommend that this building is refurbished as part of a redevelopment / conversion to domestic use.

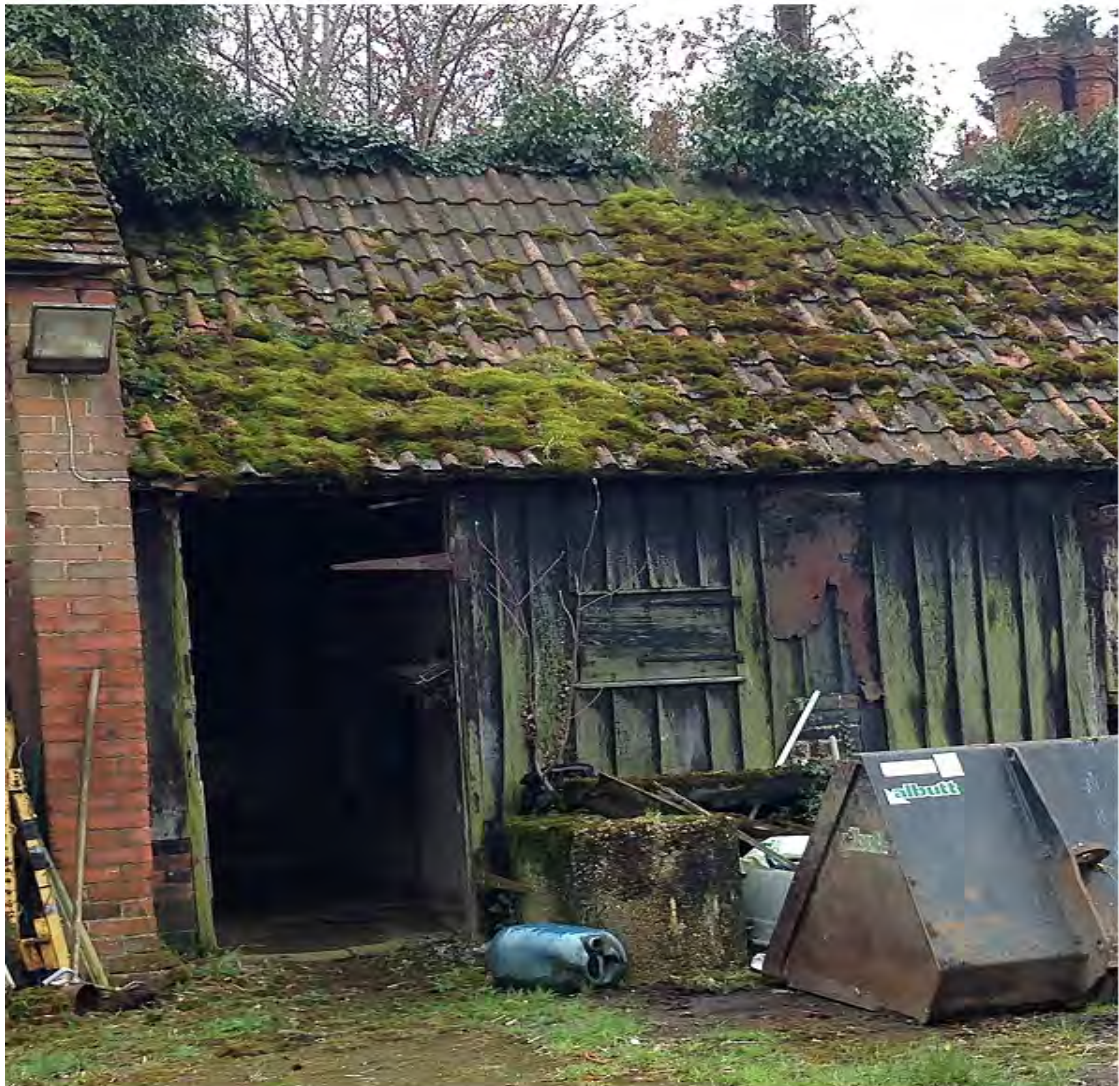
**BUILDING 'C'**

**Walls:** brickwork dado walls –approximate 600mm high with timber panel boarding over the dado walls. The timber cladding on the walls appears to be in very poor condition. The brick masonry dado walls appear to be showing signs of damp and are cracked in various locations. The walls do not appear to have damp proof course.

**Roof:** Timber rafters to create pitched roof with corrugated clay tiles. The majority of the roof is covered by the over grown vegetation and as such has restricted our observations here. The roof does not appear to have felt layer underneath the tiles in line with what would be expected in modern construction. Numerous tiles are either missing or have been displaced particularly near the ridge level allowing the water to ingress in the structure. Vegetation has encroached into the building due to lack of any ongoing maintenance.

**Other:** The guttering is missing leaving the water to drain on the fabric of the building. This has damaged the external wall cladding severely and the cladding and could affect the building structure if allowed to continue. The ceiling is timber boarded and has missing or damaged boards in various locations, generally the structure is in need of repair.

In summary the building is considered to be in a generally poor condition.

Due to the form of construction used and the condition of the building we would not recommend that this building is refurbished as part of a redevelopment / conversion to domestic use.

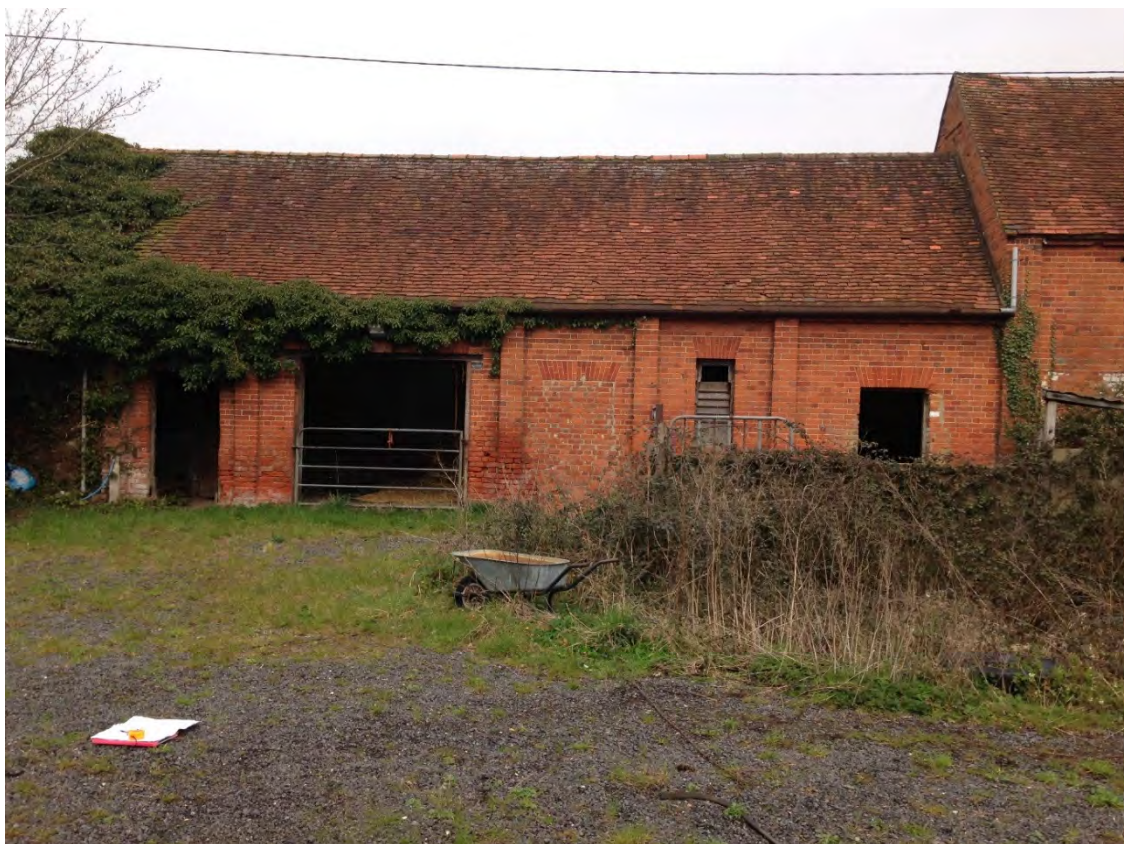
**BUILDINGS 'D' & 'E'**

**Walls:** Load bearing brickwork walls. The walls are weathered and the mortar joints required re-pointing and repairing in some areas. The faces of some bricks in the external walls are eroded and some bricks are missing in several locations due to vehicular impact, building alterations, erosion and weathering effects over the years. There are several pockets formed in the walls due to missing bricks. The walls do not appear to have damp proof course.

The flank wall appears to have two leaves of bricks and one of the leaf is not constructed up to and underside of the roof. The flank wall has been severely cracked and shows signs of bowing. It appears that the one of the flank wall leaf had been repaired but the repair works does not appear to be carried out appropriately while the other leaf has been covered up with 2 ply sheets and that restricted our inspection but the exposed brick work appeared to be in very poor state and was potentially unstable.

The walls around the entrance of the building 'E' appear to have been repaired but these works appear to be of poor standard.

The entrance to the fodder store has steel framed opening. The steelwork is not galvanised and appears to have no significant coating to protect it. The steel frame appears to have been hit by a vehicle at some stage and has been damaged, the vehicular impact has also displaced the bricks over the opening leaving the wall damaged and potentially in an unstable condition.

**Roof:** The main building structure is formed from timber trusses, the pitched roof is covered with 'rosemary' type clay tiles. Part of the roof is covered by the over grown vegetation, as such we could not survey the full roof. The roof does not appear to have a felt layer under the tiles in line with what would be expected with modern construction. There are a number of tiles that are missing or displaced allowing water to ingress into the building.

**Other:** The guttering is missing leaving the water to drain on the structure. The ceilings are lath and plaster ceilings. The ceilings are largely missing from various location.

In summary the building is considered to be in a generally poor condition and repairs are necessary to ensure the longevity of the building and prevent continued decay of the building fabric.

Due to the form and construction of the building we believe that it could be refurbished as part of a redevelopment / conversion to domestic use. The structural issues noted above would need to be addressed plus any works to the building fabric necessary for the building to comply with the Building Regulations and other design standards.

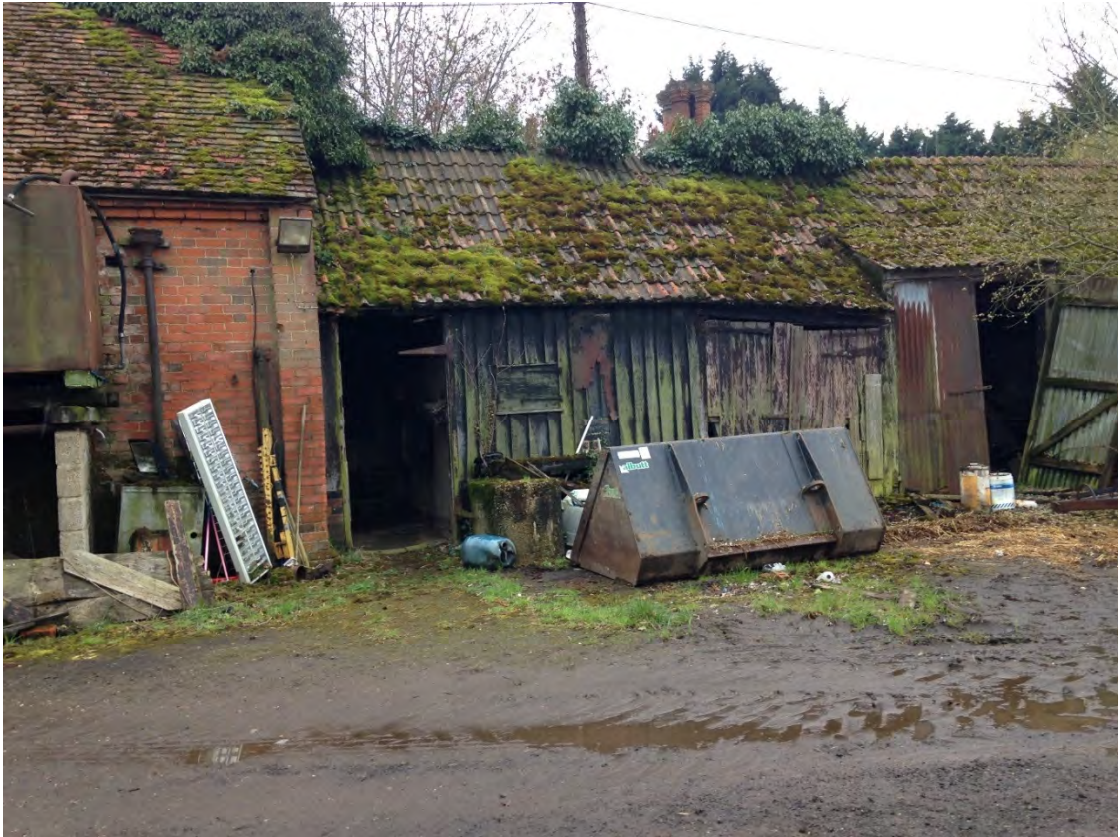
**BUILDING 'J'**

Walls: Timber studs with timber cladding on the walls. The walls appear to be in very poor state of maintenance and requires to be replaced with new. Part of the building was inaccessible that has restricted our inspection.

Roof: Timber rafters to create pitched roof with corrugated clay tiles. Part of the roof is covered by the over grown vegetation. The roof does not appear to have felt layer in line with the modern construction. Numbers of tiles are missing or displaced near the ridge level allowing the water to ingress in the structure. The vegetation has encroached in the building due to lack of maintenance works. The roof shows significant signs of sagging, this is due to decayed timber rafters and support members, bearing beams/posts.

Other: The guttering is in a poor condition.

In summary the building is considered to be in a very poor condition.

Due to the form of construction used and the condition of the building we would not recommend that this building is refurbished as part of a redevelopment / conversion to domestic use.

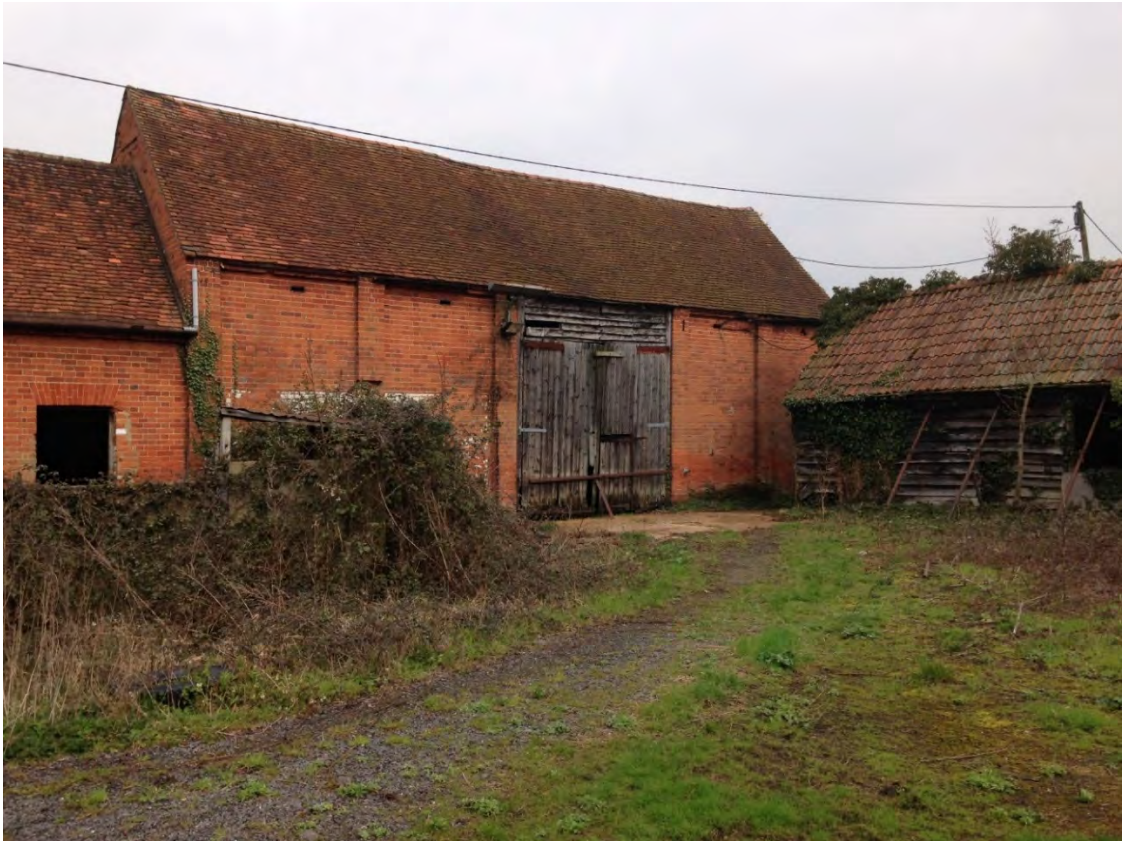
**BUILDING 'K'**

**Walls:** The building is constructed of load bearing brickwork walls. The mortar joints in the front elevation external walls are in need of re-pointing in several locations due to erosion and weathering. One of the brick piers in the front elevation has several bricks missing. The gable wall also appears to have poor mortar joints and has several weathered / eroded bricks.

The wall sections supporting the timber trusses at the underside of roof level / eaves generally appear to be bowed and cracked. One of the wall corner supporting the timber truss appears to be severely cracked and on the verge of collapse.

**Roof:** Timber trussed, pitched roof with rosemary clay tiles as a roof covering. Part of the roof is covered by the over grown vegetation and as such we could not assess the condition of the roof covering in this area. The roof does not appear to have an underfelt layer in line with the modern construction. Roof tiles near to the rear door and at the ridge levels are missing allowing the water to ingress in the structure. There are several other locations the tiles are dislocated for the original position. Timber purlins and cut timber members appear under sized by modern standards and shows signs of excessive deflection and this has lead the roof to sag.

The timber frame creating the entrance to the building appears to be undersized and shows signs of significant deflection. The timber columns forming the part of the frame are decayed and appear to be in a poor condition.

The timber framed mono-pitched extension at rear appears to be in a poor condition.

In summary the building is considered to be in a poor condition for its age and type and is in need of maintenance / repair works.

Due to the form and type of construction used in the building we believe that it could be refurbished as part of a redevelopment / conversion to domestic use. The structural issues noted above would need to be addressed plus any works to the building fabric necessary for the building to comply with the Building Regulations and other design standards.

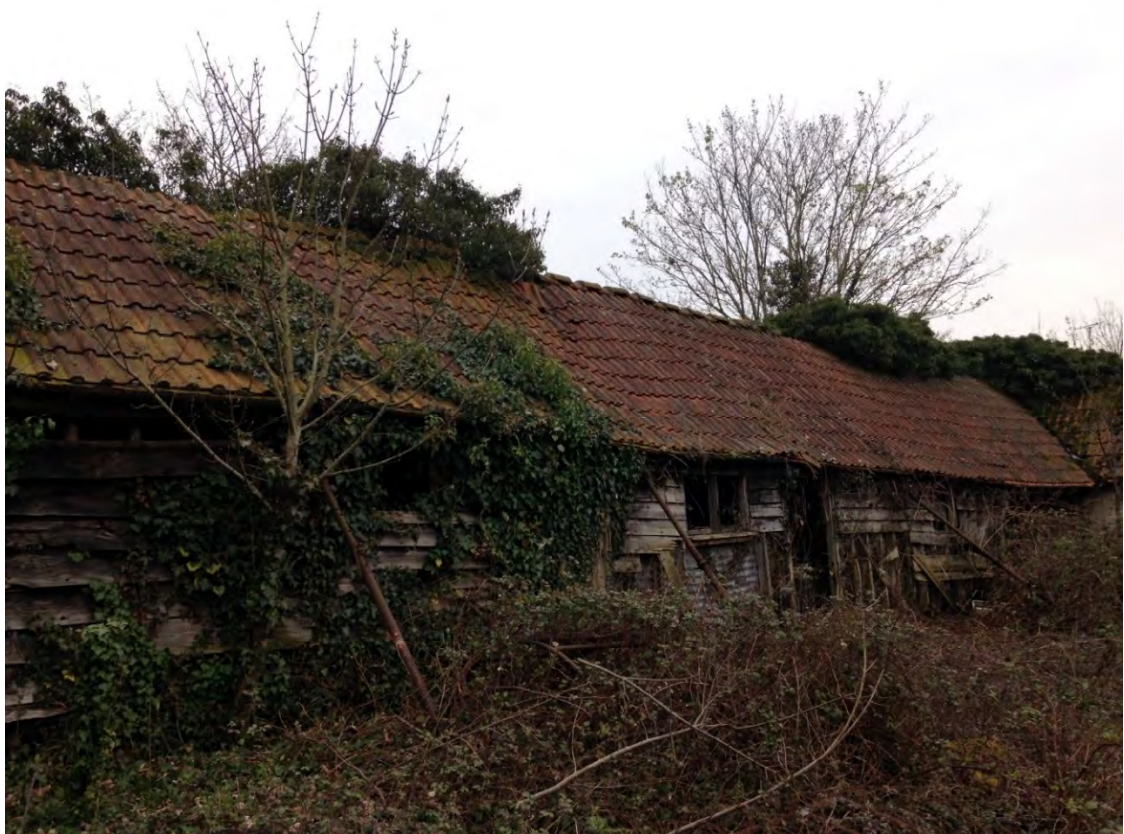
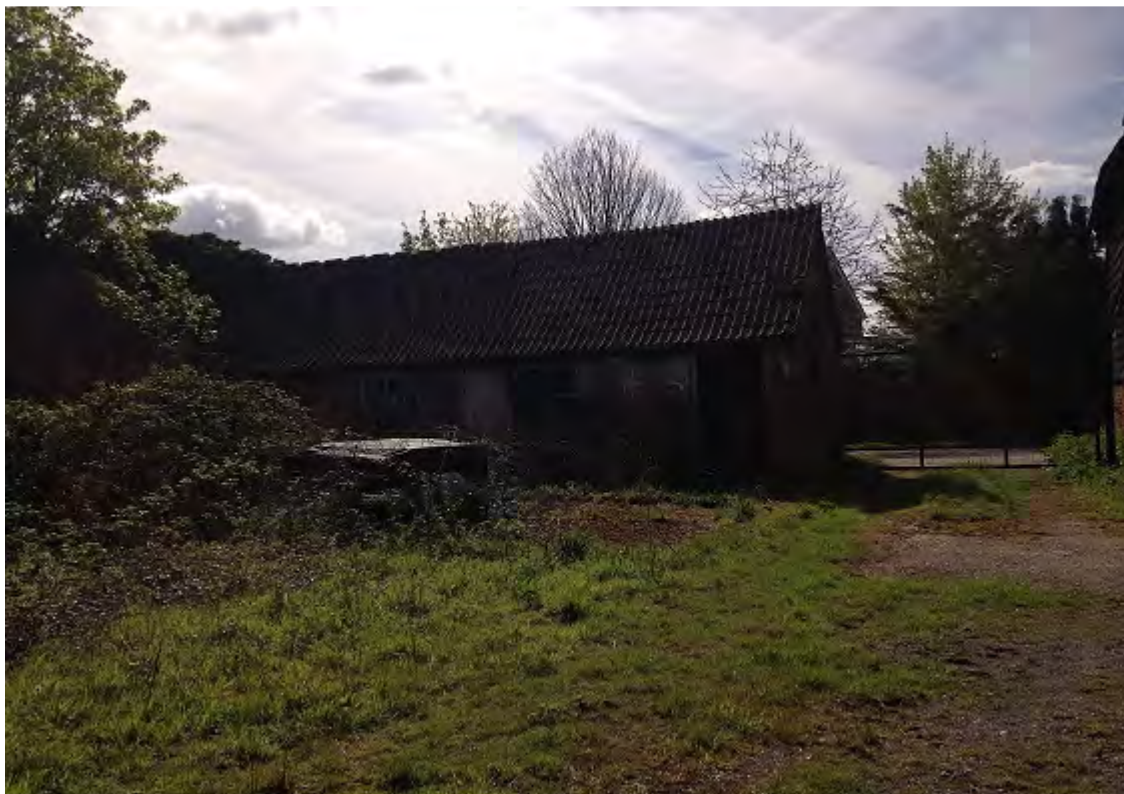
**BUILDING 'L'**

The timber framed structure is currently propped along its entire length. Due to over grown vegetation and is potentially unstable; as such we have not entered in the building. From our external observations, due to the form and condition of the building we would not recommend that this building is refurbished as part of a redevelopment / conversion to domestic use.

**Walls:** The building is constructed of load bearing brickwork walls. The mortar joints in the external walls are in need of re-pointing in several locations due to erosion and weathering. Left hand side of the building is covered with overgrown vegetation and that had limited our survey to inspect the wall externally.

**Roof:** Timber rafters to create pitched roof with corrugated clay tiles as a roof covering. The roof does not appear to have an underfelt layer in line with the modern construction. Several Roof of tiles at the ridge levels are missing allowing the water to ingress in the structure. There are several other locations the tiles are dislocated for the original position. Timber purlins and cut timber members appear under sized by modern standards and shows signs of deflection and this has lead the roof to sag.

In summary the timber framed building is considered to be structurally unstable. Due to the form and condition of the building we would not recommend that this building is refurbished as part of a redevelopment / conversion to domestic use. On the other hand the load bearing masonry building could be refurbished as part of a redevelopment / conversion to domestic use. The structural issues noted above would need to be addressed plus any works to the building fabric necessary for the building to comply with the Building Regulations and other design standards.

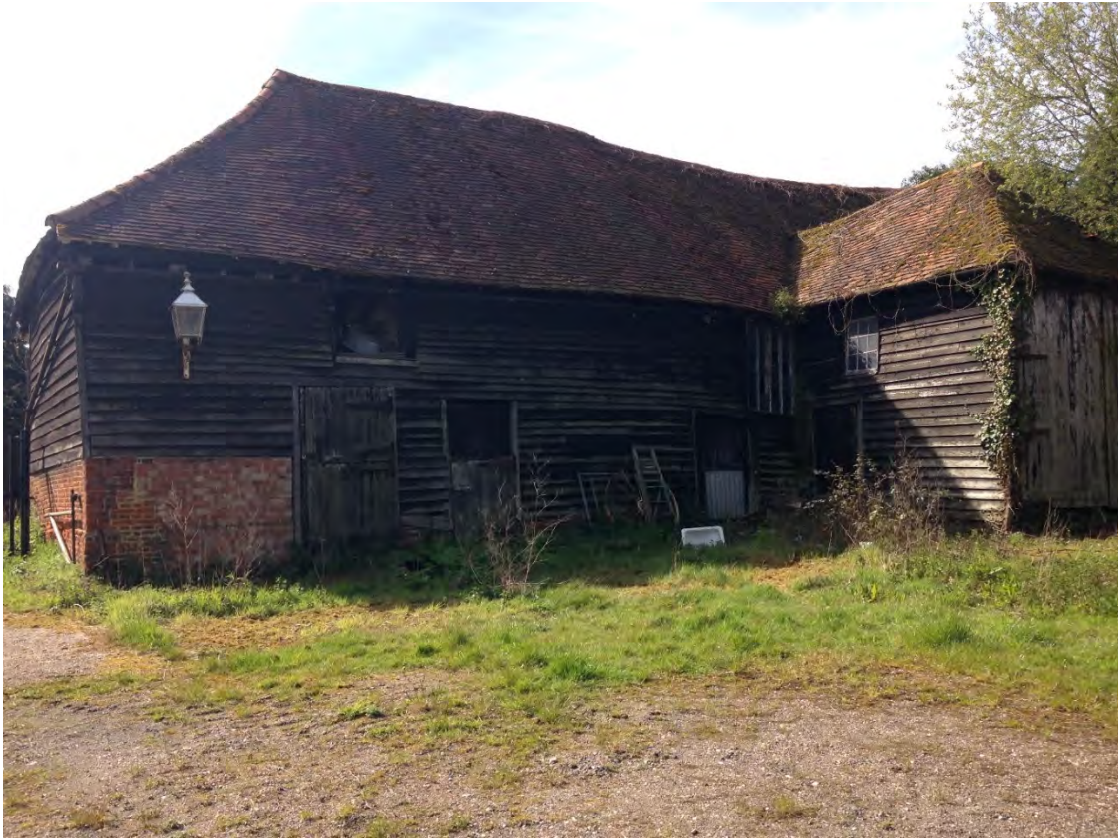
**BUILDING 'M'**

Walls: Part timber, part brick wall construction. The dado walls appeared to be repaired in the past which appear to be of poor standard. The walls do not appear to have damp proof course.

Gable end of the timber cladded wall appears to be bowed. The timber cladding is in a poor condition and have missing timbers in various locations leaving the timber walls exposed to external elements / weathering.

Roof: Pitched roof with rosemary clay tiles. The hip ends and the ridge of the roof are sagging. From what could be gleaned externally the roof structure appears to be in poor condition.

Other: The guttering is missing in part. The timber members forming the structure appear to be decayed and appears to be in poor condition.

Due to the form and type of construction used in the building we believe that it could be refurbished as part of a redevelopment / conversion to domestic use. We would need to gain access to the building in order to survey the building and comment upon its condition structurally. Any works to the building would need to address the fabric of the building to ensure conformance with the Building Regulations and other design standards.

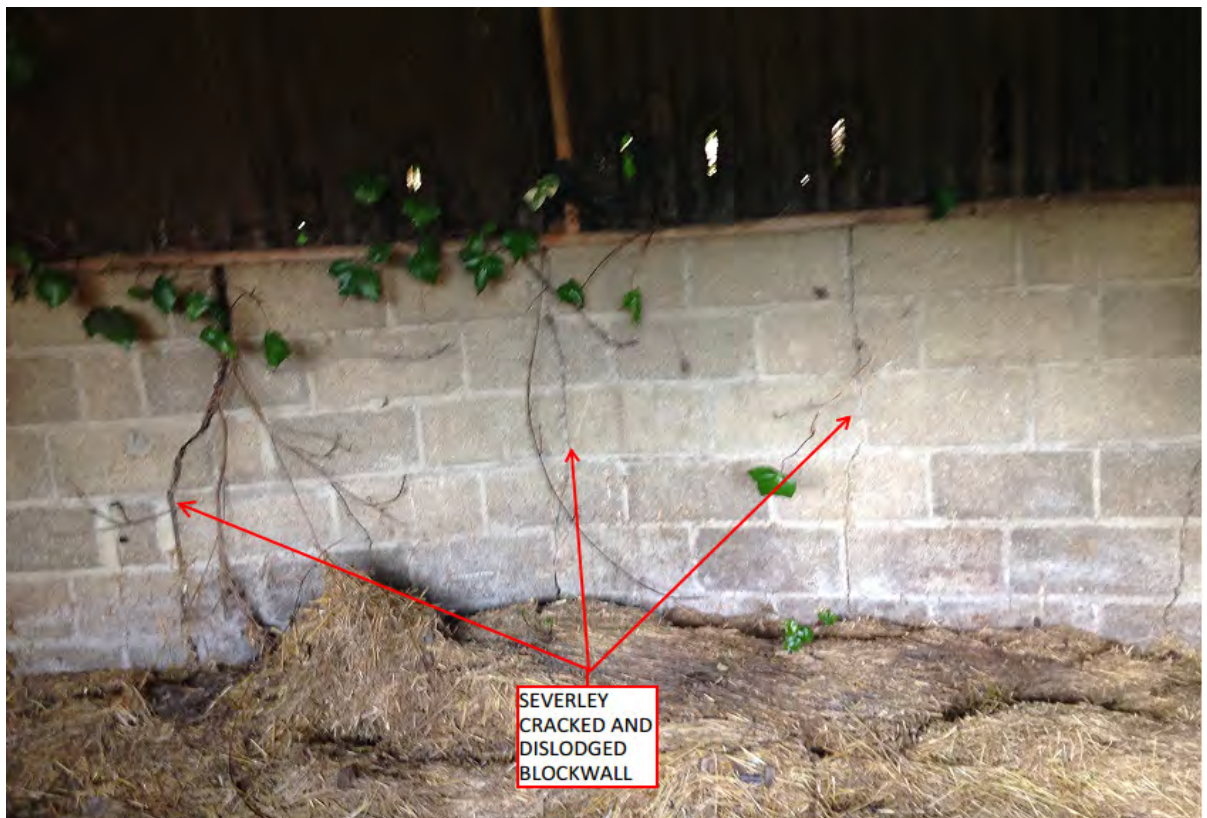
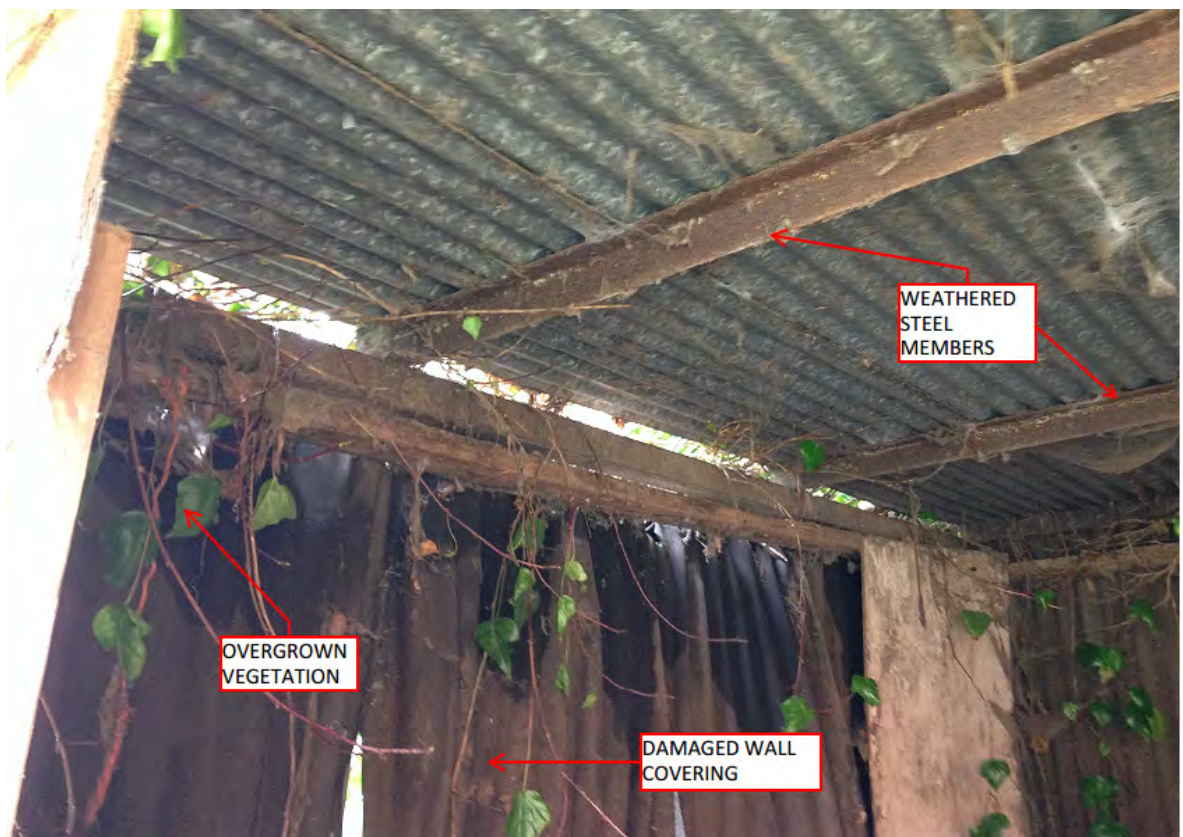
**DEFECTS OBSERVED IN BUILDING 'B'**

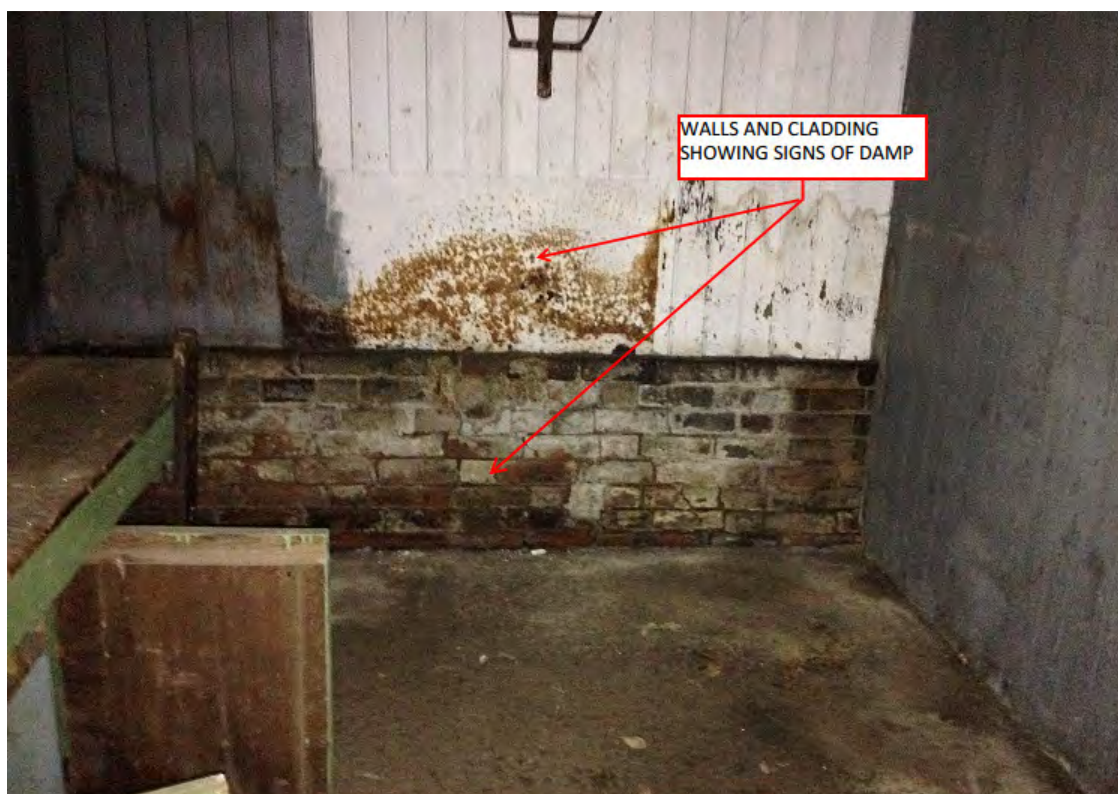
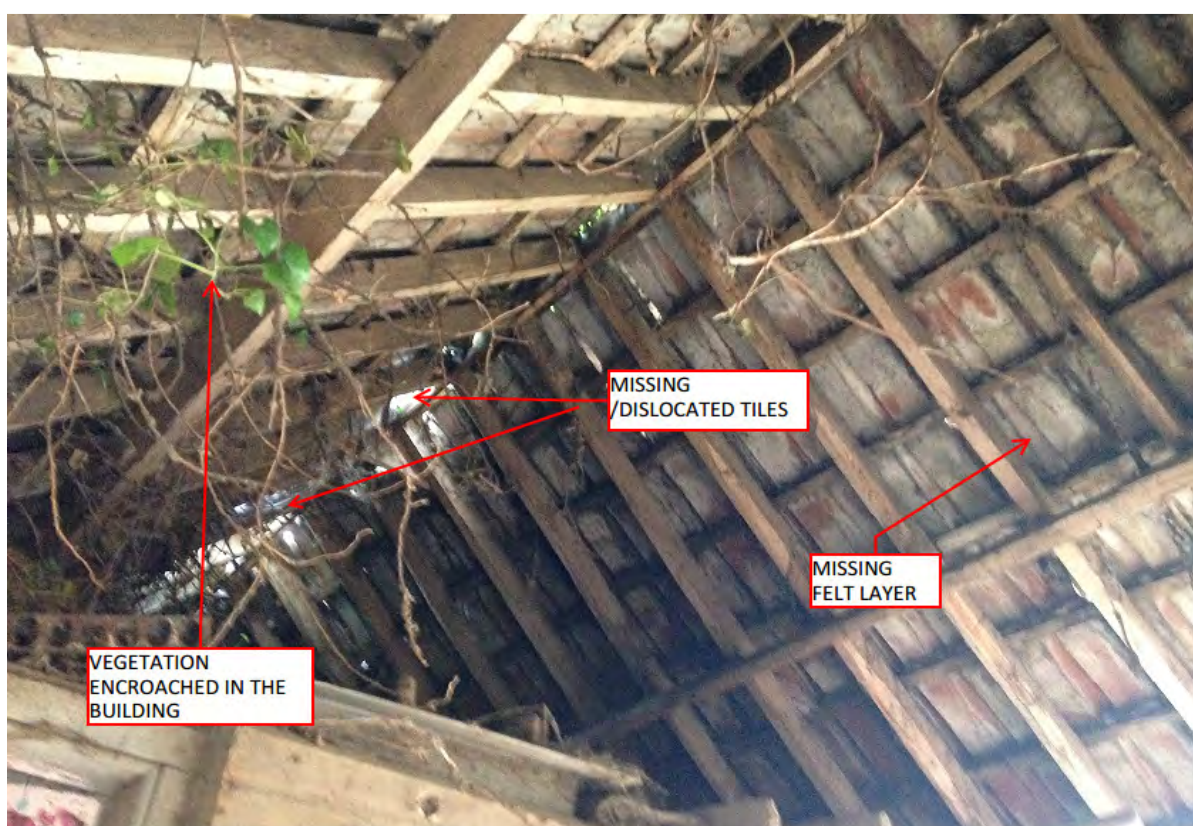
**DEFECTS OBSERVED IN BUILDING 'C'**

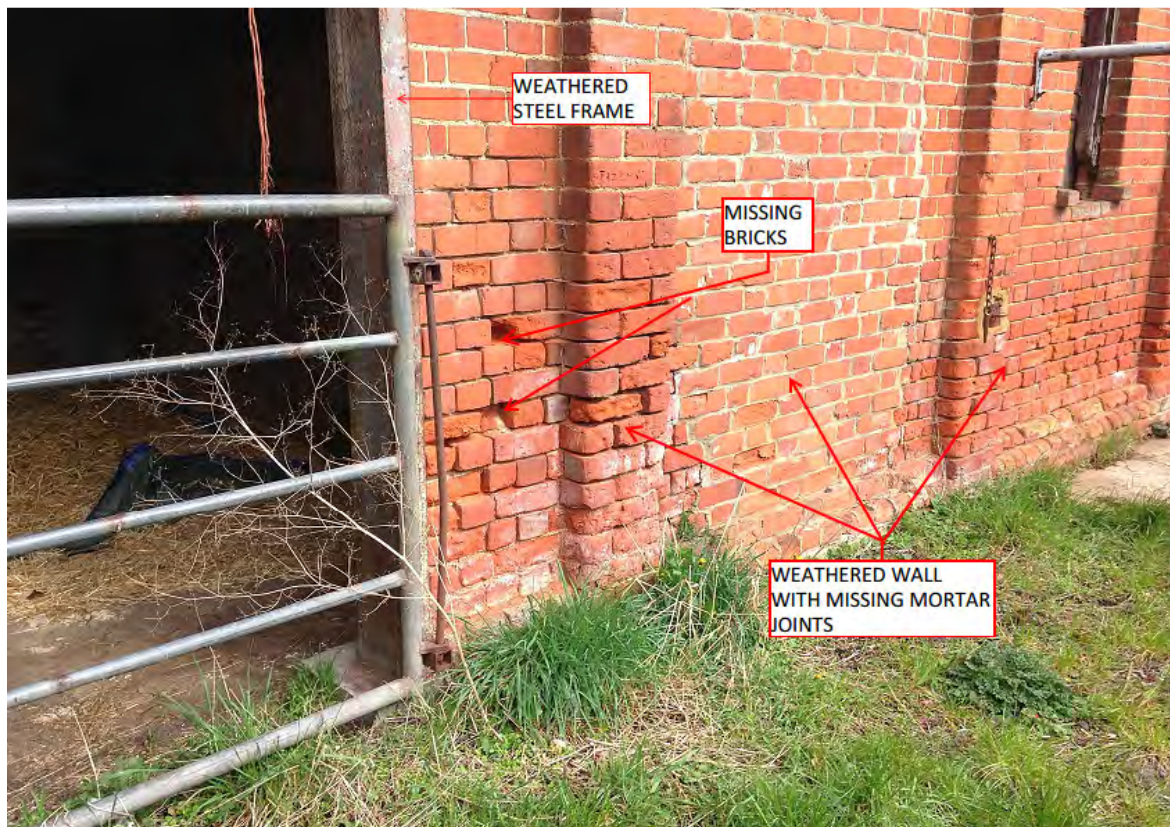
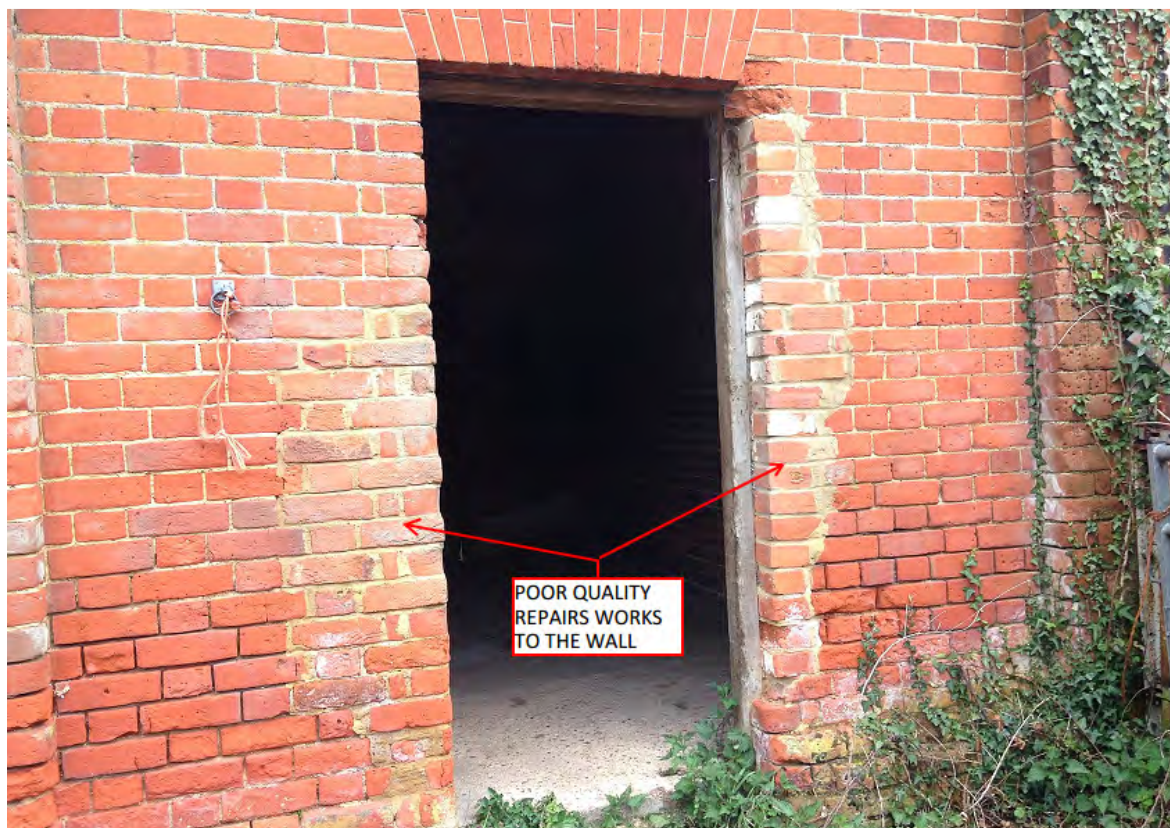
**DEFECTS OBSERVED IN BUILDING 'D' & 'E'**

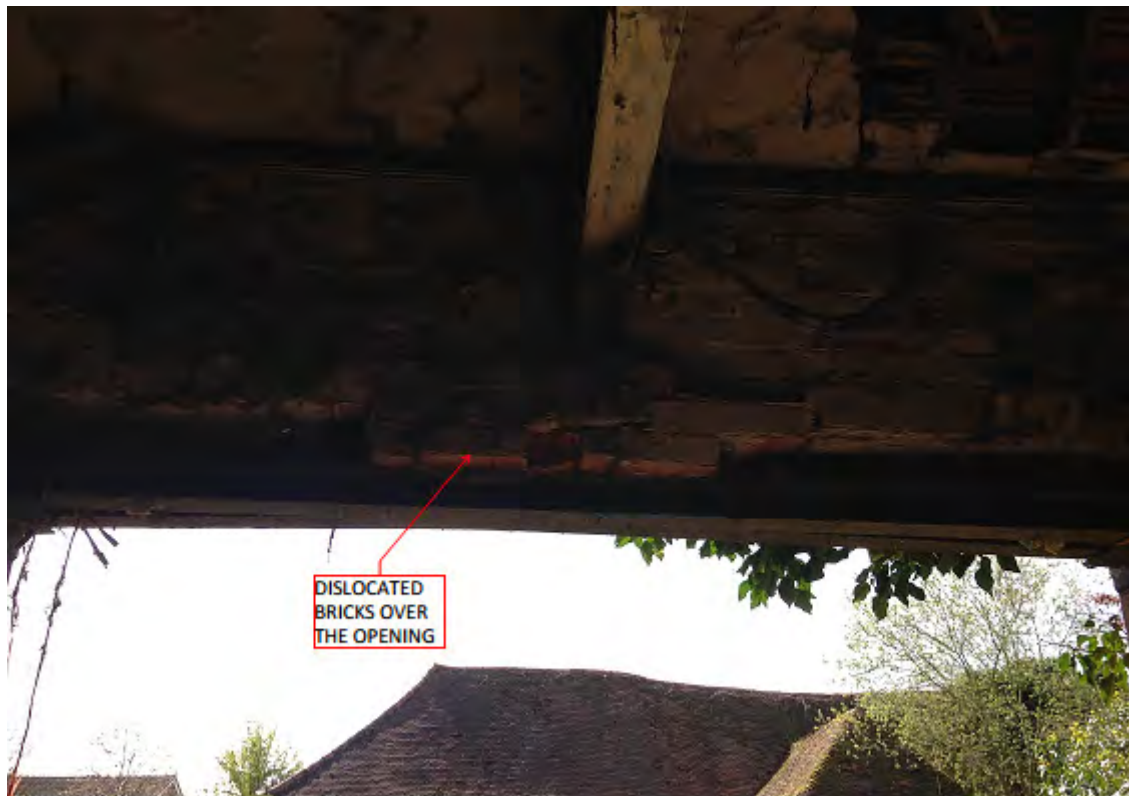
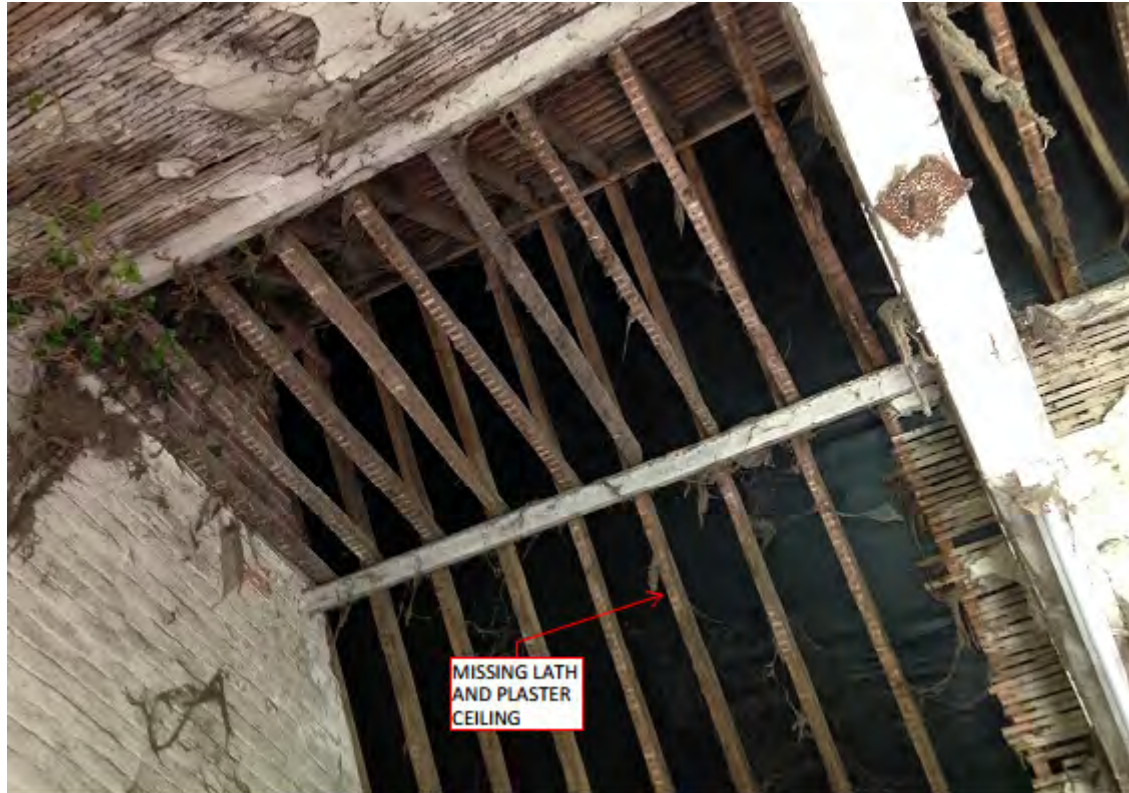
**DEFECTS OBSERVED IN BUILDING 'D' & 'E'**

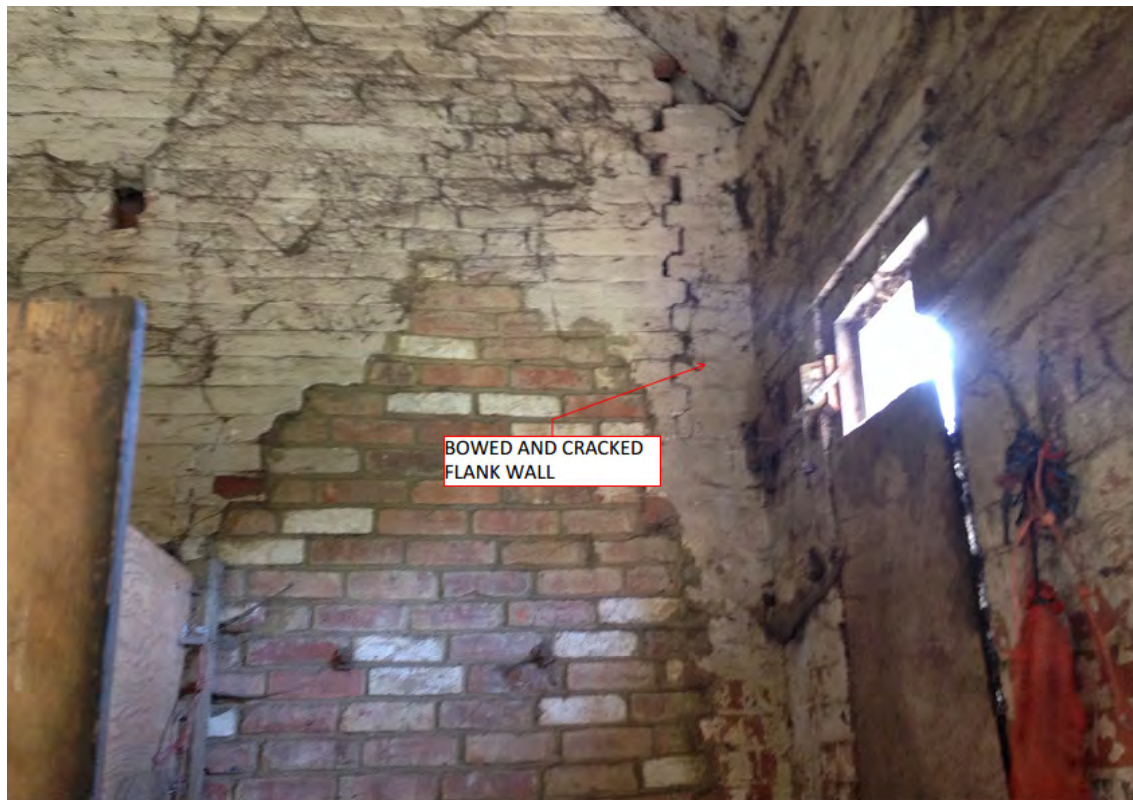
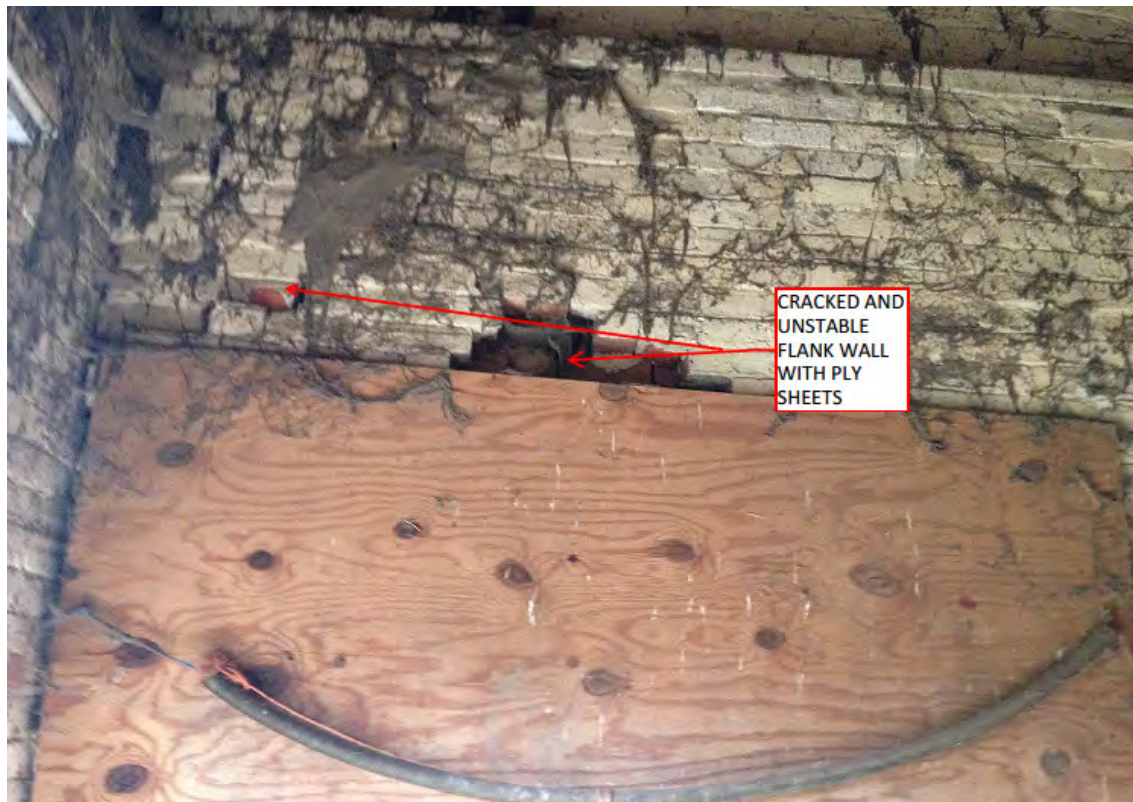
**DEFECTS OBSERVED IN BUILDING 'D' & 'E'**

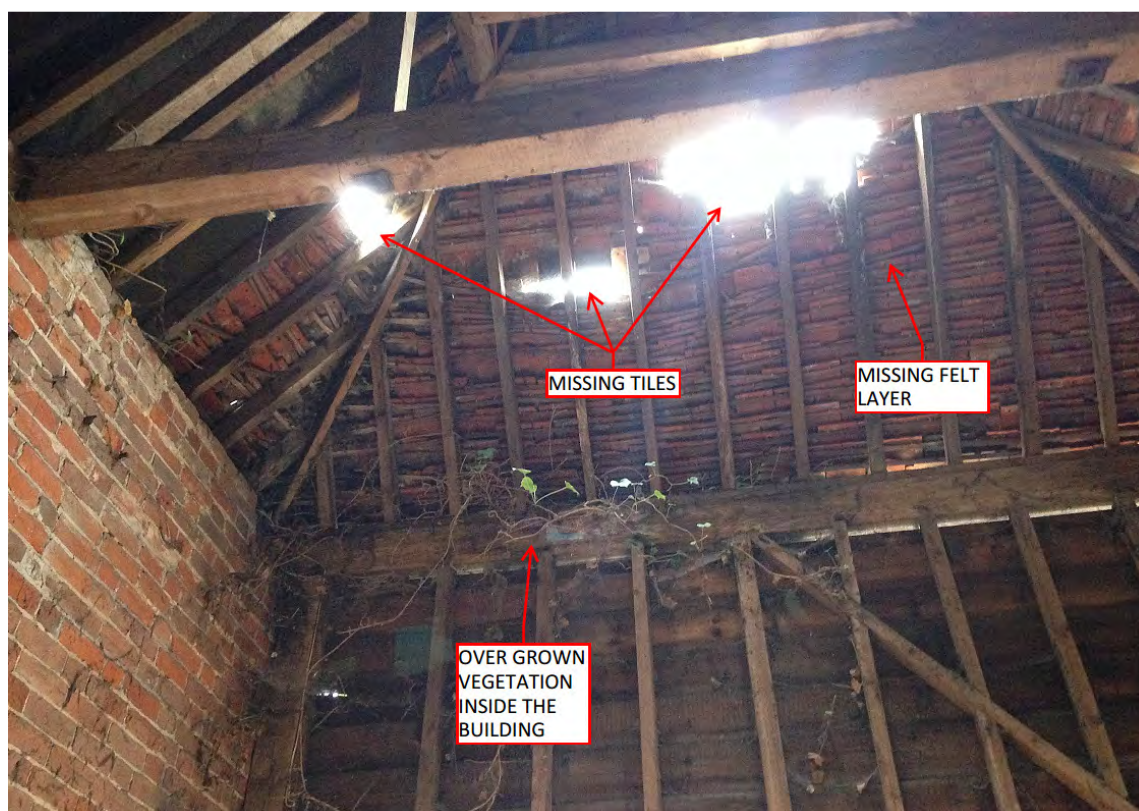
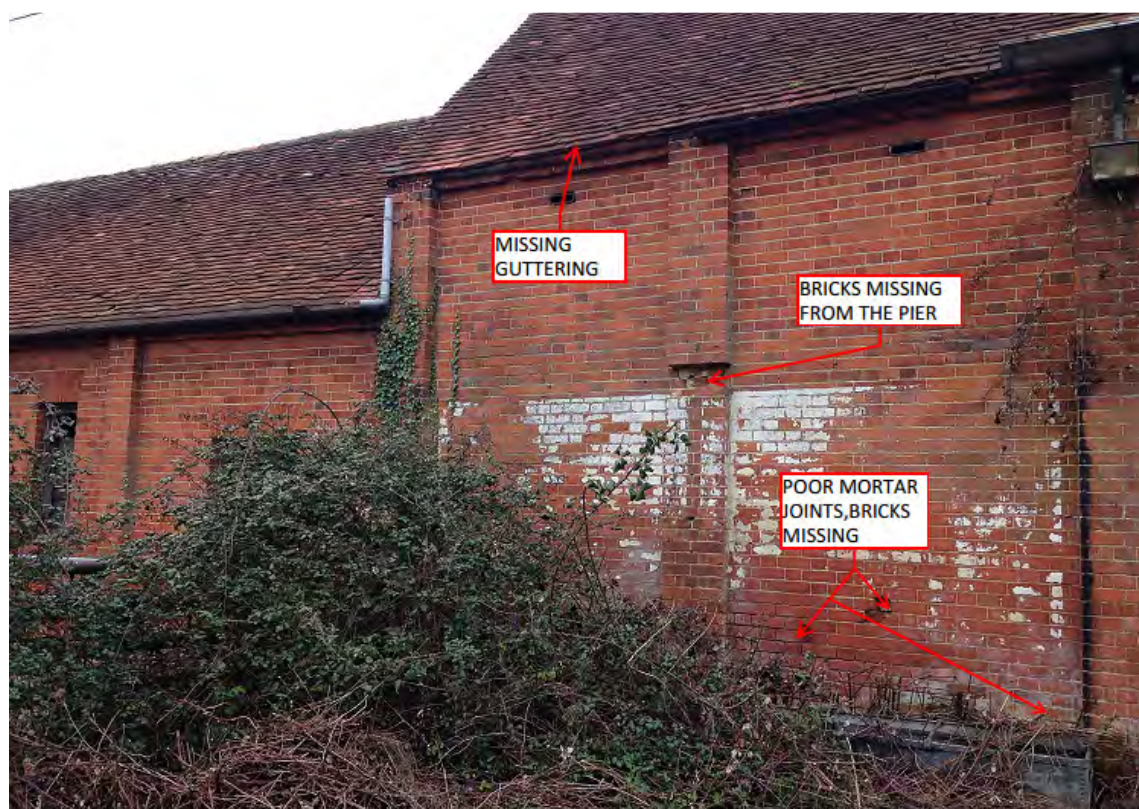
**DEFECTS OBSERVED IN BUILDING 'K'**
