**Structural Survey**

**Ashridge Farm**

**Warren House Road, RG40 5QB**

**Document Ref:** NA/667422/RP  
**Revision:** 2  
**Date:** 26 July 2016

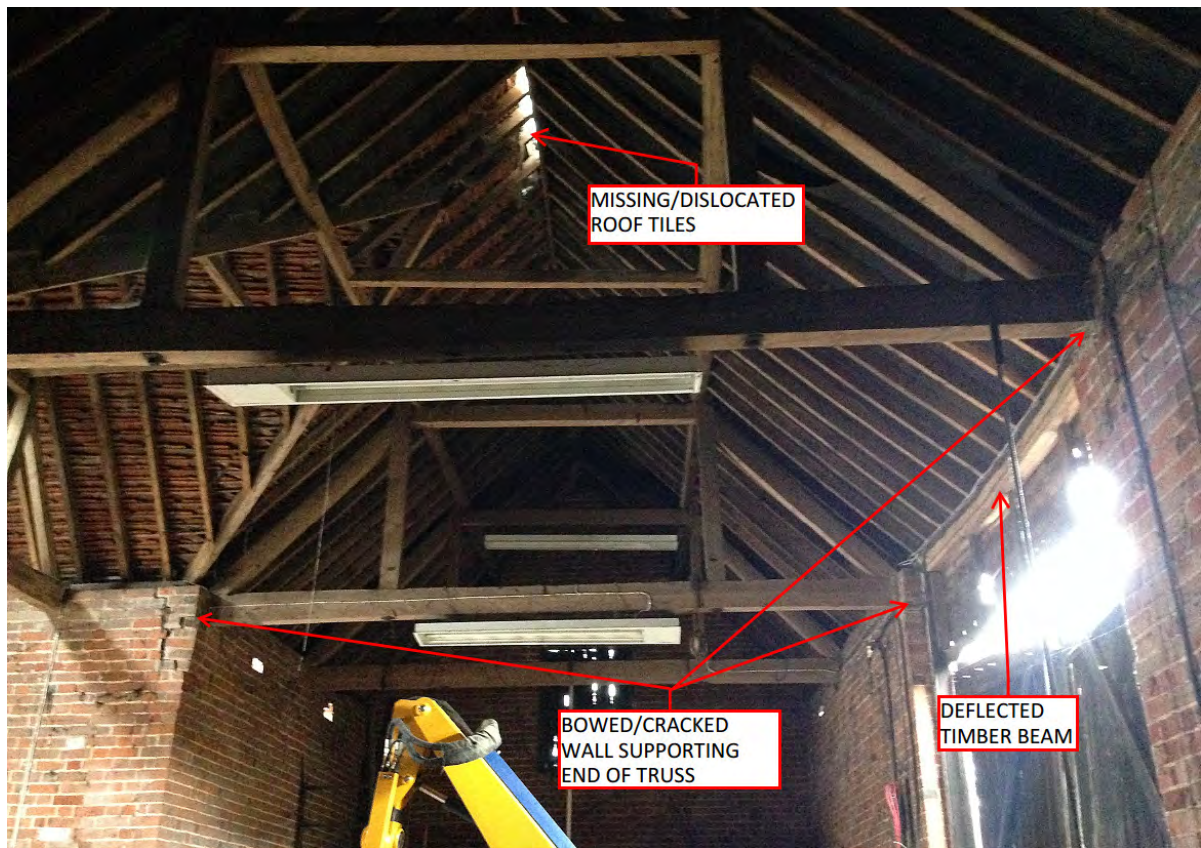
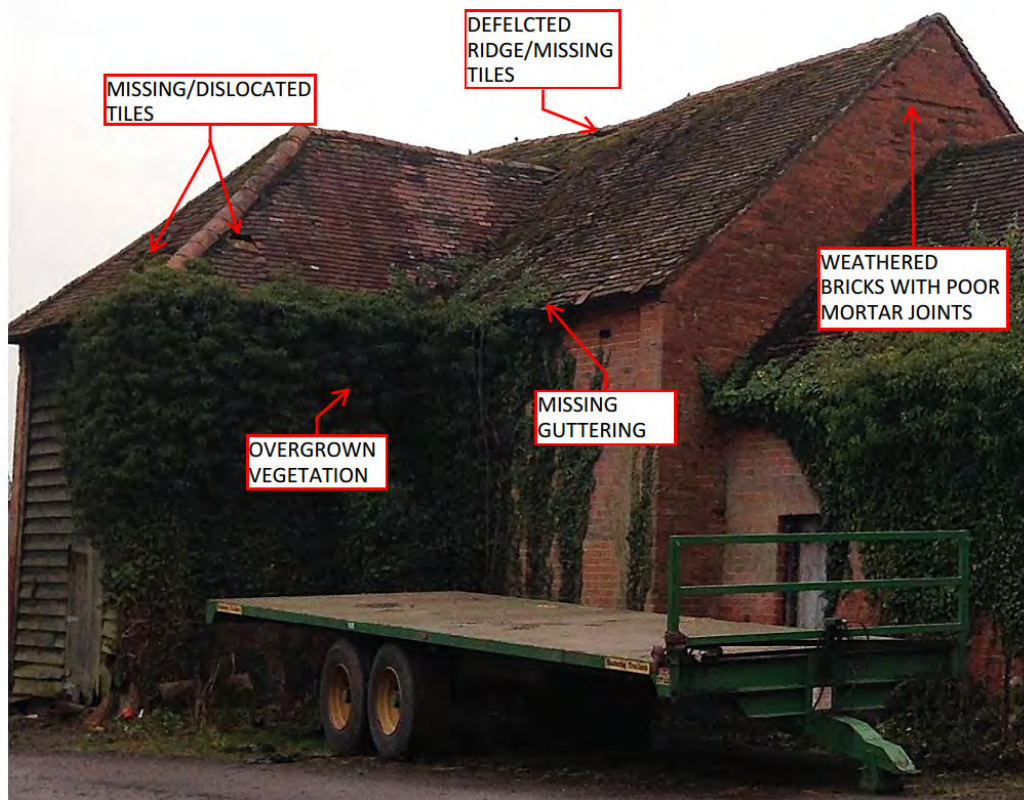
**DEFECTS OBSERVED IN BUILDING 'K'**

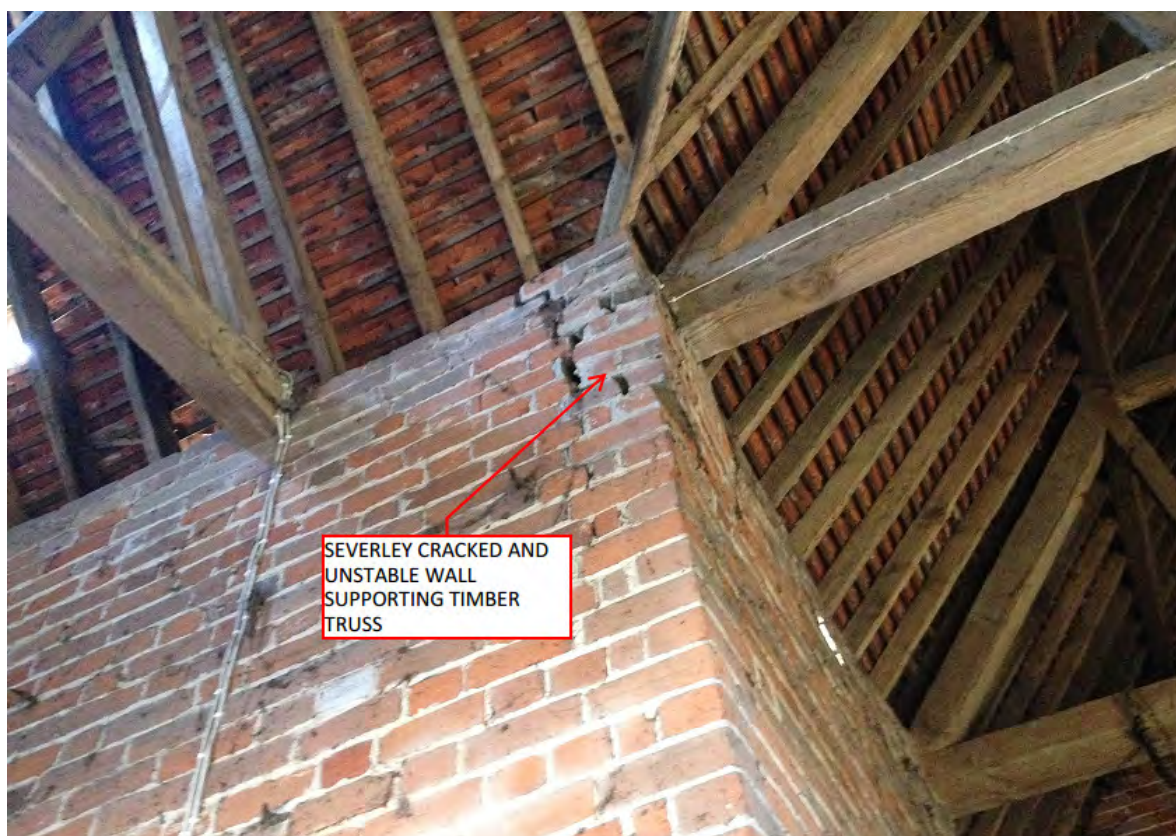
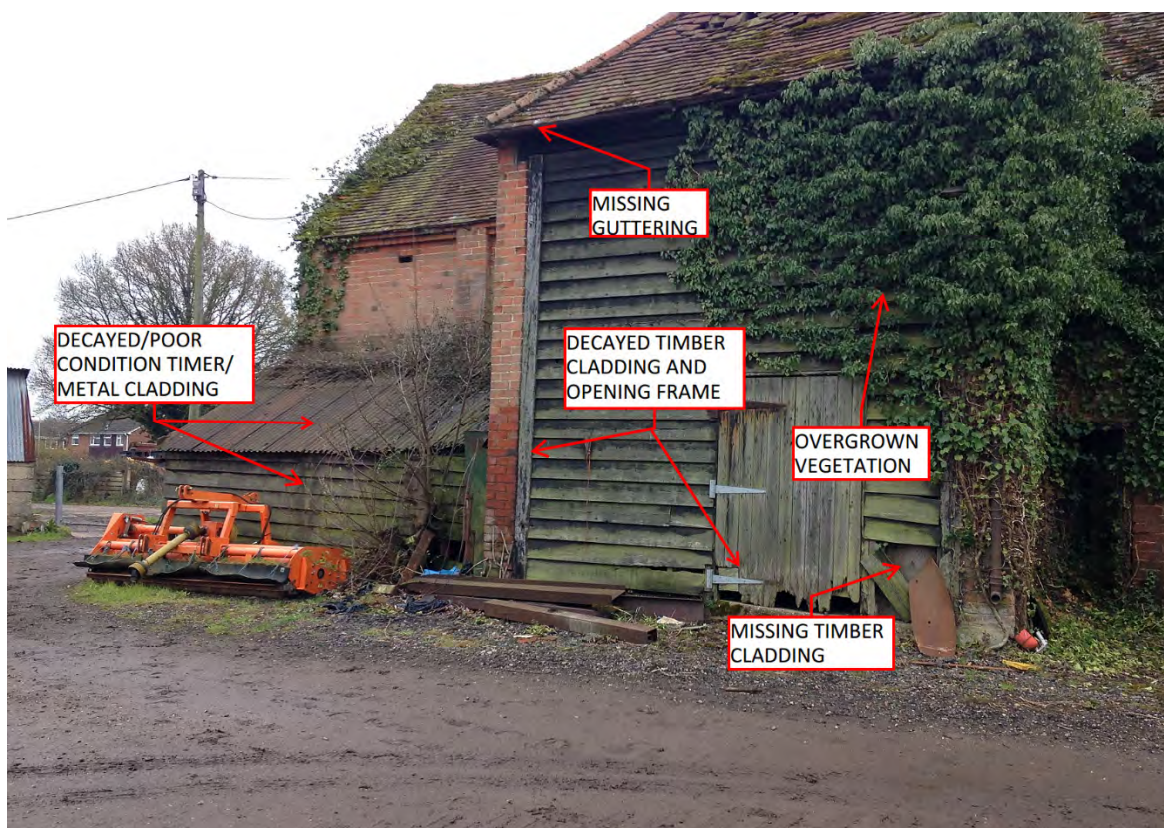
**DEFECTS OBSERVED IN BUILDING 'K'**

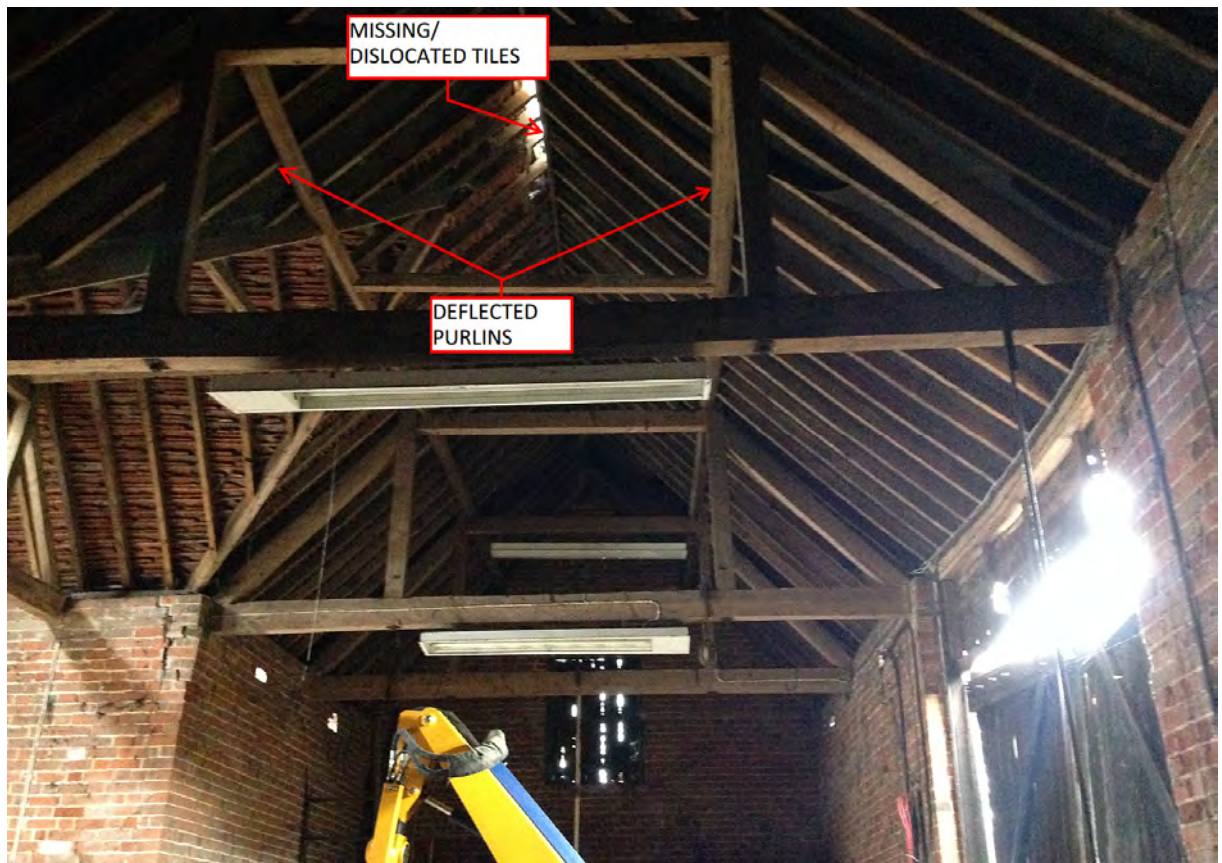
**DEFECTS OBSERVED IN BUILDING 'K'**

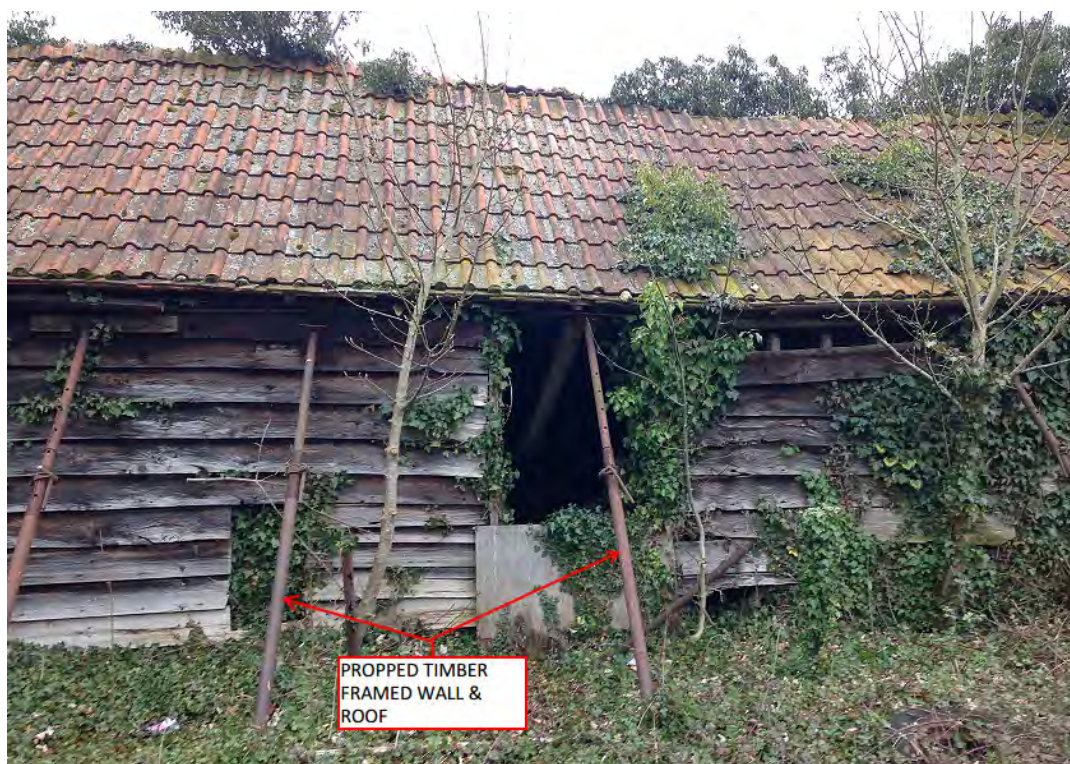
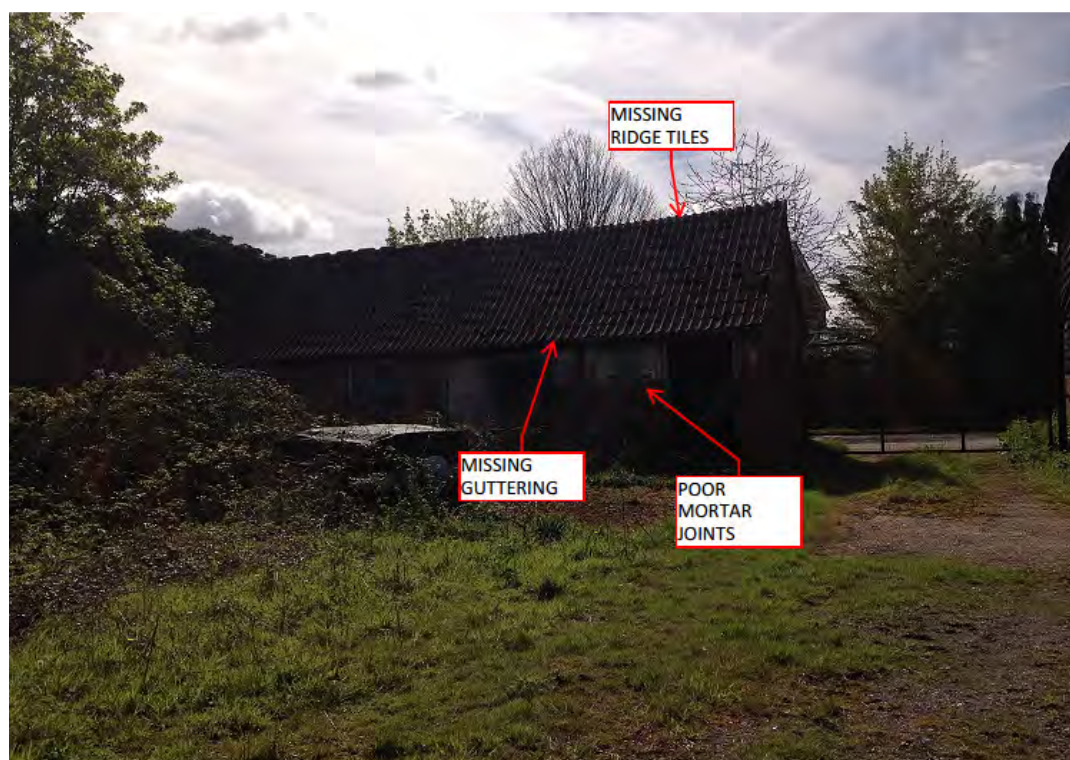
**DEFECTS OBSERVED IN BUILDING 'K'**
