# ASHRIDGE FARM BARNs

## Photographic record – Unit 5

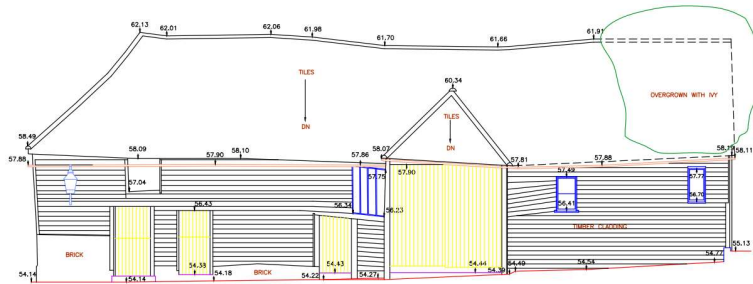
External façade – southern elevation, facing courtyard.

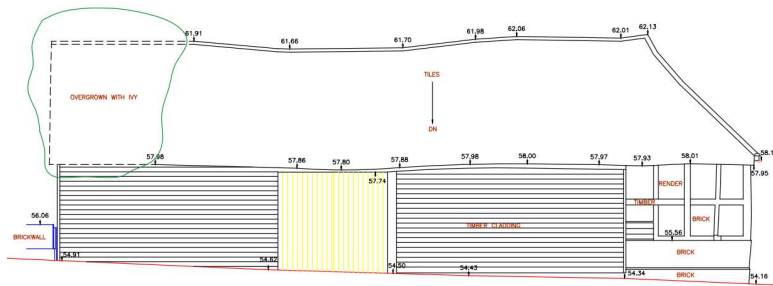
Northern elevation, facing public highway.

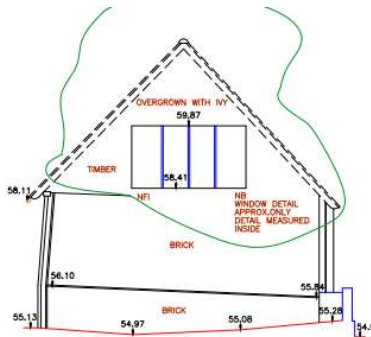
Gable ends – Western elevation

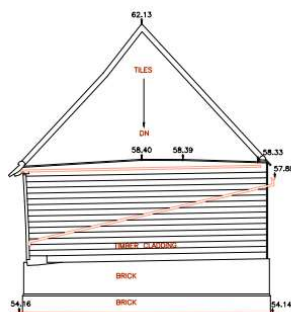
Eastern elevation

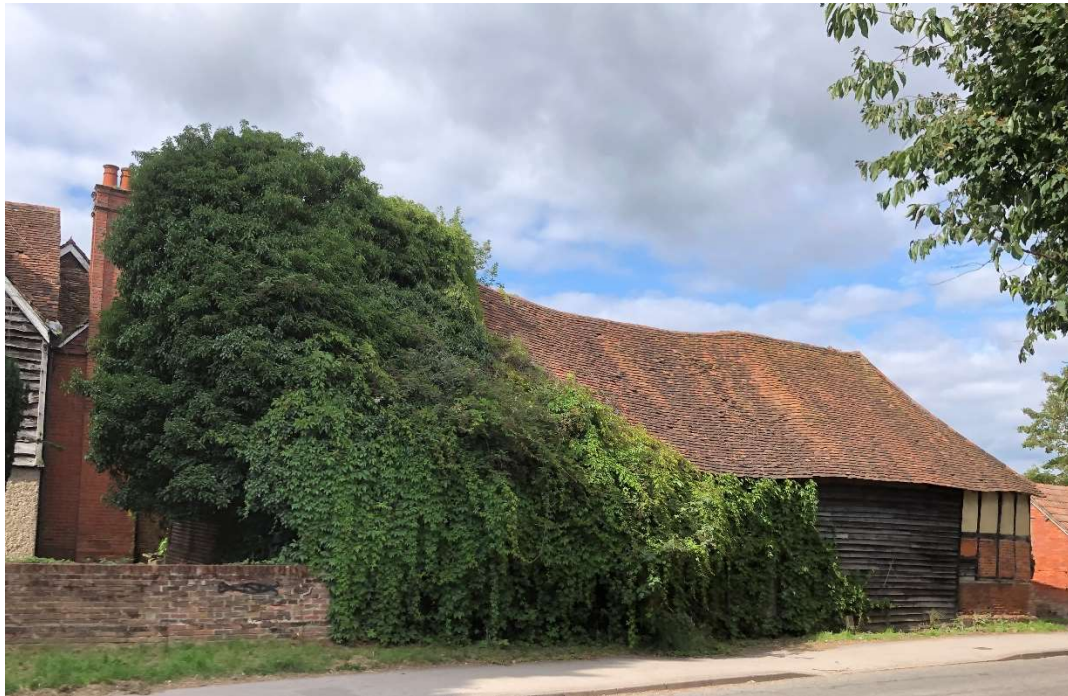
Photo 1 – Southern elevation

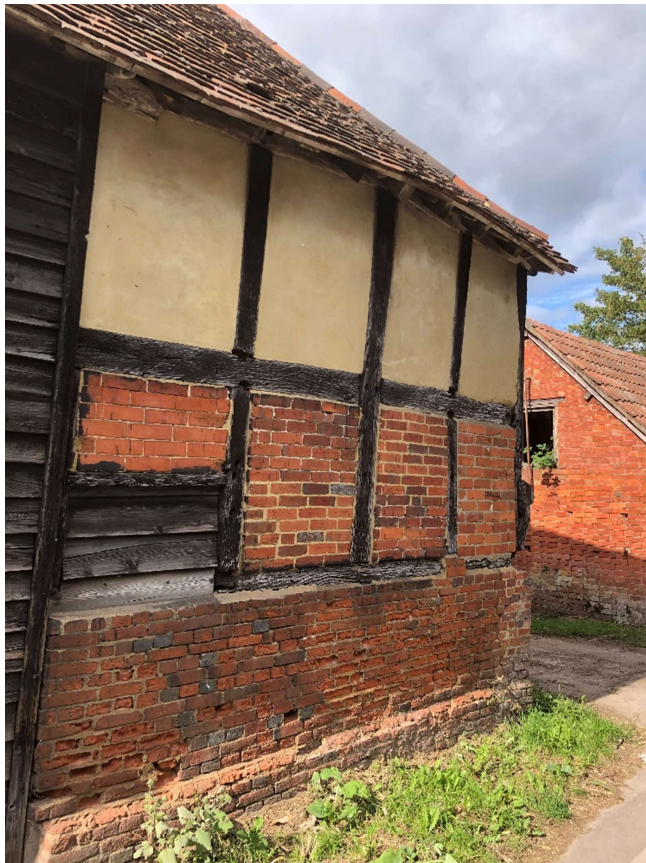
Photo 2 – South-eastern corner panels in timber frame

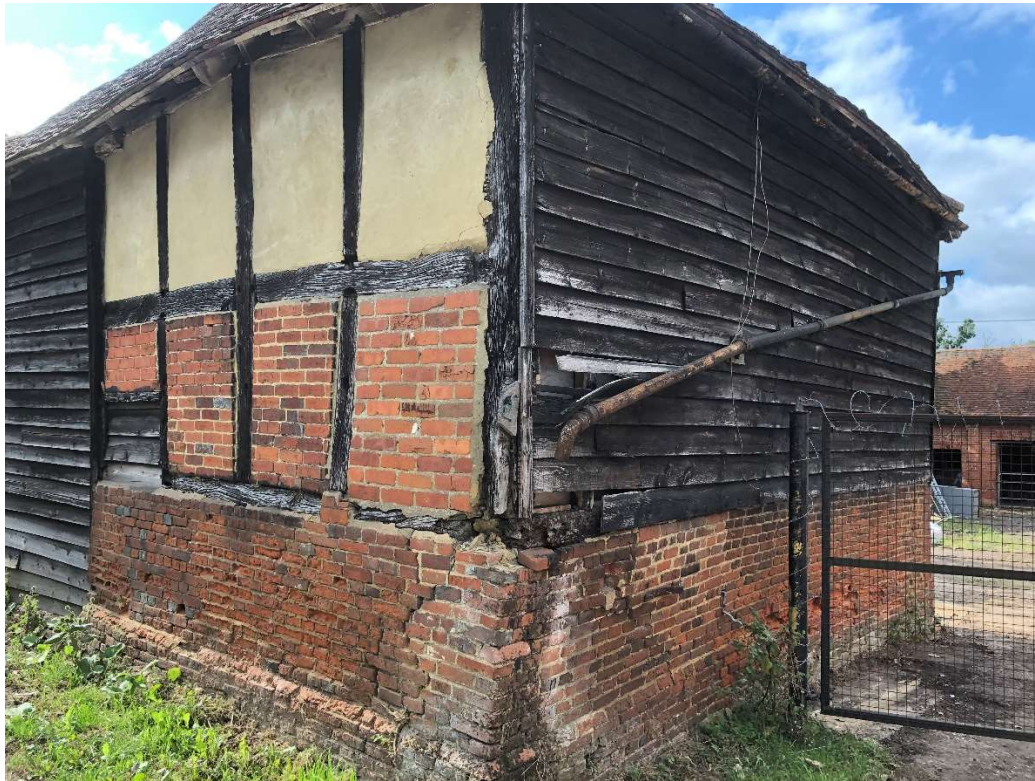
Photo 3 – South-east corner elevation

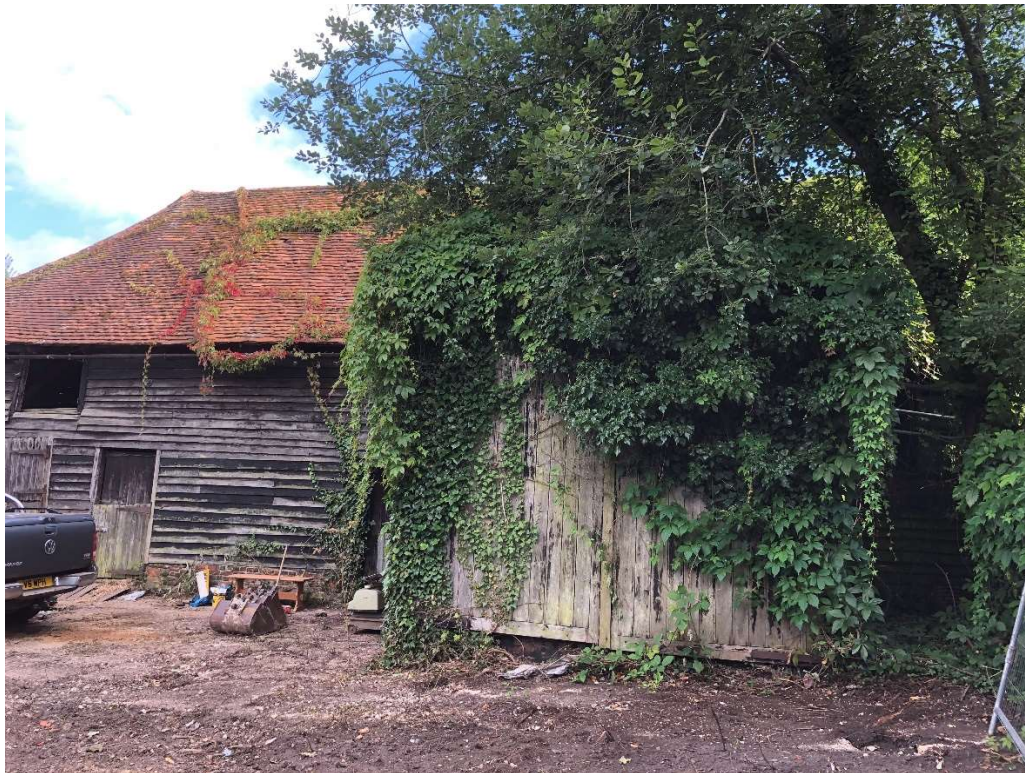
Photo 4 – Northern elevation and porch

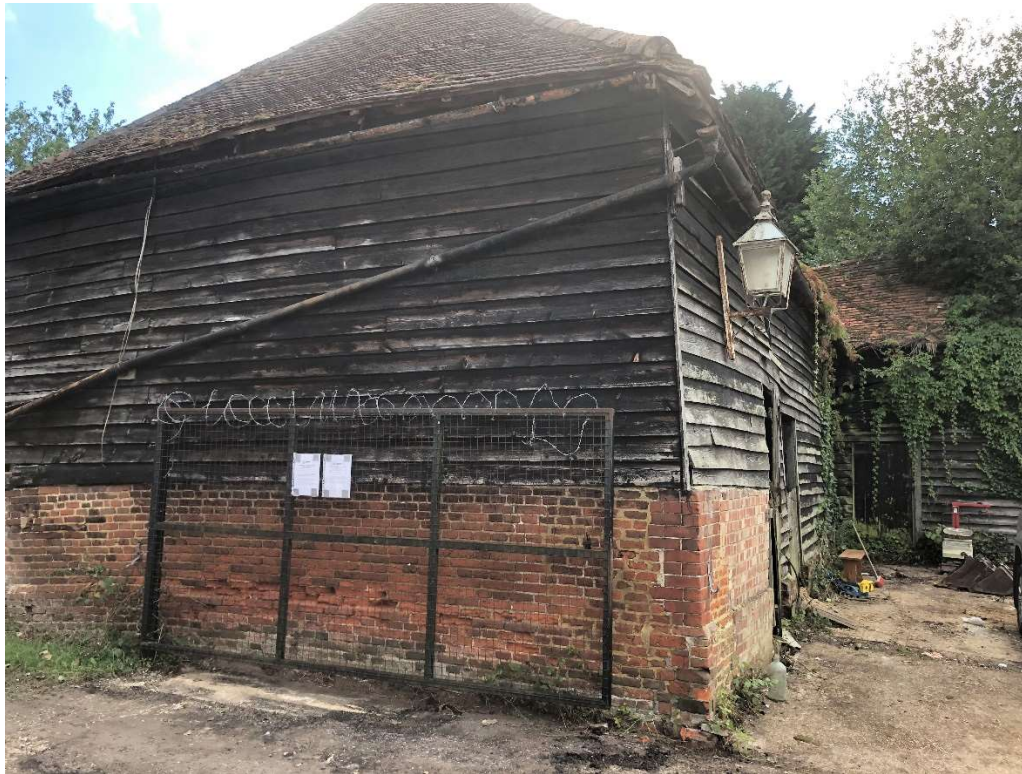
Photo 5 – East and Northern elevations

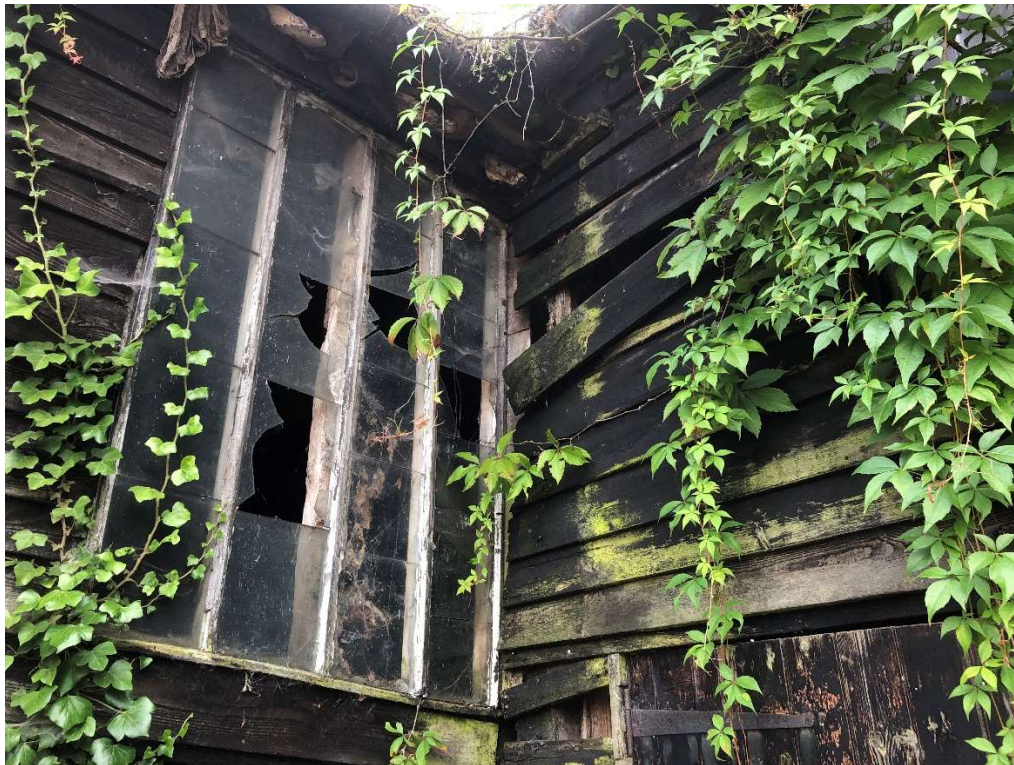
Photo 6 – Window to North elevation Bay 4

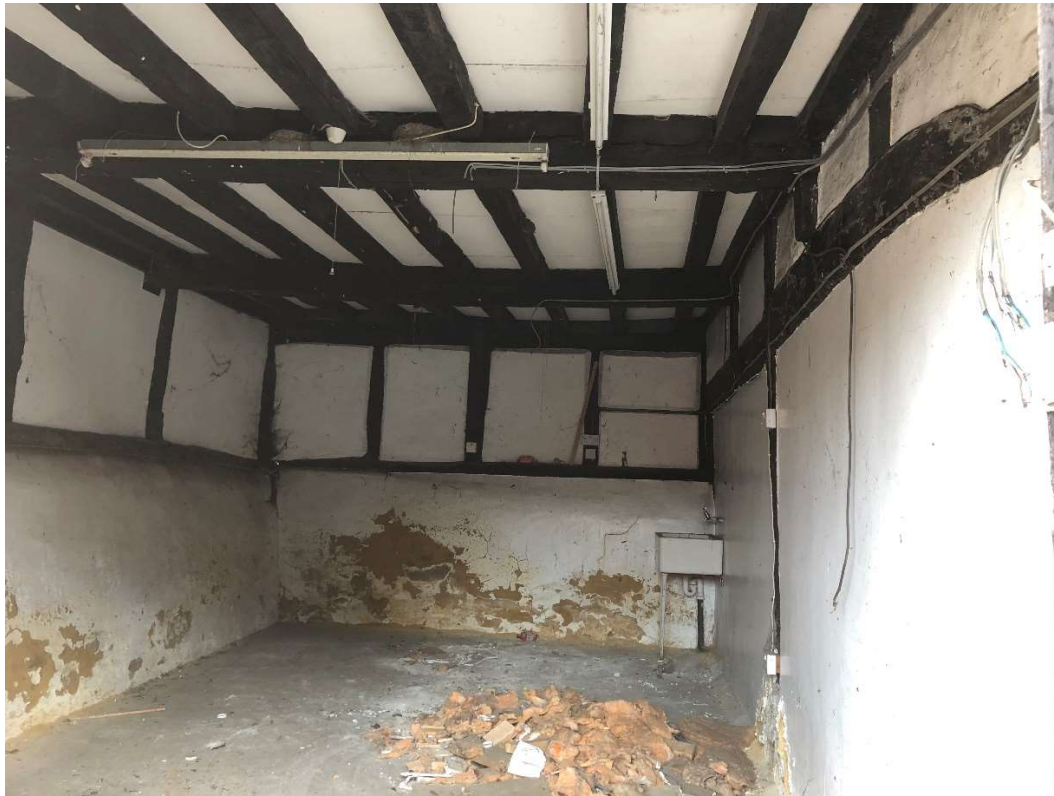
Photo 7 – Bay 7, hayloft ground floor

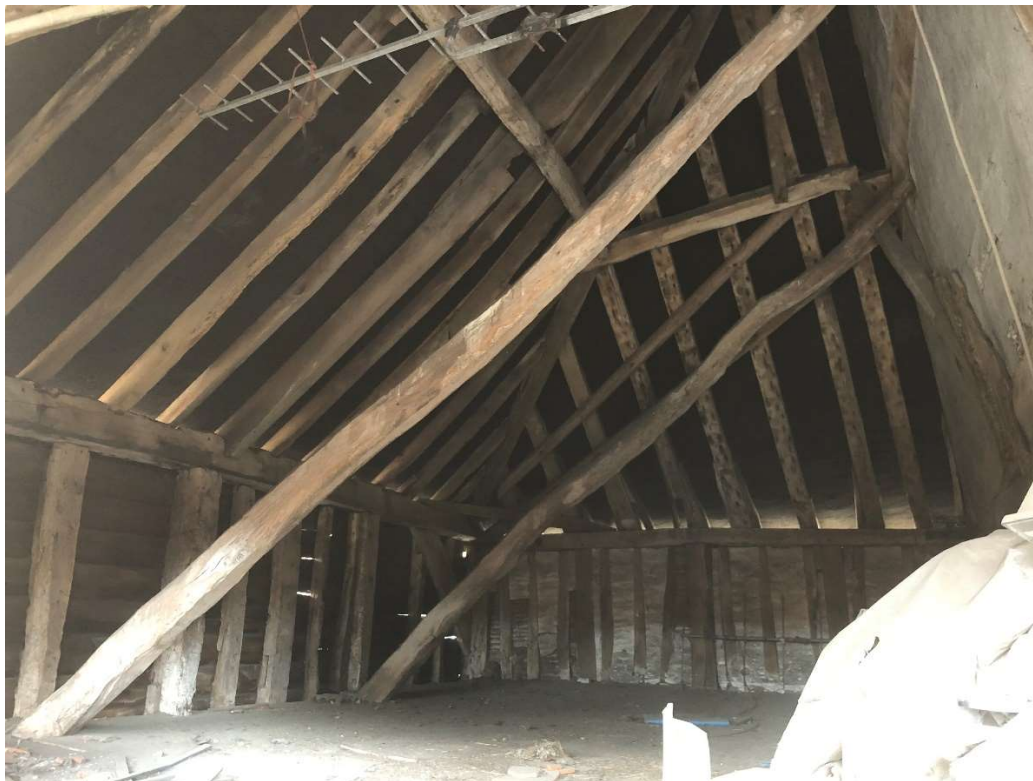
Photo 8 – Roof Bay 7, hayloft first floor

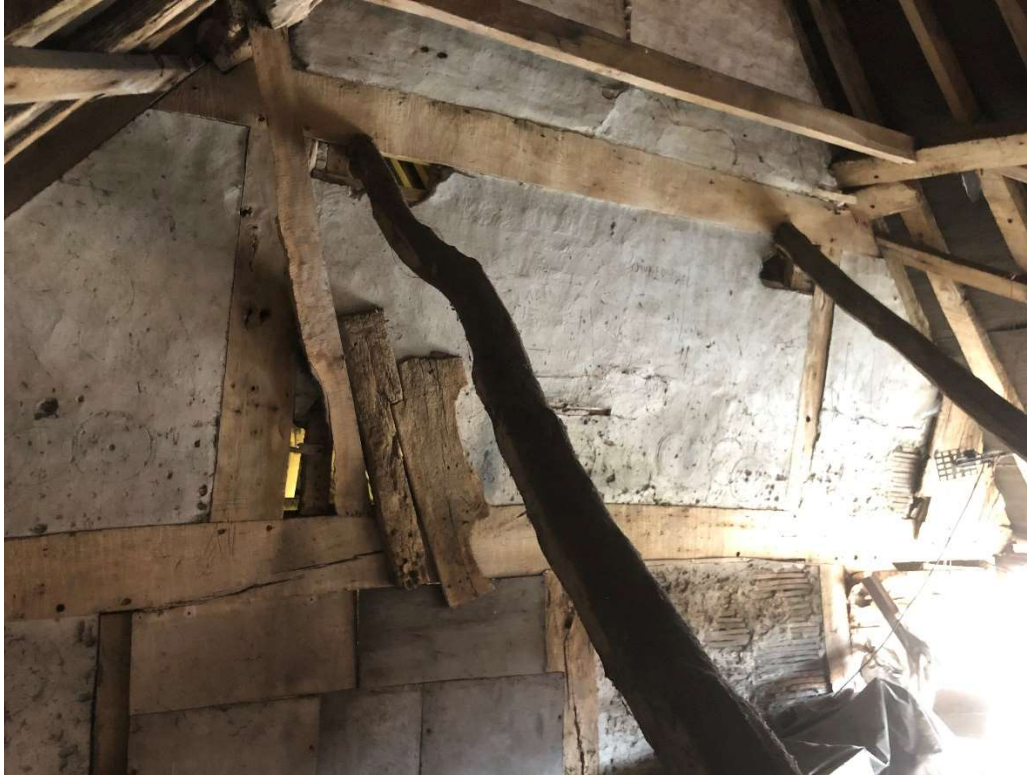
Photo 9 – Roof Bay 7 wattle and daub panels

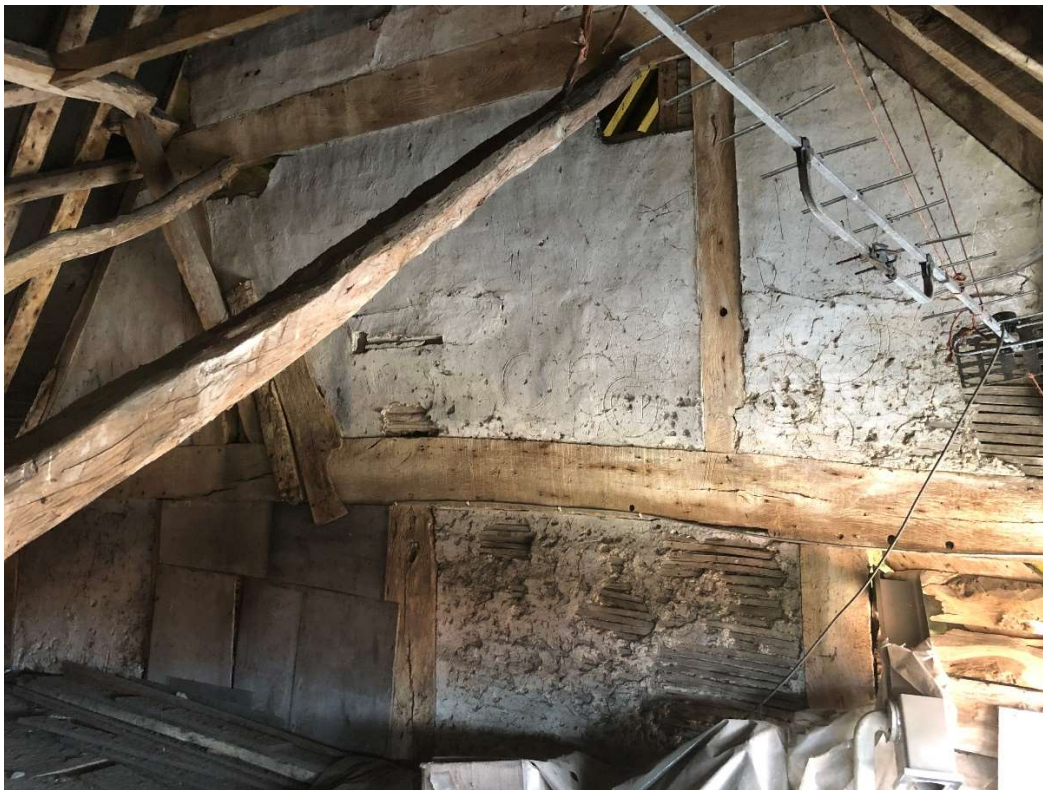
Photo 10 – Roof Bay 7 wattle and daub panels

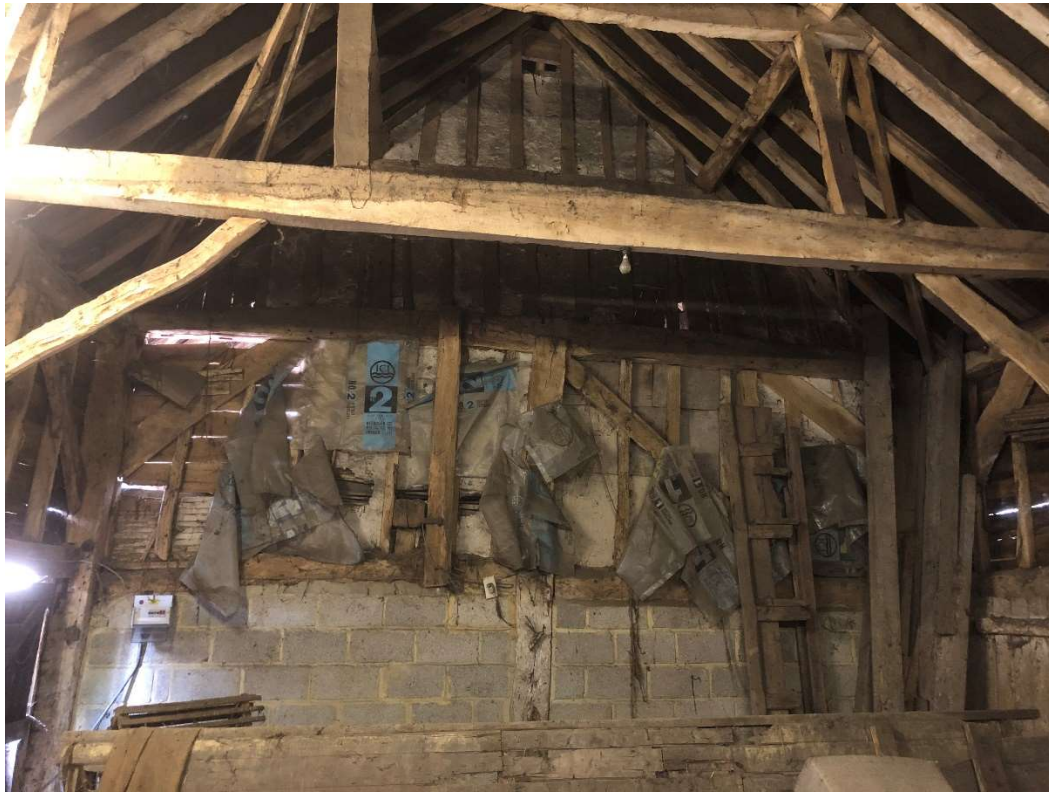
Photo 11 – Bay 6 facing East

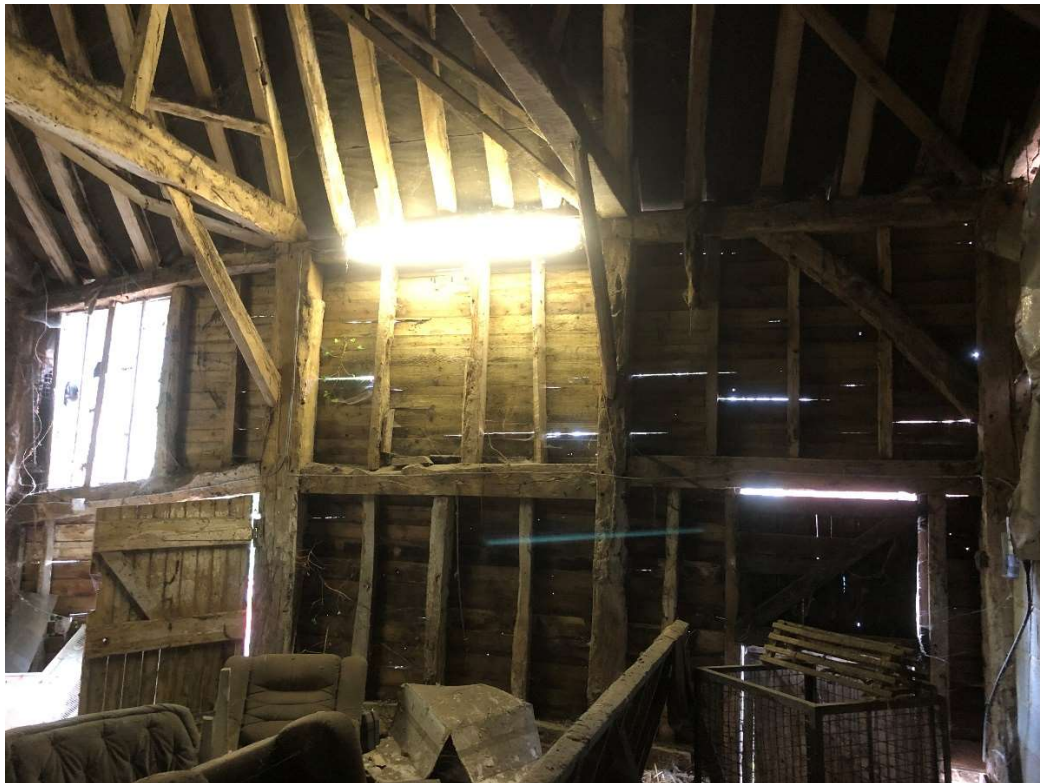
Photo 12 – Bay 5 Northern wall panel

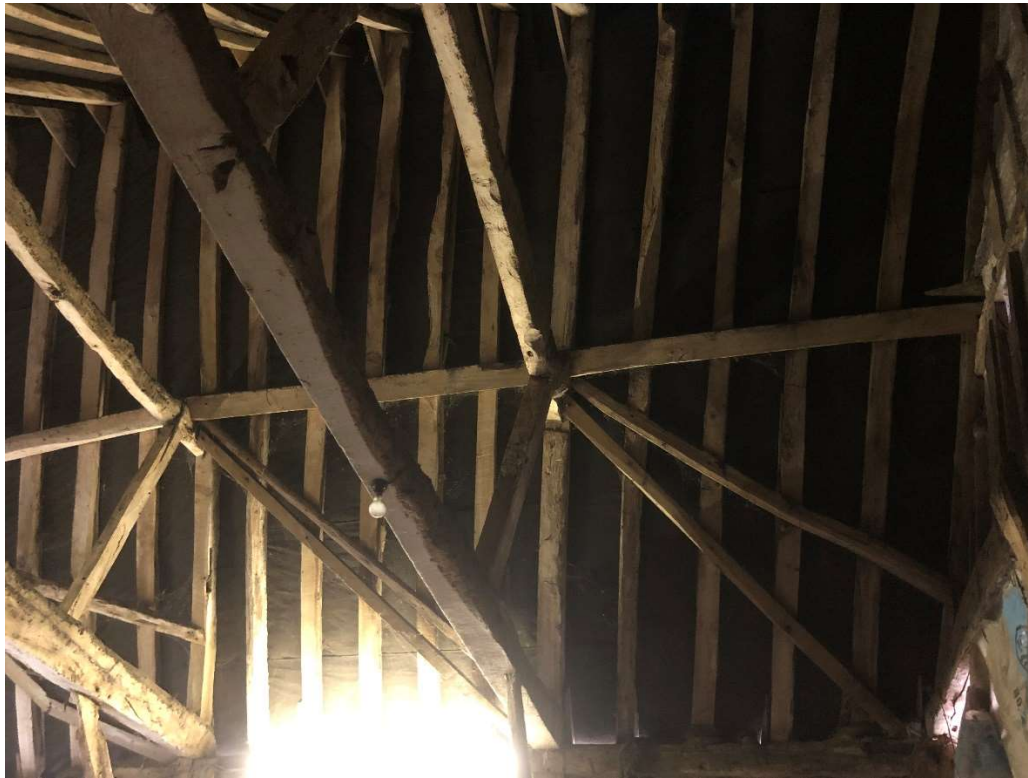
Photo 13 – Roof Bays 4 and 5 facing North

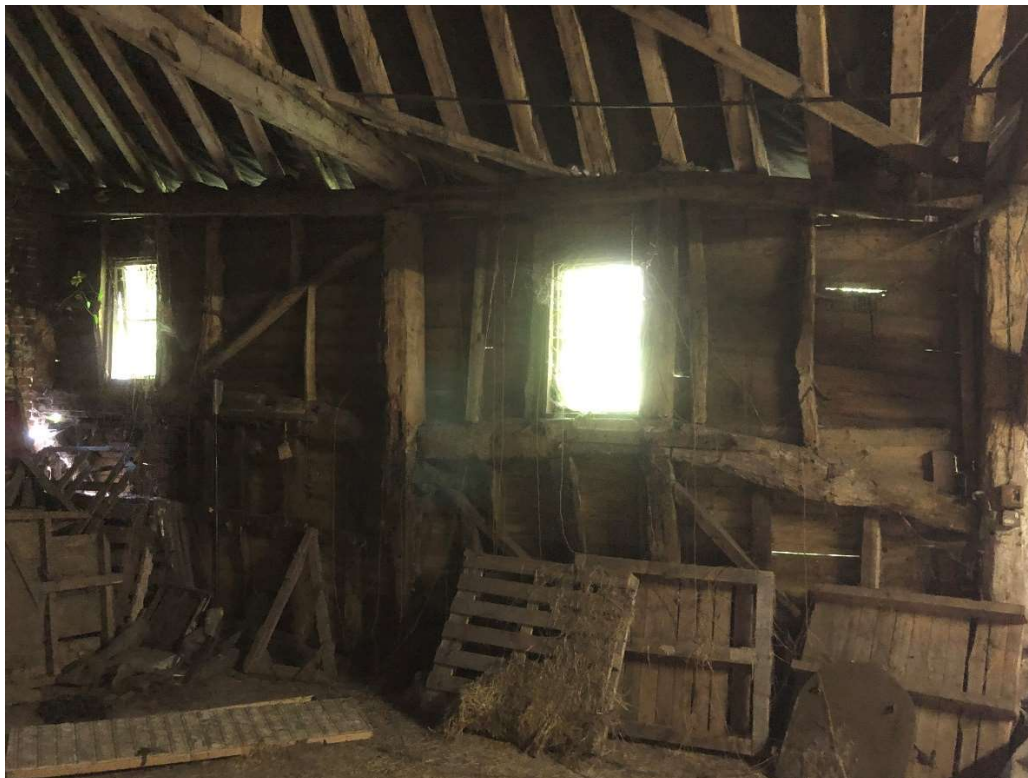
Photo 14 – Bay 2 North wall panel

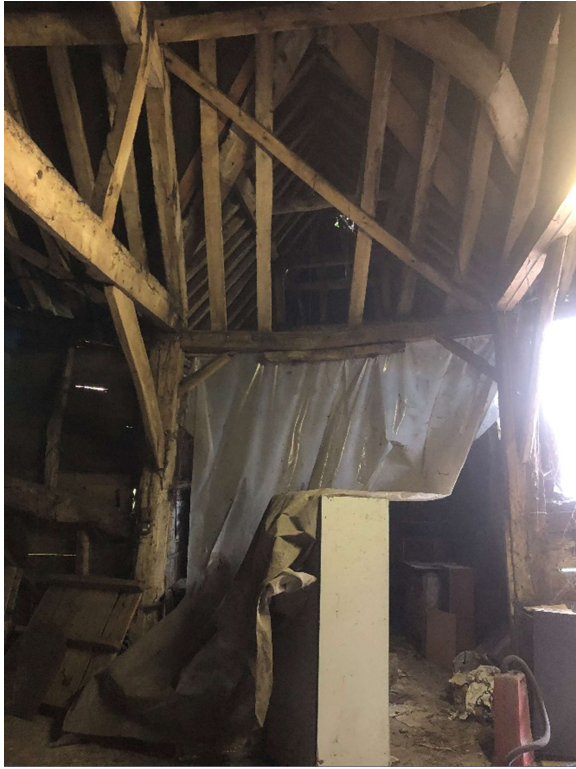
Photo 15 – Porch facing North from main barn

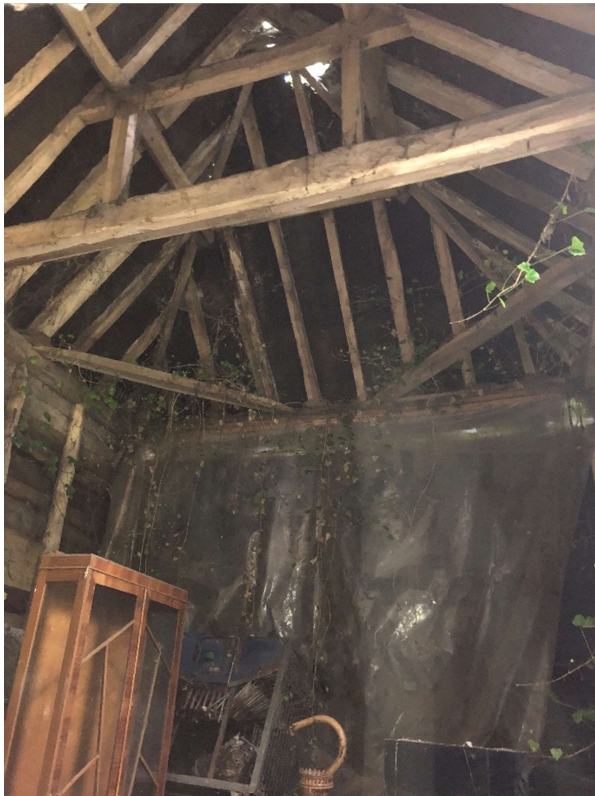
Photo 16 – Porch roof bay facing North

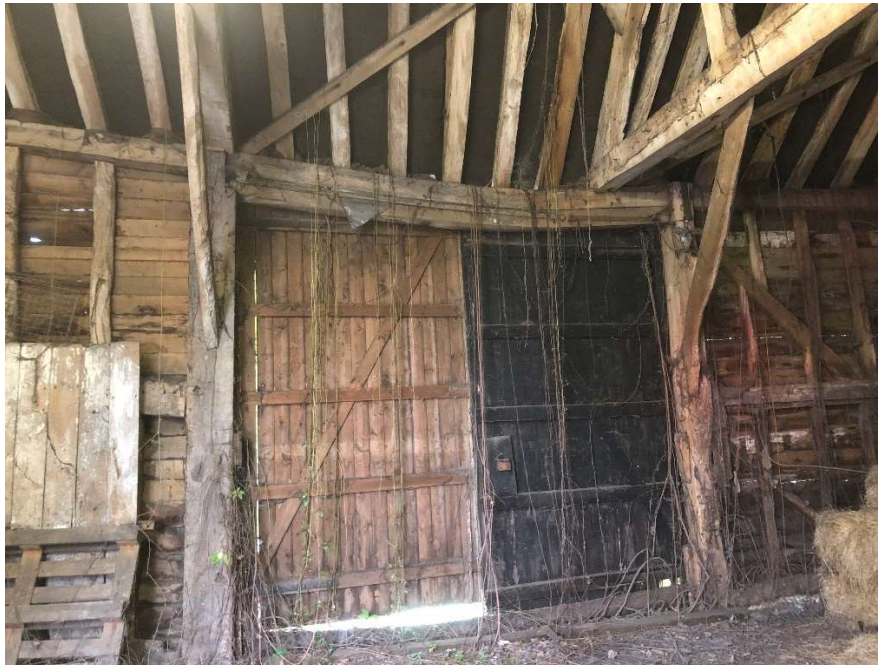
Photo 17 – Bay 3 - Main southern barn doors

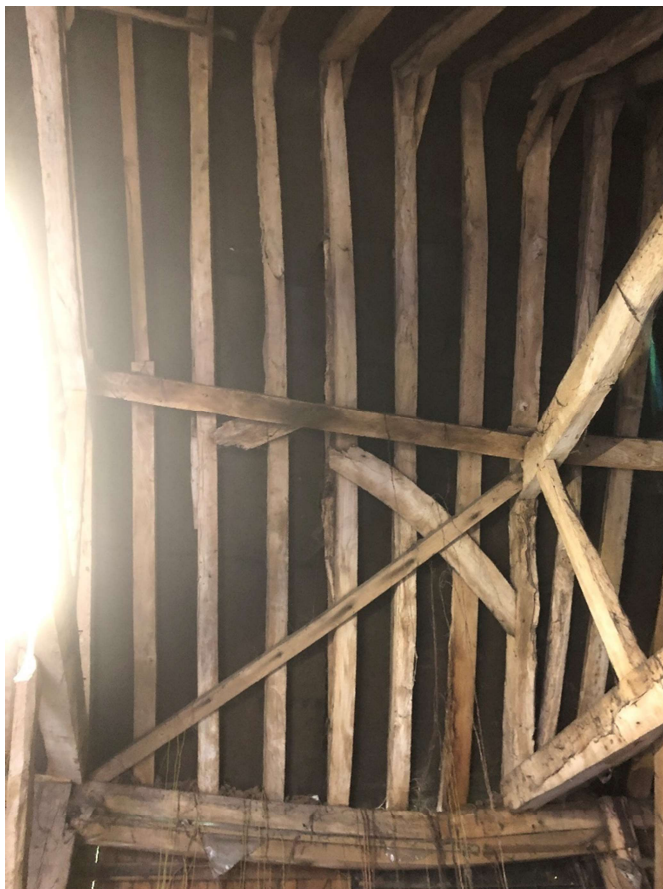
Photo 18 – Bay 3 Roof section facing south

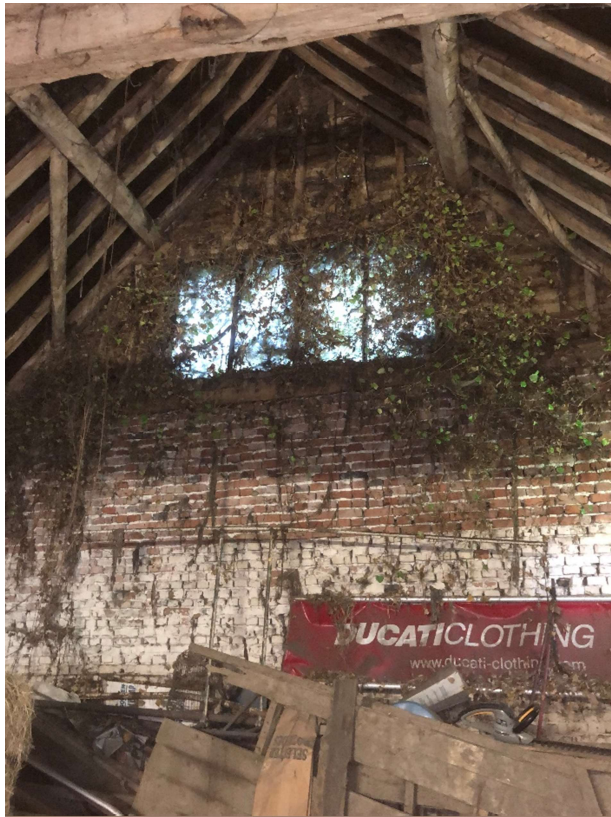
Photo 19 – Bay 1 – Window in brickwork to west elevation

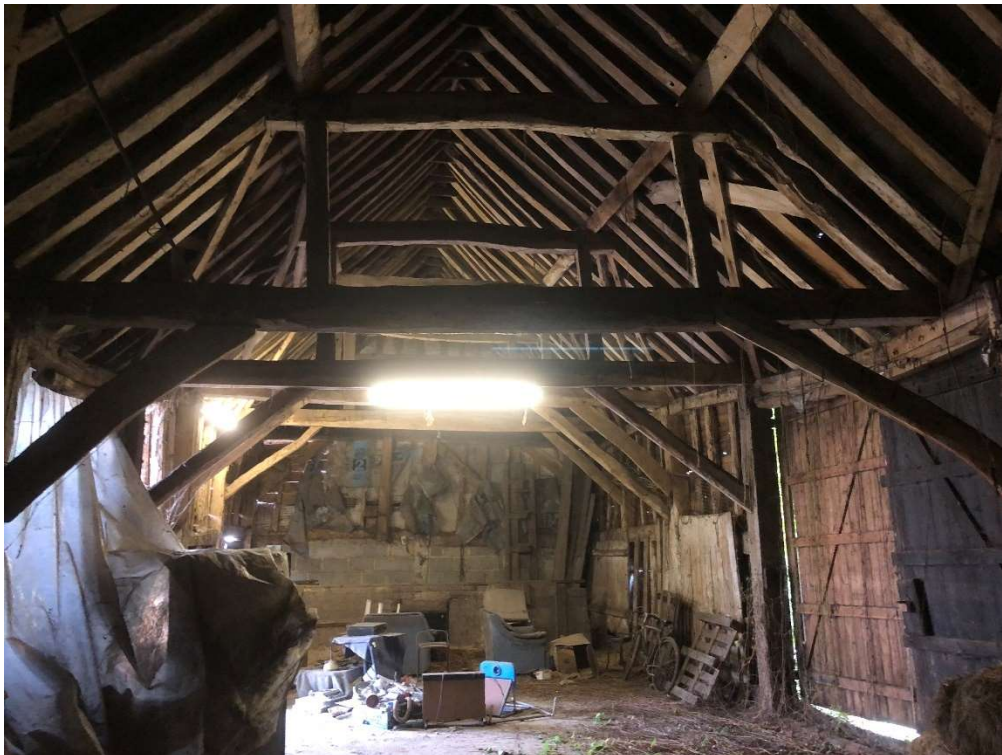
Photo 20 – Internal bays 2-6 facing East from Bay 1

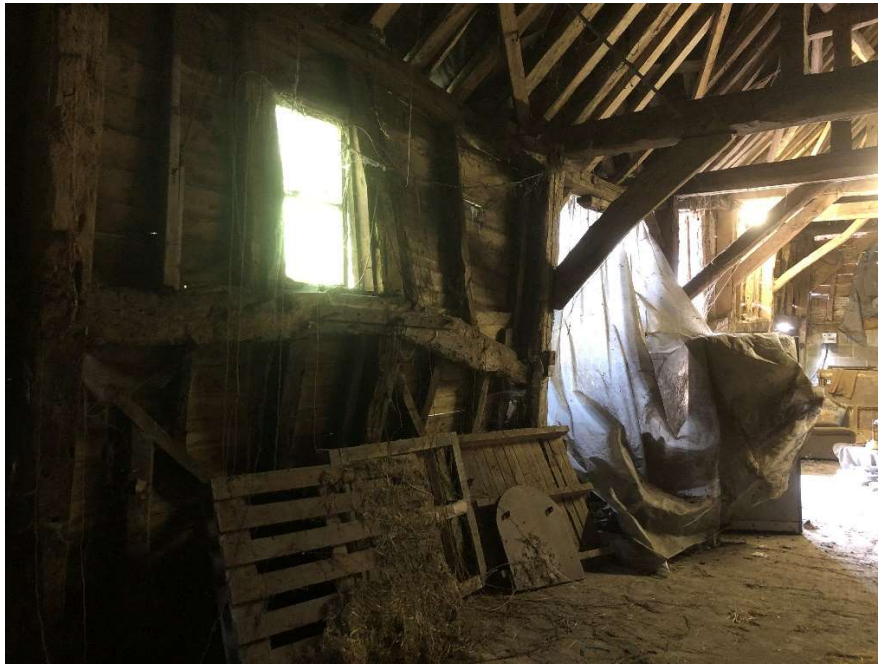
Photo 21 – Bay 2 wall section facing northeast

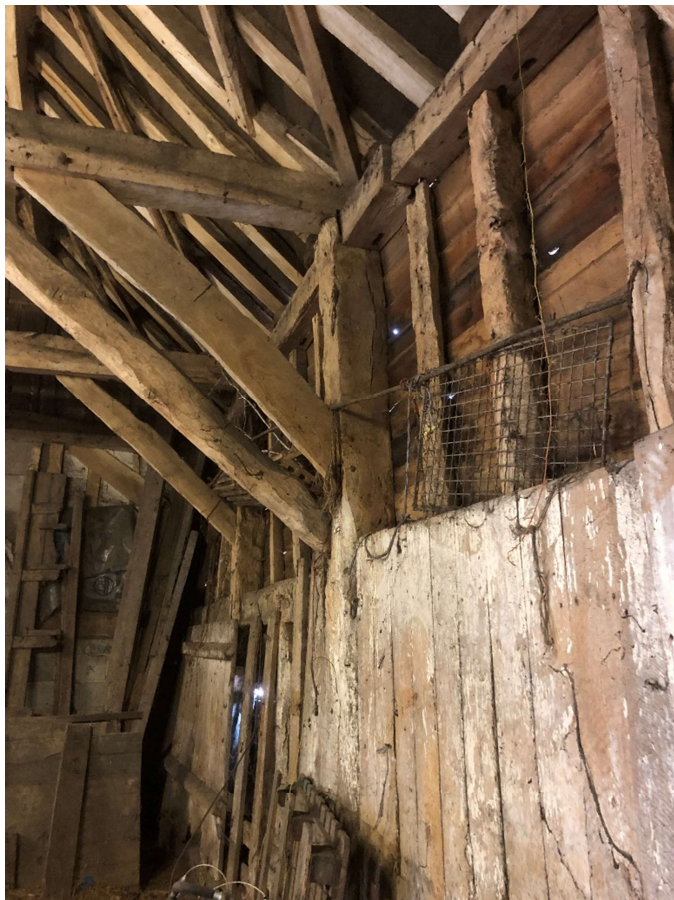
Photo 22 – Bay 4 facing southeast detail of wall section showing additional wall cladding
