DUCKWORTHS  
ARBORICULTURE LTD.

## TREE CONDITION SURVEY

144 WARGRAVE ROAD  
TWYFORD  
BERKSHIRE  
RG10 9PN

SEPTEMBER 2025  
Ref: 06718 / 2025

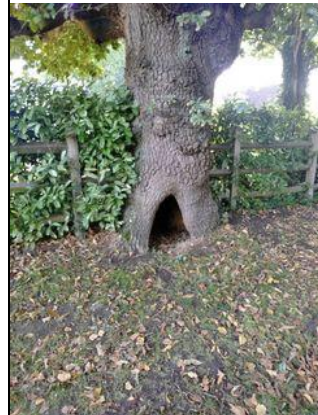
| Ref: | Species | Measurements | Survey Notes | Condition | Other Data | Recommendations | Photo |
|---|---|---|---|---|---|---|---|
| T001 | Pedunculate oak<br>( <i>Quercus robur</i> ) | Height (m): 11<br>Crown Radius (m): 5.5<br>DBH (cm): 100<br>Life Stage: Veteran<br>Life Exp.: 40+ Years | Large oak, topped at 3.5m. Soft landscaped rooting area has been mulched with chipped bark which will benefit tree health. Fence rails pushing into trunk. Hollow trunk with large historic basal cavity on roadside of trunk. Large, mature ribs of healthy looking wound wood formation. Hammer test around base even. No fungal fruiting bodies evident. Stem expected to be hollow up to topping point. Canopy created by dense branching from around the topping point. Foliage dense and even. Good physiological health. Previous works undertaken to reduce the canopy by 2m recommended in order to manage the tree with a reduced canopy in order to prevent stem failure – tree has recovered well, satisfactory rates of regrowth around 1m for much of the crown, 2m for selective few branches on lower north side of canopy. New shoots under 20mm diameter. Too early for further reduction. | Good | Wildlife Value: High<br>Inspection Limitations: Dense Vegetation | Remove or cut back 6x wooden fence rails pushing into trunk.<br><br><b>Timescale:</b><br>08-Dec-2025<br>(3 Months) | |

| Ref: | Species | what3words<br>(Location Identifier) | Recommendations | Work Timescale |
|---|---|---|---|---|
| T001 | Pedunculate oak<br>(Quercus robur) | ///begun.boardroom.guarded | <ul style="list-style-type: none"> <li>Remove or cut back 6x wooden fence rails pushing into trunk.</li> </ul> | 08-Dec-2025<br>(3 Months) |

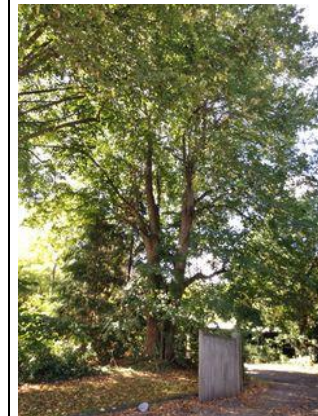
| Ref: | Species | Measurements | Survey Notes | Condition | Other Data | Recommendations | Photo |
|---|---|---|---|---|---|---|---|
| T002 | Lime<br>( <i>Tilia sp.</i> ) | Height (m): 23<br>Crown Radius (m): 7<br>DBH (cm): 70<br>Stems: 2<br>Life Stage: Mature<br>Life Exp.: 40+ Years | Twin stem tree. Epicormic growth around base. Where accessible Base clear, bark intact. No fungal fruiting bodies evident. Included bark between stems to 3m above ground level which appear fused together at the top. Crown formed from two even sized trunks. Phone through canopy.<br>Broad crown. Vertical water shoots of one or two branches. Foliage dense. Good vitality. Small to medium sized deadwood over low occupancy area. | Fair | Wildlife Value: Good | Remove epicormic shoots.<br><br>Crown lift to 5m over road and access to 144 Wargrave Road.<br><br>Cut back branch tips to create 1m canopy clearance to phone line as part of these works.<br><br><b>Timescale:</b><br>08-Mar-2026<br>(6 Months) | |

| Ref: | Species | what3words<br>(Location Identifier) | Recommendations | Work Timescale |
|---|---|---|---|---|
| T002 | Lime<br>(Tilia sp.) | ///resides.obliging.dizziness | <ul style="list-style-type: none"> <li>Remove epicormic shoots</li> <li>Crown lift to 5m over road and access to 144 Wargrave Road</li> <li>Cut back branch tips to create 1m canopy clearance to phone line as part of these works.</li> </ul> | 08-Mar-2026<br>(6 Months) |

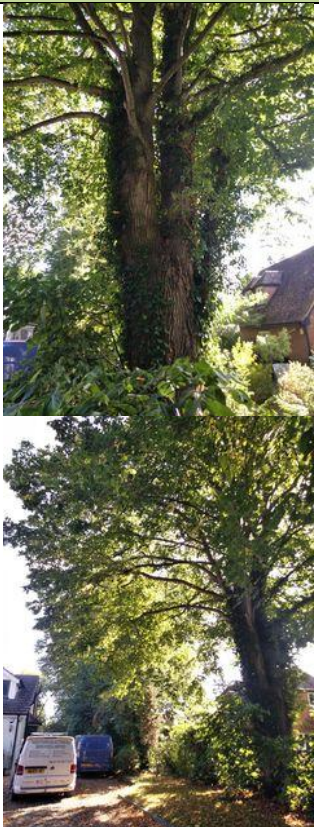
| Ref: | Species | Measurements | Survey Notes | Condition | Other Data | Recommendations | Photo |
|---|---|---|---|---|---|---|---|
| T003 | Lime<br>( <i>Tilia sp.</i> ) | Height (m): 25<br>Crown Radius (m): 6.5<br>DBH (cm): 100<br>Life Stage: Mature<br>Life Exp.: 40+ Years | <p>Mature epicormic growth partially obscures base and lower trunk. Where accessible, base clear, bark intact. No fungal fruiting bodies evident. Twin stem from 3m with two evenly sized trunks above fruiting vertically. Small area of included bark likely at fork.</p> <p>Broad crown previously reduced, 2-4m from previous reduction points.</p> <p>Foliage dense and even. Good vitality. No major deadwood.</p> | Fair | Wildlife Value:<br>Good<br>Inspection<br>Limitations:<br>Epicormic growth and ivy. | <p>Reduce low lateral branches on North side of trunk back up to 2m to previous reduction points.</p> <p>Sever ivy.</p> <p>Remove epicormic growth.</p> <p><b>Timescale:</b><br/>08-Sep-2026<br/>(1 Year)</p> | |

| Ref: | Species | what3words<br>(Location Identifier) | Recommendations | Work Timescale |
|---|---|---|---|---|
| T003 | Lime<br>(Tilia sp.) | ///loafing.currently.corner | <ul style="list-style-type: none"> <li>Reduce low lateral branches on North side of trunk back up to 2m to previous reduction points.</li> <li>Sever ivy</li> <li>Remove epicormic growth.</li> </ul> | 08-Sep-2026<br>(1 Year) |

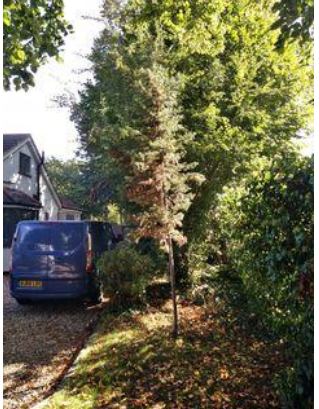
| Ref: | Species | Measurements | Survey Notes | Condition | Other Data | Recommendations | Photo |
|---|---|---|---|---|---|---|---|
| T004 | Italian cypress<br>( <i>Cupressus sempervirens</i> ) | Height (m): 4<br>Crown Radius (m): 0.5<br>DBH (cm): 4<br>Life Stage: Semi Mature<br>Life Exp.: 20+ Years | Small fastigiate tree, heavily crown lifted. Low vitality. | Fair | Wildlife Value:<br>Inspection<br>Limitations: | No works identified. | |

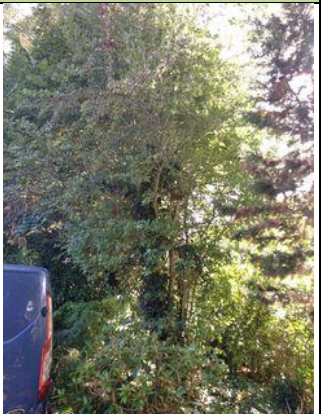
| Ref: | Species | Measurements | Survey Notes | Condition | Other Data | Recommendations | Photo |
|---|---|---|---|---|---|---|---|
| T005 | Common hawthorn<br>( <i>Crataegus monogyna</i> ) | Height (m): 7<br>Crown Radius (m): 2<br>DBH (cm): 15<br>Life Stage: Mature<br>Life Exp.: 20+ Years | Multi-stem small tree, ivy clad. Asymmetrical crown. | Fair | Wildlife Value:<br>Moderate<br>Inspection<br>Limitations: Prolific ivy | No works identified. | |

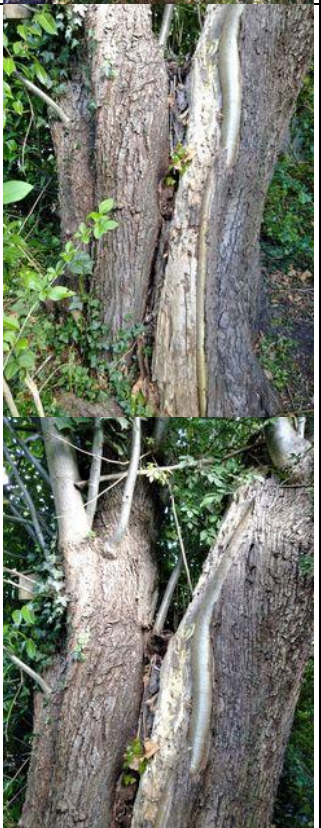
| Ref: | Species | Measurements | Survey Notes | Condition | Other Data | Recommendations | Photo |
|---|---|---|---|---|---|---|---|
| T006 | Lime<br>( <i>Tilia sp.</i> ) | Height (m): 10<br>Crown Radius (m): 3.5<br>DBH (cm): 90<br>Stems: 2<br>Life Stage: Over Mature<br>Life Exp.: 40+ Years | Large stump of topped tree. Twin stem from 1.5m Trunks historically topped at 2.5m under a '5 day notification' under the TPO due to the imminent failure of a weak fork. Dense regrowth and sucker growth from base and trunk. Extensive decay visible around southern side of trunk. Mature regrowth now 7m long and up to 100mm diameter. Foliage dense. Good vitality. | Poor | Wildlife Value:<br>Good | Reduce regrowth back to main stem and continue to manage as a pollard<br><br><b>Timescale:</b><br>08-Dec-2025<br>(3 Months) | |

| Ref: | Species | what3words<br>(Location Identifier) | Recommendations | Work Timescale |
|---|---|---|---|---|
| T006 | Lime<br>(Tilia sp.) | ///gravitate.tinted.torso | Reduce regrowth back to main stem and continue to manage tree as a low pollard | 08-Dec-2025<br>(3 Months) |

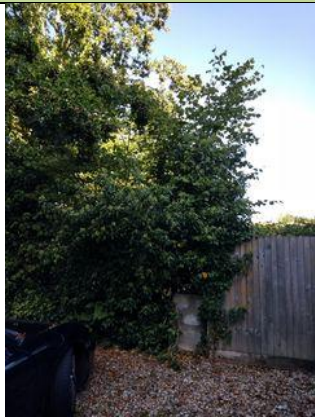
| Ref: | Species | Measurements | Survey Notes | Condition | Other Data | Recommendations | Photo |
|---|---|---|---|---|---|---|---|
| T007 | Lime<br>( <i>Tilia sp.</i> ) | Height (m): 5<br>Crown Radius (m): 2<br>DBH (cm): 6<br>Stems: 5<br>Life Stage: Mature<br>Life Exp.: 40+ Years | Multi-stem tree heavily suppressed by ivy.<br>Possible regeneration from felled maiden tree.<br>Previously cut back to clear property. | Fair | Wildlife Value: Low<br>Inspection<br>Limitations: Ivy and dense vegetation | No works identified. | |

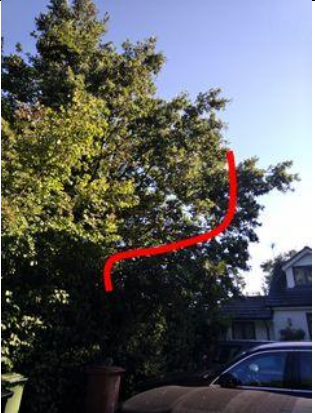
| Ref: | Species | Measurements | Survey Notes | Condition | Other Data | Recommendations | Photo |
|---|---|---|---|---|---|---|---|
| T008 | Pedunculate oak<br>( <i>Quercus robur</i> ) | Height (m): 13<br>Crown Radius (m): 6<br>DBH (cm): 40<br>Life Stage: Early Mature<br>Life Exp.: 40+ Years | Offsite tree, fair form and vitality. Low crown to 2m over parking of 144 Wargrave Road. | Good | Wildlife Value: Good<br>Inspection<br>Limitations: Access | Crown lift to create 3.5m canopy clearance over parking bays.<br>Reduce one slender elongated branch over parking by 2m back to surrounding canopy profile.<br><br><b>Timescale:</b><br>08-Sep-2026<br>(1 Year) | |

| Ref: | Species | what3words<br>(Location Identifier) | Recommendations | Work Timescale |
|---|---|---|---|---|
| T008 | Oak<br>(Quercus robur) | ///demanding.grouping.stuck | <ul style="list-style-type: none"> <li>Crown lift to create 3.5m canopy clearance over parking bays.</li> <li>Reduce one slender elongated branch over parking by 2m back to surrounding canopy profile.</li> </ul> | 08-Sep-2026<br>(1 Year) |

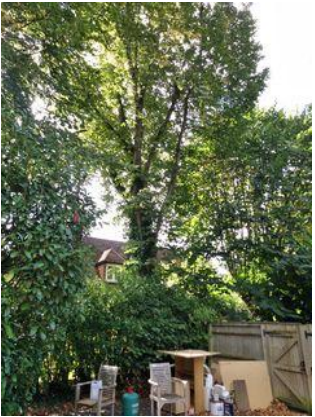
| Ref: | Species | Measurements | Survey Notes | Condition | Other Data | Recommendations | Photo |
|---|---|---|---|---|---|---|---|
| T009 | Lime<br>( <i>Tilia sp.</i> ) | Height (m): 20<br>Crown Radius (m): 4<br>DBH (cm): 65<br>Life Stage: Mature<br>Life Exp.: 40+ Years | Smaller tree within linear group. Base & trunk obscured by dense privet hedge & epicormic growth which restricts access around base. Ivy on trunk. Where accessible no fungal fruiting bodies or audible decay. Twin stem from approx. 3m above ground level. Asymmetrical canopy due to competition with adjacent tree (felled). Asymmetrical crown with elongated branches on south side of canopy over neighbouring garden. One of these branches lacks vigour and is prematurely autumnal. Elsewhere foliage dense and healthy. Epicormic growth in lower crown. | Fair | Wildlife Value: Good<br>Inspection<br>Limitations: Dense Vegetation | Sever ivy and remove epicormic growth on lower trunk to a height of 5m.<br>Reduce overextended branches over neighbouring residential property by 3-4m to reduce exposure and risk of breakage.<br><br><b>Timescale:</b><br>08-Sep-2026<br>(1 Year) | |

| Ref: | Species | what3words<br>(Location Identifier) | Recommendations | Work Timescale |
|---|---|---|---|---|
| T009 | Lime<br>(Tilia sp.) | ///driving.distilled.legend | <ul style="list-style-type: none"> <li>Sever ivy and remove epicormic growth on lower trunk to a height of 5m.</li> <li>Reduce overextended branches over neighbouring residential property by 3-4m to reduce exposure and risk of breakage.</li> </ul> | 08-Sep-2026<br>(1 Year) |

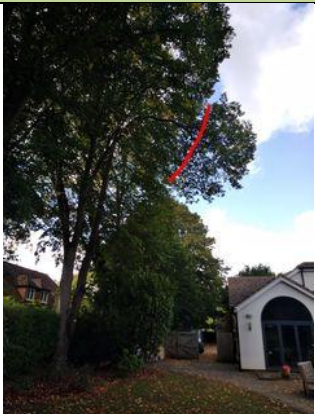
| Ref: | Species | Measurements | Survey Notes | Condition | Other Data | Recommendations | Photo |
|---|---|---|---|---|---|---|---|
| T010 | Lime<br>( <i>Tilia sp.</i> ) | Height (m): 20<br>Crown Radius (m): 8.5<br>DBH (cm): 80<br>Life Stage: Mature<br>Life Exp.: 40+ Years | Single stem tree partially obscures by boundary hedge. Where accessible, base clear, no fungal fruiting bodies or audible decay. Twin stem com 1.5m. cup union forming. Small Elder sapling growing in fork. Two stems grow vertically. Oval suppressed crown. Foliage dense and even. Good vitality. No major deadwood. | Fair | Wildlife Value:<br>Good<br>Inspection<br>Limitations: Dense<br>Vegetation | Cut back low limb over garden of 144 Wargrave Road by 3m to suitable reduction points in order to leave a natural looking canopy outline (within 12 months).<br><br><b>Timescale:</b><br>08-Sep-2026<br>(1 Year) | |

| Ref: | Species | what3words<br>(Location Identifier) | Recommendations | Work Timescale |
|---|---|---|---|---|
| T010 | Lime<br>(Tilia sp.) | ///weeded.covenants.juggles | Cut back low limb over garden of 144 Wargrave Road by 3m to suitable reduction points in order to leave a natural looking canopy outline (within 12 months). | 08-Sep-2026<br>(1 Year) |

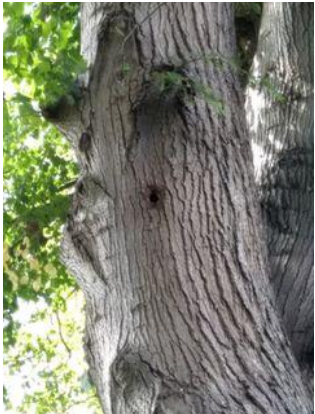
| Ref: | Species | Measurements | Survey Notes | Condition | Other Data | Recommendations | Photo |
|---|---|---|---|---|---|---|---|
| T011 | Lime<br>( <i>Tilia sp.</i> ) | Height (m): 20<br>Crown Radius (m): 8<br>DBH (cm): 85<br>Life Stage: Mature<br>Life Exp.: 40+ Years | Single stem tree. Base and lower trunk obscured by dense vegetation. Where accessible, base clear, bark intact. No fungal fruiting bodies evident. Twin stem from 4m with 0.5m of included bark between stems. Small habitat hole @5m on western side of tree not associated with any pruning cut or branch removal. No visible sign of bark necrosis or decay in this area, however the hole is indicative of decay. High, oval crown. Foliage dense and even. Good vitality. | Fair | Wildlife Value:<br>Good<br>Inspection<br>Limitations: Dense<br>Vegetation | Remove epicormic growth to a height of 6m above ground level. Reduce lateral spread of northern crown over garden of 144 Wargrave Road to reduce overbearing branches in relation to garden. Climbing inspection of habitat hole.<br><br><b>Timescale:</b><br>08-Sep-2026<br>(1 Year) | |

| Ref: | Species | what3words<br>(Location Identifier) | Recommendations | Work Timescale |
|---|---|---|---|---|
| T011 | Lime<br>(Tilia sp.) | ///fattening.stems.clings | <ul style="list-style-type: none"> <li>Remove epicormic growth to a height of 6m above ground level.</li> <li>Reduce lateral spread of northern crown over garden of 144 Wargrave Road to reduce overbearing branches in relation to garden. Inspect the depth and condition of wood around area with habitat hole when climbing tree.</li> </ul> | 08-Sep-2026<br>(1 Year) |

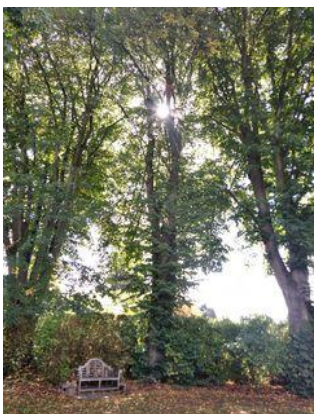
| Ref: | Species | Measurements | Survey Notes | Condition | Other Data | Recommendations | Photo |
|---|---|---|---|---|---|---|---|
| T012 | Lime<br>( <i>Tilia sp.</i> ) | Height (m): 20<br>Crown Radius (m): 8.5<br>DBH (cm): 95<br>Life Stage: Mature<br>Life Exp.: 40+ Years | Single stem. Base partially obscured by hedge and dense epicormic growth. Where accessible base clear, bark intact. Three even sized stems grow vertically from 2.2m. Union satisfactory. 1of 3 stems heavily reduced which will reduce strain on area of bark inclusion in the fork. Union between remaining stems satisfactory. Oval, suppressed crown. Foliage dense and even. No major deadwood. | Fair | Wildlife Value:<br>Good<br>Inspection<br>Limitations: Dense<br>Vegetation | Remove epicormic growth and crown lift to create 5m canopy clearance above ground level. Reduce lateral spread of northern crown over garden of 144 Wargrave Road to reduce overbearing branches in relation to garden.<br><br><b>Timescale:</b><br>08-Sep-2026<br>(1 Year) | |

| Ref: | Species | what3words<br>(Location Identifier) | Recommendations | Work Timescale |
|---|---|---|---|---|
| T012 | Lime<br>(Tilia sp.) | ///keyboards.forced.garlic | <ul style="list-style-type: none"> <li>Remove epicormic growth and crown lift to create 5m canopy clearance above ground level</li> <li>Reduce lateral spread of northern crown over garden of 144 Wargrave Road to reduce overbearing branches in relation to garden.</li> </ul> | 08-Sep-2026<br>(1 Year) |

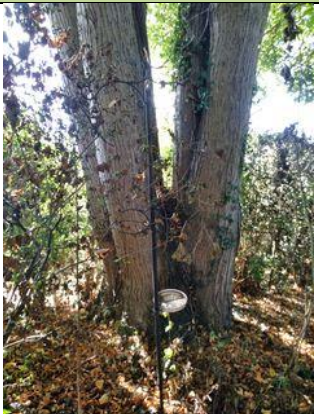
| Ref: | Species | Measurements | Survey Notes | Condition | Other Data | Recommendations | Photo |
|---|---|---|---|---|---|---|---|
| T013 | Lime<br>( <i>Tilia sp.</i> ) | Height (m): 20<br>Crown Radius (m): 7<br>DBH (cm): 45<br>Stems: 6<br>Life Stage: Mature<br>Life Exp.: 40+ Years | Multi-stem from ground level. Included bark between individual stems. Organic matter built up in fork. No obvious defects / decay or fungi around base. No indication of cracking or separation of stems. Fastigate crown formed of multiple slender stems some forked, all of which growing more or less vertically. Full, broad canopy. Foliage dense and even. Good vitality. Occasional small dead branches in canopy. | Fair | Wildlife Value:<br>Good<br>Inspection<br>Limitations: Access | Crown lift to create 5m canopy clearance above ground level.<br><br><b>Timescale:</b><br>Optional | |

| Ref: | Species | what3words<br>(Location Identifier) | Recommendations | Work Timescale |
|---|---|---|---|---|
| T013 | Lime<br>(Tilia sp.) | ///connected.contained.<br>regrowth | Crown lift to create 5m canopy clearance above ground level. | Optional |

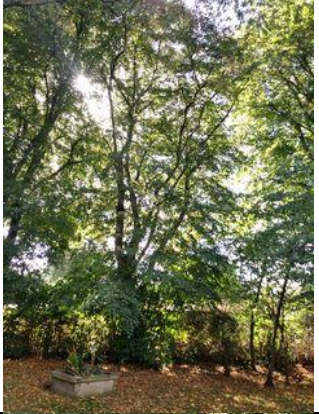
| Ref: | Species | Measurements | Survey Notes | Condition | Other Data | Recommendations | Photo |
|---|---|---|---|---|---|---|---|
| T014 | Lime<br>( <i>Tilia sp.</i> ) | Height (m): 23<br>Crown Radius (m): 6<br>DBH (cm): 70<br>Life Stage: Mature<br>Life Exp.: 40+ Years | Base and lower trunk obscured by Mature epicormic growth on trunk. Where accessible no fungal fruiting bodies evident. Very large epicormic growth has been cut back leaving large decaying stubs. Deeply fluted trunk with three stems from 2.5m. Union satisfactory. High, full crown. Foliage dense and even. No major deadwood. Good and vitality | Good | Wildlife Value:<br>Good<br>Inspection<br>Limitations: Dense Vegetation | Remove epicormic growth off base and lower trunk as required to height of 5m above ground level.<br><br><b>Timescale:</b><br>08-Sep-2026<br>(1 Year) | |

| Ref: | Species | what3words<br>(Location Identifier) | Recommendations | Work Timescale |
|---|---|---|---|---|
| T014 | Lime<br>(Tilia sp.) | ///syndicate.wishes.charts | Remove epicormic growth off base and lower trunk as required to height of 5m above ground level. | 08-Sep-2026<br>(1 Year) |

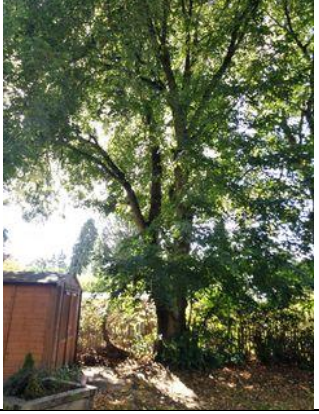
| Ref: | Species | Measurements | Survey Notes | Condition | Other Data | Recommendations | Photo |
|---|---|---|---|---|---|---|---|
| T015 | Lime<br>( <i>Tilia sp.</i> ) | Height (m): 25<br>Crown Radius (m): 7.5<br>DBH (cm): 95<br>Life Stage: Mature<br>Life Exp.: 40+ Years | Mechanical damage to exposed surface roots. Base and trunk partially obscured by boundary, mature epicormic growth and light ivy growth. Where accessible, base clear and bark intact. No fungal fruiting bodies evident. Four-way stem fork at 2.25m. Fork structure satisfactory for species.<br><br>Broad crown, foliage dense and even. No major deadwood. | Fair | Wildlife Value:<br>Good<br>Inspection<br>Limitations: Dense Vegetation | No works identified. | |

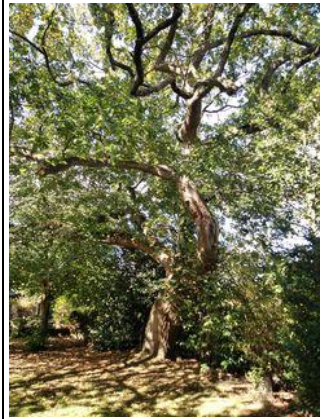
| Ref: | Species | Measurements | Survey Notes | Condition | Other Data | Recommendations | Photo |
|---|---|---|---|---|---|---|---|
| T016 | Pedunculate oak<br>( <i>Quercus robur</i> ) | Height (m): 17<br>Crown Radius (m): 10<br>DBH (cm): 130<br>Life Stage: Veteran<br>Life Exp.: 40+ Years | Swept stem, characterful tree. Base clear, bark intact. Audible decay / hollowing on east side of lower trunk around 300mm wide and 0.6 high. Elsewhere sound initiation even. No fungal fruiting bodies evident. Swept stem northeast broad three-way stem fork 3.5m above ground level from which grow very large extended lateral branches. Larger deadwood in canopy. Large wound from historic storm damage of branch east side of canopy approx. 400mm wide by 800mm high. Good wound wood formation. Foliage slightly sparse and clustered. Epicormic growth on upper side of branches. | Fair | Wildlife Value: High<br>Inspection Limitations: Dense Vegetation | Mulch tree.<br>Remove deadwood.<br><br><b>Timescale:</b><br>Optional | |

| Ref: | Species | what3words<br>(Location Identifier) | Recommendations | Work Timescale |
|---|---|---|---|---|
| T016 | Pedunculate oak<br>(Quercus robur) | ///slipping.slyly.padding | <ul style="list-style-type: none"> <li>Mulch tree.</li> <li>Remove deadwood.</li> </ul> | Optional |

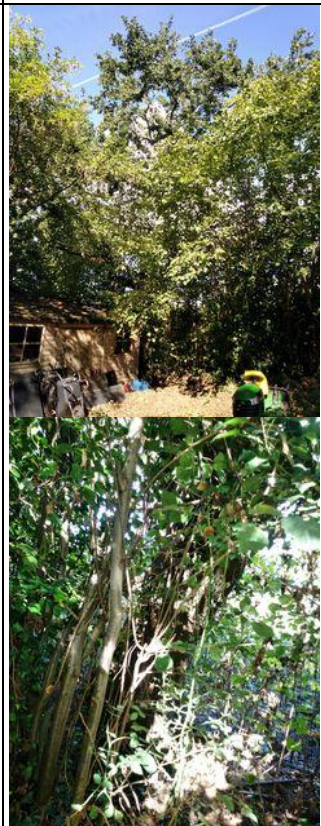
| Ref: | Species | Measurements | Survey Notes | Condition | Other Data | Recommendations | Photo |
|---|---|---|---|---|---|---|---|
| T017 | Pedunculate oak<br>( <i>Quercus robur</i> ) | Height (m): 12<br>Crown Radius (m): 6.5<br>DBH (cm): 60<br>Life Stage: Mature<br>Life Exp.: 40+ Years | Rear tree to rear of shed and within dense hedgerow. Restricted access to base. Where visible swept trunk to north forks at 1.5m. stems above curve back to the south and over the shed within the garden of 144 Wargrave road. Asymmetrical canopy, having been cut back regularly by electricity board to clear adjacent pylon & apparatus. Consequently, tree crown has poor form. Minor deadwood in crown. Foliage slightly sparse and clustered. Low crown over sheds. | Fair | Wildlife Value: Good<br>Inspection Limitations: Access and dense vegetation | Crown lift to create 1.5m canopy clearance over sheds.<br><br><b>Timescale:</b><br>08-Mar-2026<br>(6 Months) | |

| Ref: | Species | what3words<br>(Location Identifier) | Recommendations | Work Timescale |
|---|---|---|---|---|
| T017 | Oak<br>(Quercus robur) | ///depravity.hint.overcomes | Crown lift to create 1.5m canopy clearance over sheds. | 08-Mar-2026<br>(6 Months) |

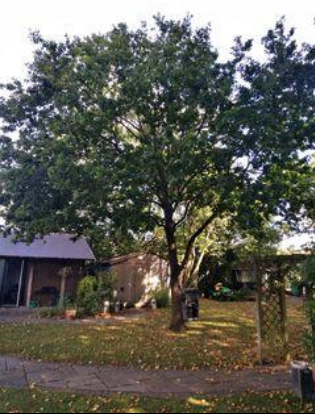
| Ref: | Species | Measurements | Survey Notes | Condition | Other Data | Recommendations | Photo |
|---|---|---|---|---|---|---|---|
| T018 | Pedunculate oak<br>( <i>Quercus robur</i> ) | Height (m): 10<br>Crown Radius (m): 5.5<br>DBH (cm): 34<br>Life Stage: Early Mature<br>Life Exp.: 40+ Years | Young tree with long term potential, good form and vitality. Capacity for significant future growth. | Good | Wildlife Value: Moderate | No works identified. | |

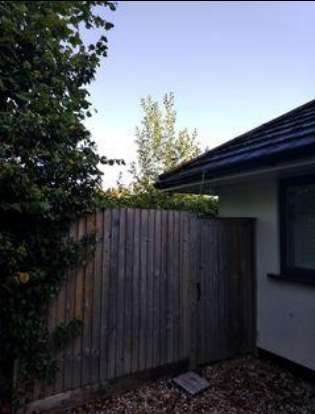
| Ref: | Species | Measurements | Survey Notes | Condition | Other Data | Recommendations | Photo |
|---|---|---|---|---|---|---|---|
| G019 | Willow<br>( <i>Salix sp.</i> ) | Height (m): 4.5<br>Crown Radius (m): 1<br>DBH (cm): 50<br>Life Stage: Young<br>Life Exp.: 40+ Years | Slender young trees, sucker growth from previous felled trees. | Fair | Wildlife Value: Low<br>Inspection Limitations: Access | No works identified. | |

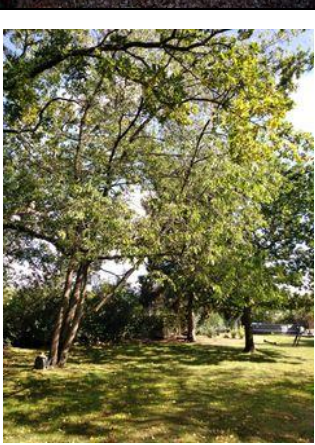
| Ref: | Species | Measurements | Survey Notes | Condition | Other Data | Recommendations | Photo |
|---|---|---|---|---|---|---|---|
| G020 | Mixed species | Various | Walk-over survey of trees in a lower-occupancy area towards the end of the rear garden. Access to area usually weather dependent. Trees include a variety of species including Apple and Cherry, Oak and Norway Spruce, Lime and Hazel mostly mature or semi-mature. Some trees have poor structural form – multi-stem and tight forks – general condition currently satisfactory and no indication of imminent failure. There is localised dieback in the canopy of one Wild Cherry. Minor hazard identified for trees in this area from deadwood or small branch breakages which pose low risk in this area. | Fair | Wildlife Value: Good<br>Inspection Limitations: None | No works identified. | |
