# ARBORICULTURAL REPORT

## TREE CONDITION SURVEY

12 CHESTNUT AVENUE  
WOKINGHAM  
BERKSHIRE  
RG41 3HX

Ref: 06652 / 2025

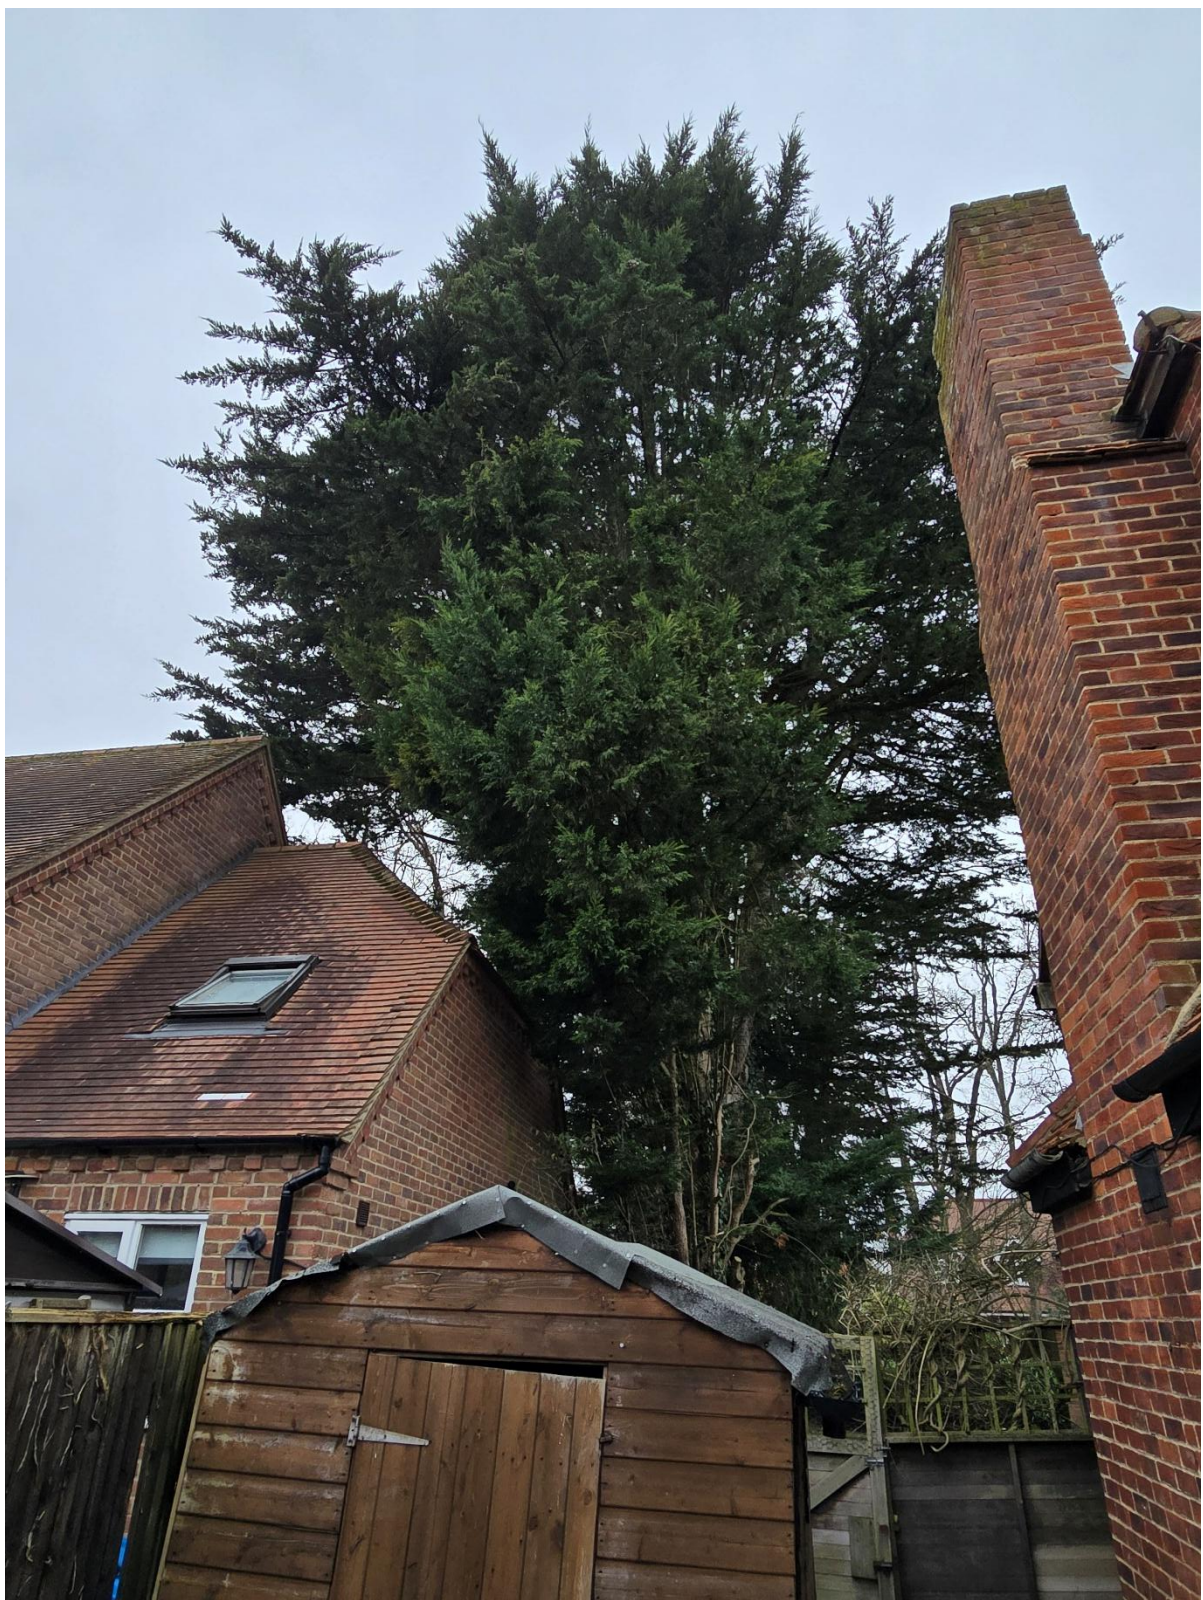
Very asymmetrical, suppressed crown. Dense branching. Weak form but in a sheltered location. Foliage density slightly sparse due to the recent branch breakouts. Low branches in direct contact with neighbouring residential property.

Photo 3) Branches close to neighbouring residential property.

| <b>Recommended Tree Works:</b> <ul style="list-style-type: none"> <li>Selectively reduce and remove secondary and tertiary branches to create 0.5-1m clearance of branches to the neighbour's garage.</li> <li>Crown clean removing any deadwood, split or broken branches</li> </ul> | Priority | Within 6 months |

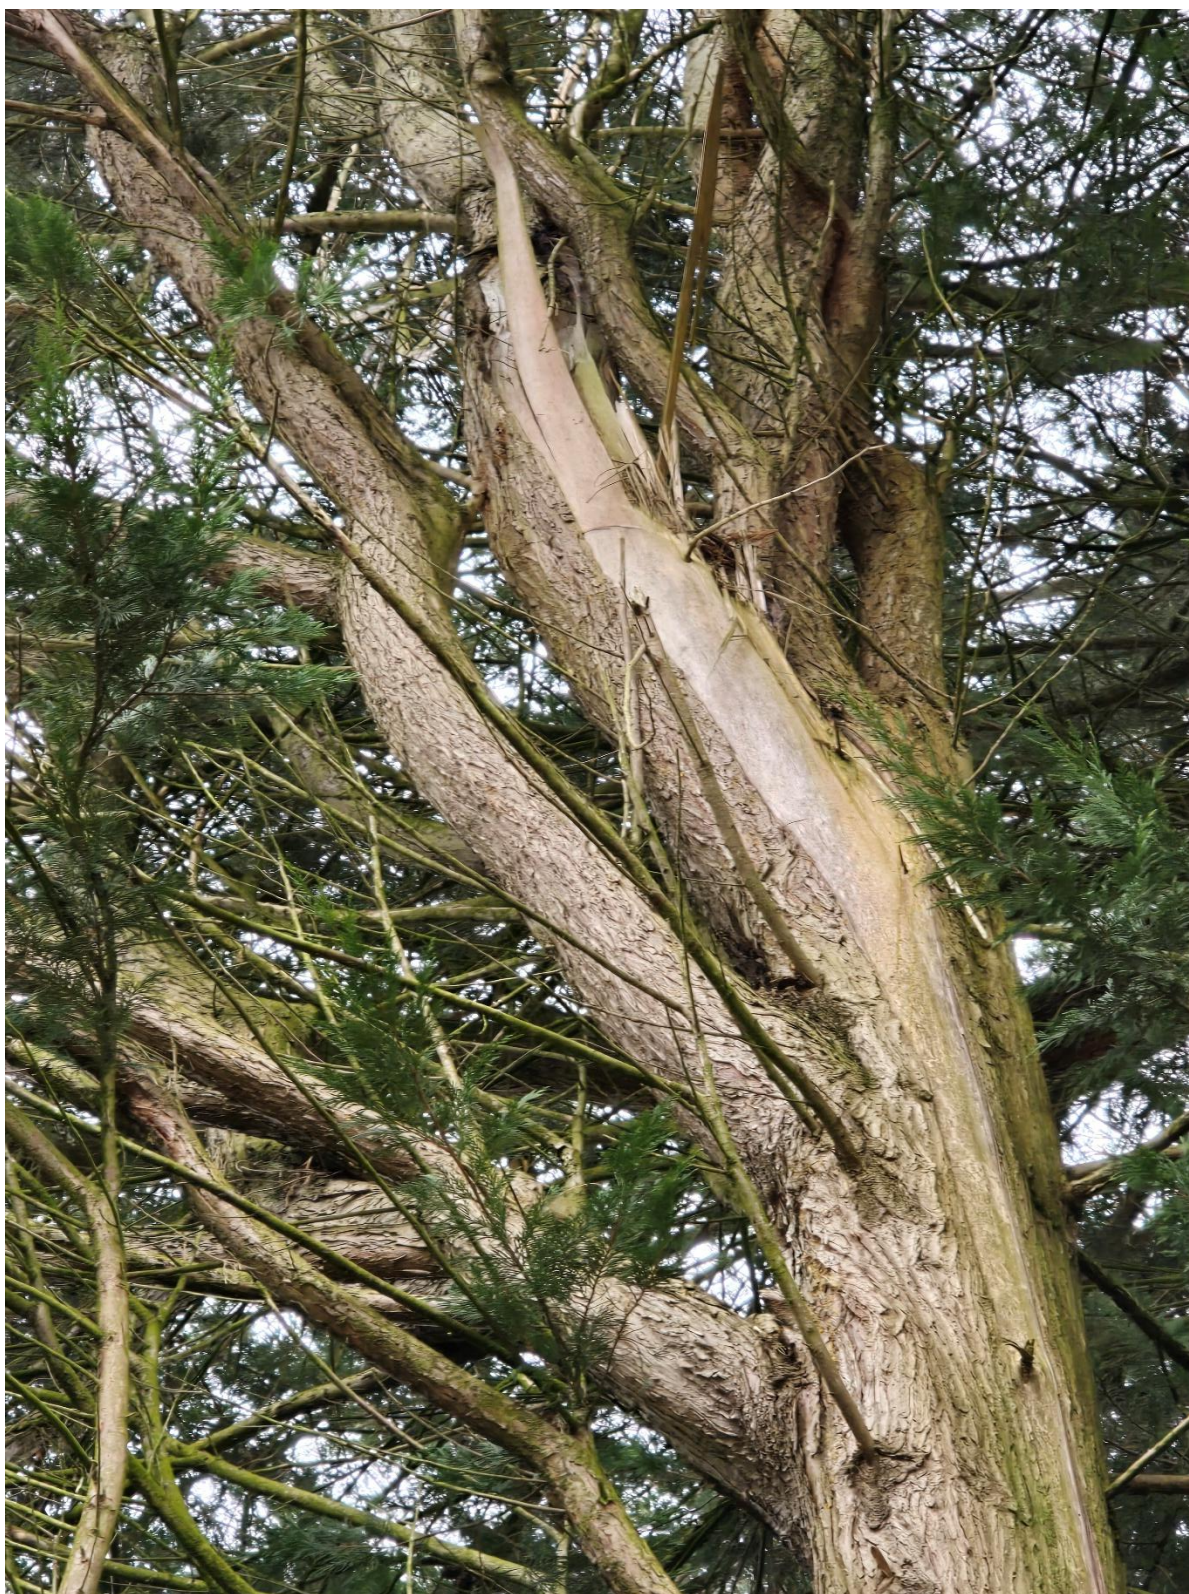
T2 has recently suffered a significant branch breakage which required emergency works to remove broken hanging branches from the tree's canopy. The falling branch has left a large wound within the canopy of the tree. A large wound remains on the trunk and bark has been stripped off for approximately 3m below the wound site.

Photo 4) Wound and bark damage following recent branch failure

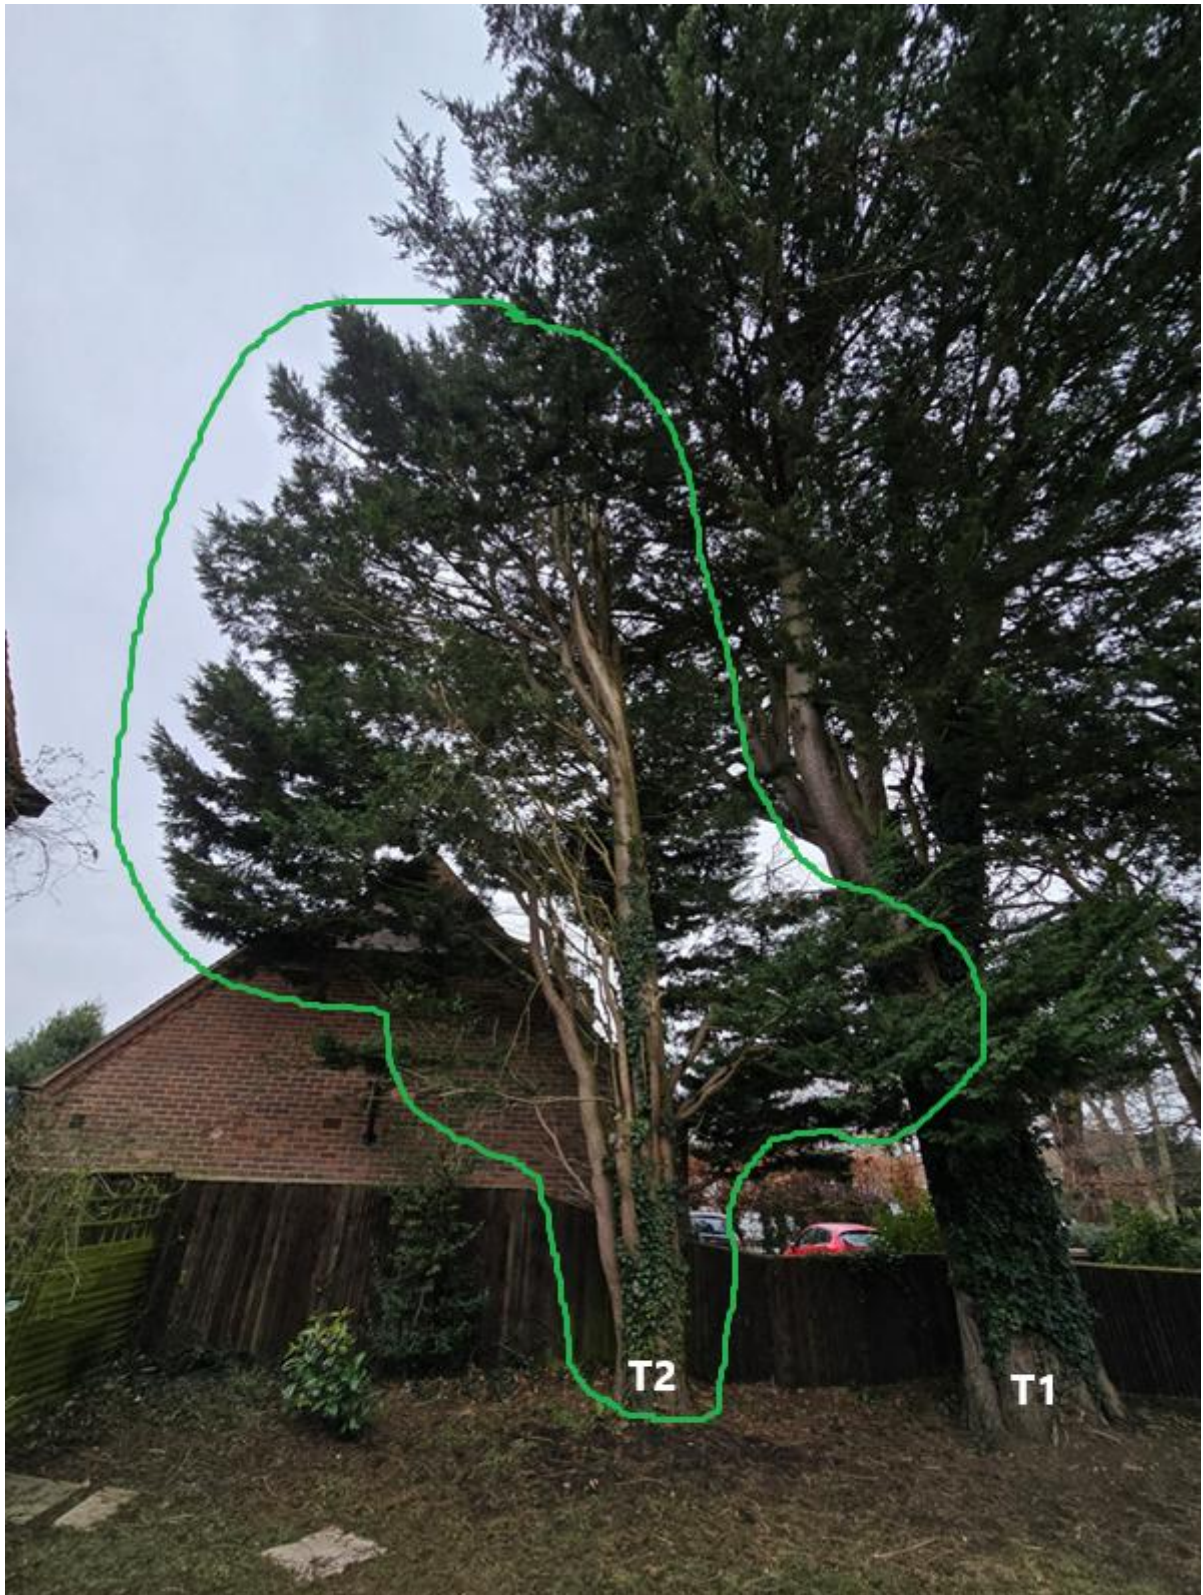
**DISCUSSION:** T2 is a poorly formed conifer with a multi-stem form and very asymmetrical crown having been suppressed throughout its growing life by the adjacent larger crown of T1 (Monterey Cypress). Many species of mature conifers are prone to shed branches, and the multi-stem form of the tree is common for mature Leylandii and an inherently weaker structure.

Photo 5) Suppressed asymmetrical canopy of T2 (Leyland Cypress)
