# ARBORICULTURAL REPORT

## TREE CONDITION SURVEY

8 SOUTH DRIVE  
WOKINGHAM  
BERKSHIRE  
RG40 2DH

AUGUST 2025  
Ref: 06810 / 2025

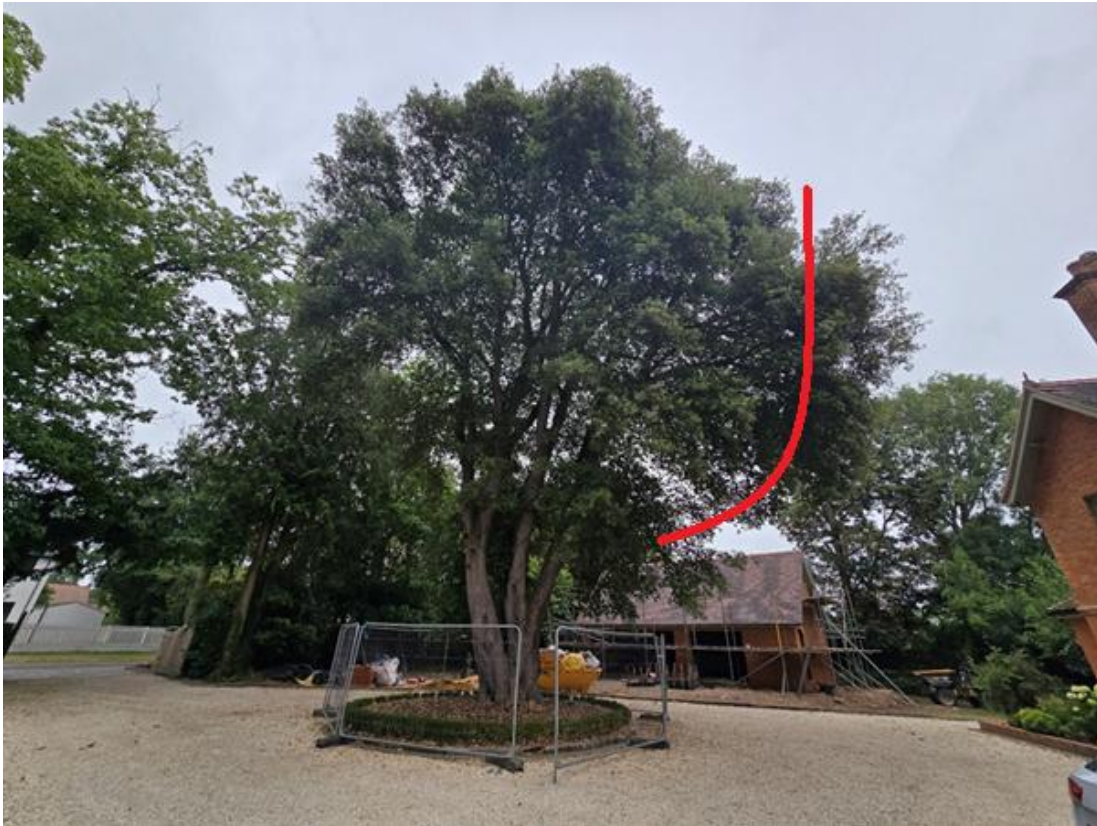
The physiological health of the tree varies across the crown. Branches on the southern side of the crown are elongated and are more heavily weighted than in other areas. Minor works are therefore recommended to selectively reduce the lateral spread on the south side of the tree only in order to reduce the weight of the branches and asymmetry of the tree's canopy.

Photo 1 – T1 (Holm Oak) Indicative line of proposed reduction of denser elongated branch tips on south side of canopy

| <b>Recommended Tree Works:</b> <ul style="list-style-type: none"> <li>Crown lift 5m over private driveway of 8 South Drive</li> <li>Selectively thin and reduce branch tips on the south side of crown by up to 2m to reduce on weight / exposure of dense branches on south side of crown.</li> </ul> | Priority | Within 6 months |

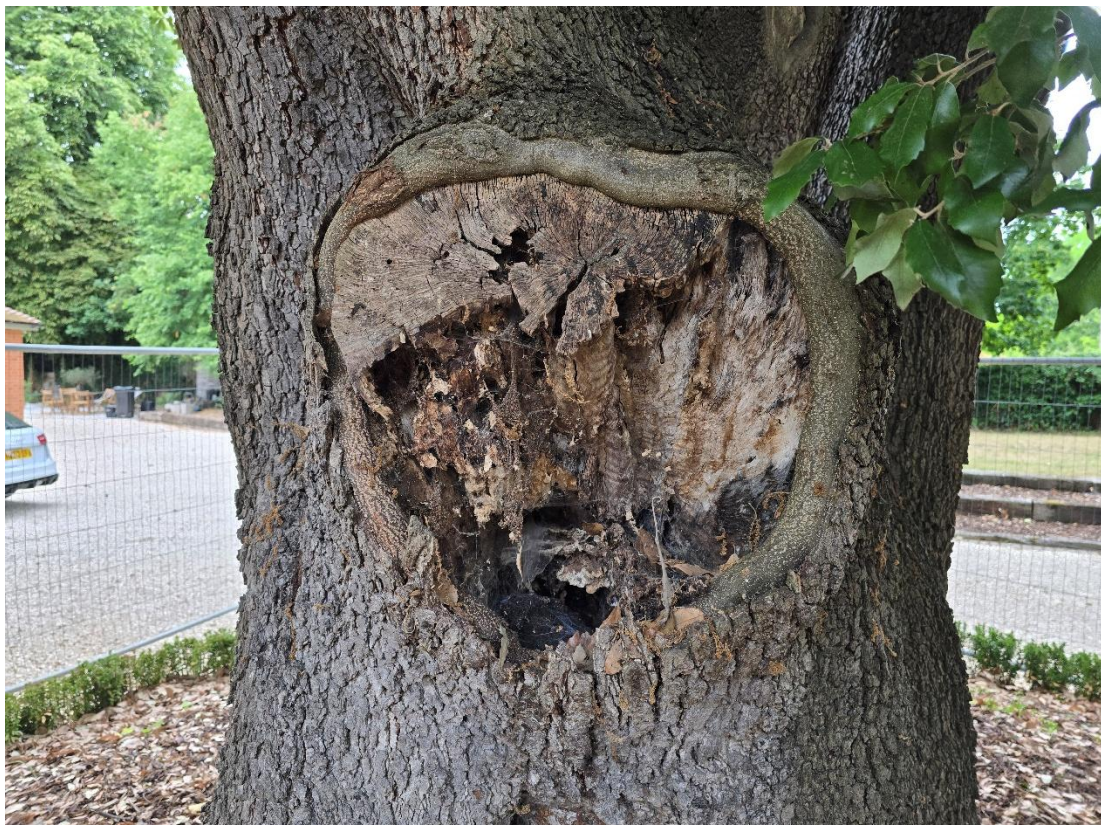
Cavity on east side 1.2-1.8m 400mm diameter associated with previous branch removal, Active decay present. Limited wound wood formation. Wound cannot be probed for beyond cavity (500mm deep).

Photo 2 – T1 (Holm Oak) historic pruning cuts and cavity on trunk

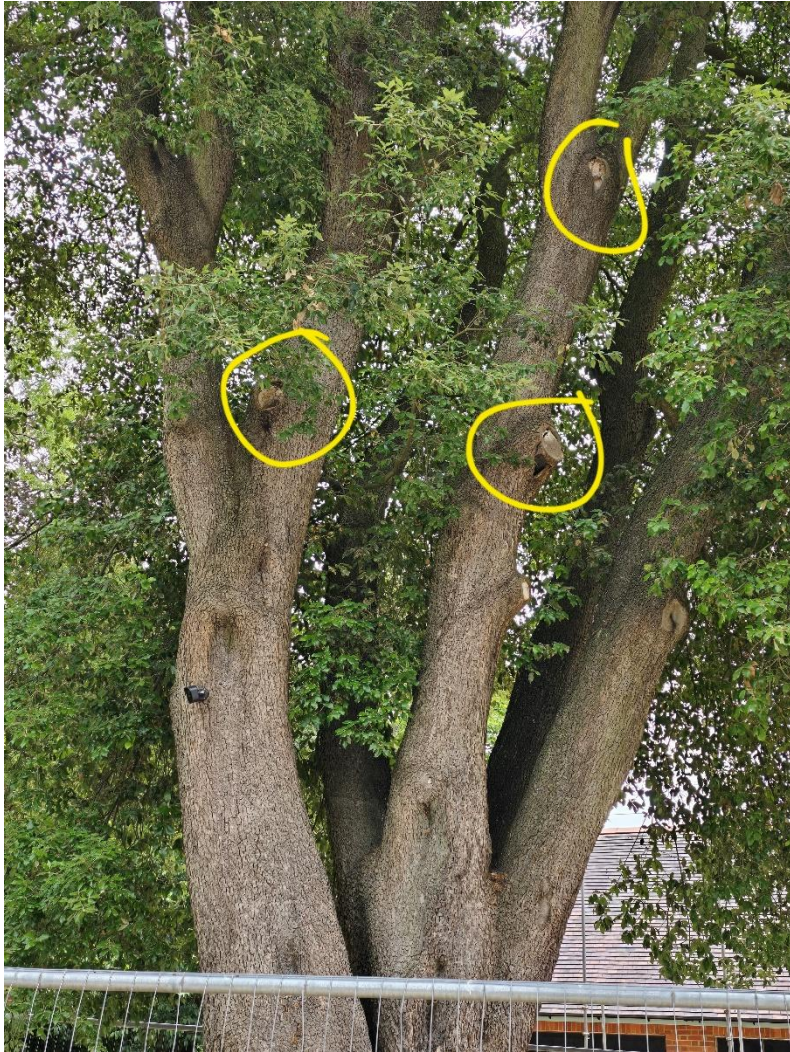
Canopy formed of 5 main stems. High broad, asymmetrical crown. No sign of separation or gaps in the crown which could indicate separation of stems / trunks. Multiple cavities on branches and stems throughout the crown associated with previous pruning cuts

Photo 3 – T1 (Holm Oak) historic pruning cuts and cavities in crown

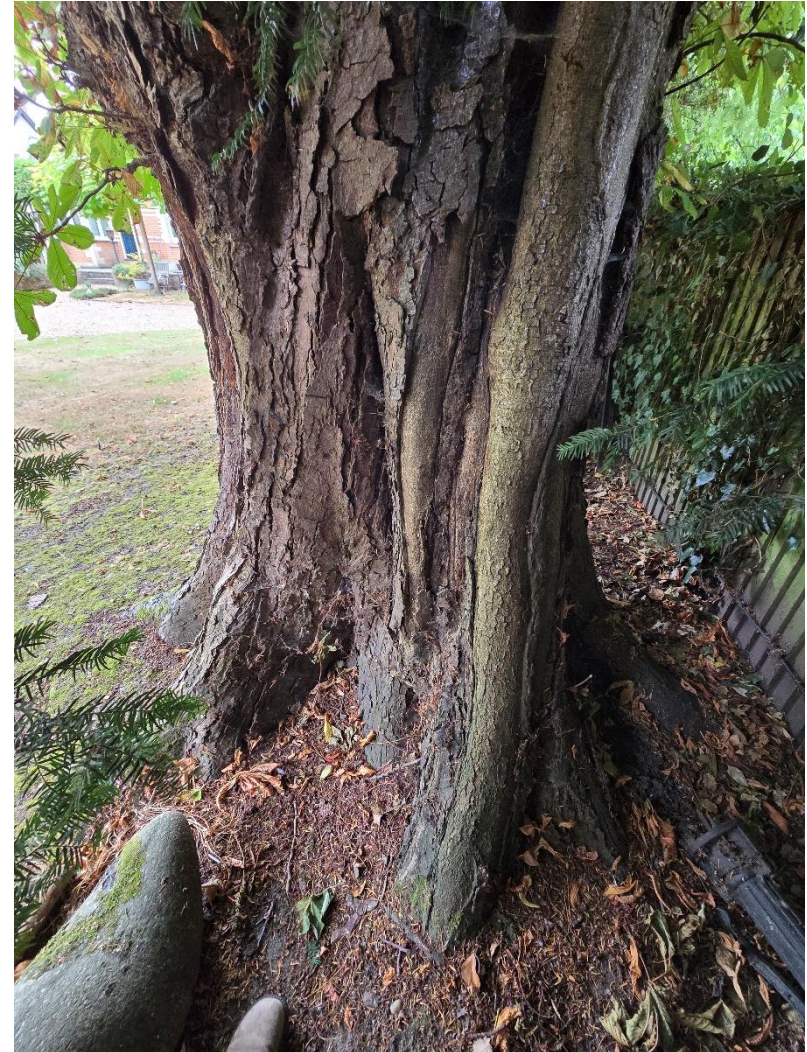
**BASE:** Pronounced buttress roots on all sides. Deeply fluted trunk. Rapid-growth vertical bark expansion scars on several ridges.

Multiple vertical cracks and ribs of wound wood formation on trunk – this feature is not uncommon for species. However, there are two large and very significant wounds on bark either side of fork with large ribs of new wood (10-12cm diameter) – this feature could indicate decay or the possible early failure of the stem fork. Further investigation of these features is recommended. Two large stems above fork approximately 600mm diameter.

Photo 4 – T2 (Horse Chestnut) rapid growth bark cracks on trunk

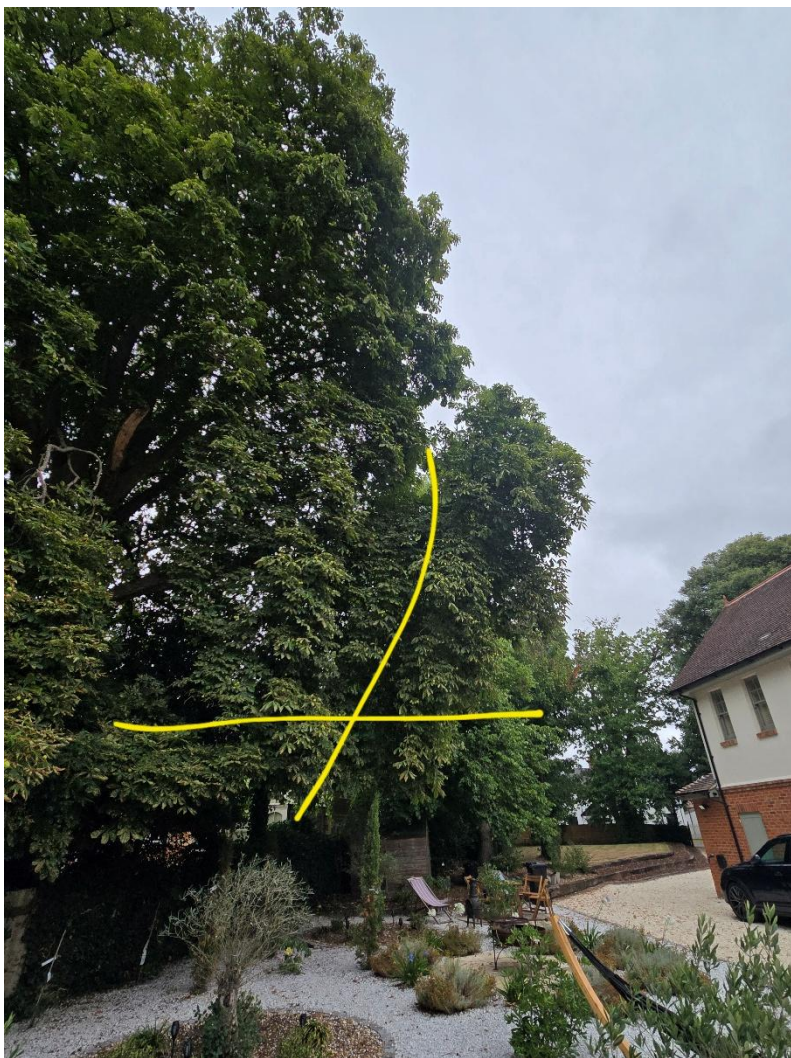
Elongated branch on east side 6m above ground level with a raised ridge close to where it joins the trunk. This feature indicates a possible internal crack / sheer of internal wood fibres. This elongated limb is undulating in form (not straight). The branch extends beyond the surrounding crown and in this location is exposed to greater wind loading. The branch has a higher risk of failure.

Photo 5 – T2 (Horse Chestnut) indicative line of proposed lateral reduction

| <b>Recommended Tree Works:</b> <ul style="list-style-type: none"> <li>Remove rope around branch on west side of crown</li> <li>Climbing inspection of fork@ 5.5m above ground level</li> <li>Crown lift to create 5m canopy clearance over garden of 8 South drive</li> <li>Reduce tips of extended branch on east side of crown back to form-from 10-6.5m radius</li> </ul> | Priority | Within 6 months |

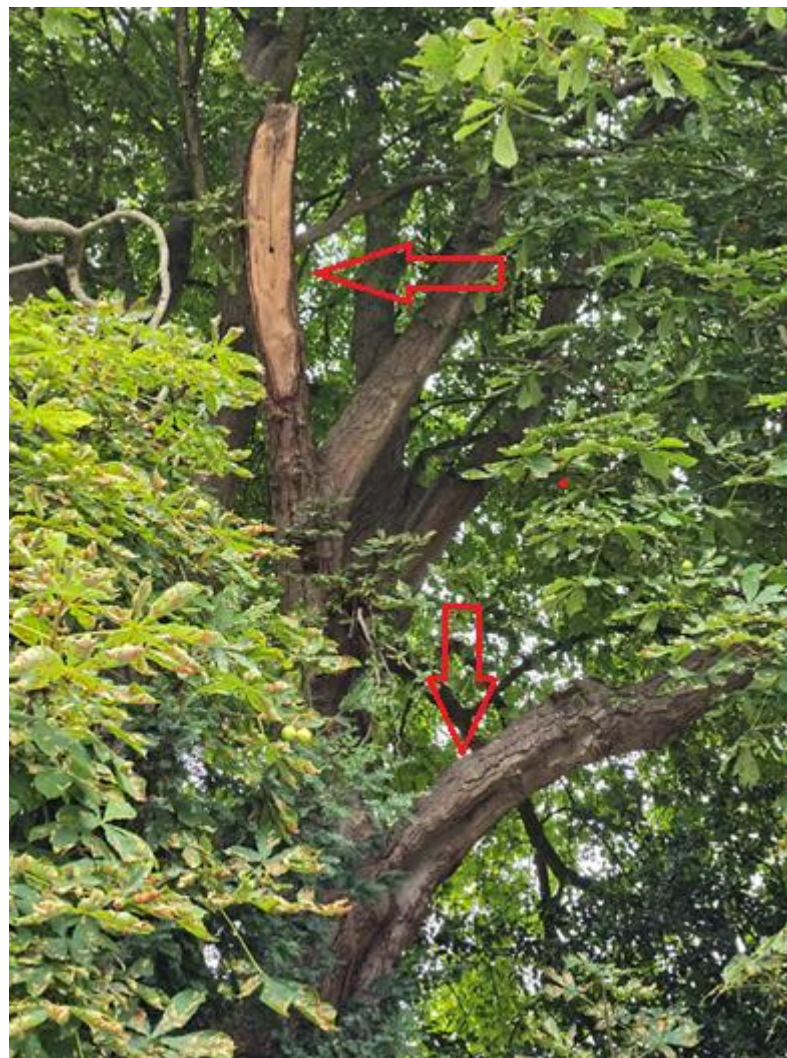
Broken branch on southeast side of crown approximately 8m above ground level over the garden of 8 South Drive. The broken branch was approximately 300mm diameter leaving broken stump 2m long.

The Horse Chestnut has previously shed a branch over the garden of 8 South Drive and there are valid concerns that an adjacent branch elongated is similarly undermined by a split close to the branch collar. Works are recommended to reduce this limb to reduce the weight of the branch and risk of the fracture spreading or breaking completely.

Photo 6 – T2 (Horse Chestnut) broken branch, and raised ridge indicating internal split on lower branch
