# ARBORICULTURAL REPORT

## TREE CONDITION SURVEY

8 SOUTH DRIVE  
WOKINGHAM  
BERKSHIRE  
RG40 2DH

AUGUST 2025  
Ref: 06810 / 2025

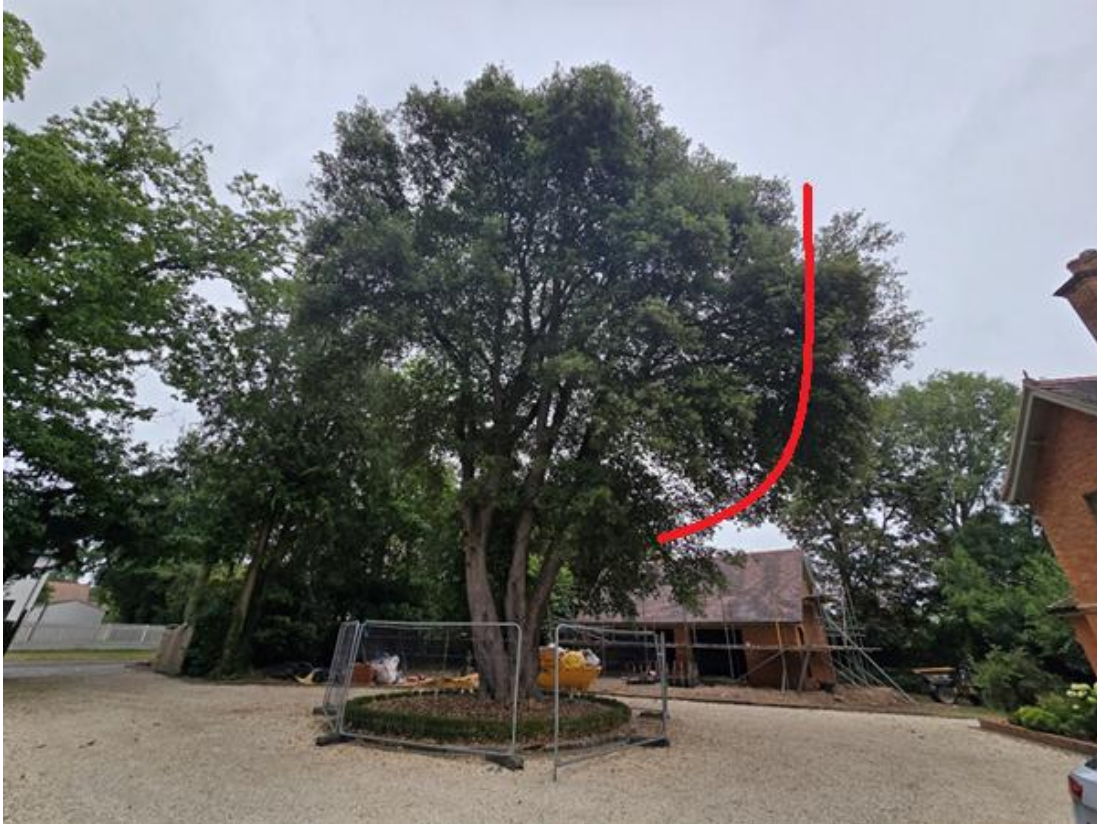
The physiological health of the tree varies across the crown. Branches on the southern side of the crown are elongated and are more heavily weighted than in other areas. Minor works are therefore recommended to selectively reduce the lateral spread on the south side of the tree only in order to reduce the weight of the branches and asymmetry of the tree's canopy.

Photo 1 – T1 (Holm Oak) Indicative line of proposed reduction of denser elongated branch tips on south side of canopy

| <b>Recommended Tree Works:</b> <ul style="list-style-type: none"> <li>Crown lift 5m over private driveway of 8 South Drive</li> <li>Selectively thin and reduce branch tips on the south side of crown by up to 2m to reduce on weight / exposure of dense branches on south side of crown.</li> </ul> | Priority | Within 6 months |

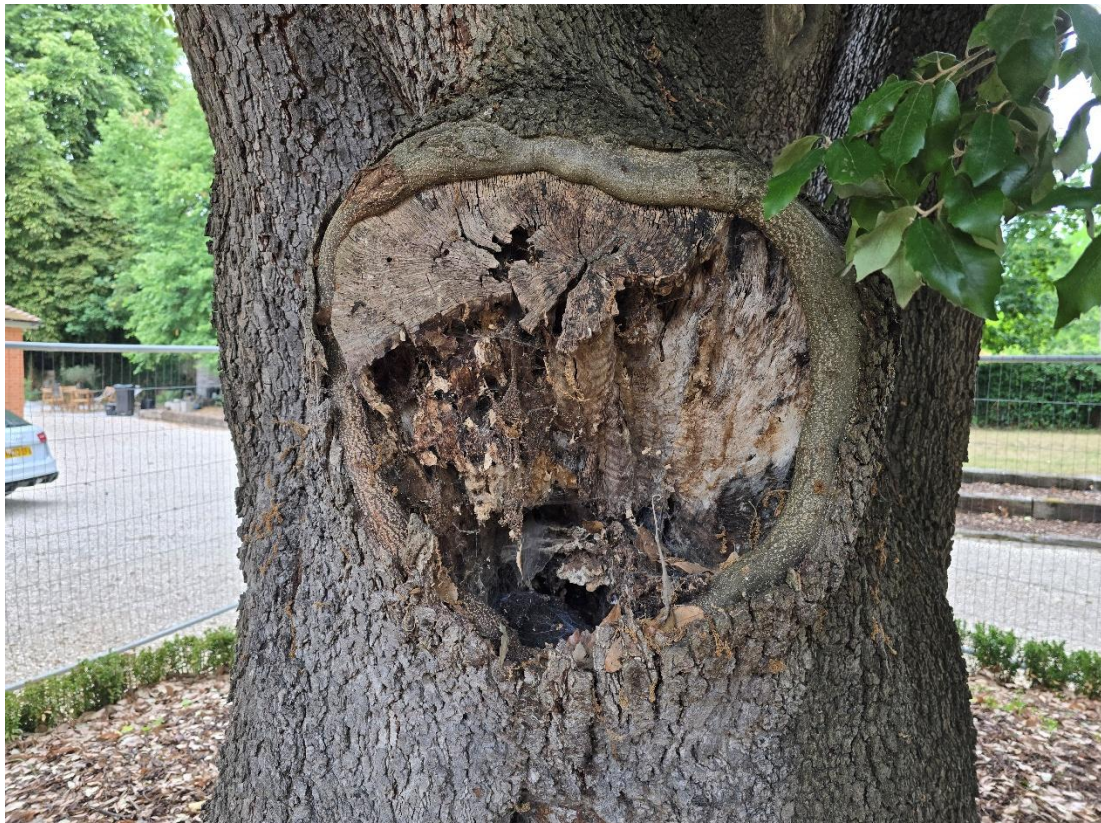
Cavity on east side 1.2-1.8m 400mm diameter associated with previous branch removal, Active decay present. Limited wound wood formation. Wound cannot be probed for beyond cavity (500mm deep).

Photo 2 – T1 (Holm Oak) historic pruning cuts and cavity on trunk

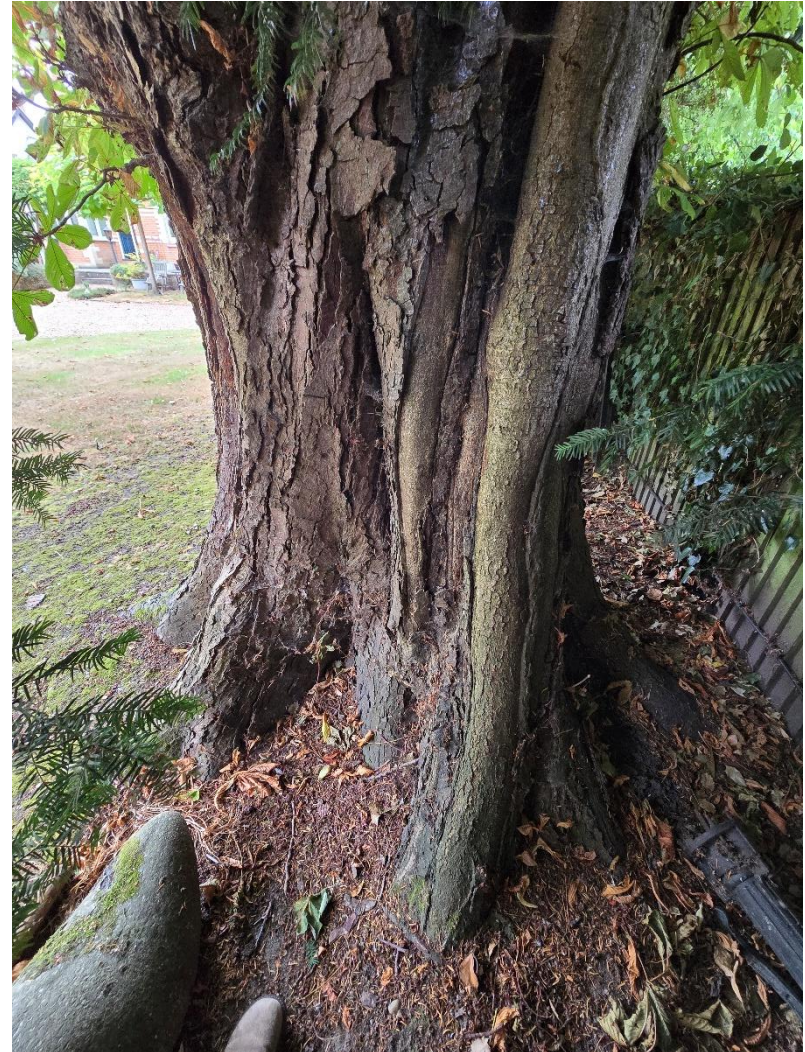
**BASE:** Pronounced buttress roots on all sides. Deeply fluted trunk. Rapid-growth vertical bark expansion scars on several ridges.

Multiple vertical cracks and ribs of wound wood formation on trunk – this feature is not uncommon for species. However, there are two large and very significant wounds on bark either side of fork with large ribs of new wood (10-12cm diameter) – this feature could indicate decay or the possible early failure of the stem fork. Further investigation of these features is recommended. Two large stems above fork approximately 600mm diameter.

Photo 4 – T2 (Horse Chestnut) rapid growth bark cracks on trunk
