# Holt Arboriculture

## TREE CONDITION ASSESSMENT REPORT

30 Henley Wood Rd  
Earley  
Reading  
RG6 7EE

Ref: 250519-1.0-30HWR-ACA

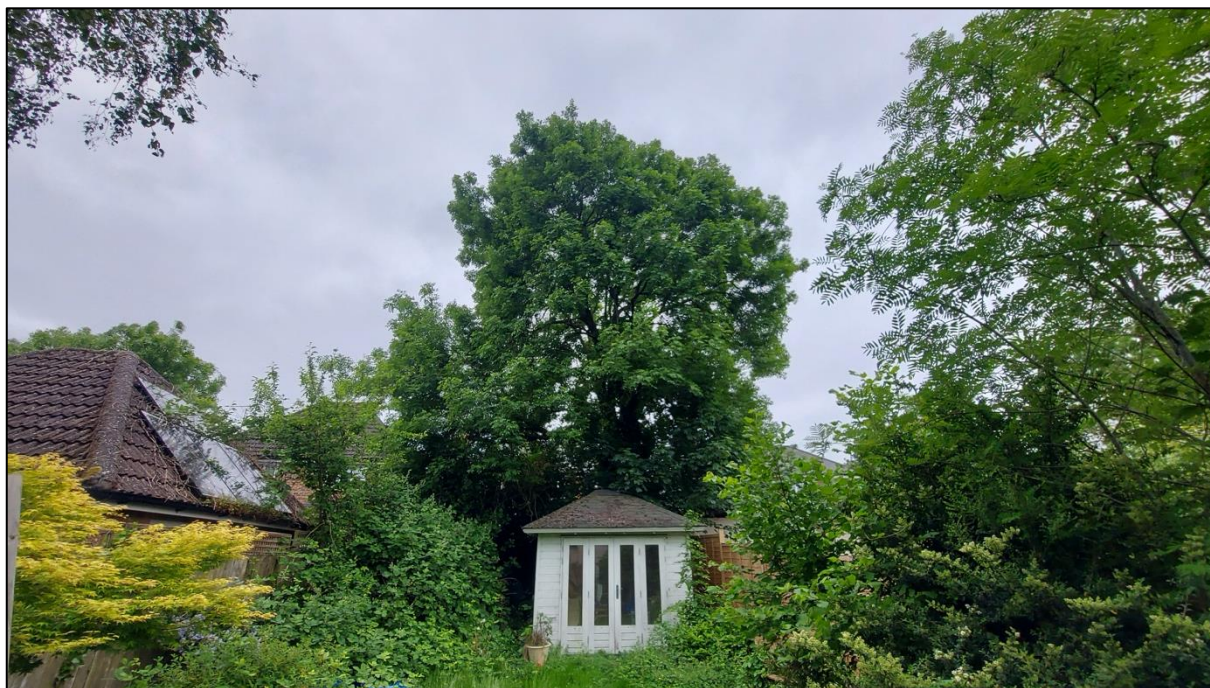
**Photo 1:** Showing T1 and T2 within a local setting.

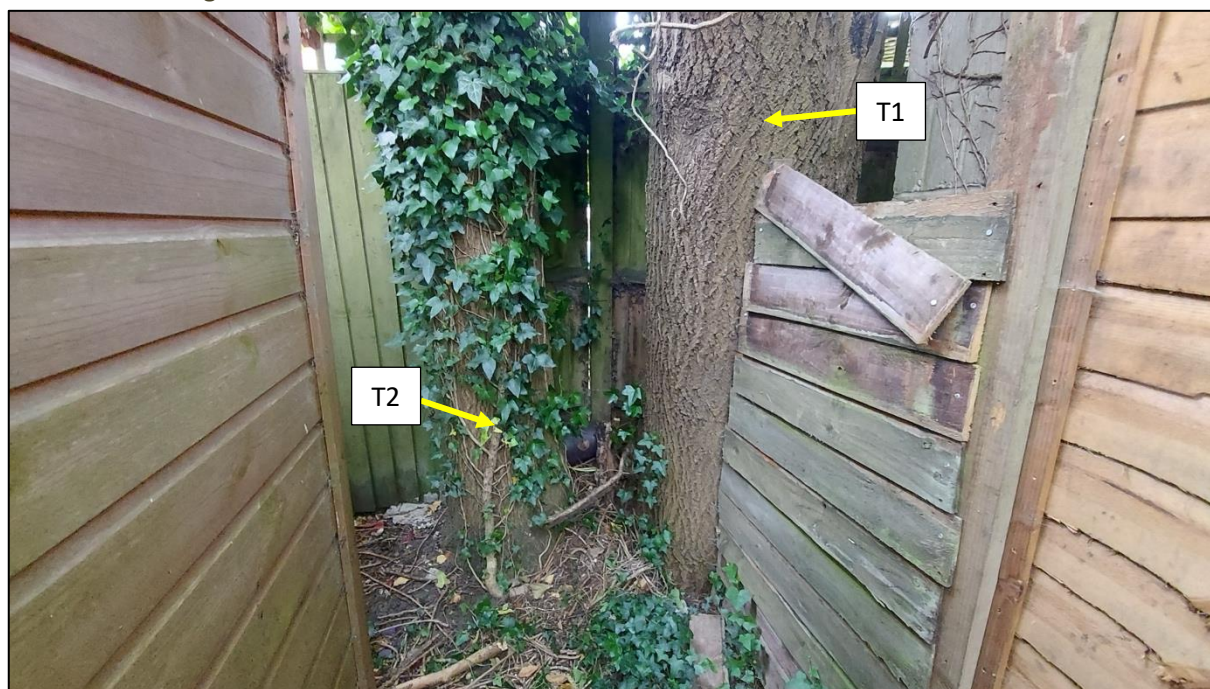
**Photo 2:** Showing base of T1 and T2

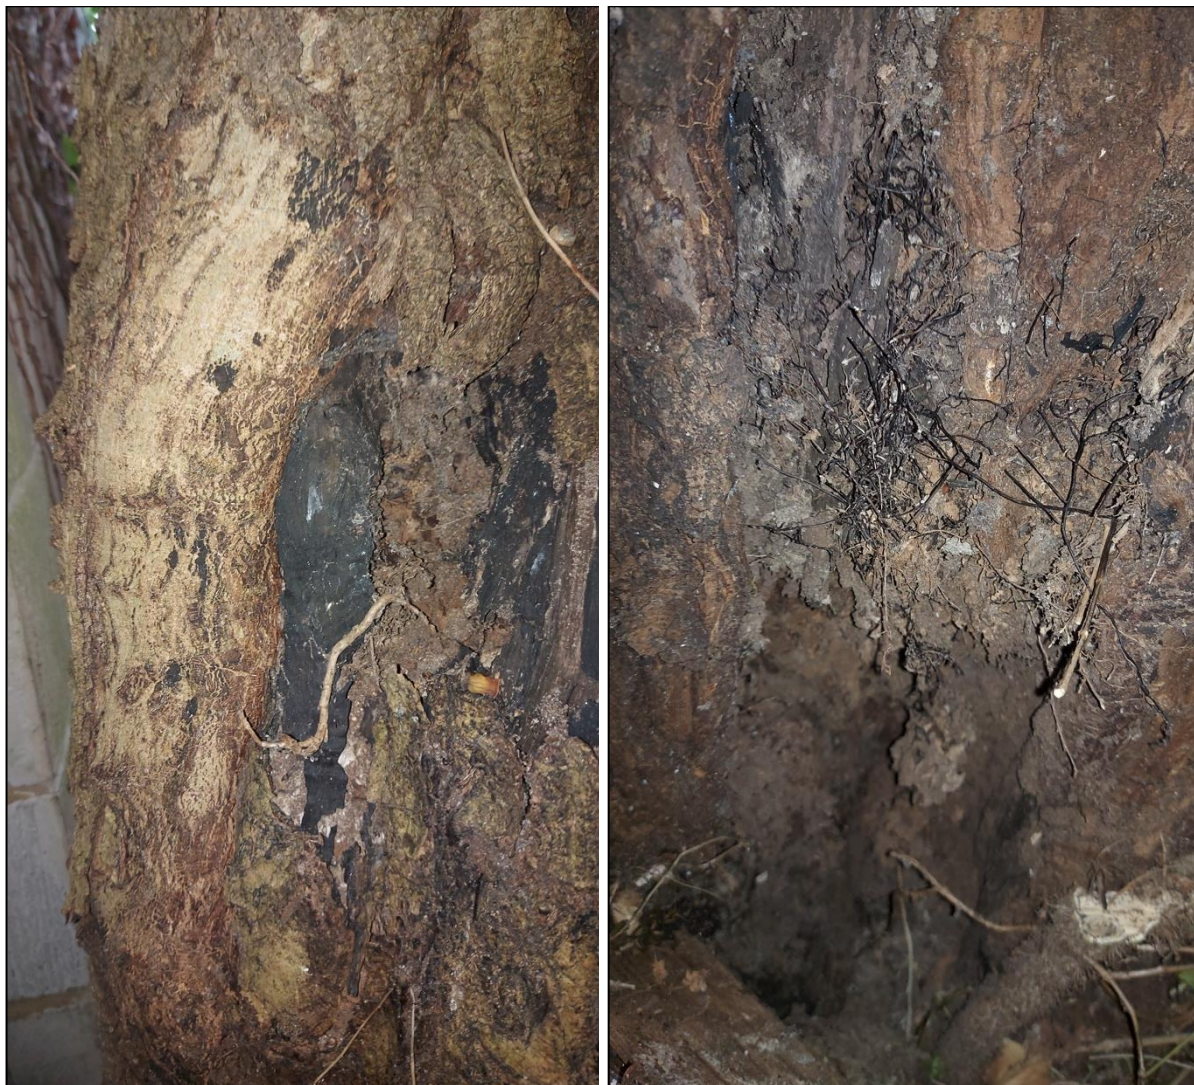
| No. | Species | Height | Diameter at 1.5m approx | Spread (m) | Age class |
|---|---|---|---|---|---|
| | | <p><u>Rooting area:</u> No access to the land to the south, however within the garden of 30 Henley Wood Drive, and the adjacent property there were several garden buildings within the rooting area of the tree. No evidence of recent root plate movement.</p> <p><u>Lower trunk:</u> Extensive decay evident on the southern side of the basal and lower trunk. Cavity within base approx. 200mm deep. Longitudinal scar from 2-5m on northern side with a partially occluded branch stub scar at top.</p> <p><u>Trunk and scaffold branches:</u> Lean to northeast. Partially obscured by foliage. Observable areas did not reveal any cavities, large broken limbs, or large diameter deadwood within the crown. Branch architecture is typical of the species.</p> <p><u>Outer branches &amp; buds/foliage:</u> Asymmetrical crown weighted to north. Reasonable foliar cover and extension growth, with no discernible impact from Chalara Ash Dieback disease (<i>Hymenoscyphus fraxineus</i>). No significant areas of dieback or deadwood, beyond what is typical of the species.</p> | | | |
| | | <p>The tree has a significant structural issue at the base and lower trunk. Whilst access was limited, I was able to lean over with a probe and find that there was a cavity at the base and other higher areas of active decay to a height of approximately 1.5m. It is likely that the decay has spread both upwards into the trunk and downwards into the roots. It is also likely that the column of decay will coalesce with the earlier damage on the north aspect.</p> <p>I do not consider that crown reduction is a suitable method of mitigating against the hazard due to the extent of the dysfunctional wood, and the location of the tree growing over well used residential gardens.</p> | | | |

**Photos 3 & 4:** Decayed areas in lower trunk of T1.

| No. | Species | Height | Diameter at 1.5m approx | Spread (m) | Age class |
|---|---|---|---|---|---|
| | | Fell tree and replace. | | Priority | Resurvey |

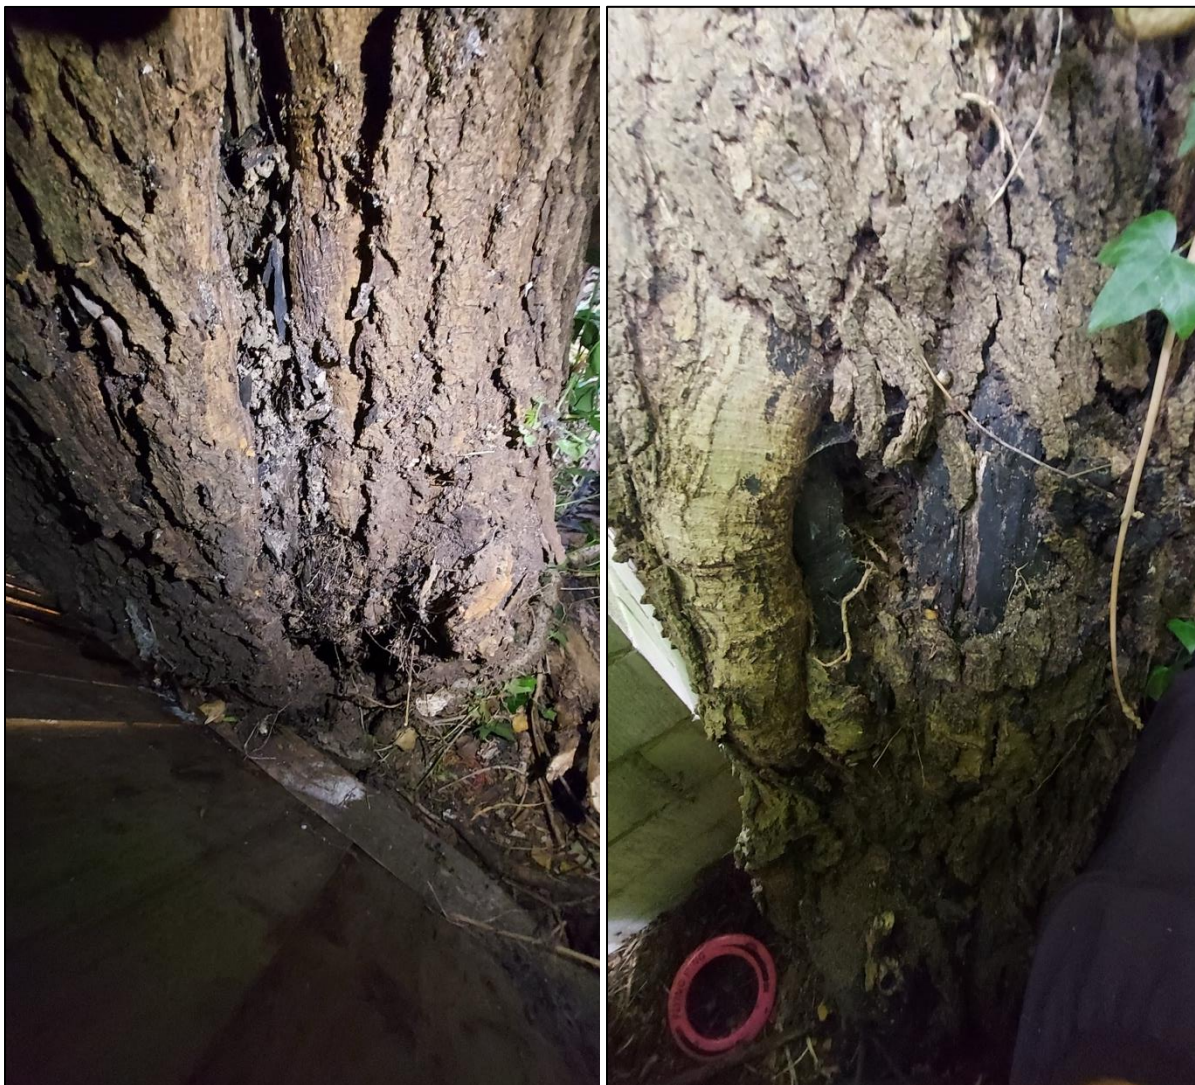
**Photos 5 & 6:** Decayed areas in lower trunk of T1.

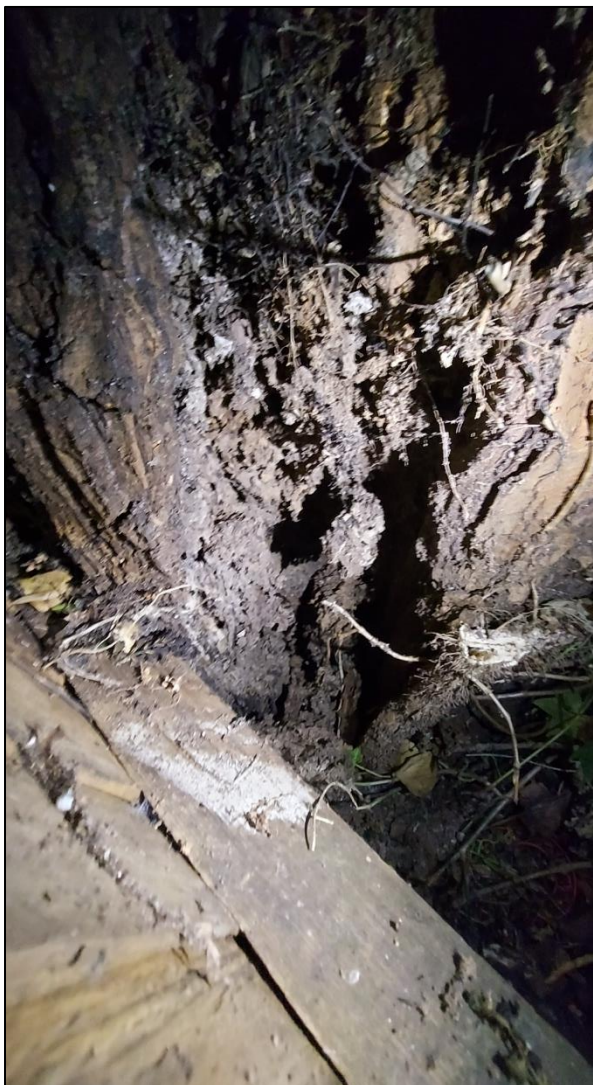
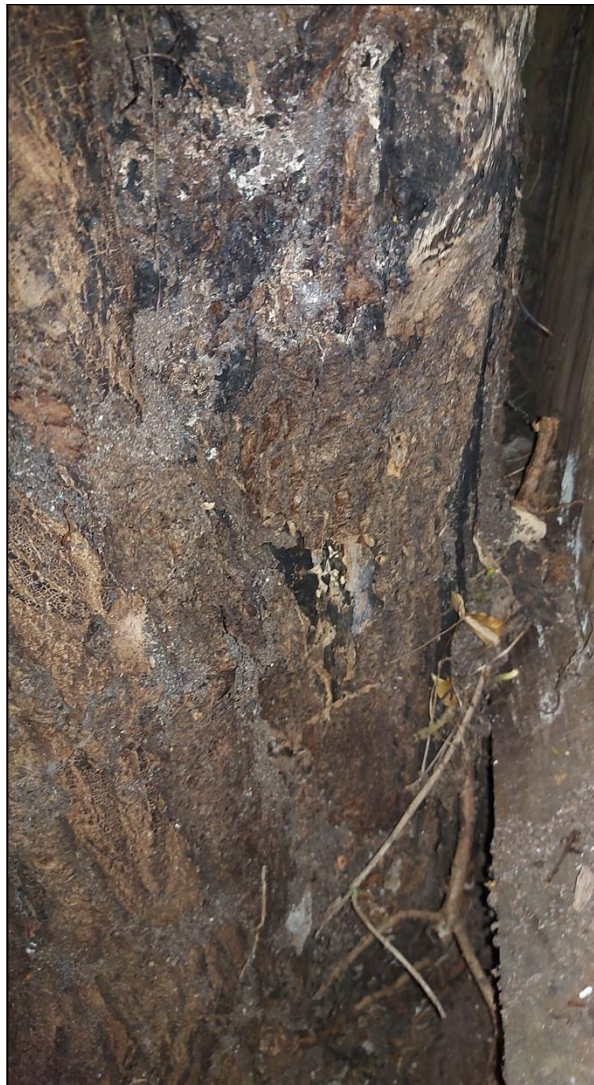
**Photos 7 & 8:** Decayed areas in lower trunk of T1.
