# Wood's

Tree Consultancy Ltd

## HEALTH AND SAFETY ARBORICULTURAL REPORT

Site Address: 58 Heathermount Drive, Crowthorne, Berkshire, RG45 6HN

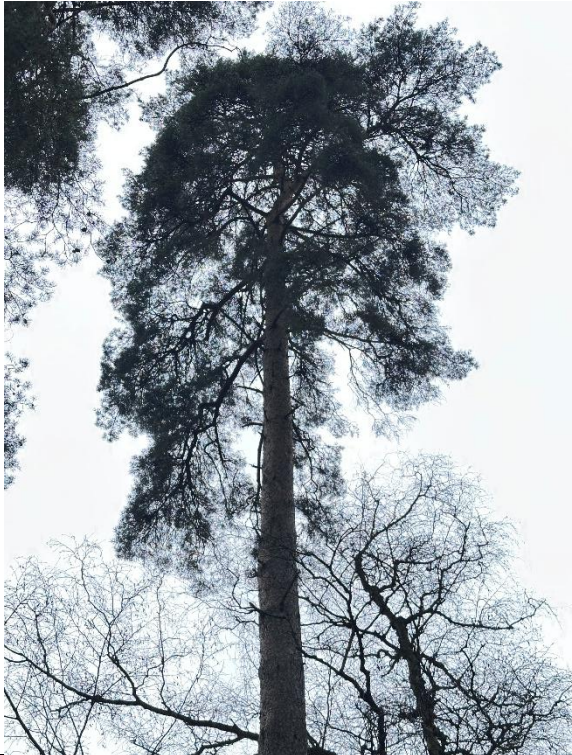
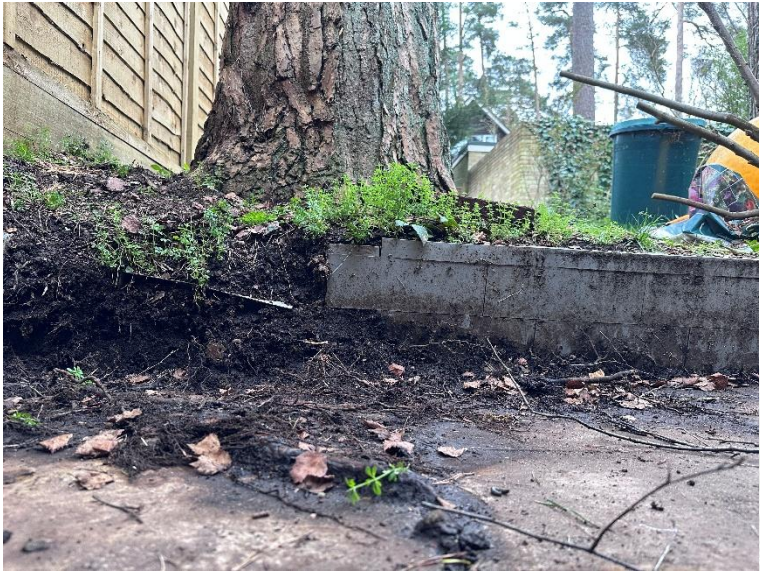
The basal area of the tree is somewhat restricted by the adjacent garage which is 2.34m away. Furthermore, there is a small retaining wall 305mm from the tree's base which descends to a depth of 245mm to a patio before reaching the garage wall. These physical structures are likely to limit root growth potential in this area.

| T1 | | T2 | |
|---|---|---|---|
| Ground level differential with wall. | | Weak included bark fork formation. | |

T1 is recommended for removal due to its proximity to the building. It is recommended for removal within 1 year of this report's writing.

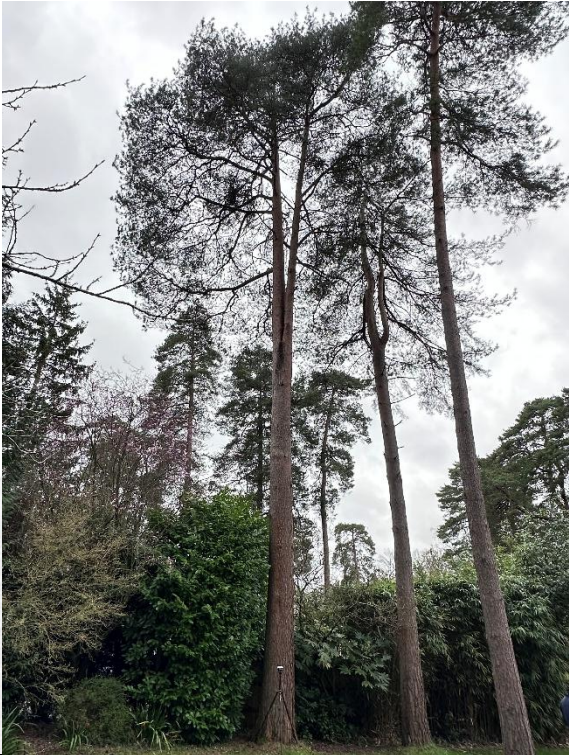
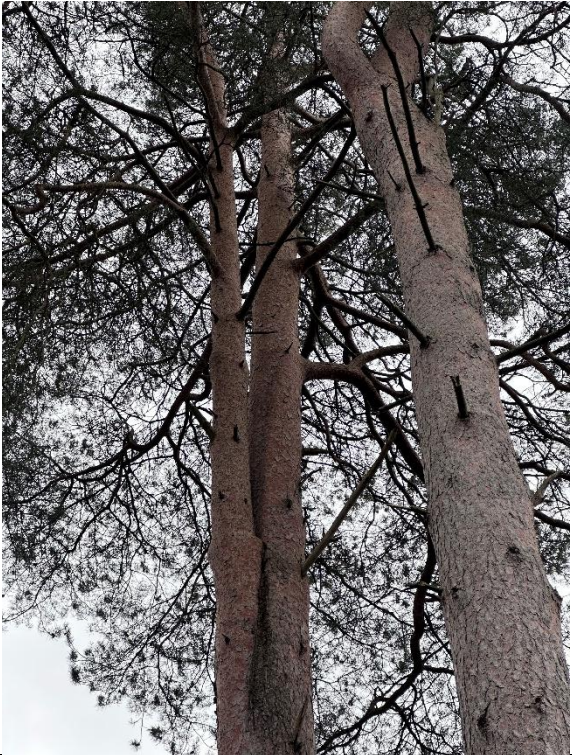
The tree is located within the rear garden, close to the western boundary of the site. The crown has a bias towards the west and has major deadwood throughout the crown. positioned along the western boundary of the site. The main stem has a slight lean but more significantly, a weak an included bifurcation of the primary stem at 8m, with clear signs of separation.

It exhibits a number of significant structural defects within the crown, stem, and basal area. The crown is biased in form and contains major deadwood throughout. A pronounced structural weakness is present within the main stem, where a significantly weak bifurcation occurs at approximately 8 metres above ground level, with clear indications of separation. This defect is further exacerbated by the presence of included bark at the union and additional weak forks within the crown. A slight lean of the tree was also observed.

T2 is recommended for removal due to its structural defects. It must be removed within 3 months of this report's writing.

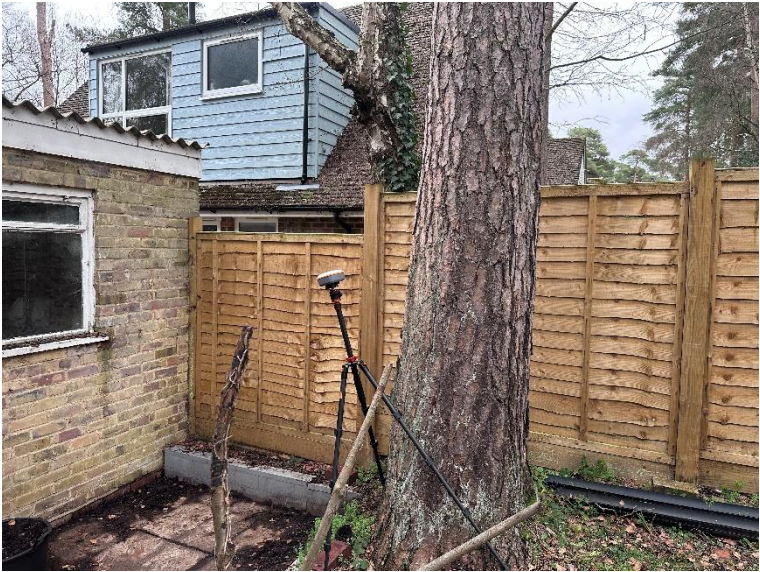
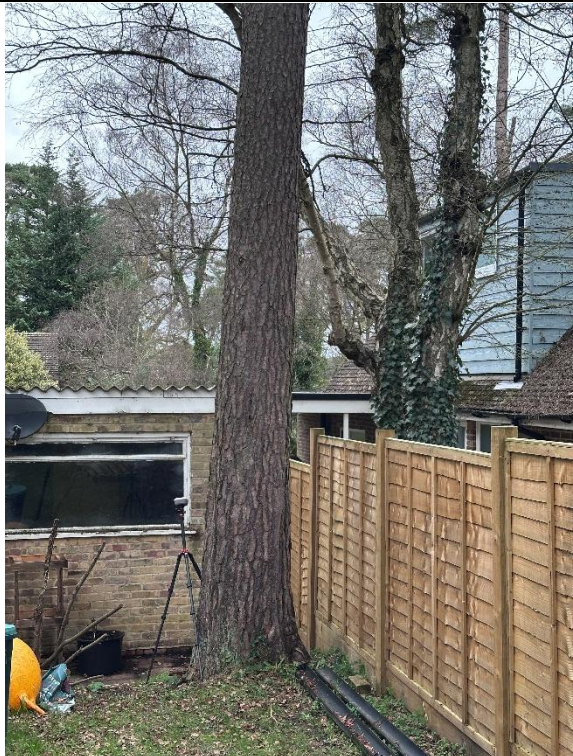
**Proximity to Structures:** 2.34 m from garage wall

Whilst on site it was noted that the garage wall was not in prime condition with some cracks in bricks. No determination has been made as to whether this cracking is attributable to the presence or influence of the tree, and no assessment of structural movement or damage has been undertaken in this regard. It should be noted that this report does not address issues of subsidence or heave, nor does it provide any conclusions relating to structural damage to adjacent built features.

| T1 | | T2 | |
|---|---|---|---|
| Proximity to garage. | | Cavity observed near weak included bifurcation. | |

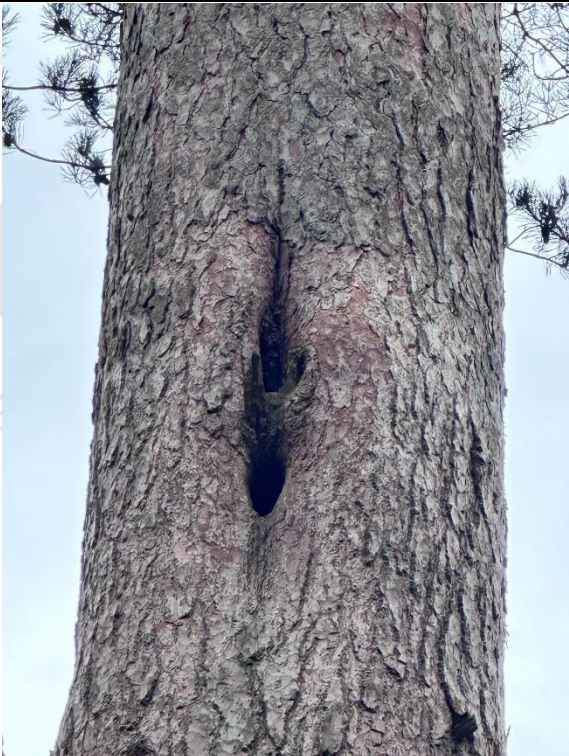
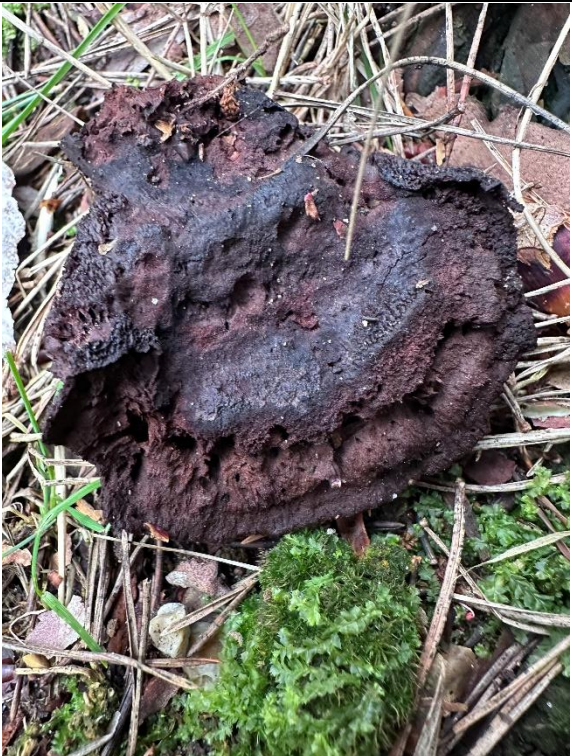
Furthermore, the main stem has a large cavity at approximately 6.5m on the north side of the stem. This further compounds the structural concerns of the bifurcation and its internal relationship with the cavity.

At the base of the tree, a *Phaeolus schweinitzii*, a cubical butt rot fungus, were identified, this provides concerns over the stability of the tree, though not root heave was observed.

| T1 | | T2 | |
|---|---|---|---|
| | | Phaeolus schweinitzii bracket found at base of T2 | |
