## Structural Inspection of Existing Barn (Non-Intrusive)

**Client:** Kennet Property

**Address:** Oak House, 4 Douglas, Hurst, Reading, RG10 0TT

| <b>Document Ref:</b> | 3221.VEC.XX.XX.CA.S.0300.A1 | |

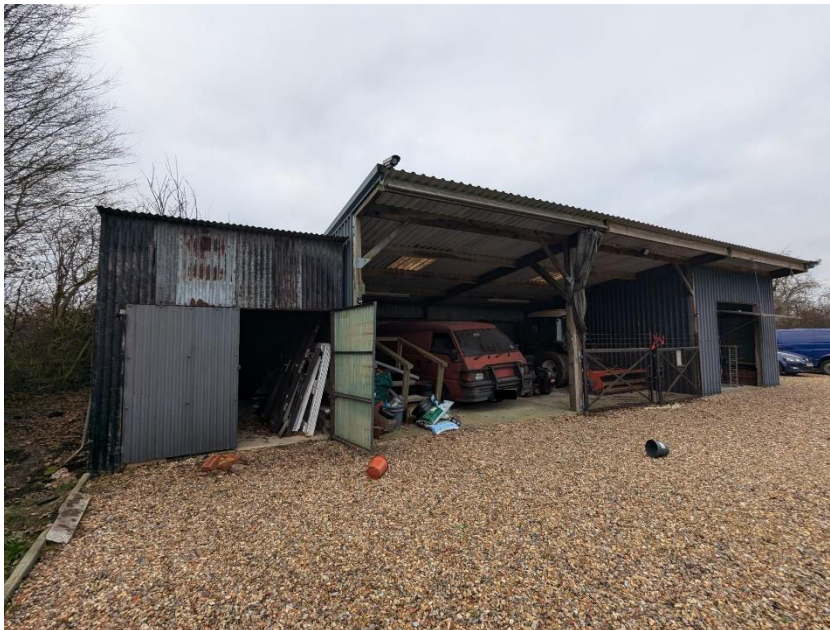
4.1: The barn was situated on a flat portion of land near the boundary of the site, flanked by trees of various species and of mature height. The barn structure consisted of four timber frames with the rightmost frame (photo 1) being enclosed to form an internal space. The roof and walls were formed using metal corrugated sheets. Timber purlins and ring beams provided support for the roof and walls. The roof overhangs at the front by 800mm. The left-hand side enclosed storage structure was constructed from a combination of timber and scaffolding.

*Photo 1 – A photo showing the front elevation of the barn.*

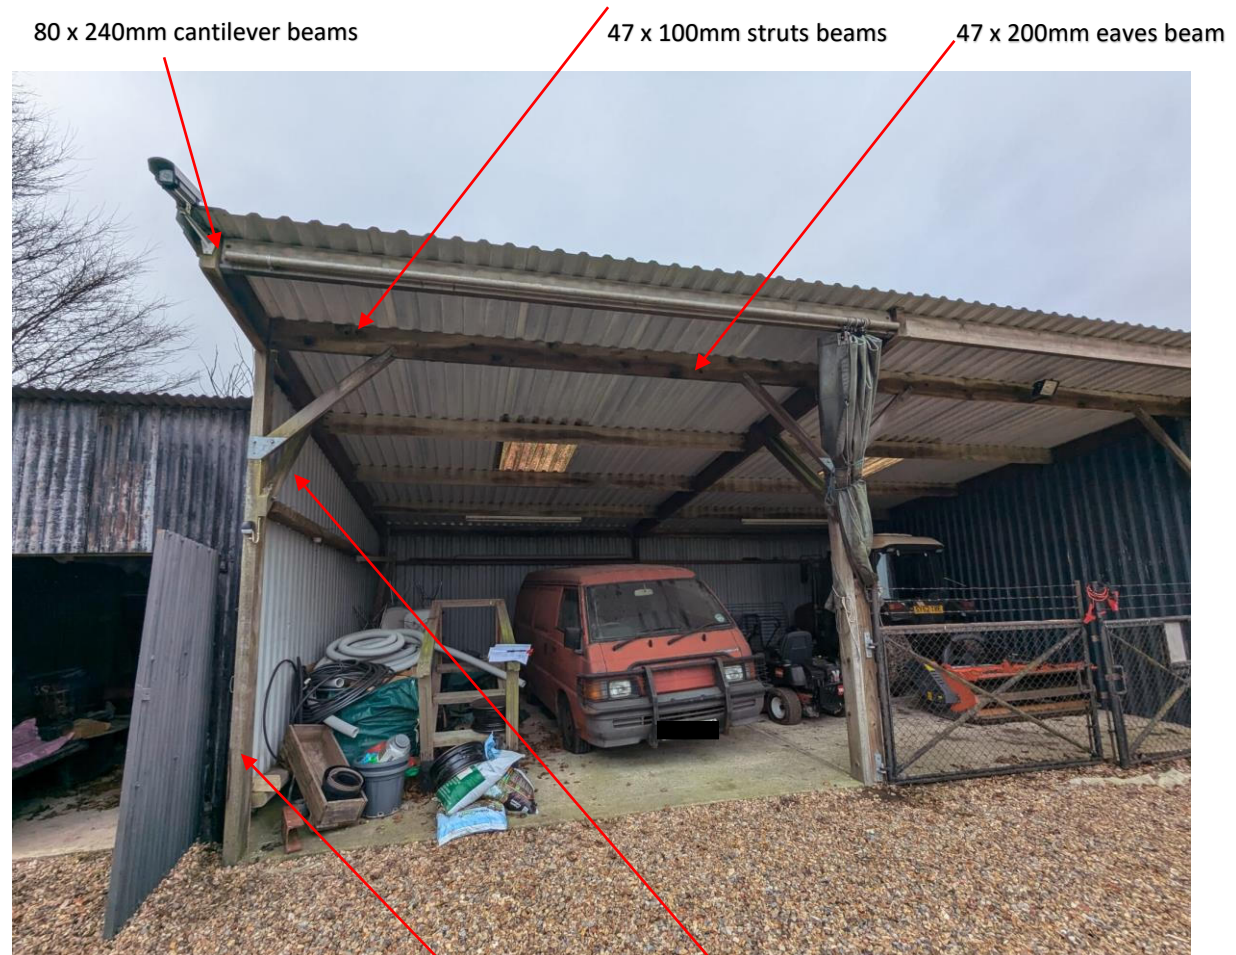
4.2: On the front elevation of the barn, four timber posts support a timber beam over to form three timber frames. The frames were braced with gallows struts. The roof beam cantilevers over the post by 800mm. The roof beams were also braced by timber struts running back to front. The corrugated sheet roof is supported by three timber purlins running between the frames. The wall cladding is also supported by timber side rails. The concrete ground floor slab is of unknown thickness. No trial pits were dug to record the depth and construction of the existing footings.

Photo 3 – Front elevation of the barn

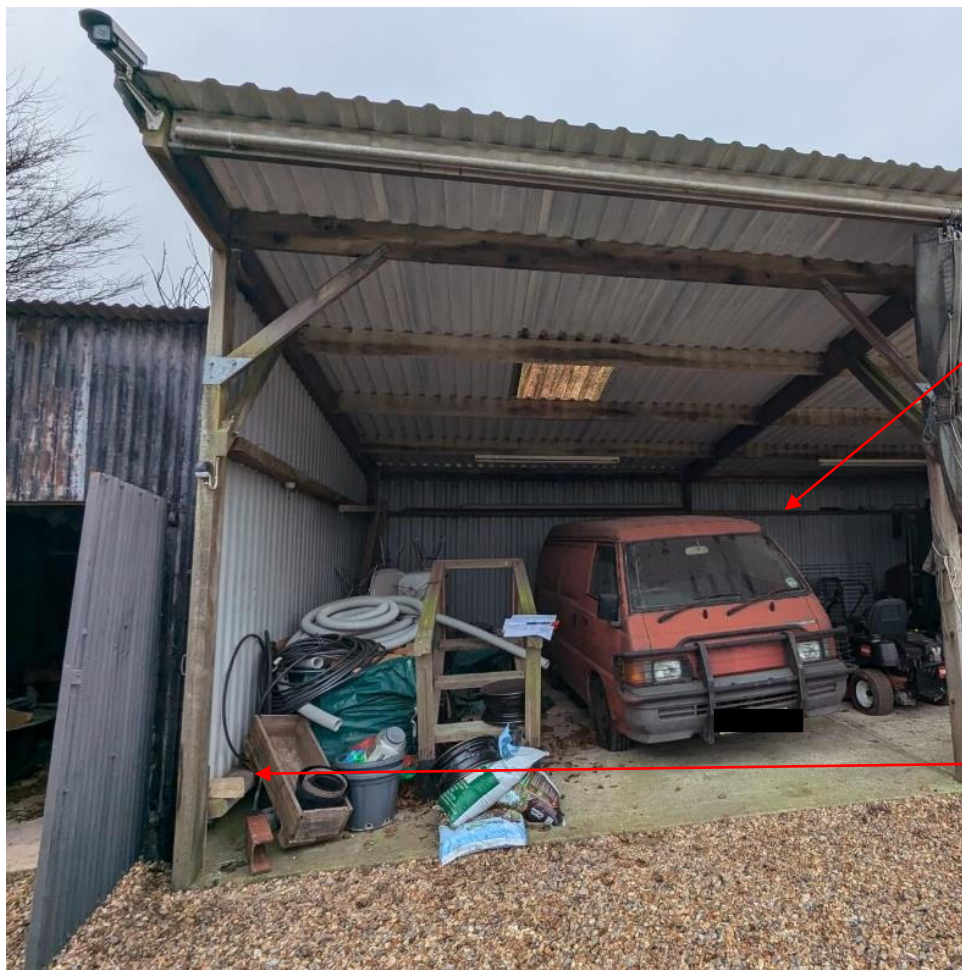
150 x 47mm wide timber  
side rails

150 x 75mm wide timber  
side rails

Photo 4 – Front elevation showing the timber ring beams

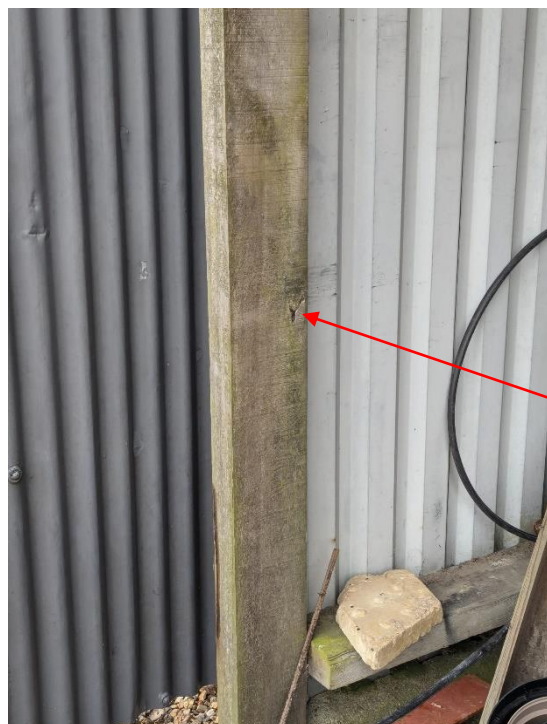
4.3: The timbers overall seem in satisfactory condition, however, one of the posts contains a knot hole of moderate size. One of the timber eaves beam showed signs of local rotting/knot holes. The outer timbers show signs of greater weather and discoloration.

Local knotting of post

Photo 5 – Knotting of one of the timber posts

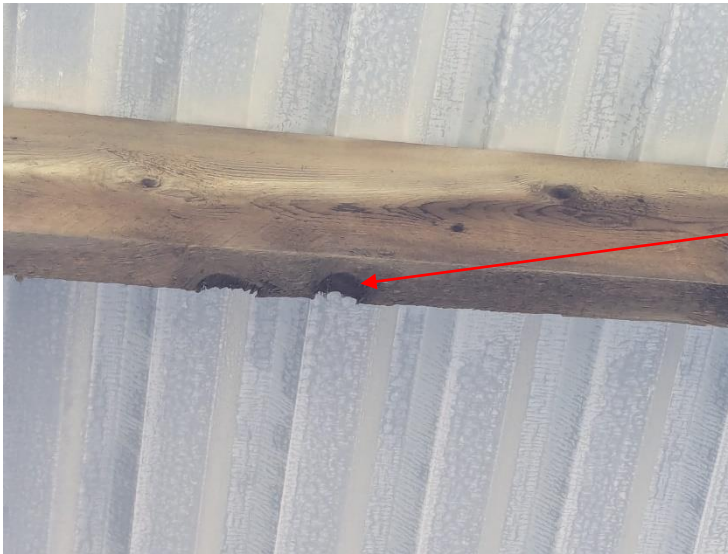
Local knotting/rotting of one of the timber beams

*Photo 6 – Knotting/rotting of one of the timber edge beams*

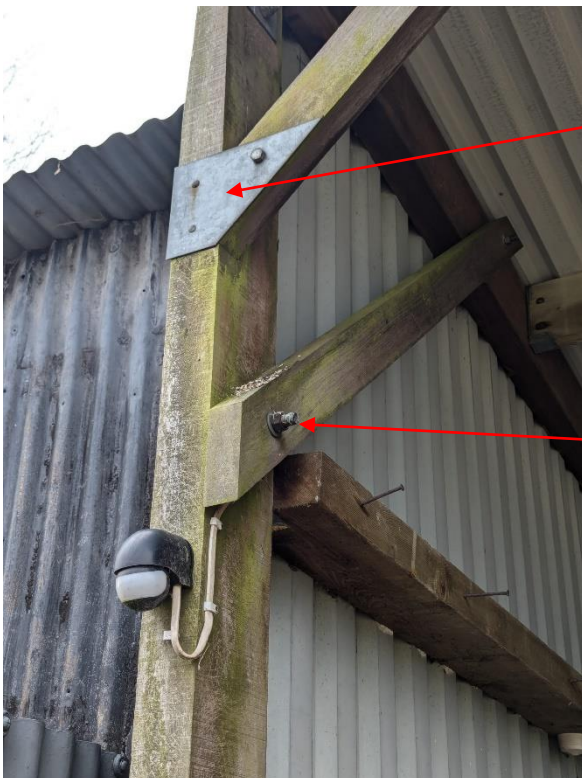
Inclined strut is fixed to post using two 6mm coach screws and one M10

Inclined strut is fixed to post using one M12 bolt

*Photo 7 – Connection of the timber post to both inclined struts*

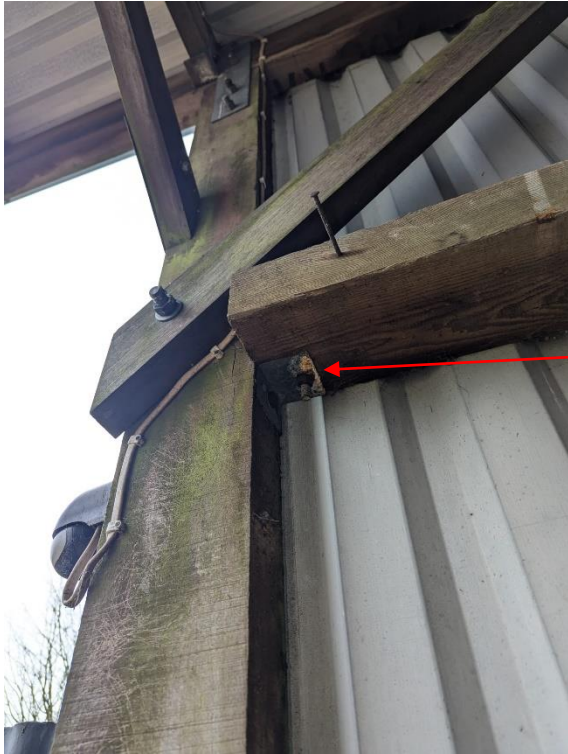
Timber ring beam fixed to post using a metal angle and M8 bolts

*Photo 8 – Connection of the timber ring beam to post*

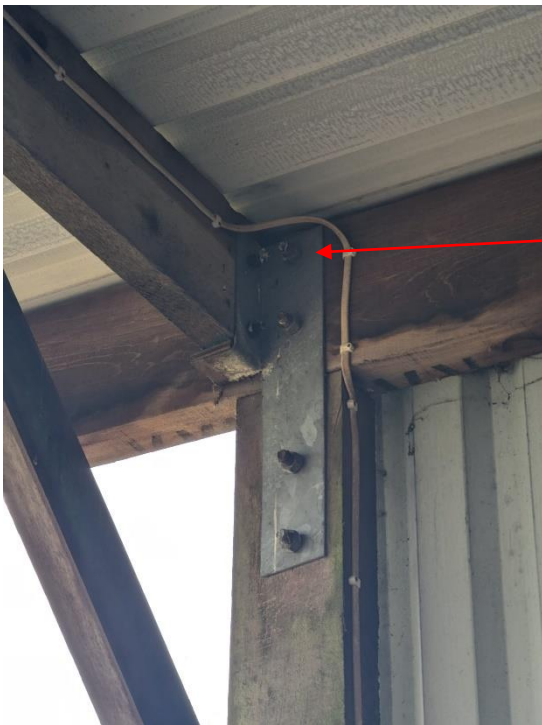
Timber eaves beam fixed to post using steel plate with four M10 bolts and fixed to cantilevered beam using two M8 bolts

*Photo 9 – connection of timber eaves beams to post and cantilevered beam*

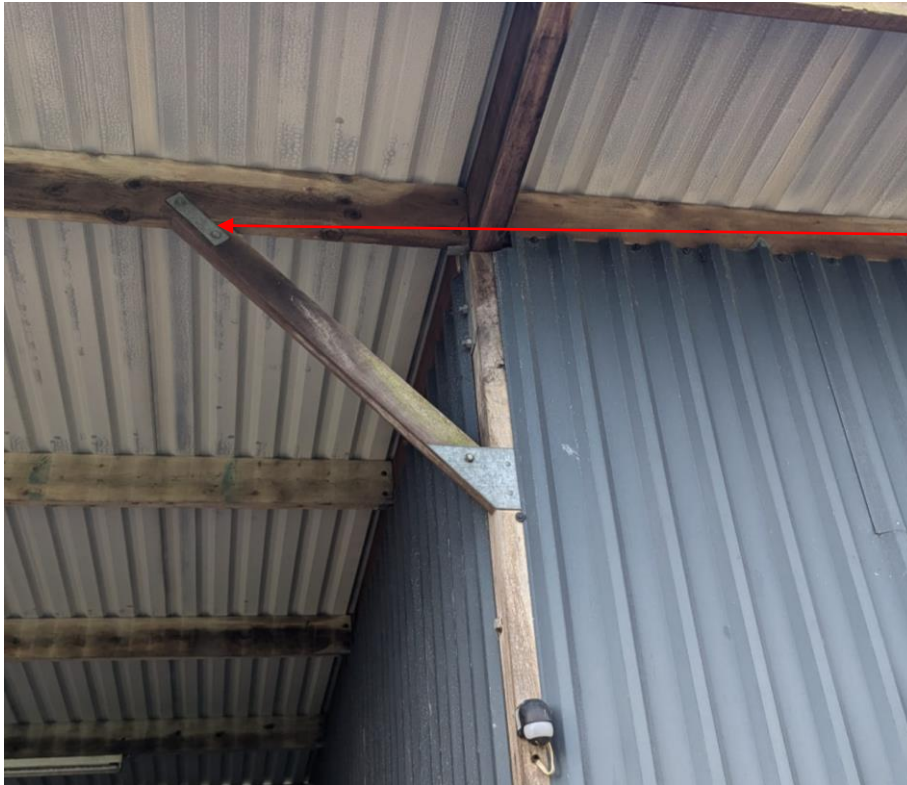
Inclined strut fixed to eaves beam using 2No, M10 bolts

*Photo 10 – Inclined strut to eaves beam*

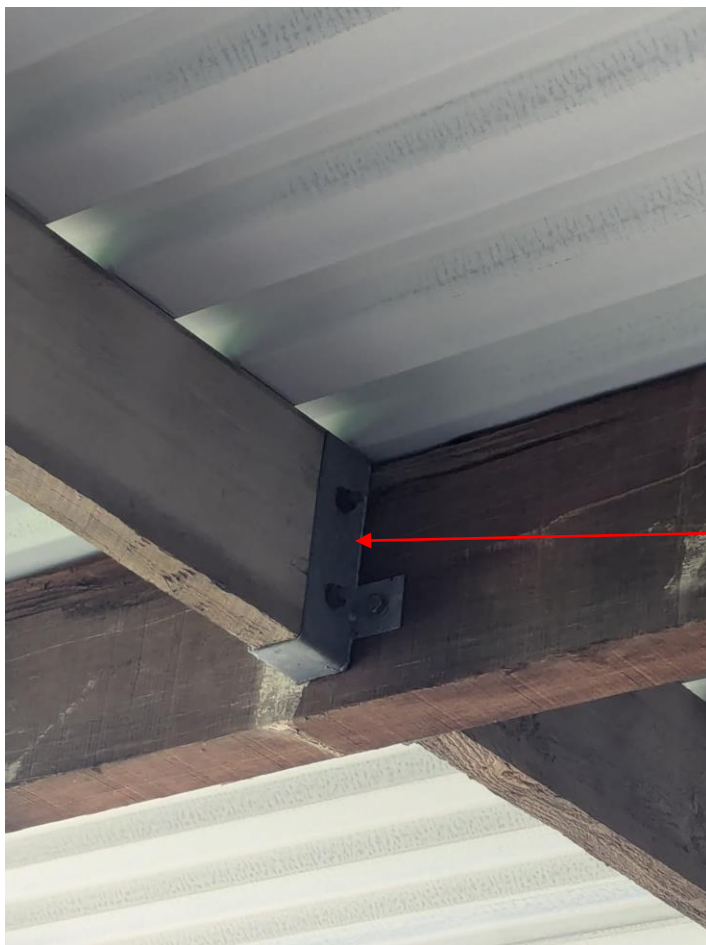
Saddle hangers fixed to the cantilevered timbers using one number m12 bolt and fixed to purlin using two number M10 bolt

*Photo 11 – Purlin to cantilevered timber*

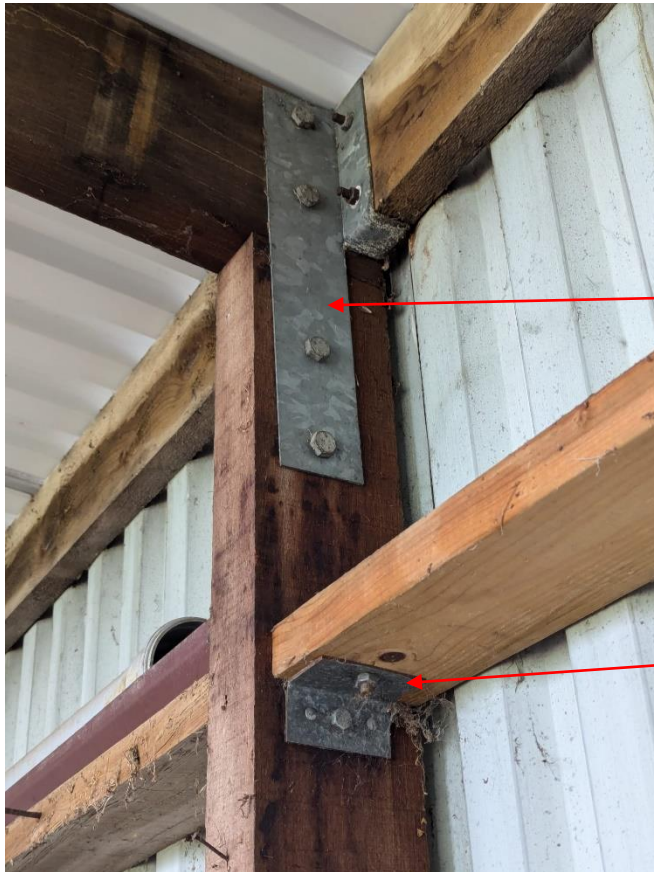
Cantilevered timber fixed to rear post using steel plate with four M12 bolts and fixed to rear eaves beam using two M10 bolts

Timber ring beam fixed to post using two M8 bolts

*Photo 12 – Timber ring beam and cantilevered beam to rear timber post*

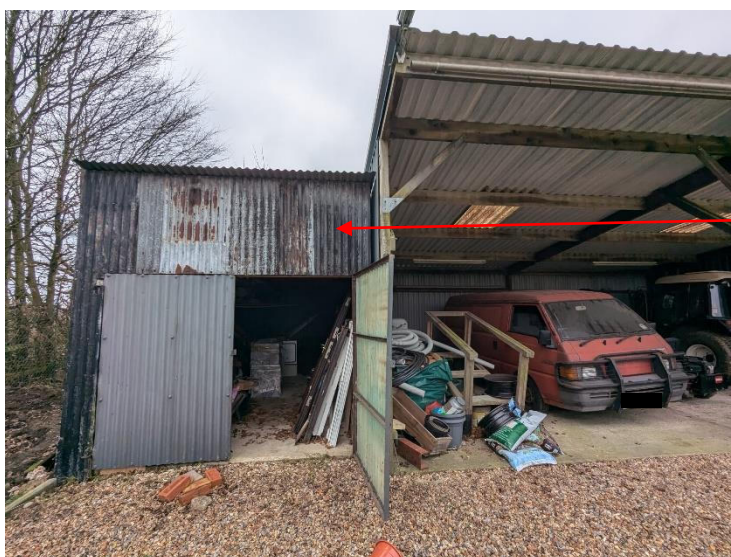
4.5: The structure of the smaller storage unit at the left-hand side of the barn was constructed using a combination of timber beams, scaffold boards and 50mm dia scaffolding. The scaffolding is fixed together using clamps. The front door is framed by a 47 x 100mm timber frame, the roof is supported by a timber eaves beams and two internal timber purlins. Eight scaffold props support the structure in total

Timber and scaffold structure

*Photo 13 – Front elevation showing the storage structure constructed from timber and scaffolding*

- The **scaffold storage structure** shown in photos 13 to 16 is not considered suitable for conversion into a residential accommodation due to poor upkeep and built material used. This should remain a storage or garage structure.

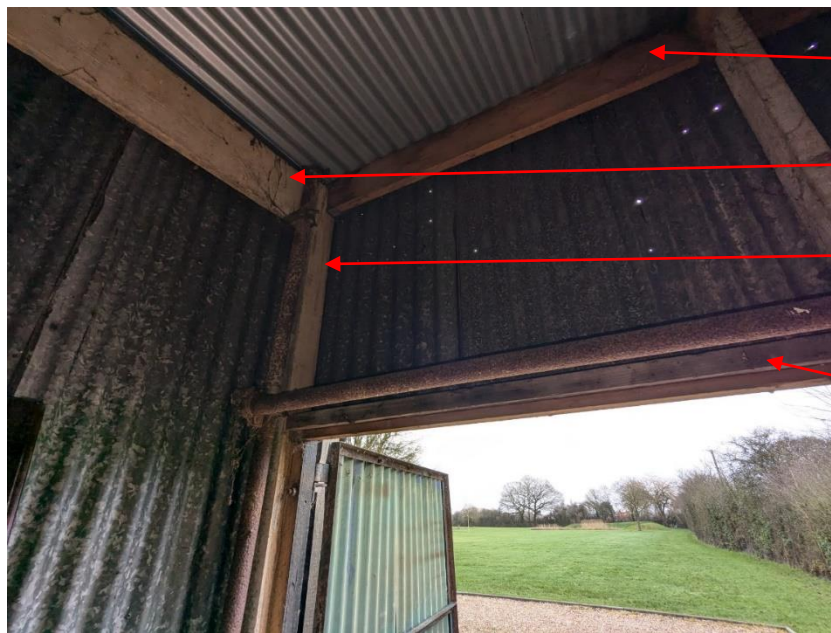
47 x 100mm timber eaves beam

38 x 225mm deep scaffold board

47 x 100mm timber post reinforcing  
a 50mm dia scaffold post

47 x 100mm timber beam acting as a  
door lintel. Reinforced with a 50mm  
dia scaffold section

Photo 14 – Inside view showing the door structure and a vertical and horizontal scaffold prop.

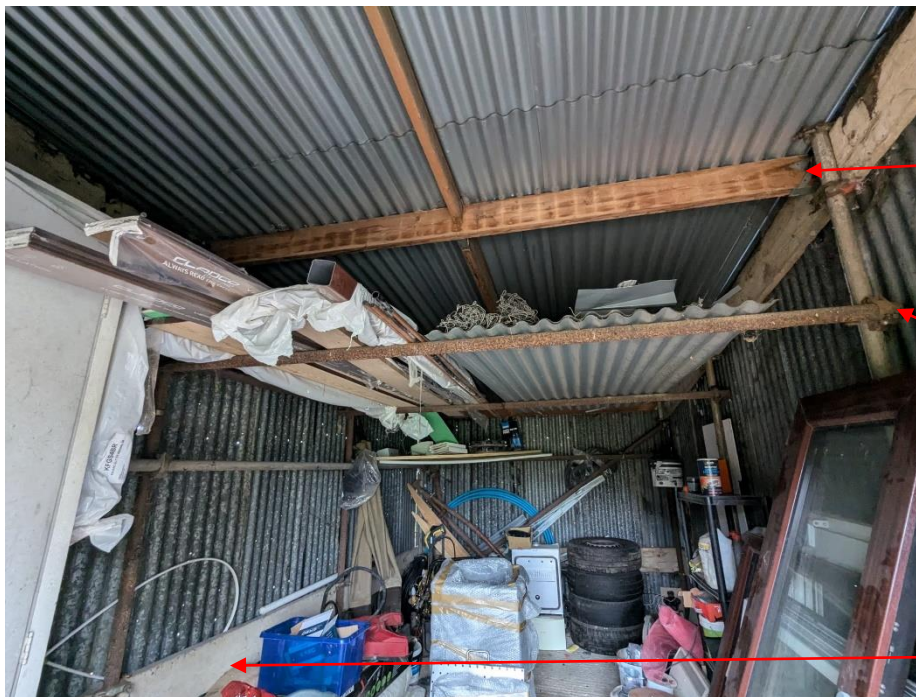
47 x 100mm timber purlins  
fixed to scaffold board edge  
beam using nailed joist hanger

Horizontal scaffold brace  
clamped to 50mm scaffold  
post

Photo 15 – photograph showing the scaffold structure within the storage area

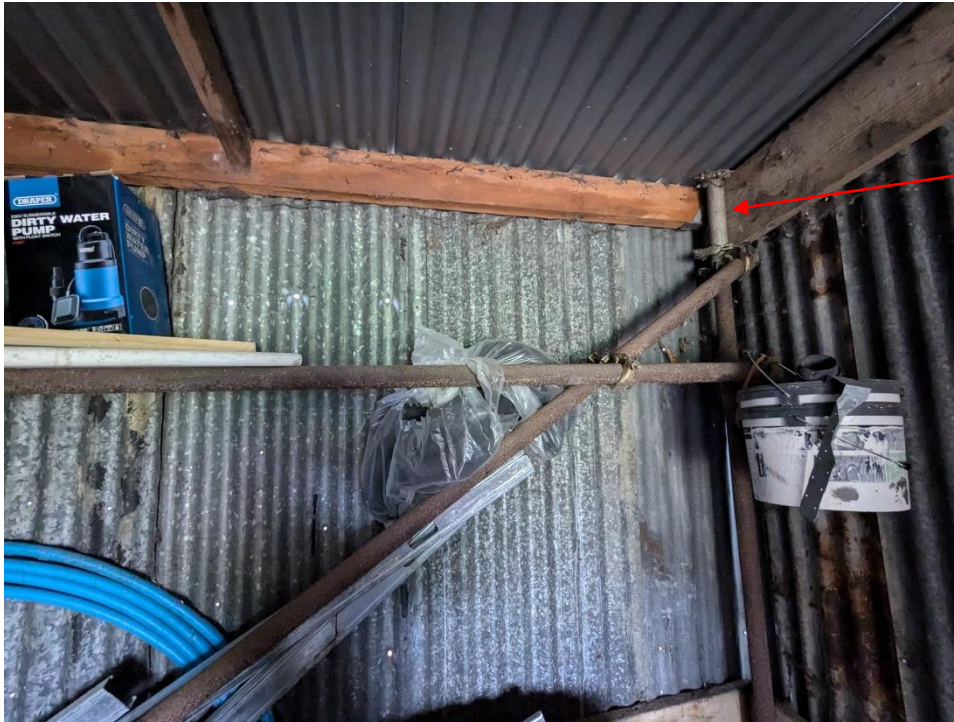
Inclined braces are fixed to vertical props using clamps

*Photo 16 – Inclined scaffold brace at the rear of the structure.*
