# ARBORICULTURAL REPORT

## TREE CONDITION SURVEY

15 SANDFORD DRIVE  
WOODLEY  
BERKSHIRE  
RG5 4RR

Ref: 06710 / 2025

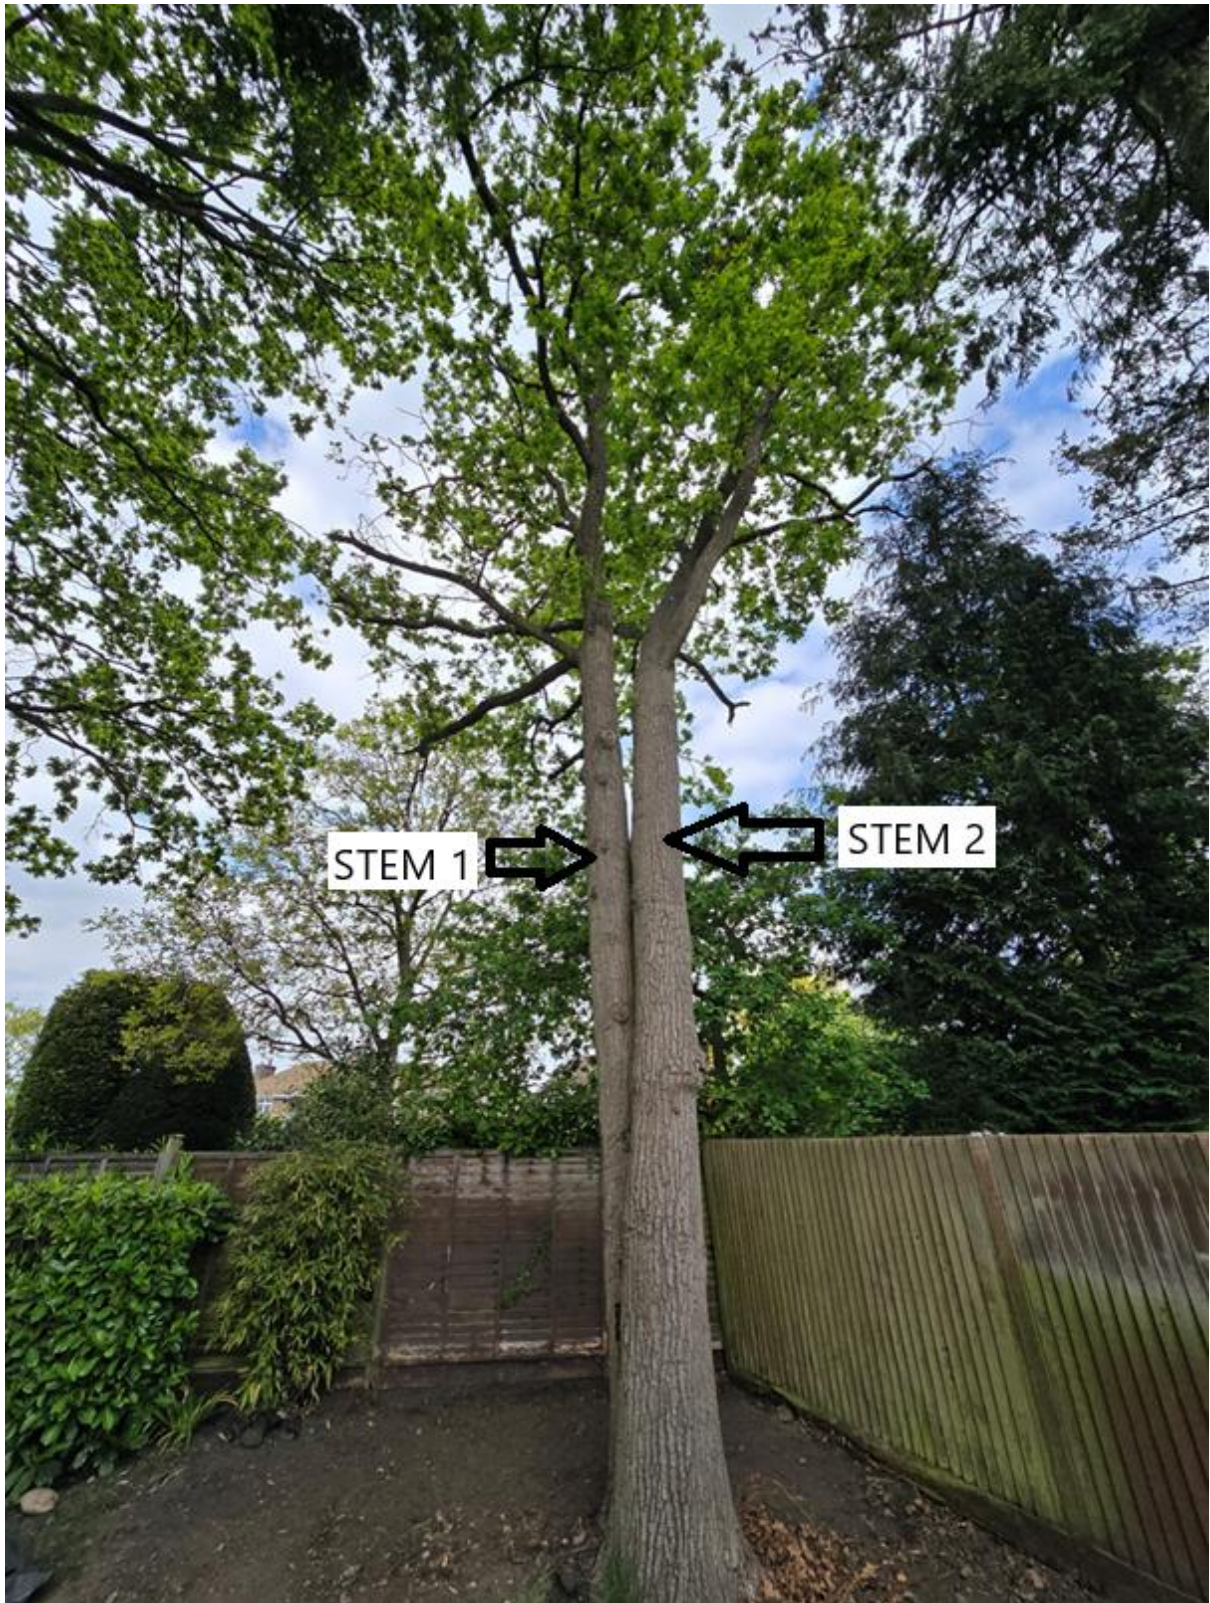
**BASE:** T1 consists of two trunks and is likely to be two trees growing from a single growth point. Superficial bark damage to buttress roots. Part of a paving slab is stuck between the two stems and impacting on the shape and growth of the lower trunks.

**DISCUSSION:** T1 is formed of two mature Oak from a single growth point. The northern trunk has historic wounding to the trunk with honey fungus present. The canopy above the defects is in an advanced state of decline. My recommendation is that the northern stem be removed. Following this work, a reduction of the crown of the southern stem (2) will be required to reduce the asymmetry of the crown and exposure following the removal of stem 1.

Photo 1 – T1 formed of 2x Oak (*Quercus robur*)

| <b>Recommended Tree Works:</b> <ul style="list-style-type: none"> <li>Fell Stem 1 leaving a 2-3m high stump for habitat value and to maintain the stability of Stem 2</li> <li>Stem 2 - Reduce canopy height and lateral spread on the north and east side of crown by 1-1.5m to reduce exposure and asymmetry following the removal of Stem 1. Cuts should be graded into the surrounding canopy to leave a sympathetic and natural-looking canopy shape.</li> <li>Mulch rooting area to cover exposed fibrous roots &amp; prevent desiccation.</li> </ul> | Priority | Within 6 months |

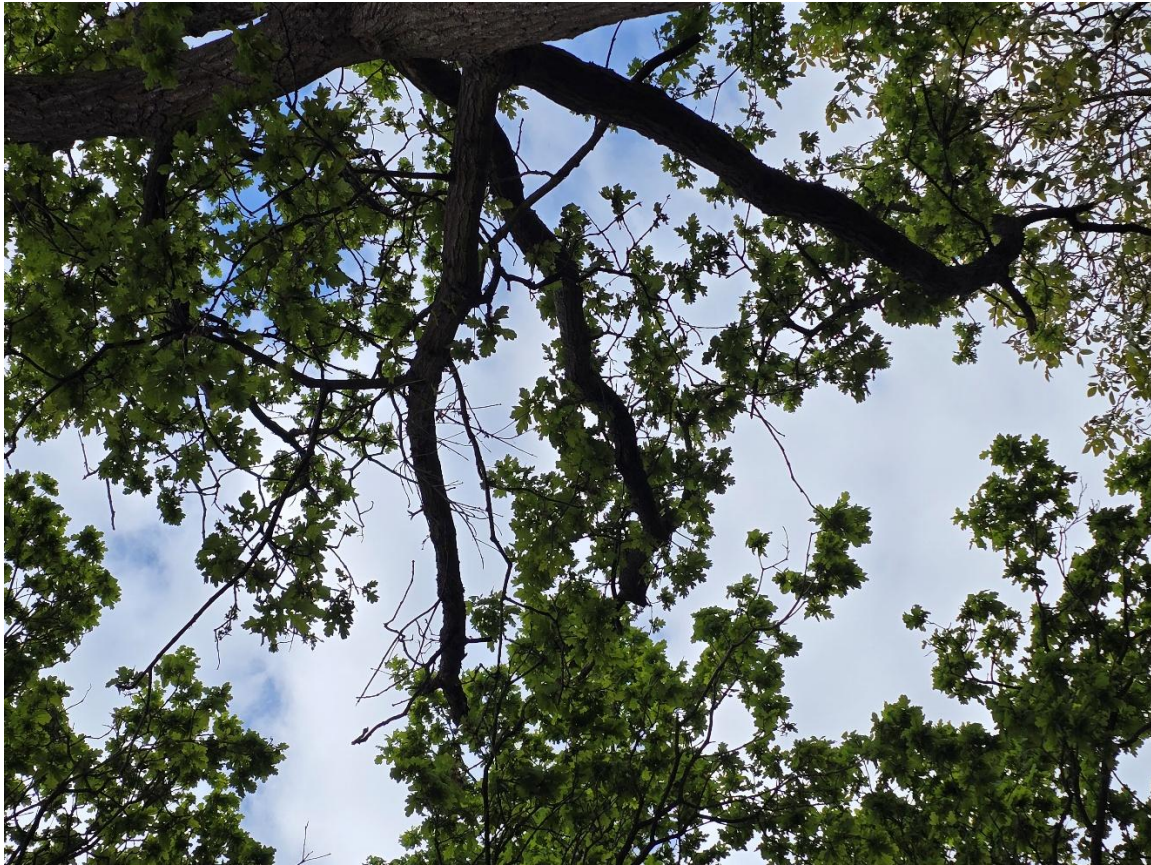
Deadwood in canopy. Canopy approximately 50% defoliated. Live foliage clustered and uneven.

Photo 2 – Deadwood and declining crown of T1 (Oak) – Northern stem

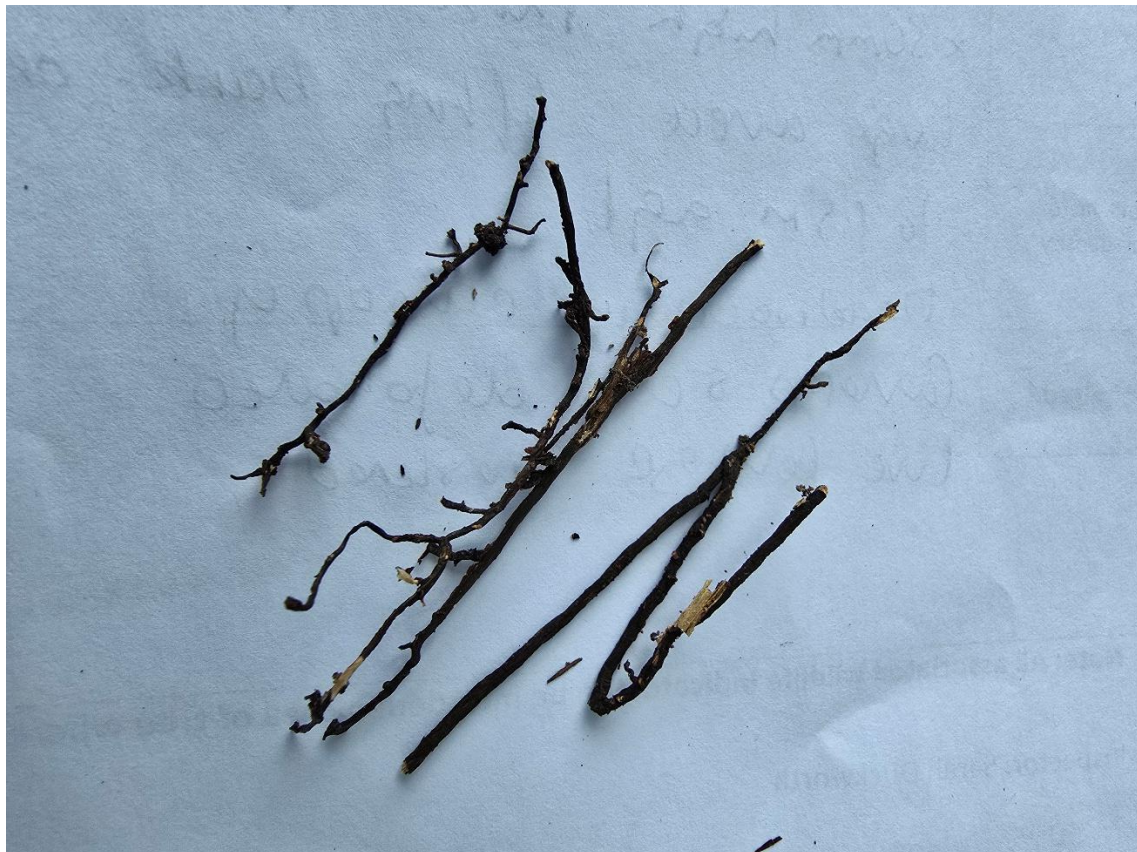
There are several visible rhizomorphs within the bark wounds on the east side of the trunk. Rhizomorphs are tough, leathery strands formed by fungal hyphae of Honey Fungus (*Armillaria*). Honey fungus spreads from living trees, dead and live roots and stumps by means of rhizomorphs. There are several species of Honey fungus some of which are pathogenic (colonise live plants), however those with larger rhizomorphs tend to be only weakly pathogenic, living on deadwood and / or declining trees. It is likely therefore that the *Armillaria* affecting the northern stem of T1 is a secondary pathogen of a tree which is already in decline rather than being the primary cause of the decline.

Photo 3 – Rhizomorphs removed from wound on east side of Stem 1

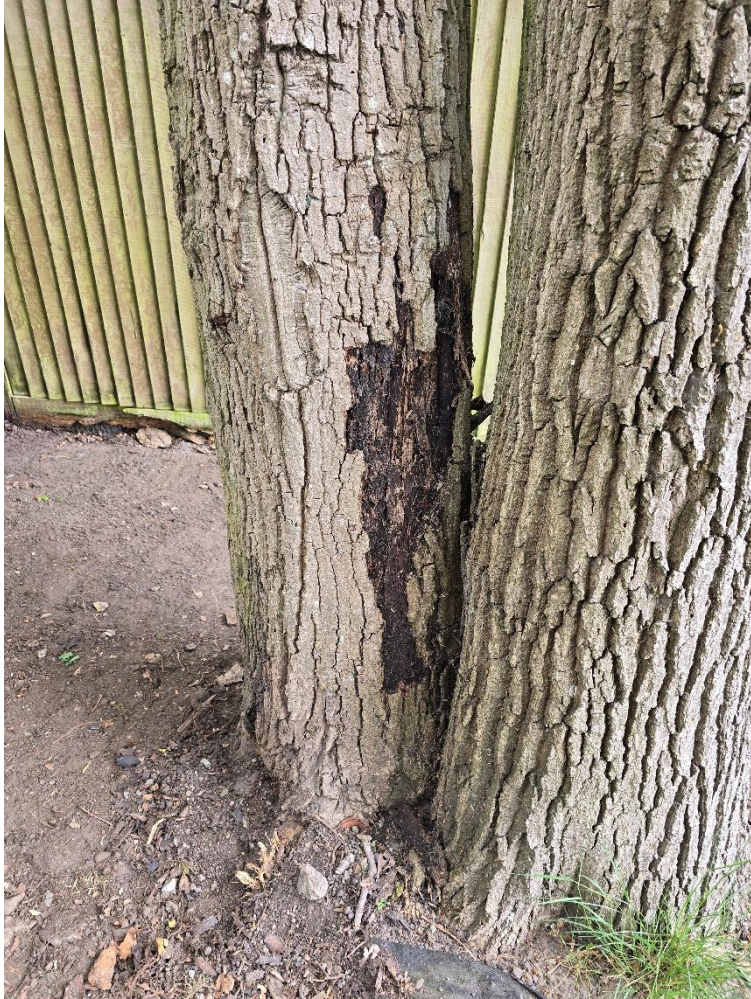
Historic linear vertical wound 300mm long on west side of the trunk 1.3m above ground level. Large area of necrotic bark on the south side on trunk above included bark between the two forks. Area of necrotic bark extends from 0.3m to 1.2m above ground level. Damaged areas is approximately 300mm wide. Some new wound wood formation around the site – more noticeable on the east side but not vigorous and wound does not appear to be well compartmentalised.

Photo 4 – Historic wounding on trunk of Stem 1 (Northernmost trunk)

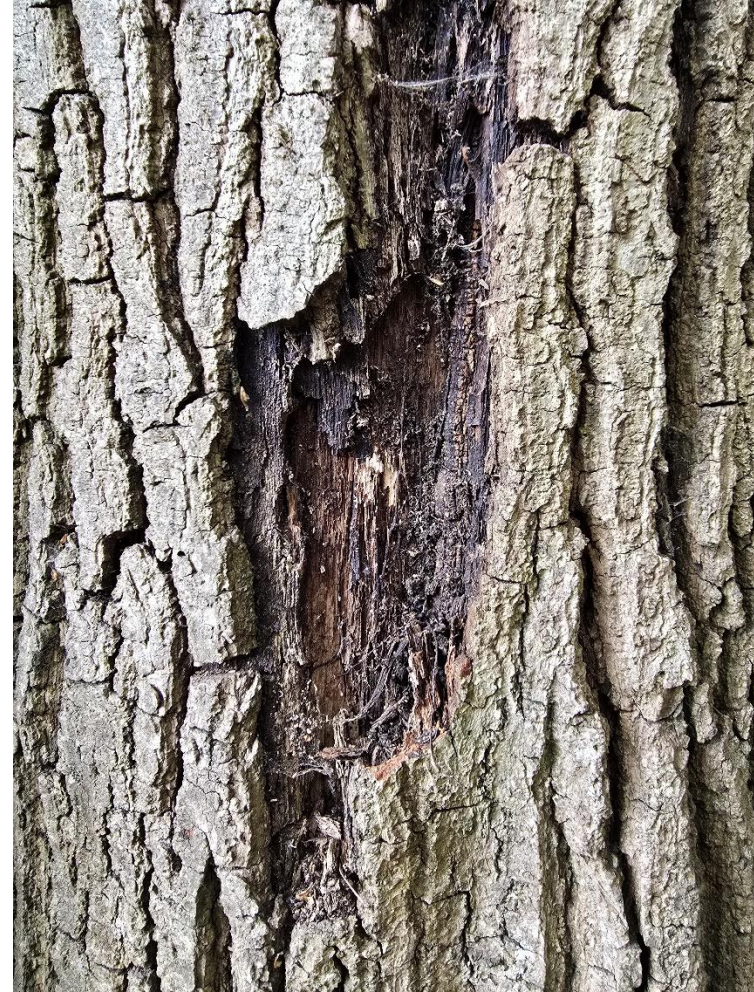
Additional area of necrotic bark on the east side of the trunk, 80mm wide x 300mm high. In addition, bark on the south east side of the trunk 1m above ground level is lifting & there is audible hollowing beneath the bark indicating dead or dysfunctional areas of the vascular cambium.

Photo 5 – Historic wounding east side of trunk with rhizomorphs
