## OAK TREE BESIDE PUBLIC RIGHT OF WAY

TPO Number: 1886/2022

## **ASSESSMENT**

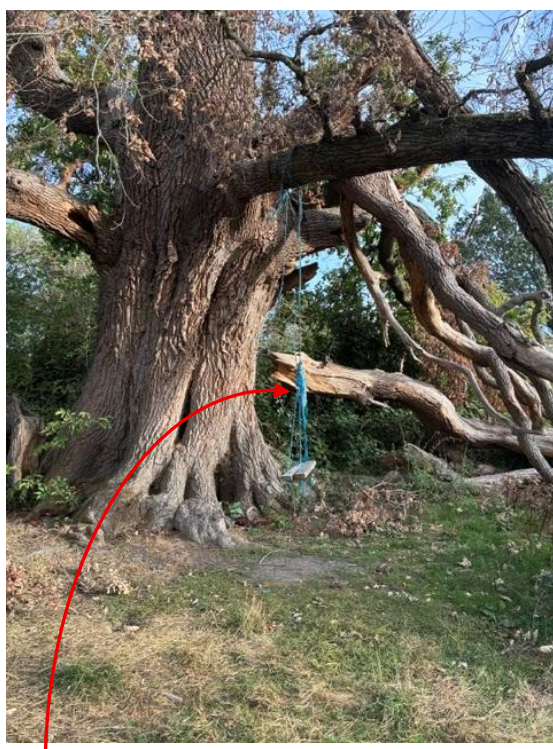
**BEFORE:** Children's swing hanging from the tree

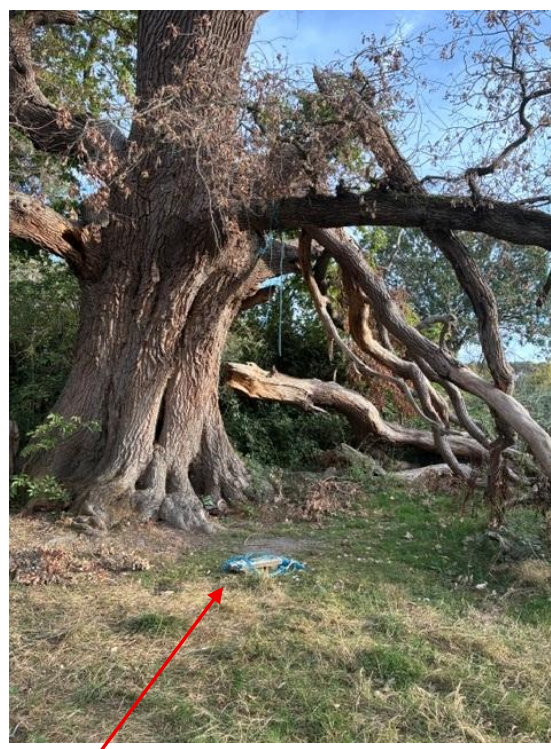
**AFTER:** Once the swing had been cut down

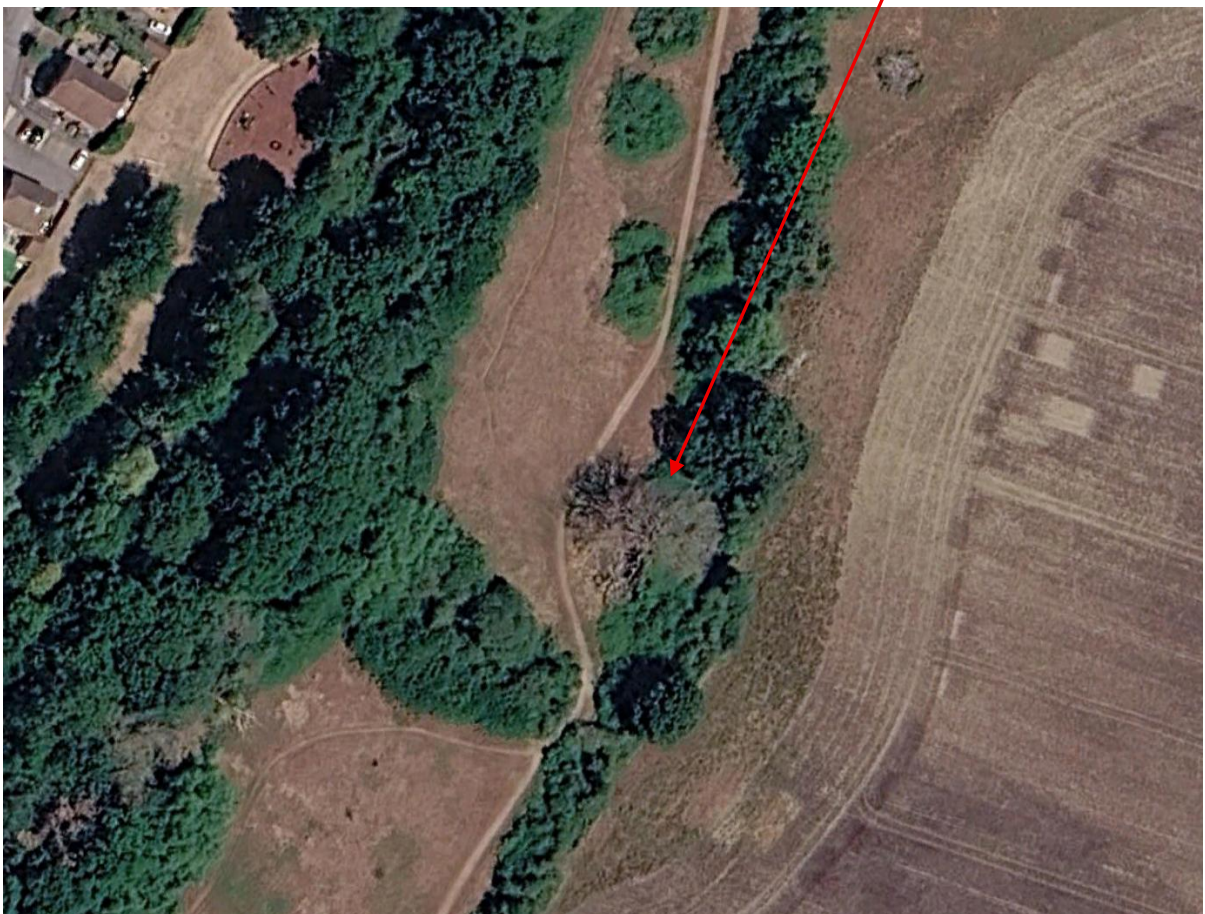
Morbund Oak Tree

The second of the two photos on page 2 is taken from Google Earth and shows how this tree stands out markedly from its neighbours. It is moribund, in terminal decline. And when viewed from the ground, it has lost its boughs to its southeast side, such that it is leaning dangerously towards the PRoW. This is clearly visible in the photo on page 3 when viewed facing East.

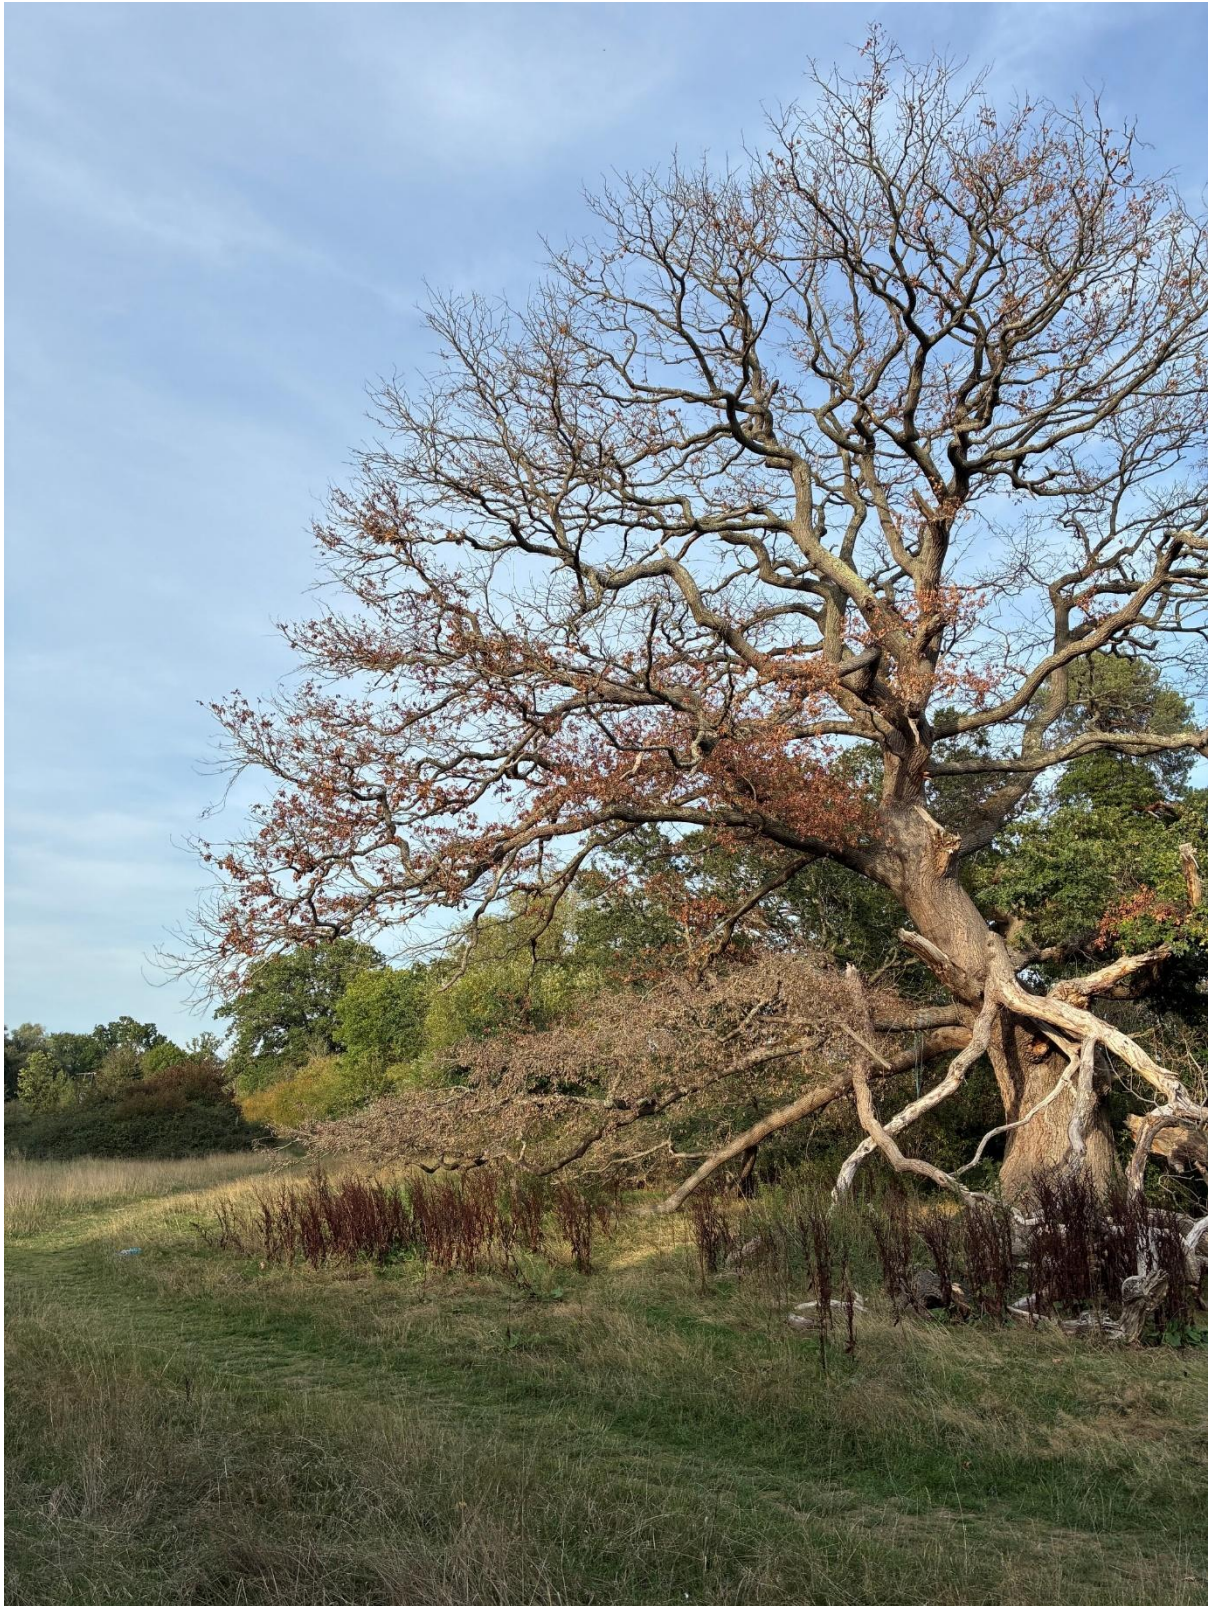
*Viewed facing East*

The TPO tree in question (Number 1886/2022) is a native English oak (*Quercus Robur* / *Quercus Petraea*). This variety of tree typically maintains its green canopy well into October or November. However, when inspected on 24<sup>th</sup> September, in contrast to the surrounding oaks – which display robust foliage – this specific tree shows a total absence of leaf development. Because this is unlikely to be caused by standard seasonal change, and given its condition is completely at odds with its immediate neighbours, this is assessed as a moribund tree in terminal decline, with clear loss of structural integrity.

It is a clear and apparent danger to the public in its current condition (which is only expected to deteriorate further). Therefore, it should have its upper boughs removed to avoid further dropping onto, or near to, the PRoW. This will also deter children from playing on, or in the vicinity of, the tree.

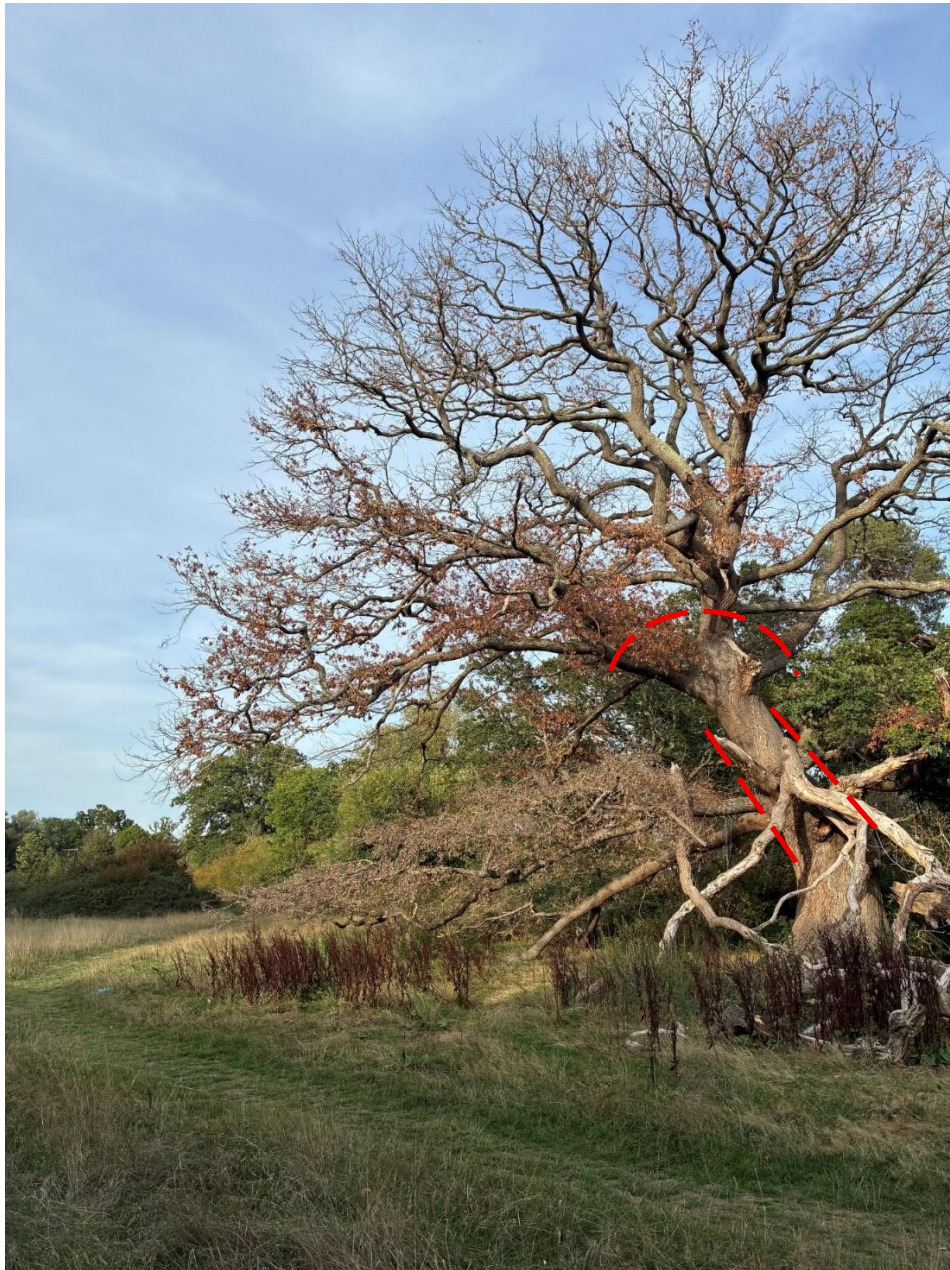
Given the poor condition of this tree and its proximity to the Public Right of Way (PRoW), it is vital that it is made safe for the public who use this PRoW. However, it would be difficult to specify a selective pruning programme that guarantees their security. Its state of deterioration – and the way in which it is leaning towards the PRoW – makes it risky to focus on just pruning part of the crown, or identifying specific branches or limbs to remove. There is a danger that any of its boughs could fall and injure someone.

— — — Proposed limb removal, leaving the trunk.

It is therefore proposed to monolith the tree by removing the outer boughs while retaining the main trunk as a standing deadwood habitat, thereby enhancing local biodiversity and supporting saproxylic insects and nesting birds.
