## Preliminary Ecological Appraisal and Roost Assessment

71 London Road, Wokingham, RG40 1YA

26<sup>th</sup> November 2024

*Front and rear extensions with associated internal alterations*

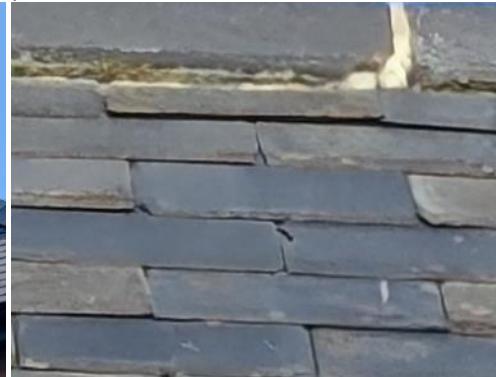
**Fig 7**

The lead flashing around the chimney appears to be tightly fitted (Fig 6), leaving no gaps. There are a small number of lifted roof tiles on the main section of the house (Fig 7), and the hip tiles do not appear to be tightly fitted (Fig 8), providing a suitable roosting location for crevice dwelling bat species.

<p>There are no anticipated impacts on B2, B3 or any trees in site, due to their negligible value for roosting bats and proximity to the works.</p>
<i>Recommendations</i>	<p>Two bat emergence/re-entry surveys are required on B1 during the active bat season to confirm presence/likely-absence of bats roosting in or on the building. These survey visits should be completed during the optimal survey period mid-May to August inclusive. The survey visits should be at least three weeks apart.</p> <p>Three surveyors are required to provide full coverage of the building's elevations to look for emerging/re-entering bats. An infrared camera should also be employed per surveyor as part of the survey to support in identifying where any specific roost access points are located.</p> <p>If any bat roosts are confirmed from this survey schedule, a bat licence would be required to demolish the buildings as it would involve the destruction of roosts. This is applied for with the help of a class 2 licensed bat ecologist after planning permission is granted, but before commencement of works.</p> <p>Enhancements are dependent on the outcome of further surveys</p>

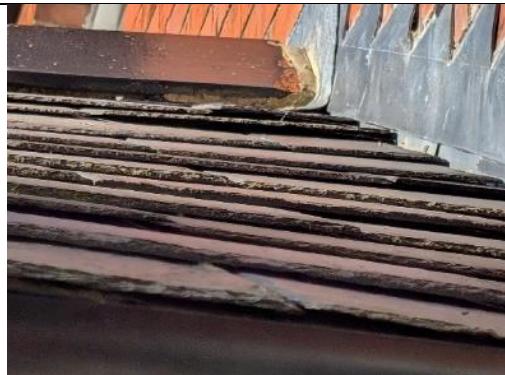
Fig 9

A high volume of the slate tiles on the southern extension are lifted (Fig 9), including gaps between the end tiles (Fig 10) and lifted ridge tiles (Fig 11), providing a suitable roosting location for crevice dwelling bat species.

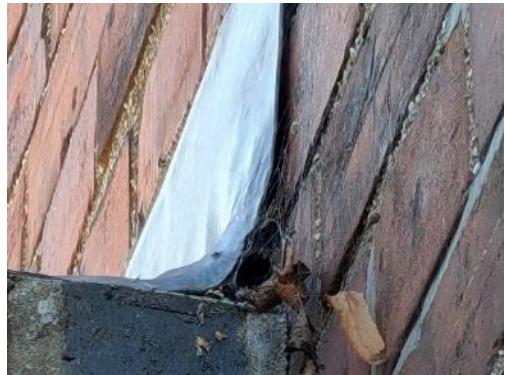
Fig 12

The lead flashing between the main house and the garage is lifted (Fig 12), providing a suitable roosting location for crevice dwelling bat species. It was not possible to fully assess the roof tiles on the garage without accessing the neighbouring property, however, the areas that could be observed appeared to be tightly fitted and in good condition (Fig 13).

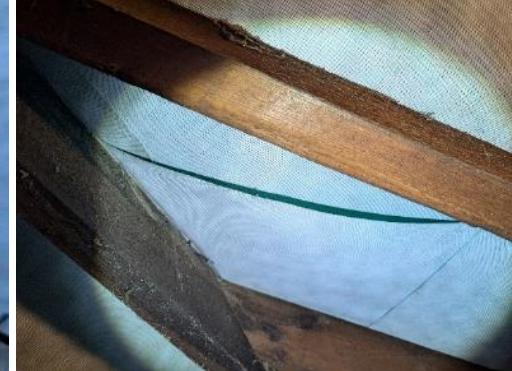
**Fig 16**

continue deep enough to provide a suitable roosting feature for crevice dwelling bat species. The roofing membrane is sagging in places (Fig 16), providing a suitable roosting location for crevice dwelling bat species. No light ingress or direct points of access were identified within V1, however, as there are lifted tiles externally bats may be able to access the loft void via the roof tiles and loosely fitted loft lining.

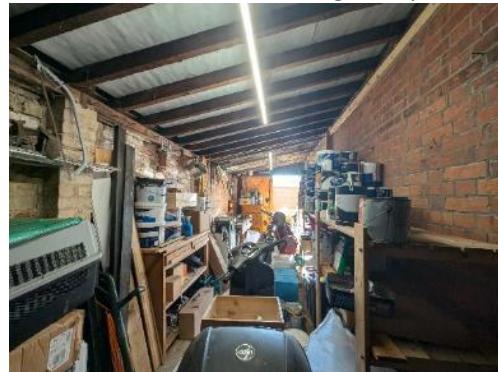
**Fig 17**

**Garage:** The garage is lined with breathable membrane, with timber beams throughout (Fig 17) providing a suitable roosting location for void dwelling bat species. The mortar between bricks is missing in places (Fig 18), providing a suitable roosting location for crevice dwelling bat species.

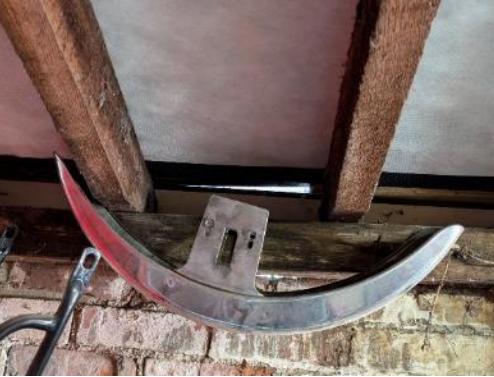
There is a gap around the northern garage door (Fig 19) in addition to light ingress at the eastern eaves (Fig 20), demonstrating two potential points of access to the garage for both void and crevice dwelling bat species. The eaves could not be surveyed

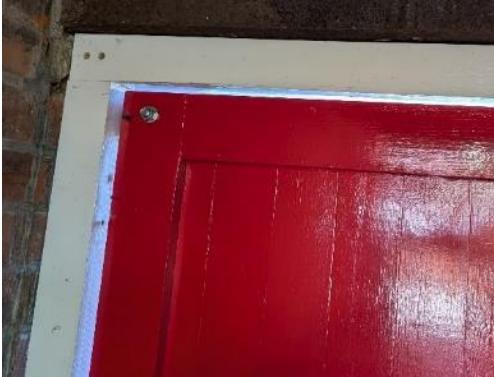
<p>externally without accessing the neighbouring property, therefore, it is assumed access could be gained at the point of light ingress.</p>

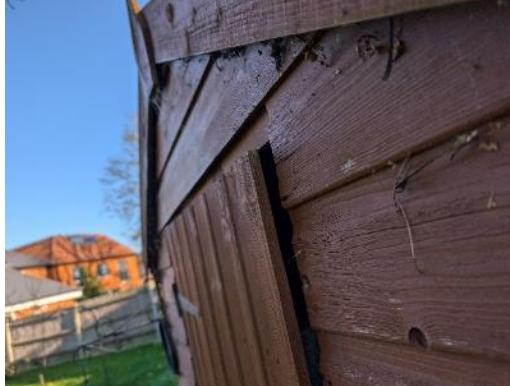
<p><b>Fig 29</b></p> <p><b>Fig 30</b></p> <p>The bitumen felt roof appears to be in good condition (Fig 31), leaving no gaps. The door does not close fully, even when locked (Fig 32), providing a potential point of access for void dwelling bat species.</p>

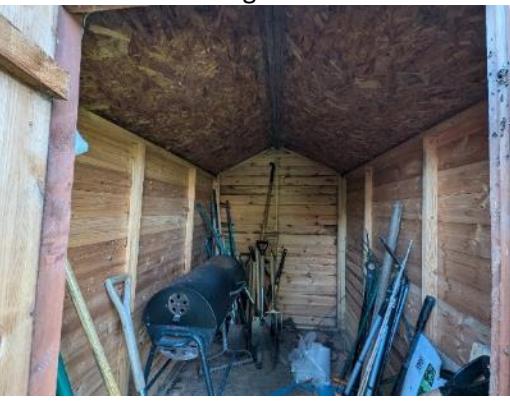
<b>Fig 31</b>	<b>Fig 32</b>	
B3 – interior	<p>There is a chipboard roof with a small ridge beam through the centre (Fig 33), providing a suitable roosting location for void dwelling bat species. No other suitable roosting features were identified. The interior of B3 could be assessed in full, with no crevices or lining for bats to roost beneath, and no bats or evidence of bats were identified. It is therefore considered unlikely that bats are roosting within B3.</p>
