**Castleman's Cottage**

Client: Ashley Bryant and Kate Carson

**Roof Repairs: Replace Wall Plate**

225131 - MNP - XX - XX - SK - S - 4001

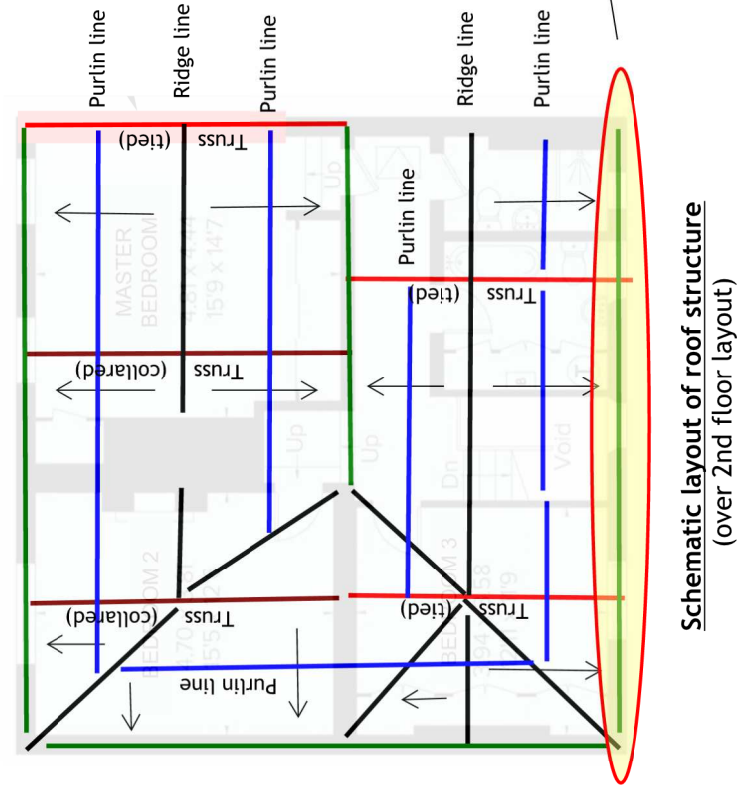
**Schematic layout of roof structure**  
(over 2nd floor layout)

- The oak wall plate along the front elevation shows extensive decay that compromises its bearing capacity.
- A central section of the wall plate has previously been replaced in soft wood.

- Support the ends of the trusses (shown in red) and the ceiling joists to the left end room from below (not damaging ceiling)
- Remove the decayed wall plate by trimming any nail fixings and sliding it outwards.

- Prepare new sections of oak (air-dried) to replace the full length of the wall plate. The section to be of the same width as the original but of reduced depth (to allow insertion and lifting to alignment)

- The wall plates below the trusses should be rebated in their upper surface to receive the dovetail at the tie beam ends (to ensure the wall plate is restrained against outward movement).

- Joints in the wall plate to be half-lapped (with 200mm overlap) located within 400mm of the truss bearing. The half lap joint to be glued and screwed (use West System Epoxy Resin - by Wessex Resins and Adhesives) . Suggest setting end timbers first that extend below the trusses and then the central section)

- The wall plates should be positioned using slate or oak packers, the bedding plane should then be rammed with a lime based dry pack (approx 25mm thick).

- Secure rafter feet using 6mm diameter TORX headed screws.
