**Castleman's Cottage**

Job No: 225131

**Roof Repair: Ridge and Rafter Works**

225131 - MNP - XX - XX - SK - S - 4002

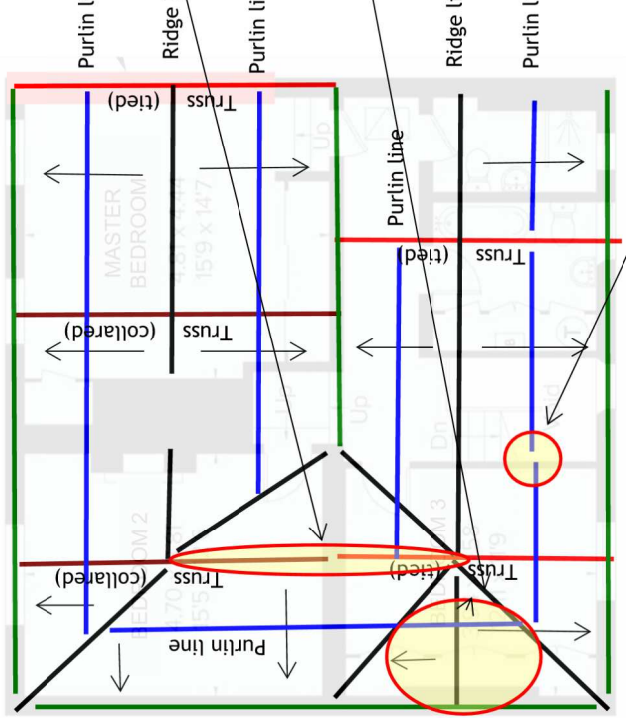
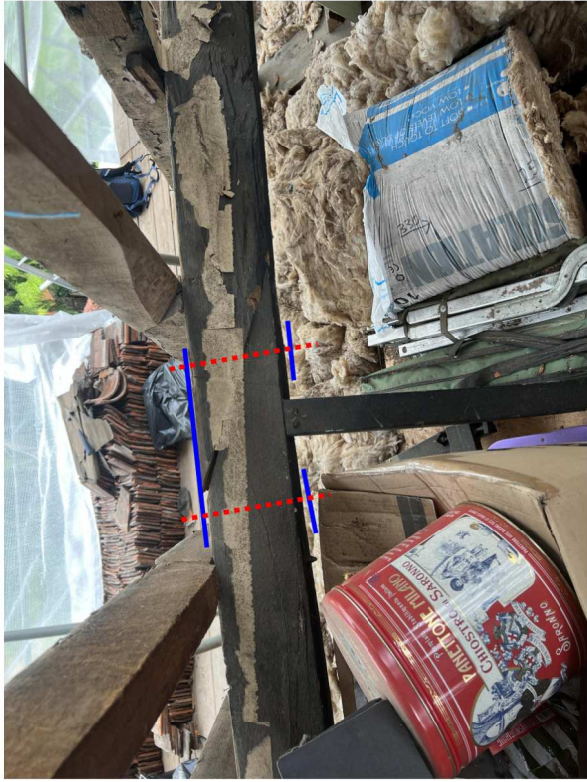
**Schematic layout of roof structure**  
(over 2nd floor layout)

**Decayed Ridge Board**

- The softwood ridge board to the noted area is highly decayed (with a mid-length section missing)
- The discontinuity is causing a misalignment of the rafters in this area.
- Remove the existing ridge board and replace in similar sized soft wood.

**Poor Modern Carpentry**

**Poor Bearing of Rafters on ridge boards and hips (General)**

**Poor bearing of rafters on purlins. (General)**

**Poor bearing of rafter feet on Wall plates (General)**

**Improve continuity of purlin**

**Decay affected rafters**

- Improve / Replace the poorly built modern soft wood ridge and rafters.

- Where required, introduce play or soft wood packers to realign the slipped rafters with the ridge line, to ensure adequate bearing and alignment.
- Secure packers with screws.
- Secure rafters to packers / ridge board with skew driven TORX screws (reversible improvement on original skew nails)

- Secure rafters to pulins with skew driven TORX screws.

- Secure rafters to wallplates with skew driven TORX screws.

- Apply steel plate 50mm wide x 5mm thick to upper side (between rafters) over the diagonal overlap.
- Drill through the purlins close to the rafters for 12mm diameter bolts.
- Fit 50x50x5mm steel washers to underside and draw together (do not over-tighten).

- Where significant decay is found to the rafters, retain existing rafter and pace another of similar size (softwood) next to it. Secure together using 6mm diameter TORX screws @ 300mm centres (staggered)
- 1No has been identified, allow for say 5No total.
