Castleman's Cottage

Job No: 225131

Roof Repair: Tied Truss Works

225131 - MNP - XX - XX - SK - S - 4003

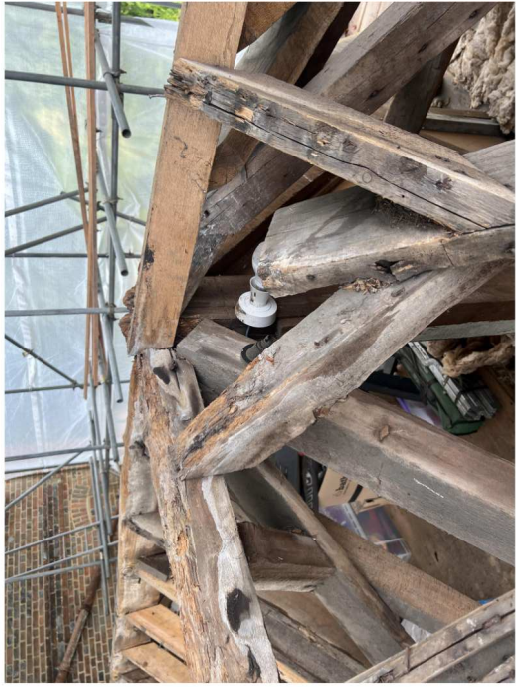
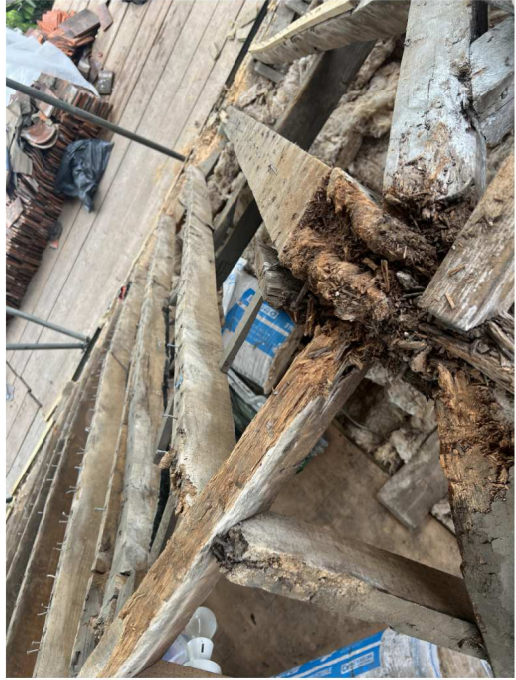
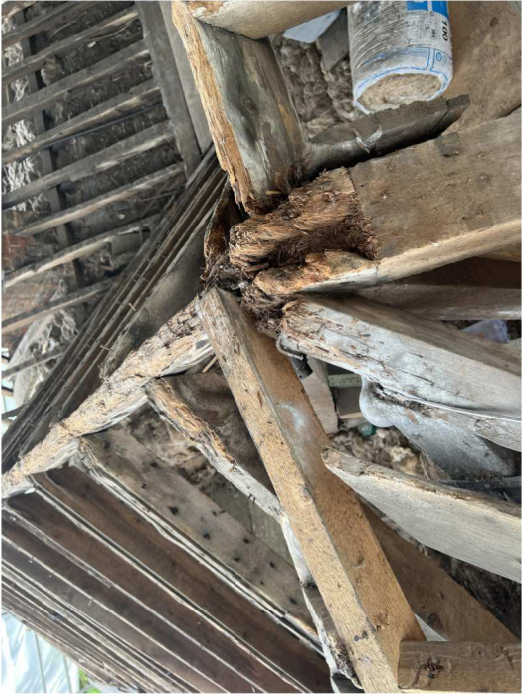
Problem

- The apex of the truss has decayed (water ingress through ridge intersection)
- The ability of the joint to transfer tensile force (from the central hanger post) to put compressive force into the principal rafter, has been adversely affected.

- After propping the truss from below.
- Reform the joint by cutting away the ends of the two rafters and the post
- Then splicing new ends on to a new replica (mortice and tenon) carpentry joint.
- Spliced connections to be scarf joints with lap length of 3 x depth (ie 300mm) for diagonals and 5x depth from the hanger (ie 500mm).
- Glue joists with Epoxy Resin (by Wessex Resins and Adhesives) and screw together to hold in place during curing.

- no need to prop the truss.
- Add 100mm wide x 5mm thick steel plates to each side and bolt through. Extend plates 500mm beyond decayed timber and use 5No M16 through bolts.
- Suggest applying ply template and drill through to ensure alignment of holes.
