**Castleman's Cottage**

Job No: 225131

**Roof Repair: Collared Truss Works**

225131 - MNP - XX - XX - SK - S - 4004

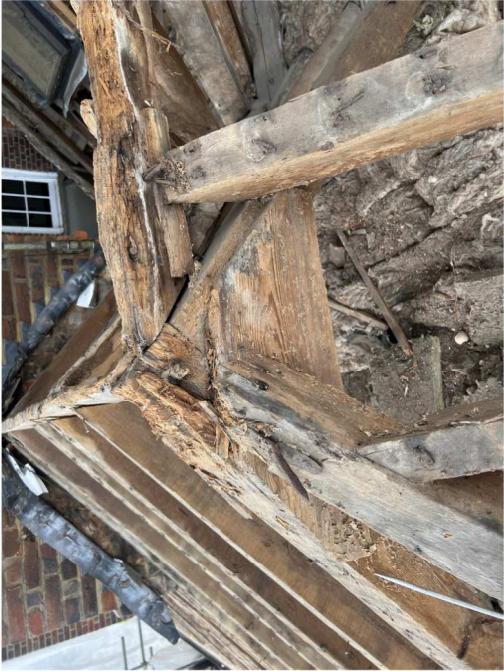
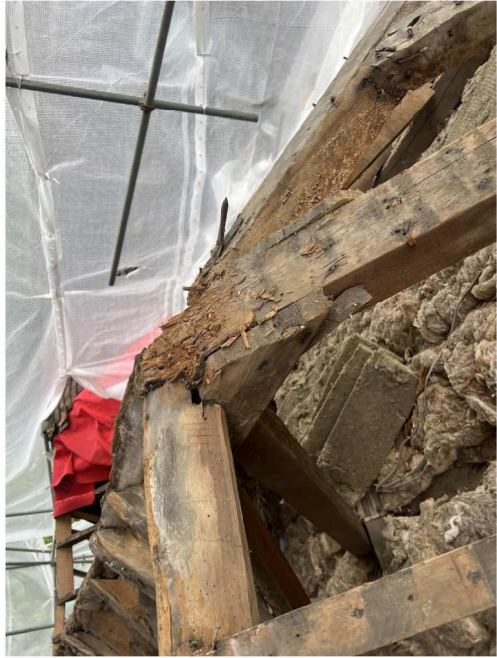
- The apex of the collared truss has decayed (water ingress through ridge intersection)
- The ability of the joint to transfer compressive force from one rafter to the other has been adversely affected.
- NOTE: THE TRUSS RAFTERS ARE HIGHLY STRESSED IN BENDING AND SHOULD NOT BE CUT (on site, see bend at the collar as the rafter foot cantilevers)

- no need to prop the truss.
- Add 100mm wide x 5mm thick steel plates to each side and bolt through. Extend plates 500mm beyond decayed timber and use 5No M16 through bolts.

Note: Use of top and bottom plates allows retention of historic ridge seatings.

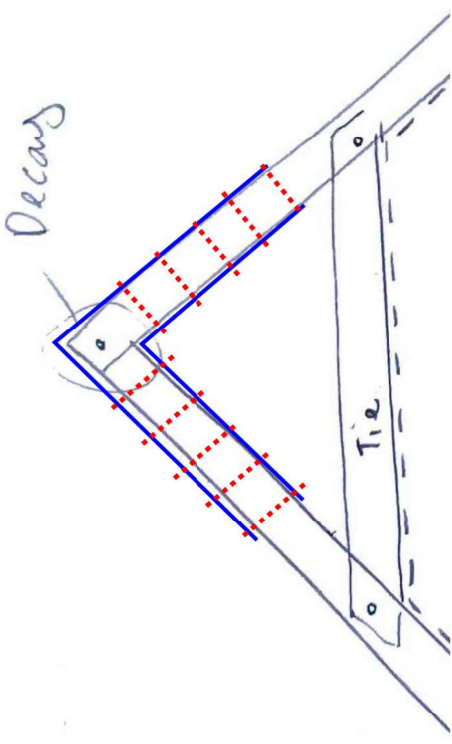
Steel Plates top and Bottom.
