# ARBORICULTURAL REPORT

## TREE CONDITION SURVEY

ST JAMES CHURCH  
SOUTHLAKE  
WOODLEY  
BERKSHIRE  
RG5 3LH

Ref: 06576 / 2024

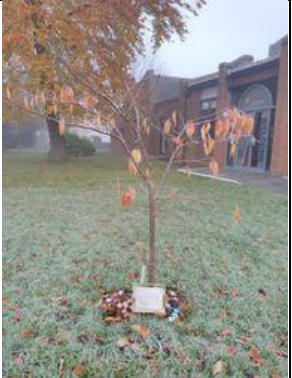
| Ref: | Species | Measurements | Survey Notes | Condition | Recommendations | Photo |
|---|---|---|---|---|---|---|
| T001 | Flowering cherry<br>(Prunus Serrulata) | Height (m): 2<br>Crown Radius (m): 1N, 1E, 0.5S, 1.5W<br>DBH (cm): 3<br>Life Stage: Young<br>Life Exp.: 20+ Years | Small commemorative tree planted in 2019.<br>Reasonable bud density and form. | Fair | No works identified. | |

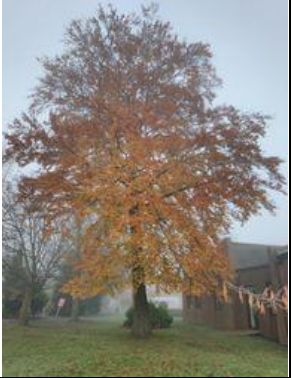
| Ref: | Species | Measurements | Survey Notes | Condition | Recommendations | Photo |
|---|---|---|---|---|---|---|
| T002 | Common beech<br>(Fagus sylvatica) | Height (m): 16<br>Crown Radius (m): 5.5N, 6.5E, 7.5S, 7W<br>DBH (cm): 70<br>Life Stage: Mature<br>Life Exp.: 40+ Years | Base clear, bark intact.<br>No fungal fruiting bodies evident. Single stem swept slightly south. No visible defects on base and trunk. Small wound on underside of first lateral branch on south side of canopy 5m above ground level. Good wound wood formation. Nest box strapped to trunk at 4.5m. straps are adjusted annually to avoid restricting trunk. Upper canopy resumes vertical growth. Foliage autumnal. Dense, good vitality. Low crown to 1.5m above ground level. | Good | Crown lift to 3m above ground level.<br><br><b>Timescale:</b><br>Optional | |

| Ref: | Species | what3words<br>(Location Identifier) | Recommendations | Work<br>Timescale |
|---|---|---|---|---|
| T002 | Common beech | ///feast.store.voices | Crown lift to 3m above ground level. | Optional |

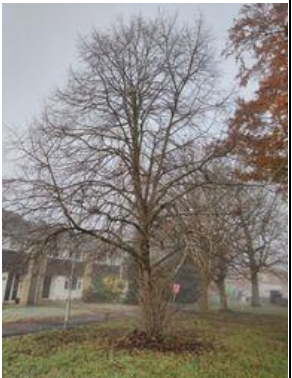
| Ref: | Species | Measurements | Survey Notes | Condition | Recommendations | Photo |
|---|---|---|---|---|---|---|
| T003 | Lime<br>(Tilia sp.) | Height (m): 11<br>Crown Radius (m): 4N, 5.5E, 5S, 4.5W<br>DBH (cm): 37<br>Life Stage: Mature<br>Life Exp.: 40+ Years | Uneven buttress root formation. Base partially obscured by dense epicormic growth. Where accessible bark intact. No fungal fruiting bodies evident.<br>Included bark in branch forks from 2m and into higher canopy. Young tree so weaker forks are not a concern at this time.<br>Broad canopy. Buds dense. Good vitality. Low crown to 1.2m above ground level. | Good | Remove epicormic growth.<br>Cut back elongated branch overhanging footpath by 1.6m back to previous reduction point.<br>Reduce lateral branches to create 0.5m canopy clearance to streetlight & lamp column.<br>Crown lift around canopy to 2.5m reducing secondary and tertiary branch tips only.<br><br><b>Timescale:</b><br>28-May-2025<br>(6 Months) | |

| Ref: | Species | what3words<br>(Location Identifier) | Recommendations | Work<br>Timescale |
|---|---|---|---|---|
| T003 | Lime | ///either.tests.zone | Remove epicormic growth.<br>Cut back elongated branch overhanging footpath by 1.6m back to previous reduction point.<br>Reduce lateral branches to create 0.5m canopy clearance to streetlight and lamp column.<br>Crown lift around canopy to 2.5m reducing secondary and tertiary branch tips only. | 28-May-2025<br>(6 Months) |

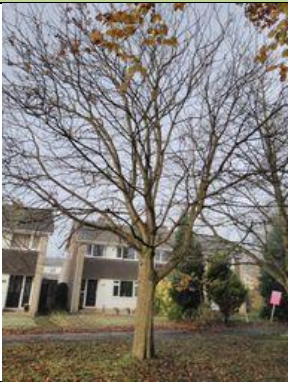
| Ref: | Species | Measurements | Survey Notes | Condition | Recommendations | Photo |
|---|---|---|---|---|---|---|
| T004 | Horse chestnut<br>(Aesculus hippocastanum) | Height (m): 11<br>Crown Radius (m): 4N, 5E, 4S, 5W<br>DBH (cm): 45<br>Life Stage: Mature<br>Life Exp.: 40+ Years | Base clear, bark intact. No fungal fruiting bodies evident. No defects at base or lower trunk. Broad crown. Small to medium dead branches in lower central crown. 2m canopy clearance above ground level. Buds dense, good vitality. | Good | Remove deadwood.<br><br><b>Timescale:</b><br>28-Nov-2025<br>(1 Year) | |

| Ref: | Species | what3words<br>(Location Identifier) | Recommendations | Work<br>Timescale |
|---|---|---|---|---|
| T004 | Horse chestnut | ///emerge.swept.insert | Remove deadwood. | 28-Nov-2025<br>(1 Year) |

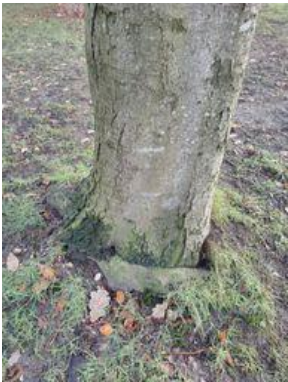
| Ref: | Species | Measurements | Survey Notes | Condition | Recommendations | Photo |
|---|---|---|---|---|---|---|
| T005 | Horse chestnut<br>(Aesculus hippocastanum) | Height (m): 14<br>Crown Radius (m): 5N, 5E, 4.5S, 6.5W<br>DBH (cm): 44<br>Life Stage: Mature<br>Life Exp.: 40+ Years | Girdling root around West side of Lost trunk. Bark intact. No fungal fruiting bodies evident. Broad crown. Wound on slender branch in east side of crown caused by secondary branch breakage. Large lateral branch on West side over footpath and assuming apical dominance. 2m canopy clearance above ground level. Small to medium dead branches in lower central crown. Buds dense, good vitality. | Good | Reduce tips of large lateral branch on West side of crown by up to 3m in length and 1-2m of side shoots to check apical dominance in relation to main canopy. Remove deadwood and declining branch stubs in lower canopy. Crown lift secondary and tertiary branches to 3m over footpath only.<br><br><b>Timescale:</b><br>28-Nov-2025<br>(1 Year) | |

| Ref: | Species | what3words<br>(Location Identifier) | Recommendations | Work<br>Timescale |
|---|---|---|---|---|
| T005 | Horse chestnut | ///blocks.herbs.dots | Reduce tips of large lateral branch on West side of crown by up to 3m in length and 1-2m of side shoots to check apical dominance in relation to main canopy. Remove deadwood and declining branch stubs in lower canopy. Crown lift secondary and tertiary branches to 3m over footpath only. | 28-Nov-2025<br>(1 Year) |

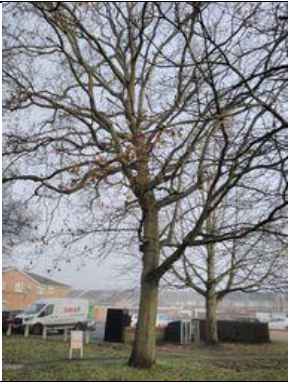
| Ref: | Species | Measurements | Survey Notes | Condition | Recommendations | Photo |
|---|---|---|---|---|---|---|
| T006 | Pedunculate oak<br>(Quercus robur) | Height (m): 17<br>Crown Radius (m): 7N, 7E, 8.5S, 8W<br>DBH (cm): 71<br>Life Stage: Mature<br>Life Exp.: 40+ Years | Base clear, bark intact. No fungal fruiting bodies evident. No visible defects on base and trunk. Nest box strapped to trunk at 4m. Straps are adjusted annually to avoid restricting trunk. Foliage autumnal. Buds dense, good vitality. Canopy mostly over 2.5m. dead branch stubs throughout crown. | Good | Crown lift cutting a small number of low branch tips to 3m above ground level. Remove deadwood.<br><br><b>Timescale:</b><br>28-May-2025<br>(6 Months) | |

| Ref: | Species | what3words<br>(Location Identifier) | Recommendations | Work<br>Timescale |
|---|---|---|---|---|
| T006 | Pedunculate oak | ///lion.mats.pines | Crown lift cutting a small number of low branch tips to 3m above ground level.<br>Remove deadwood. | 28-May-2025<br>(6 Months) |

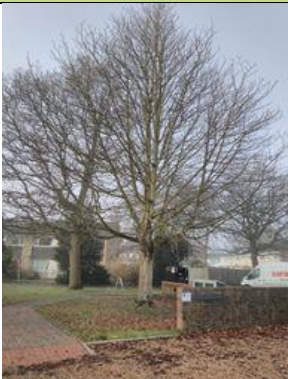
| Ref: | Species | Measurements | Survey Notes | Condition | Recommendations | Photo |
|---|---|---|---|---|---|---|
| T007 | Horse chestnut<br>(Aesculus hippocastanum) | Height (m): 14<br>Crown Radius (m): 6N, 6.5E, 7S, 4.5W<br>DBH (cm): 62<br>Life Stage: Mature<br>Life Exp.: 40+ Years | Wall 3m from base on North side and 4.7m on east side. Base clear, bark intact. Small girdling root on east side. Helical growth on trunk. Rapid growth bark cracks on trunk and branches. Large lateral limb on southeast side. Broad crown, slight asymmetry due to proximity of T006. Twin stem from 4m. Union satisfactory. Broad crown. Bud density and vitality good. | Good | Crown lift to create 2.5-3m canopy clearance above ground level.<br><br><b>Timescale:</b><br>28-Nov-2025<br>(1 Year) | |

| Ref: | Species | what3words<br>(Location Identifier) | Recommendations | Work<br>Timescale |
|---|---|---|---|---|
| T007 | Horse chestnut | ///sleeps.rising.paying | Crown lift to create 2.5-3m canopy clearance above ground level. | 28-Nov-2025<br>(1 Year) |

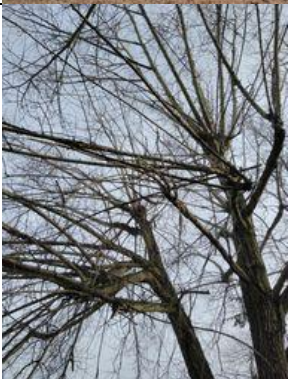
| Ref: | Species | Measurements | Survey Notes | Condition | Recommendations | Photo |
|---|---|---|---|---|---|---|
| T008 | Crack willow<br>(Salix fragilis) | Height (m): 16.5<br>Crown Radius (m): 10N, 8E, 8S, 5.5W<br>DBH (cm): 66<br>Life Stage: Mature<br>Life Exp.: 20+ Years | Base clear, bark intact. Hammer test inconclusive due to thick corky bark. Large pruning cut on east side of trunk. Three way stem fork at 2m. Canopy formed of 5 principal branches topped around 8m. Dense regrowth up to 100mm diameter. Some shoots dead. Pollarded form increases risk of major branch breakage. Branch tips touching streetlight. | Poor | Re-pollard to 1m beyond previous reduction points leaving 1m stumps to reduce size of cuts and spread of decay.<br><br><b>Timescale:</b><br>28-May-2025<br>(6 Months) | |

| Ref: | Species | what3words<br>(Location Identifier) | Recommendations | Work<br>Timescale |
|---|---|---|---|---|
| T008 | Crack willow | ///charmingly.sting.bud<br>get | Re-pollard to 1m beyond previous reduction points leaving 1m stumps to reduce size of cuts and spread of decay. | 28-May-2025<br>(6 Months) |

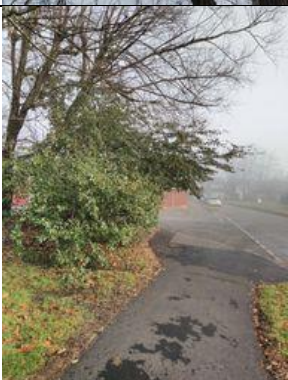
| Ref: | Species | Measurements | Survey Notes | Condition | Recommendations | Photo |
|---|---|---|---|---|---|---|
| T009 | Cotoneaster<br>(Cotoneaster sp.) | Height (m): 5<br>Crown Radius (m): 2.5N, 2E, 2.5S, 4.5W<br>DBH (cm): 20<br>Stems: 2<br>Life Stage: Mature<br>Life Exp.: 20+ Years | Ivy clad large shrub/small tree. Short trunk angled low, close to ground for 1m. Cut b back over highway. Foliage dense, good vitality. | Fair | Cut back crown on south side by up to 2.5m to clear footpath.<br><br><b>Timescale:</b><br>28-May-2025<br>(6 Months) | |

| Ref: | Species | what3words<br>(Location Identifier) | Recommendations | Work<br>Timescale |
|---|---|---|---|---|
| T009 | Cotoneaster | ///horses.over.linked | Cut back crown on south side by up to 2.5m to clear footpath. | 28-May-2025<br>(6 Months) |

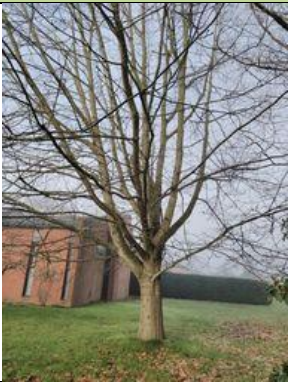
| Ref: | Species | Measurements | Survey Notes | Condition | Recommendations | Photo |
|---|---|---|---|---|---|---|
| T010 | Red oak<br>(Quercus rubra) | Height (m): 14<br>Crown Radius (m): 7.5N, 5E, 7.5S, 7.5W<br>DBH (cm): 56<br>Life Stage: Mature<br>Life Exp.: 40+ Years | Base clear, bark intact. No fungal fruiting bodies evident. Rapid growth bark cracks on trunk. Branching from 1.5m with large low lateral branch on southwest side on east trunk. Early areas of included bark in stem forks above. Condition currently satisfactory. Broad low crown Bud density and vitality good. 1m canopy clearance over lawn and 2m over footpath. | Good | Crown lift secondary and tertiary branches to 3m over footpath and 2m over lawn for maintenance.<br><br><b>Timescale:</b><br>28-Nov-2025<br>(1 Year) | |

| Ref: | Species | what3words<br>(Location Identifier) | Recommendations | Work<br>Timescale |
|---|---|---|---|---|
| T010 | Red oak | ///calm.owners.lasted | Crown lift secondary and tertiary branches to 3m over footpath and 2m over lawn for maintenance. | 28-Nov-2025<br>(1 Year) |

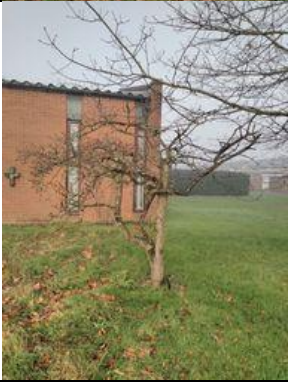
| Ref: | Species | Measurements | Survey Notes | Condition | Recommendations | Photo |
|---|---|---|---|---|---|---|
| T011 | Prunus<br>(Prunus sp.) | Height (m): 2.5<br>Crown Radius (m): 2<br>DBH (cm): 80<br>Life Stage: Mature<br>Life Exp.: 20+ Years | Small commemorative tree. Reasonable bud density and form. Minor deadwood in East side of crown where suppressed by T010. | Fair | No works identified. | |
