### Asbestos Survey Report & Register

| Survey Type: | Demolition Survey (with MA only) |
| Site: | Heathlands Road Garages, Heathlands Road, Wokingham, RG40 3AY |
| Contract: | J012667 |

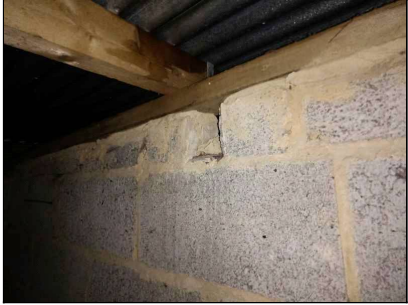
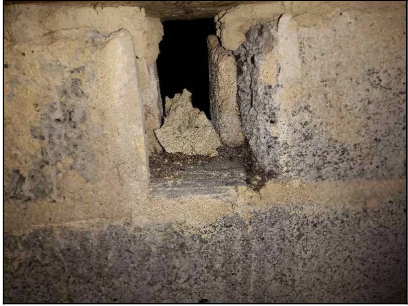
| <b>Contract No:</b><br>J0012667 | <b>Client:</b> Davis Planning Ltd | <b>Item No:</b> 1 | |

| <b>Room Area:</b> | 001 Block of 5 Garages | | |
| <b>Description</b> | Packers to wall | | |
| <b>Damage Extent</b> | Medium Damage (2) | | |
| <b>Asbestos Type:</b> | No Asbestos Detected | <b>Sample Ref:</b> | GD000404 (S) |
| <b>Comment:</b><br>Slate | | | |

| <b>Recommendations:</b><br><br>No further action required | | | |

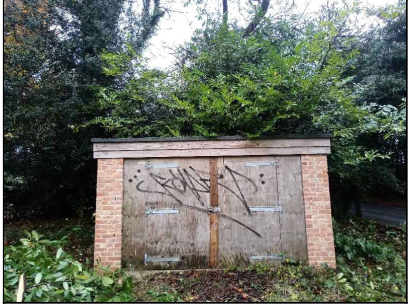
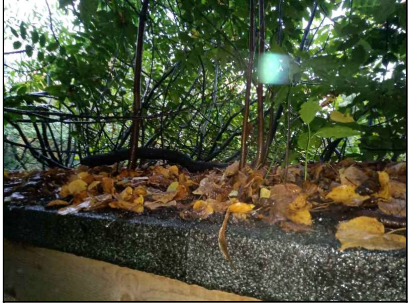
| <b>Contract No:</b><br>J0012667 | <b>Client:</b> Davis Planning Ltd | <b>Item No:</b> 2 | |

| <b>Room Area:</b> | 002 Block of 2 Garages | | |
| <b>Description</b> | Roof felt to roof | | |
| <b>Damage Extent</b> | Low Damage (1) | | |
| <b>Asbestos Type:</b> | No Asbestos Detected | <b>Sample Ref:</b> | GD000405 (S) |
| <b>Comment:</b><br>Bituminous | | | |

| <b>Recommendations:</b><br><br><br>No further action required | | | |
