17 December 2024

237 London Road, Wokingham RG40 1RB. Inspection of 5no. *Quercus robur*, English Oak.

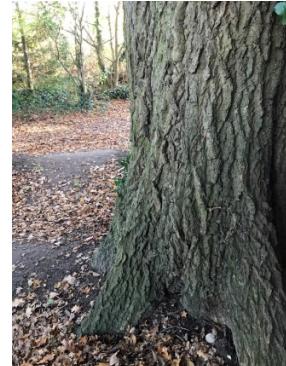
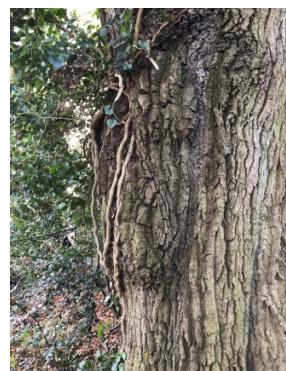
**T1:** The northern most tree considered and grows on the outside corner of the boundary fence.

The tree is predominantly upright with typical branch and union architecture of species. There is a “fibre buckle” bulge on the main stem on the eastern aspect. These are a response to a load event and are a one-off historic increase in wood to manage that singular event. All main unions are normally formed.

A moderate limb has recently failed over the drive area and has been removed to a stub. This limb was approximately 100mm diameter. A further rubbing limb exists in a similar location at 10.0m west over the drive. The lateral extent of the western mid-crown limbs extends beyond the normal crown line and increases load on these structures.

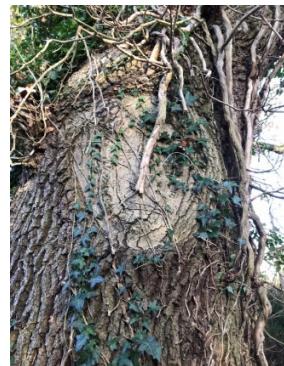
**T2:** Growing adjacent northern corner of dwelling and immediately adjacent fence line.

The tree has a slight lean to the east, not significant and self corrects to an upright form. The tree has the typical branch and union architecture of species. There is a large, historic, fully occluded wound at 2.5m south west. There are no indicators of any significant decay behind this occluded wound, e.g. exudations, increased growth, fruiting body attachments or any changes in hammer tones.

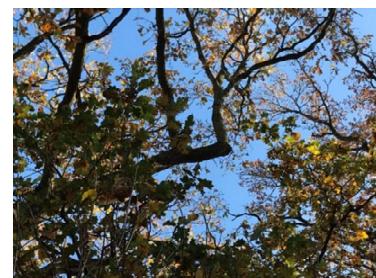
The tree has been historically reduced on the western aspect. This was poor reduction work, internodal cuts, with typical regrowth developing from those points. The mid and upper crown has not been reduced and this has left open arching, lion tailed structures above the lower removals/reductions. These limbs have some exposure to prevailing winds and have increased load.

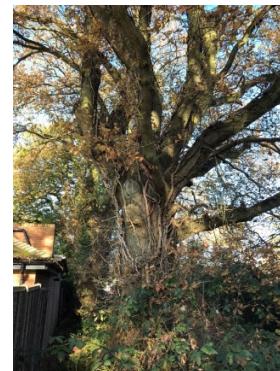
**T3:** Growing adjacent northern corner of dwelling and immediately adjacent fence line.

There are large historic branch removals from the main stem on the western aspect, fully occluded. There are no indicators of any significant decay behind these occluded wounds, e.g. exudations, increased growth, fruiting body attachments. Smaller more recent reductions have occurred in the mid-crown on the western aspect.

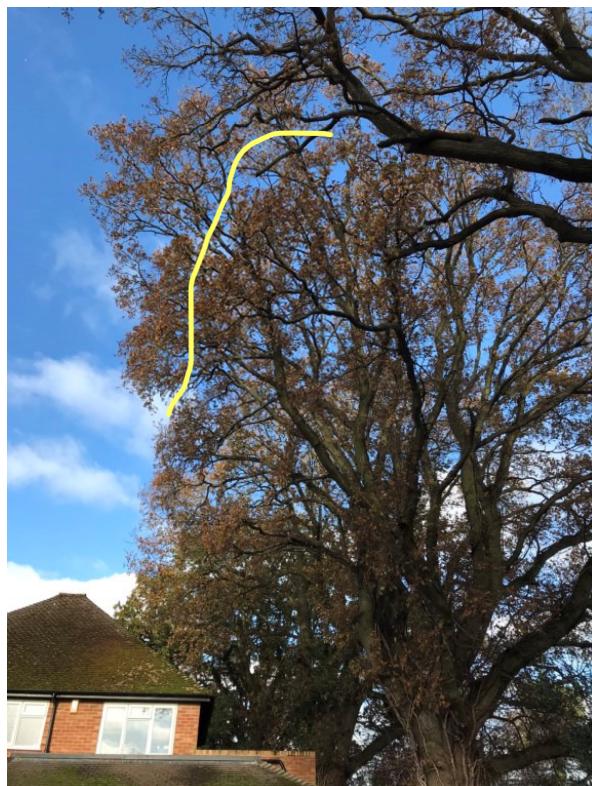
The mid and upper crown has not been reduced and this has left open arching, lion tailed structures above the lower removals/reductions. These limbs have some exposure to prevailing winds and have increased load.

Moderate deadwood is within the mid-crown over the roofs and garden with similar sized deadwood over the footpath.

Reduce lateral and height of 2no. upright stems to north and west by 2.5-3.0m.  
Reduce lower north western stem back to established epicormic growth at 5.0m from tips  
(not BS compliant but best scenario).  
Remove deadwood greater than 25mm over roofs.

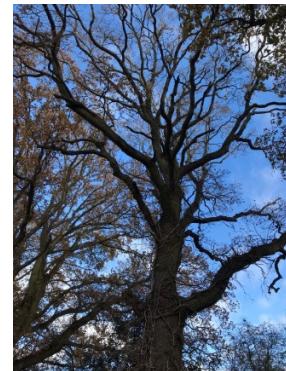
**T4:** Growing adjacent fence line.

The whole tree is in slow decline with major deadwood sections throughout the crown, over footpath and more moderate sections over the garden. There is very limited internal growth within the crown. Vitality is much reduced. However, Oaks tend to decline slowly over a long period of time and this process may have been occurring for many years and will continue for years to come.

Remove deadwood greater than 25mm over garden.

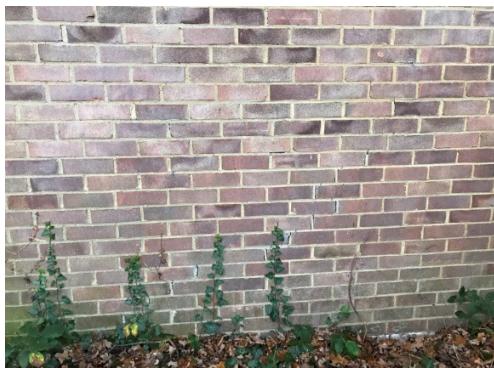
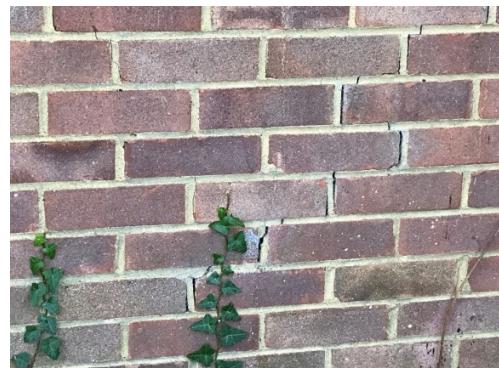
There is some cracking developing on the flank wall of the building between [T2] and [T3]. This starts at the exposed base of the wall and develops in a stepped form via the cement joints. The cracks are generally 1-2m in width. There is no cracking across individual bricks. There is no vertical or lateral displacement that can be seen. The cracking extends vertically to approximately half the height of the wall.

There appears to be no recent movement, i.e. clean exposed cement. The pattern of cracking is not generally consistent with vegetation-induced subsidence movement. This tends to start in the upper corners of a structure and generally at the weaker points, e.g. window or door corners. Cracking is generally wider at the upper points and tapers off to the lower points. The cracks are situated centrally between two of the trees and therefore cannot be attributed to direct action.

A trial pit was dug in the front garden of the property to consider the soil types. The upper horizon was a sandy loam to the depth of the pit (450mm) with gravel appearing in the lower levels. The base of the pit was a hard dense gravel layer preventing further excavation. The British Geological Survey record this area as having a bedrock formation of London Clay with no information relating to any superficial deposits. If there is concern about further movement of the building, crack monitoring to determine any increase in crack widths and locations should be carried out.
