**14 Springfield Park, Twyford. 1no. *Platanus x hispanica* – London Plane.**

I refer to my site visit to Springfield Park on 23 July 2026 to inspect the London Plane in the front garden of number 14.

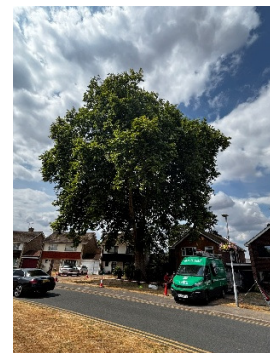
A mature London Plane of slight asymmetric form being supported by a straight short trunk. The trunk divides into three main arising stems supported by normally formed unions.

The tree is growing in the front garden of number 14 and on the southern boundary with number 16 Springfield Park. The crown overhangs the roofs of both properties and the pavement of Springfield Park itself. The tree stands 6.0m south east of the corner of 14 Springfield Park.

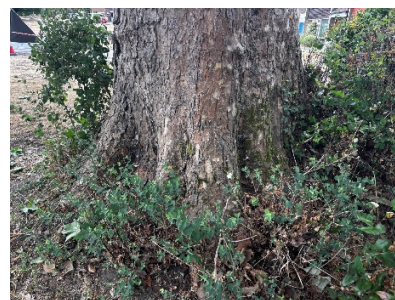
The buttresses are uniform and typical of species. Shrubs and ivy and bramble are growing on the boundary and against the southern flank of the tree. These were pulled back as far as possible to expose the buttresses at this point. There were no fruiting bodies visible at the time of inspection and probing around the buttress clefts revealed no cavities. The southern buttress has historic increment strips typical of that buttress developing quickly.

Its form evidences the opinion that it has always been an open grown tree, and has developed a virtually symmetrical crown form as a result. It is typical of species in all aspects. The buttress has a flare as to be expected, and there is normal development of buttressing as shown by the increment strips - particularly to the south.

There were no fungal fruiting bodies visible at the time of inspection around the buttresses. Probing revealed no cavity formation between the buttresses. Hammer sounding returned consistent tones all round the tree and up the trunk to 1.5m. It is therefore likely that the trunk and buttresses do not have any significant cavity, if any, in the central section as otherwise tones may well vary as wall thicknesses vary.

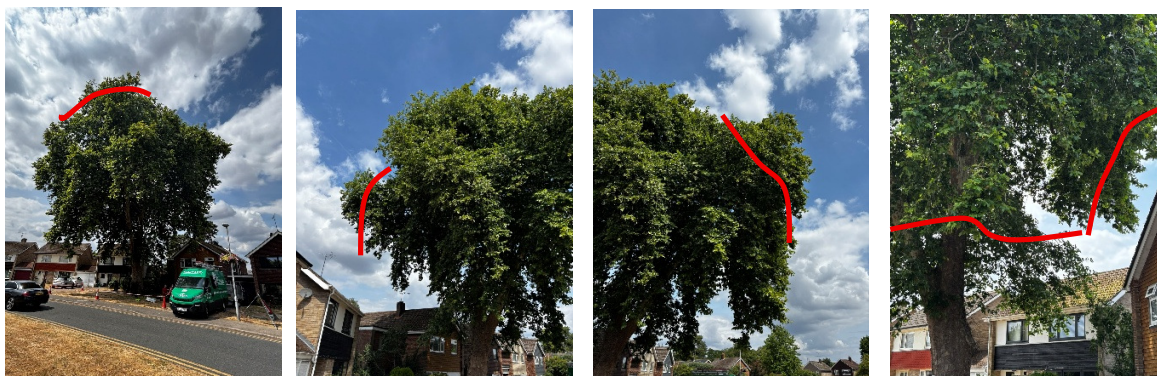
A small number of sections protrude from the crown, particularly to the west, directly over the roofs of 14 and 16 Springfield Park. Lower branches are growing down over the roof of 14 and epicormic growth has developed from the main union area.

Reduction of isolated upper crown section to maintain crown size by approximately 2.0m to suitable growth point. See photo below (left).

Reduction of isolated protruding sections from general crown line to west over/towards 16 Springfield Park (photo: left centre) and mid upper crown to south east by approximately 3.0m (photo: right centre) to blend to natural form and to suitable growth points.

Lift to ensure 3.0m clearance above property line/roof slopes (photo: right)

Remove lower epicormic below 2<sup>nd</sup> main union at 9.5m (photo: right)
