**Tree Health and  
Safety Assessment**

8 The Junipers  
Wokingham  
Berkshire

June 2014

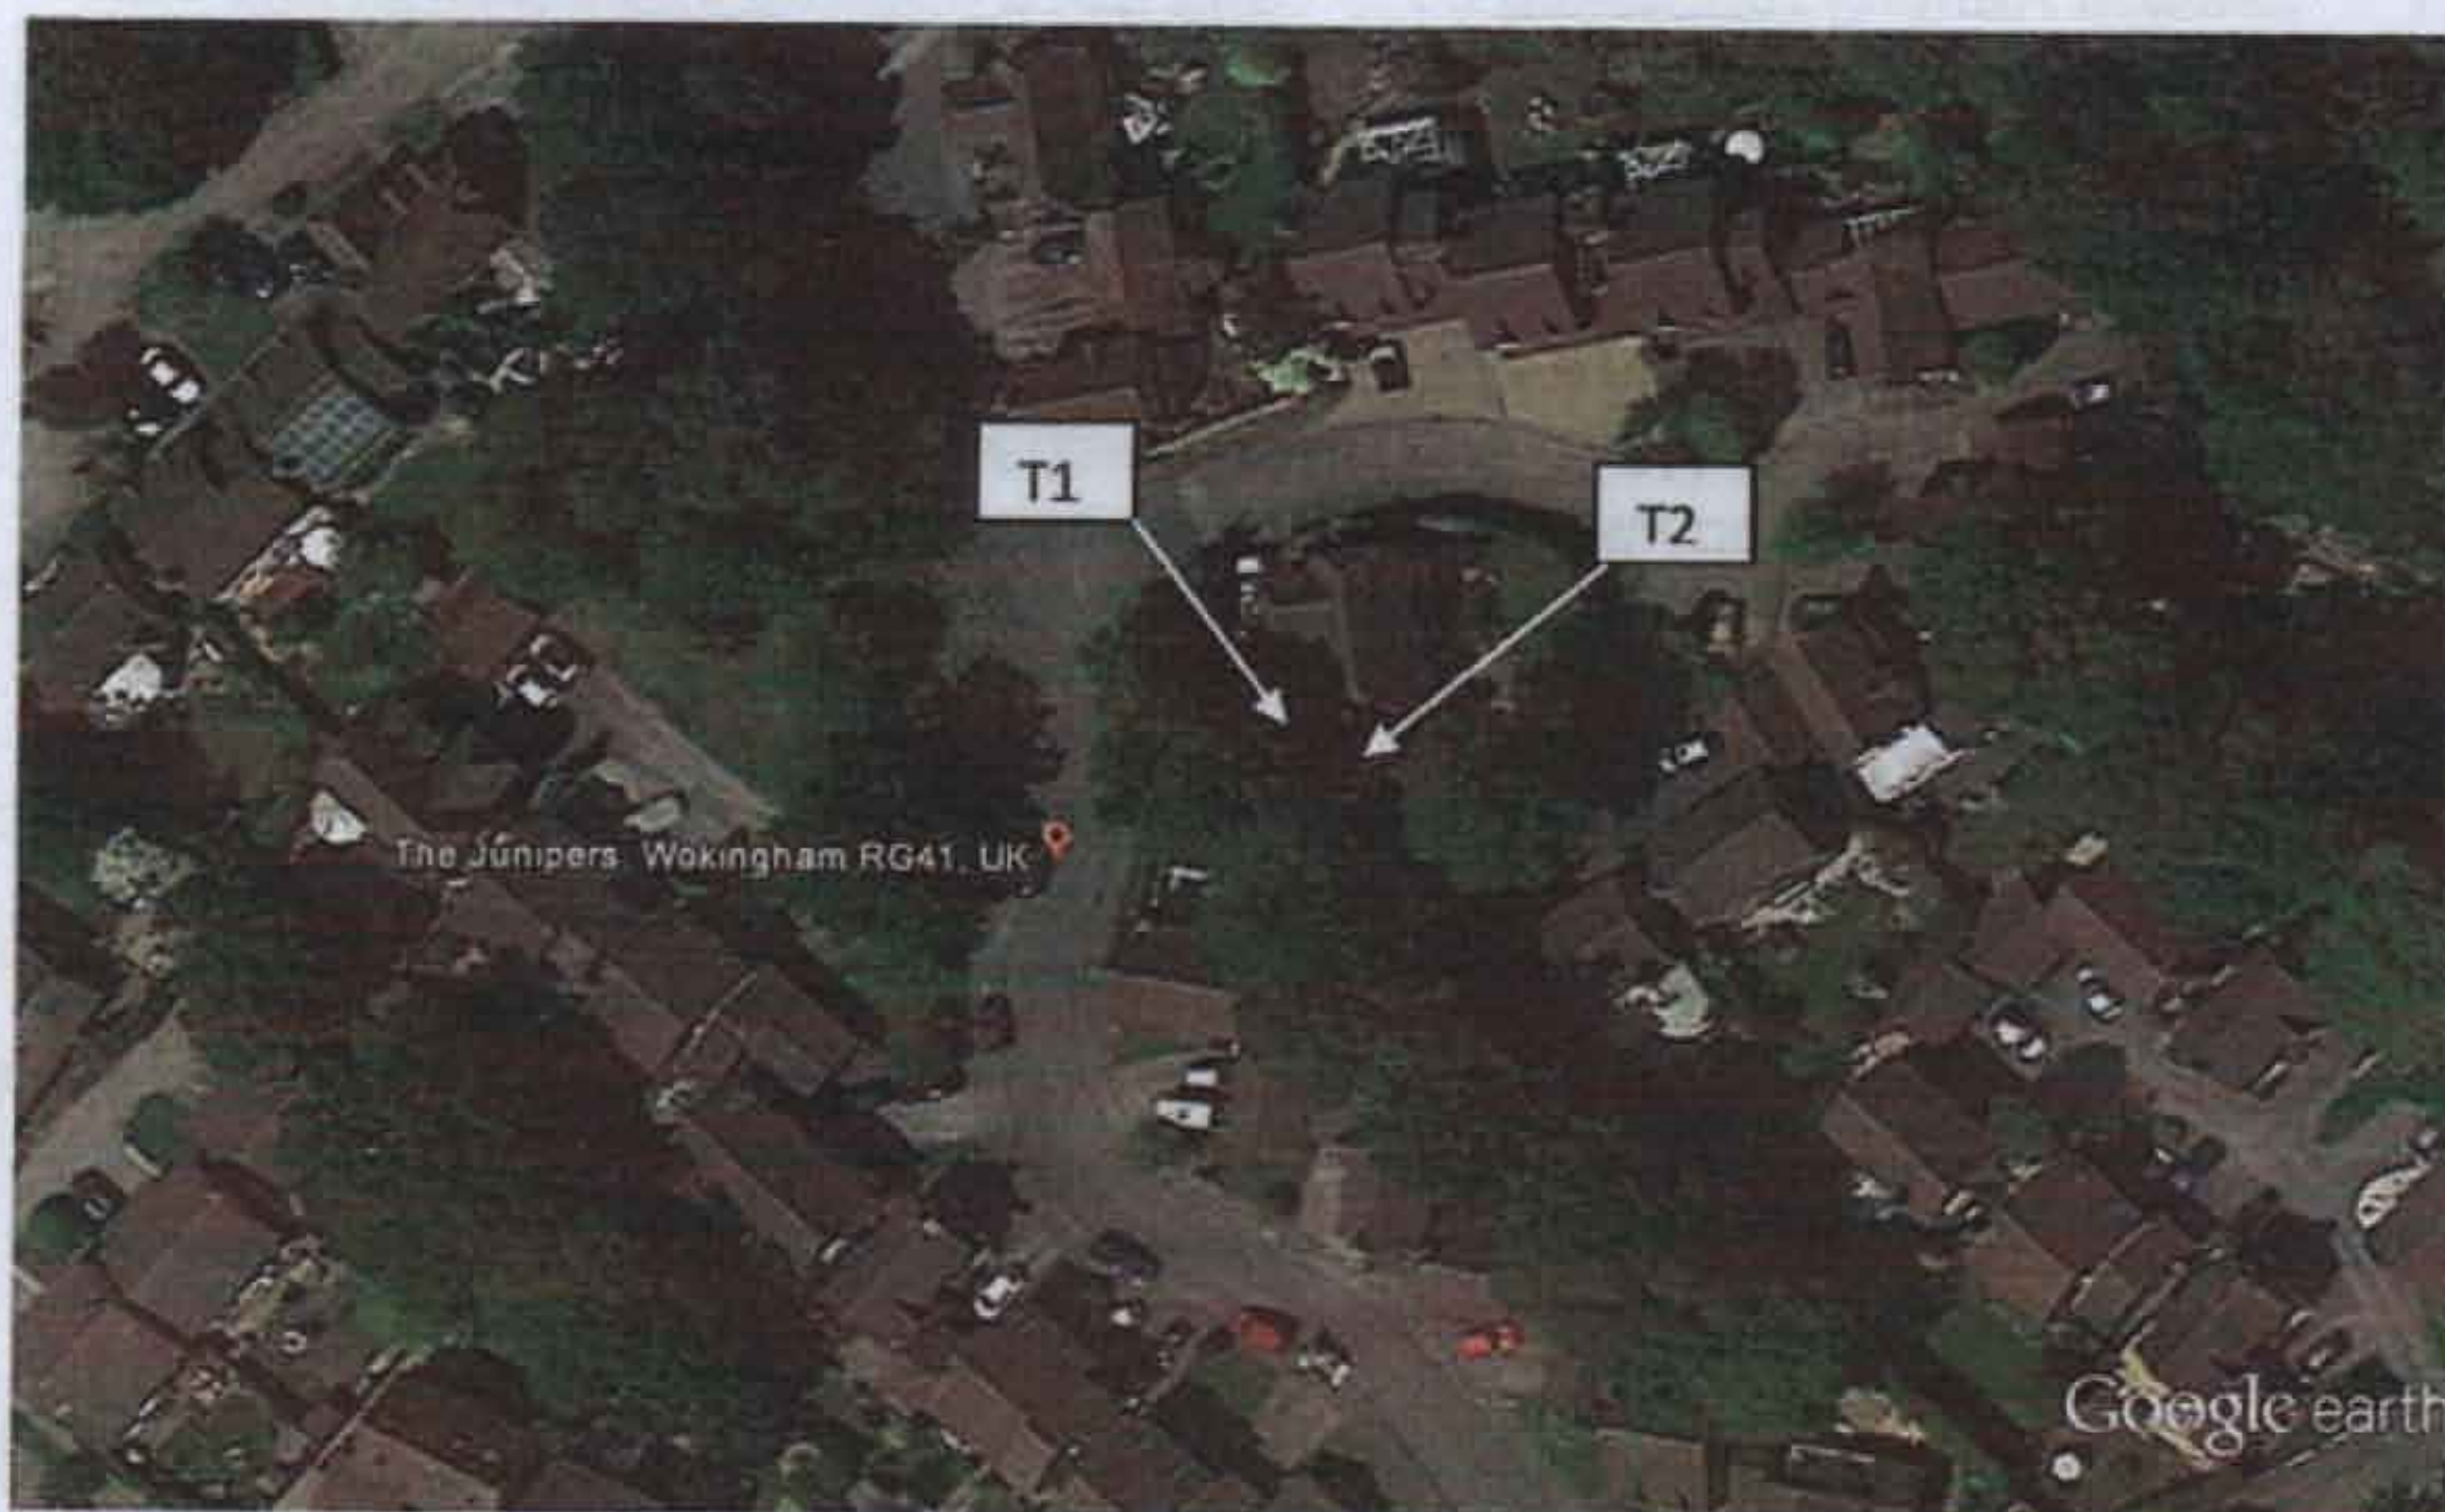
Both trees are part of a group of tall, slender "drawn-up" oak trees in relatively small rear gardens close to the neighbouring houses and associated garages of The Junipers.

The main union is located at 5m and is predominantly tensile in nature. The main scaffold stems naturally incline slightly northwards over the garage of the neighbouring dwelling. There are no obvious signs of any significant defects or decay and it is in a relatively sound and healthy condition for its species and age. It is therefore not reasonably foreseeable that the tree or a part of it will fail at this time.

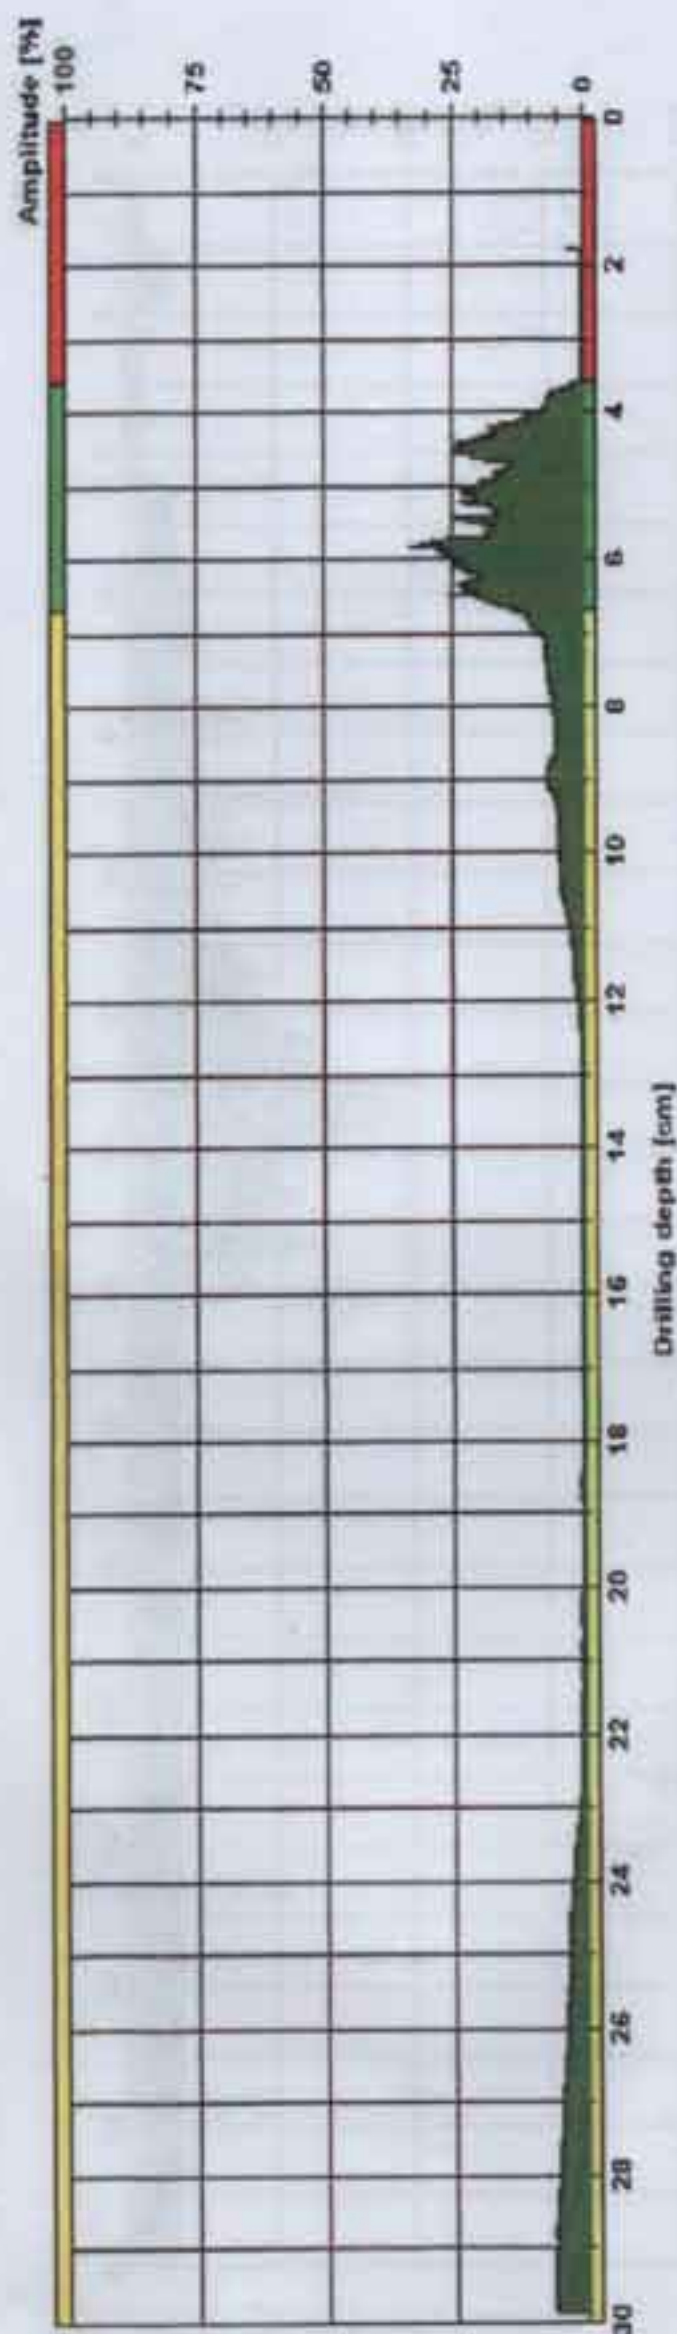
Test appears to indicate advanced decay in outer 30cm of radius on the north side. This is the point at which the fungal fruiting bracketed was probably located (suspected to be Ganoderma spp).

| From | 0.0 cm | to | 3.0 cm | Advanced decay |
| From | 3.0 cm | to | 6.7 cm | Sound wood |
| From | 6.7 cm | to | 30.0 cm | Advanced decay |

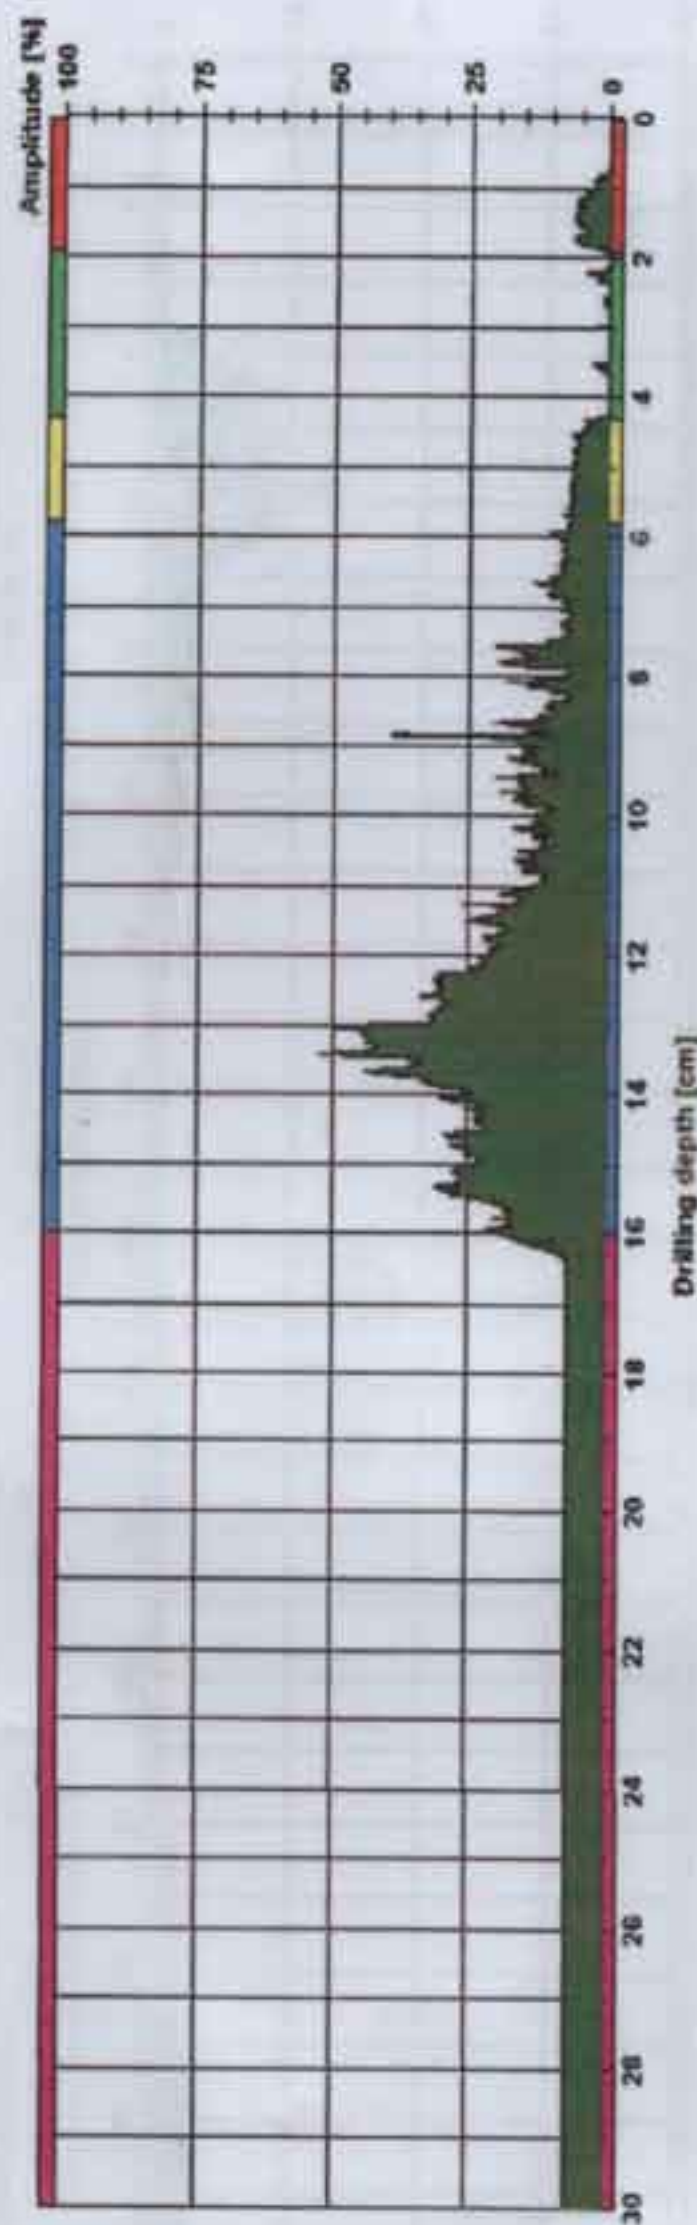
| From | 10.0 cm | to | 30.0 cm | : | Decayed timber |

Test appears to show heartwood decay radiating out from the centre. The timber in the outer 10cm shows higher resistance but with slight decay present.

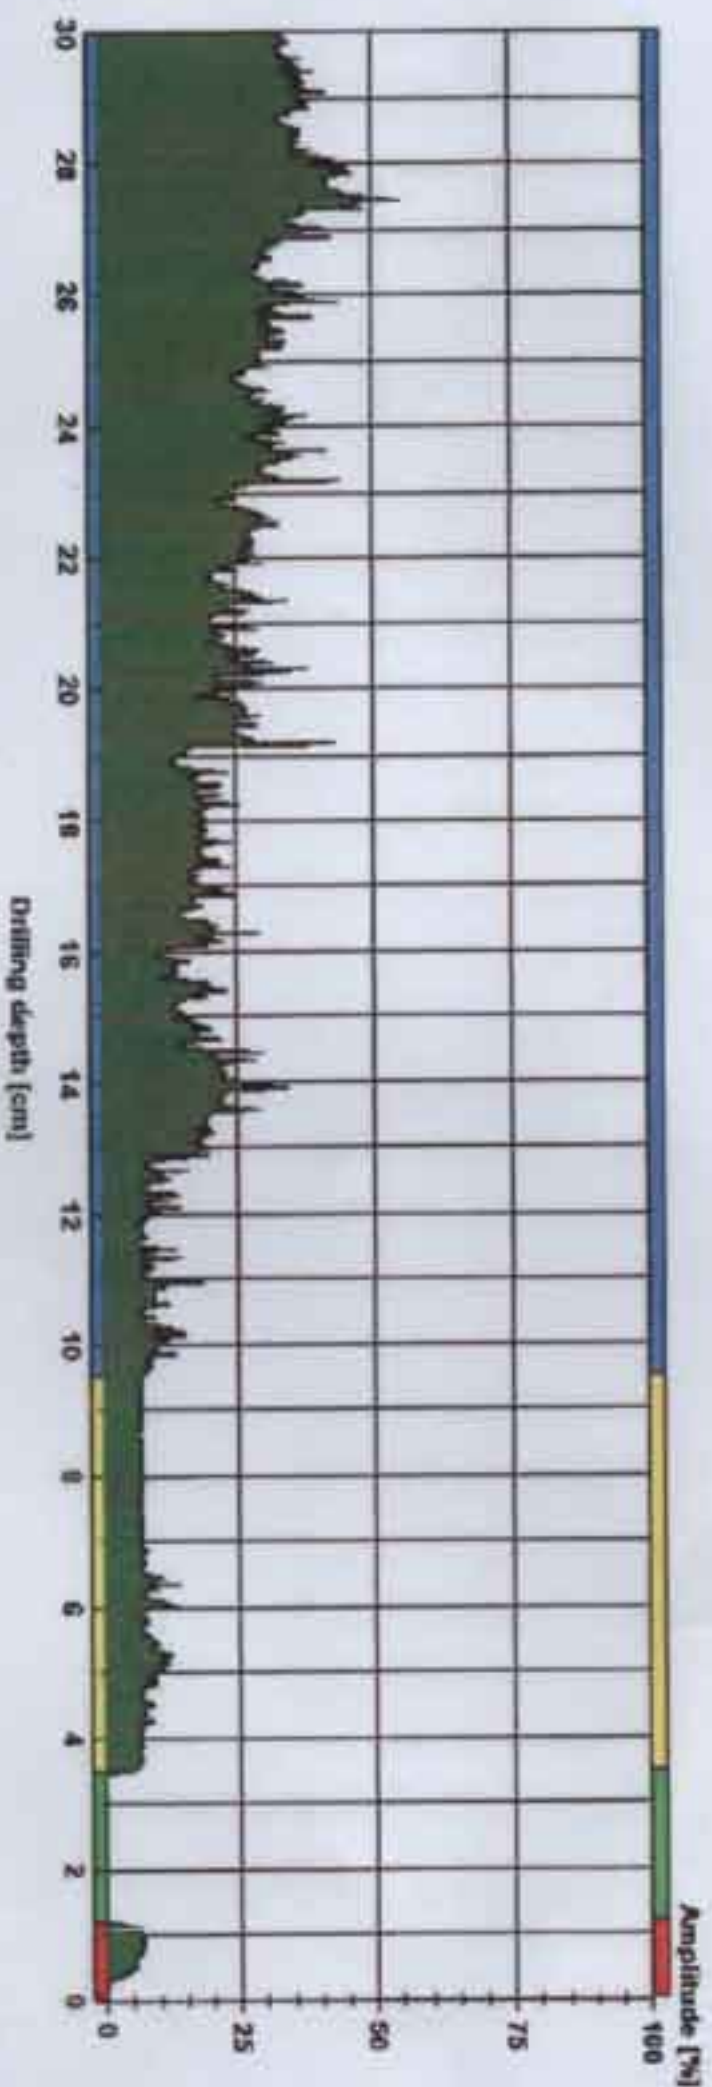
Test appears to show heartwood has good resistance (i.e. minimal decay). The outer 0.5cm appears to indicate partial decay with lower resistance.
