**HERITAGE STATEMENT IN SUPPORT OF LISTED BUILDING CONSENT APPLICATION FOR PROPOSED  
STRUCTURAL REMEDIAL WORKS TO THE BACK STAIRCASE AT REDDAM HOUSE, BEARWOOD ROAD,  
SINDLESHAM, WOKINGHAM, RG41 5BG**

**REVISED- 18<sup>th</sup> May 2026**

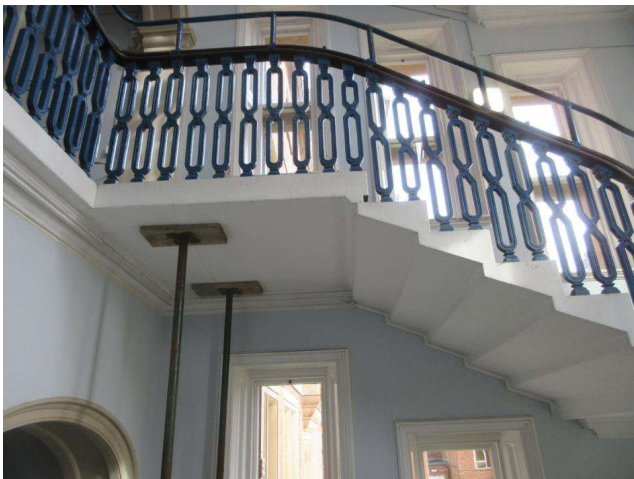
- 2.1 Listed building consent is sought for structural repair works to the first-floor landing of the Back Staircase at Reddam House. The repair is necessary both for safety reasons and to resolve the structural issue causing cracking in the sandstone landing slab.
- 2.2 The cracked first floor landing is currently secured by temporary Acrow propping, as shown in Figures 1 and 2 below. The propping has been in place for some time and cannot remain as a permanent solution.

Figure 2. Acrow props supporting the first-floor landing from below.

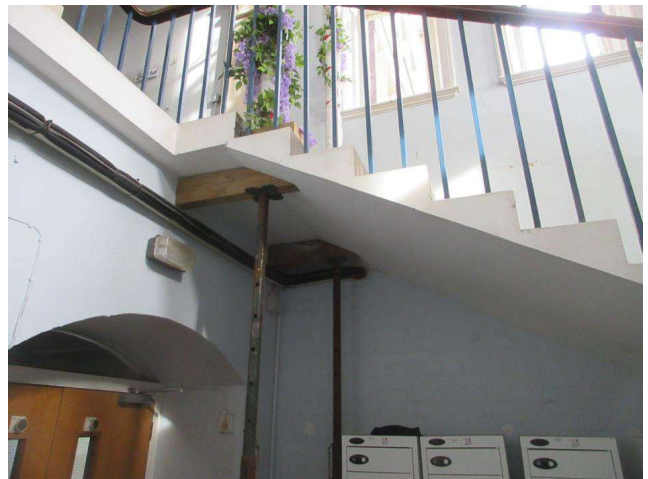
Figure 3. Back propping beneath the ground floor landing to transfer loads to ground level.

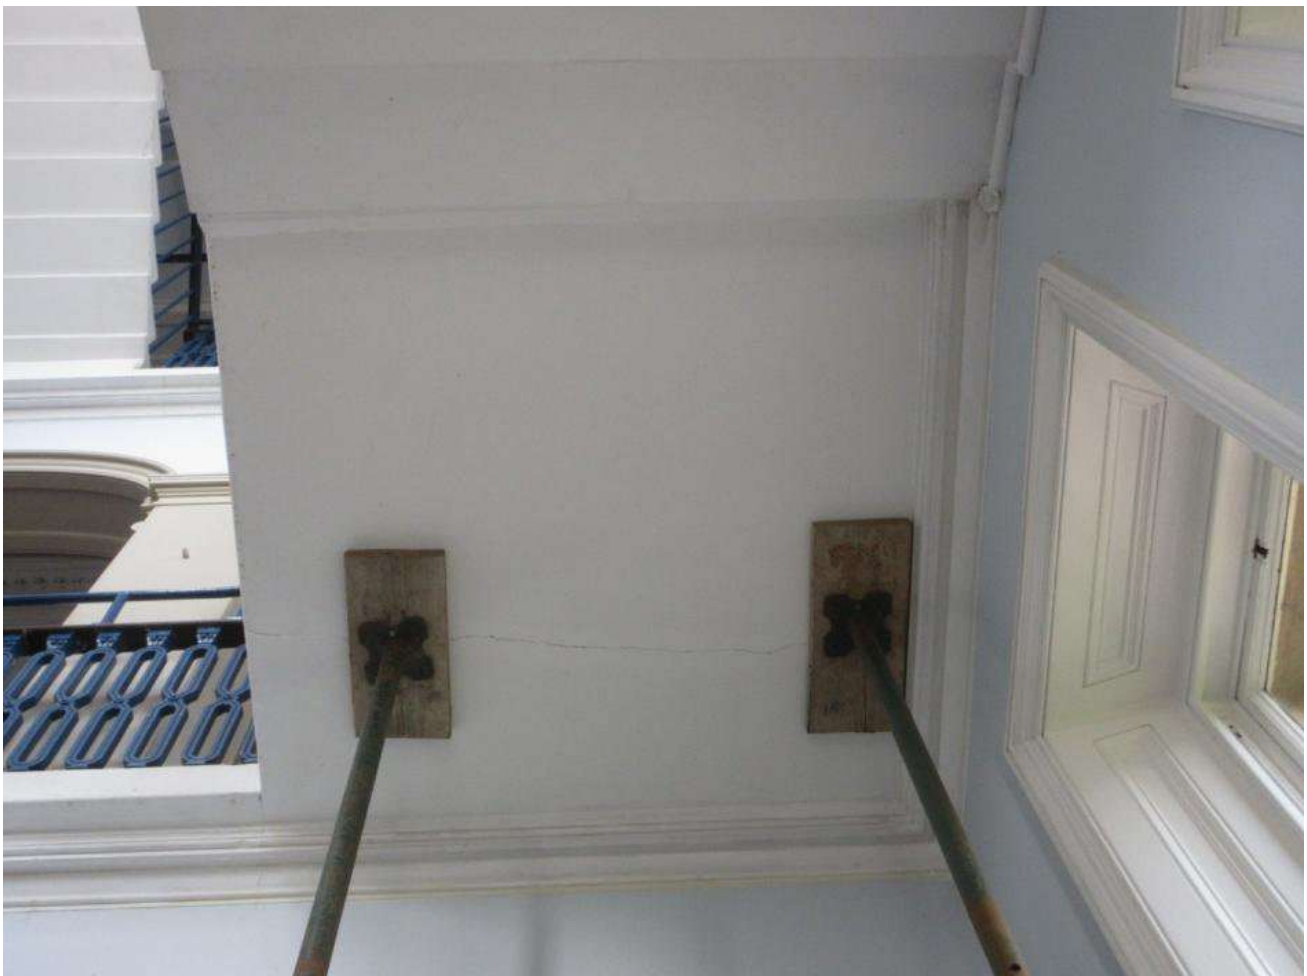
*Figure 4. The crack to the first floor landing viewed from below, with Acrow props relocated to provide access.*

- 4.4 **Scope of works:** The Built Heritage Officer questioned whether works to all landings were justified when only the first-floor landing showed cracking. The revised scheme addresses this directly: Allcott Associates inspected all landings and have confirmed on structural grounds that repair is required only at the first-floor landing owing to its length. No works are proposed to any other landing.

- 2.4 Structural resin crack injection: The crack will be injected with Fosroc Nitofil LV low viscosity epoxy resin grout, a certified system (BS EN 1504 Part 5) designed for the structural reinstatement of cracks in masonry and stone. The adhesion strength of the cured resin exceeds the calculated tensile stress in the slab, confirming structural adequacy. Near the top surface of the crack, kiln-dried sand will be mixed into the resin to provide a closer visual match to the existing sandstone.

- 2.5 Stainless steel dog cramps: Eight stainless steel dog cramps (12mm diameter, 300mm long, grade 304 or 316) will be installed to the soffit of the slab across the crack at 200mm centres. Each cramp is U-shaped and set symmetrically across the crack with each arm embedded 70mm into the slab via 14mm holes drilled using non-percussive means. The holes and a 20mm wide by 30mm deep chase between them are filled with Fosroc Lokfix E35 resin. The exposed cramp and chase are then covered flush with Fosroc Renderoc HB repair mortar, coloured to match the sandstone as closely as practical.

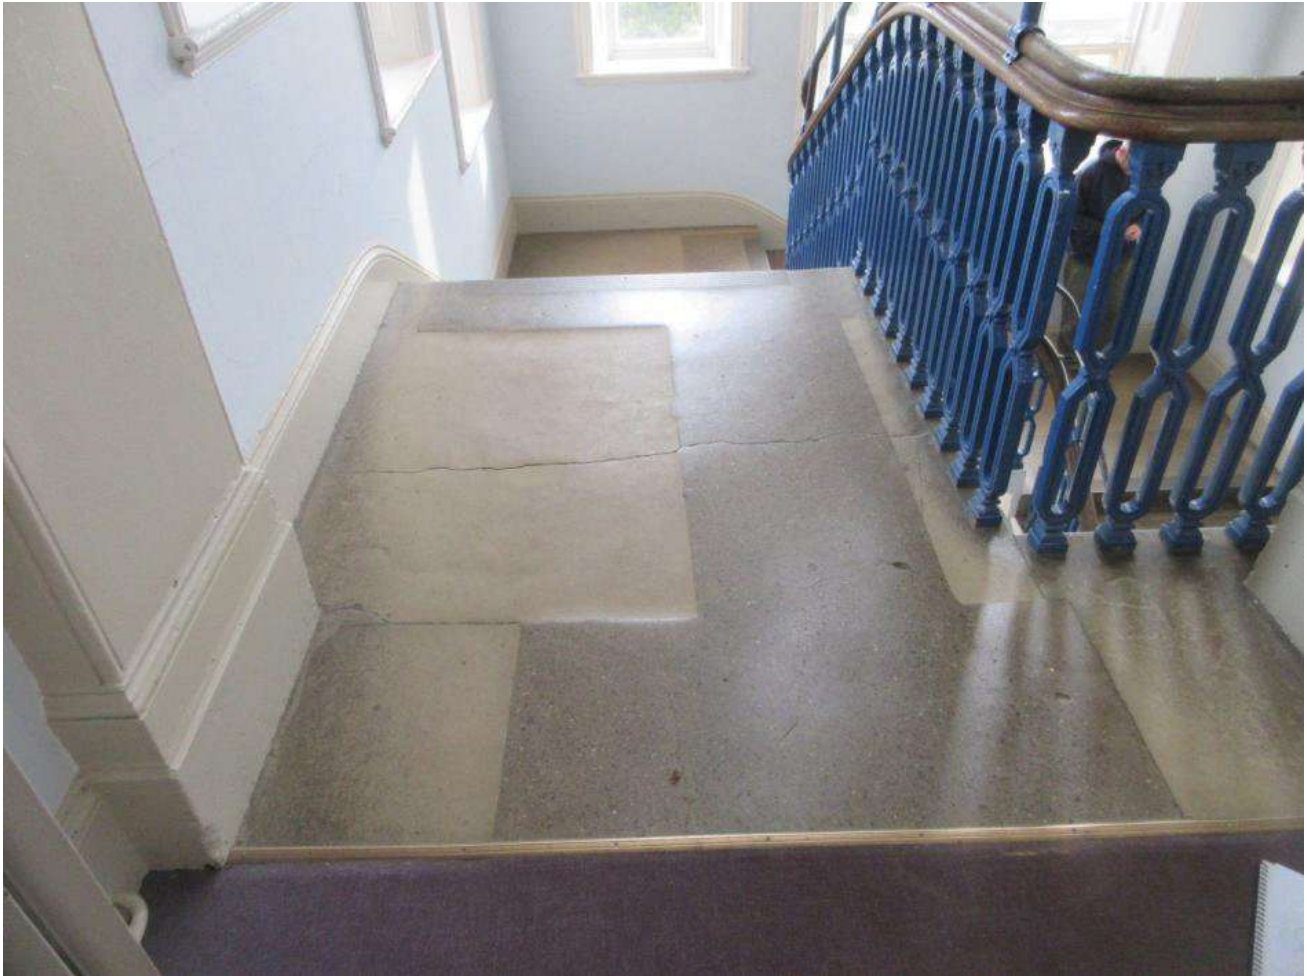
Figure 5. The crack across the full width of the first floor landing, viewed from above. The worn granolithic screed finish is visible to the top surface.

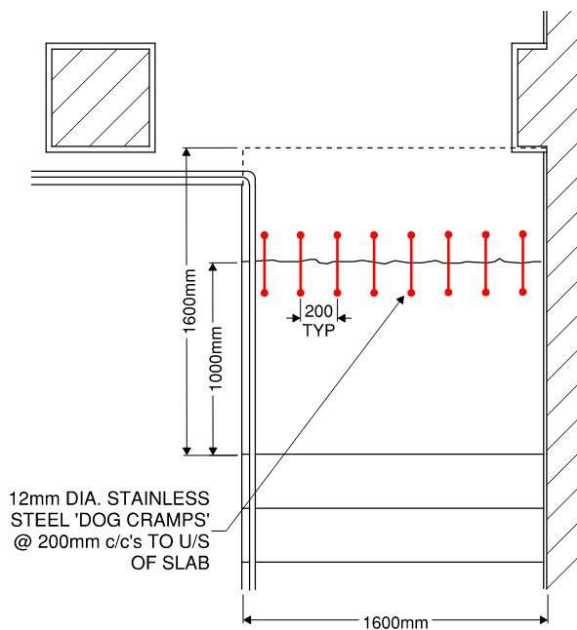
Figure 6. Plan on first floor landing slab showing dog cramp positions at 200mm centres (Allcott Associates, Ref 24543).

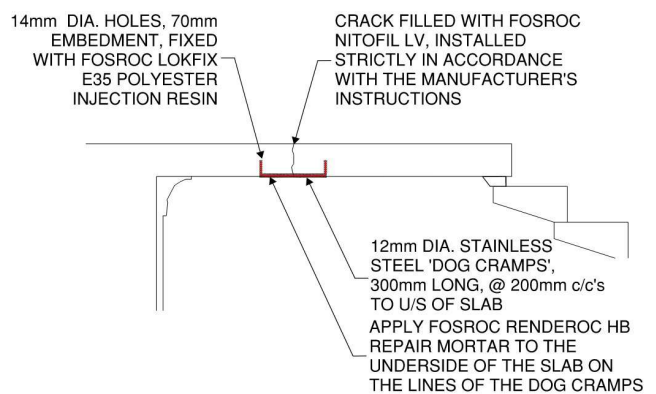
Figure 7. Section through landing slab showing resin crack injection and dog cramp installation detail (Allcott Associates, Ref 24543).

- 5.3 The crack will be thoroughly cleaned and sealed with Fosroc Nitokit Surface Sealant before Fosroc Nitofil LV epoxy resin is injected progressively along the crack. Once cured, the stainless-steel dog cramps will be installed into the slab soffit and finished flush with Fosroc Renderoc HB repair mortar.
