# Geotechnical Survey Report

FSI Ref: 25253  
Issue Date: November 2022

Risk Address: 2 Greenside  
Crowthorne  
Berkshire  
RG45 6EX

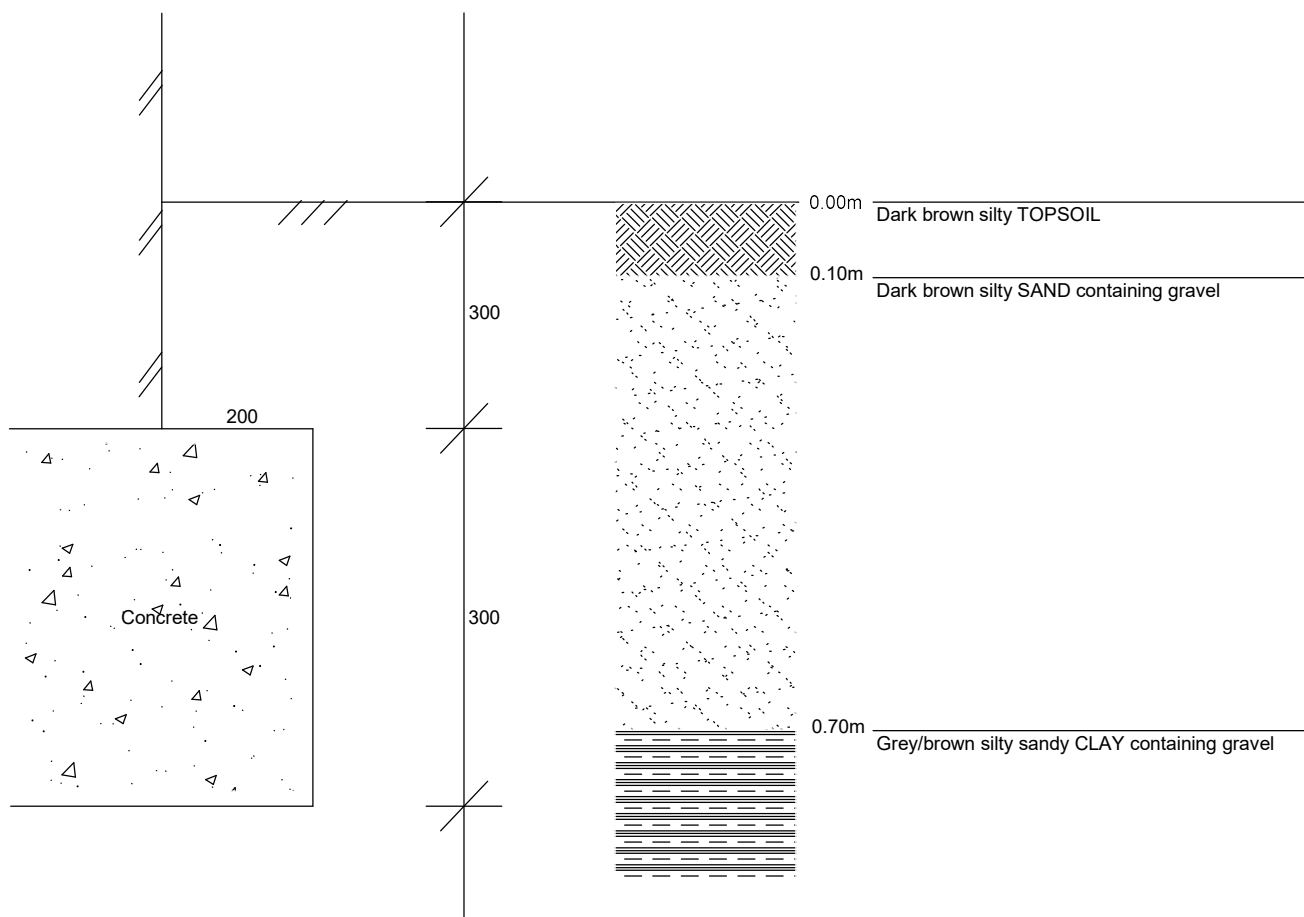
## TRIAL PIT 1

D1 @F.L. (0.80m)

V= 96-98kPa

Founding Strata: Grey/brown silty sandy CLAY containing gravel

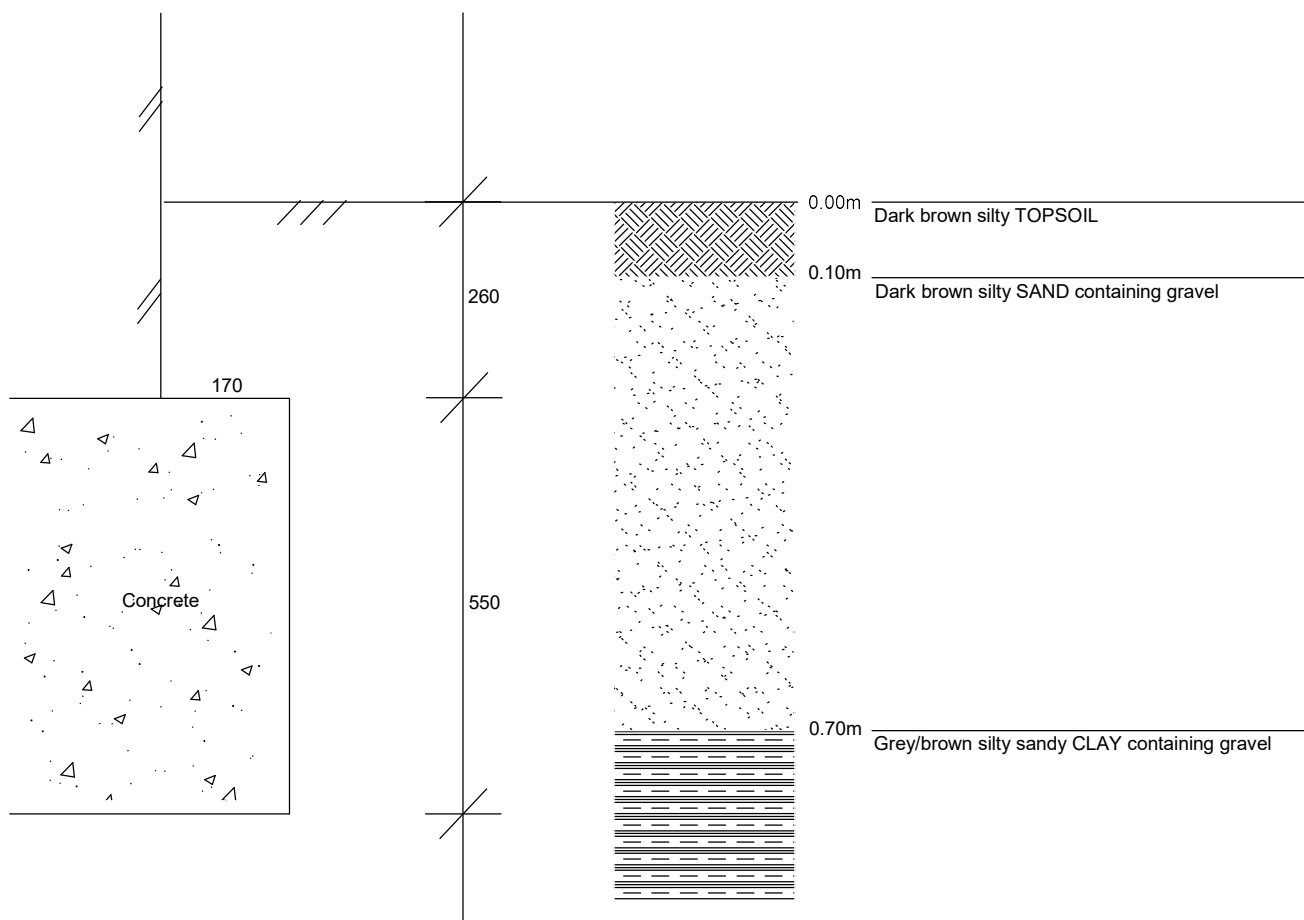
## TRIAL PIT 2

D1 @ F.L. (0.81m)

V = 100-102kPa

Founding strata: Grey/brown silty sandy CLAY containing gravel

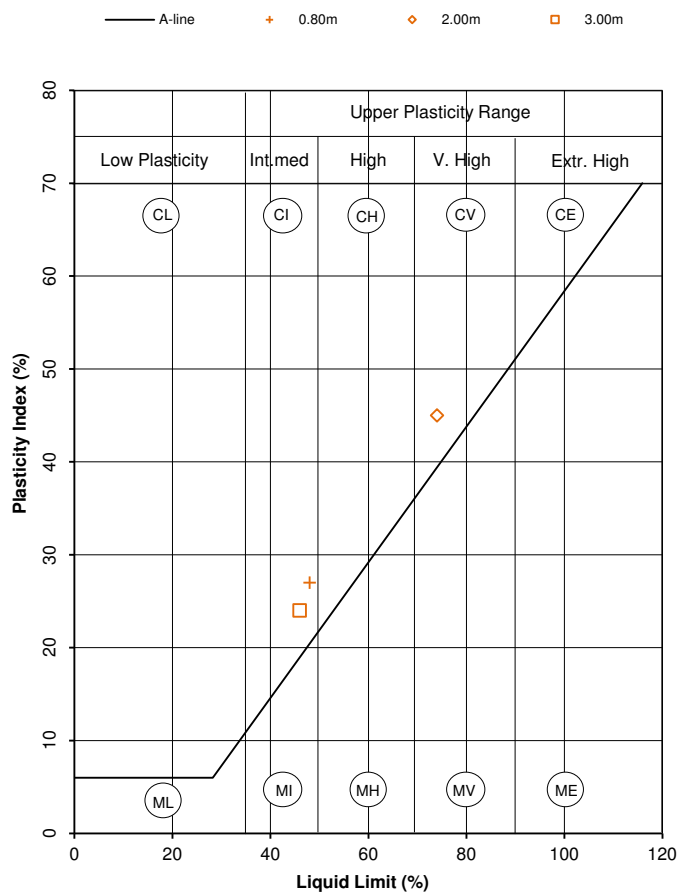
| Comments: | BH1 @ 0.80, 2.00, 3.00m - Unable to perform soil suctions due to sample being too dry |

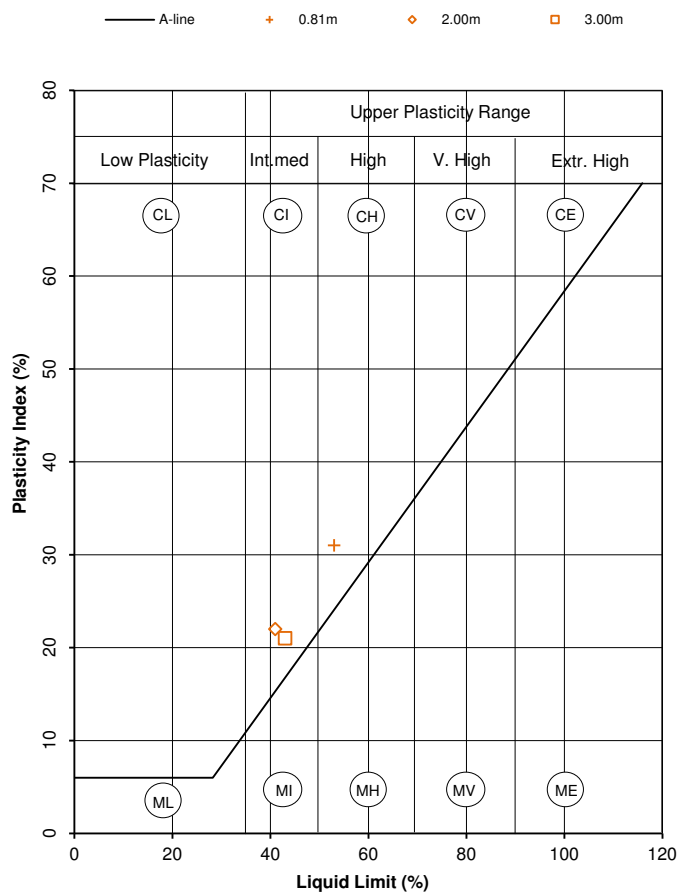
| Comments: | BH2 @ 2.00, 3.00m - Unable to perform soil suctions due to sample being too dry |
