## TECHNICAL REPORT ON A SUBSIDENCE CLAIM

**2 Greenside  
Crowthorne  
Berkshire  
RG45 6EX**

### SUBSIDENCE CLAIM

DATE 2 March 2023

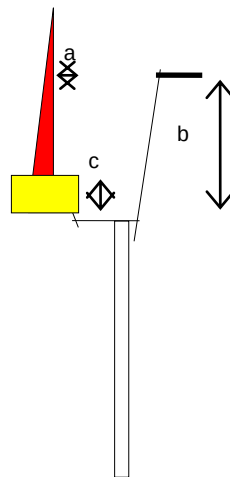
Foundation Details

Trial hole 1 shows the foundation bares onto Grey/brown silty sandy CLAY containing gravel.

Trail hole 2 shows the foundation bares onto Grey/brown silty sandy CLAY containing gravel.

| No. | Borehole Depth | Footing (a) | Underside (b) | Thickness (c) |
| TH1 | 3.00 m. | 200 mm. | 600 mm. | 300 mm. |
| TH2 | 3.00 m. | 170 mm. | 810 mm. | 550 mm. |
