**ADDENDUM ARBORICULTURAL REPORT**

**SUBSIDENCE CLAIM**

**2 Greenside**

15 November 2024

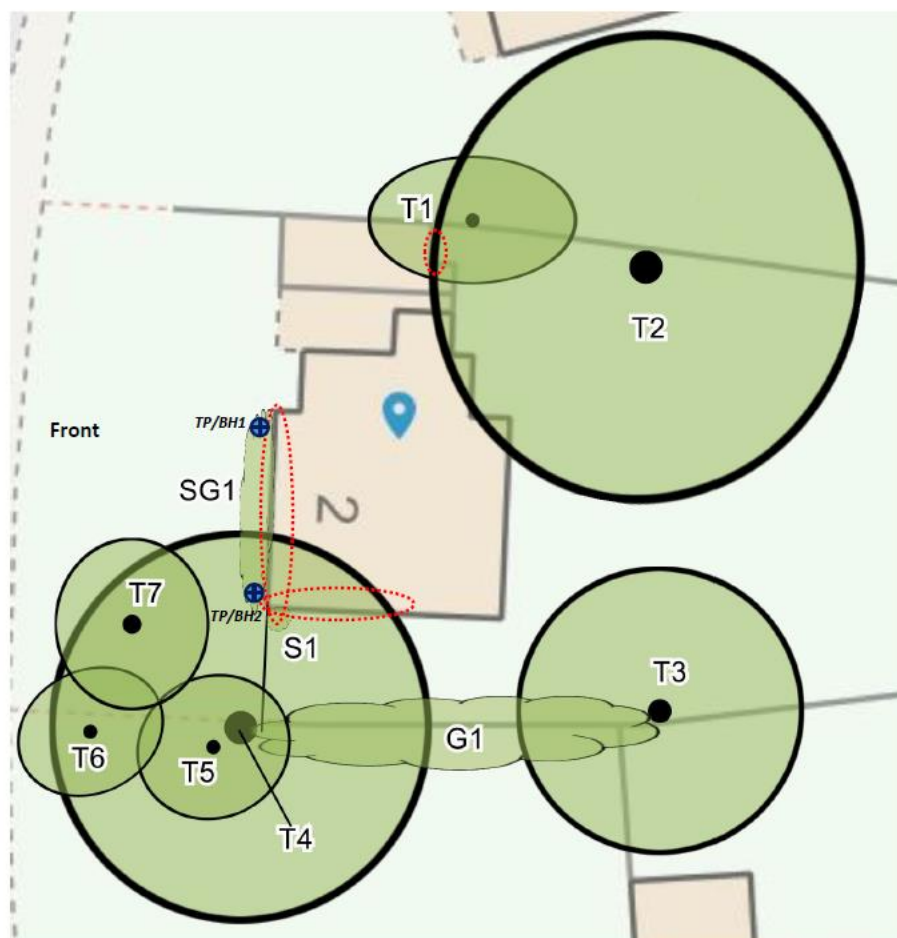
Site Plan

Approximate areas of damage

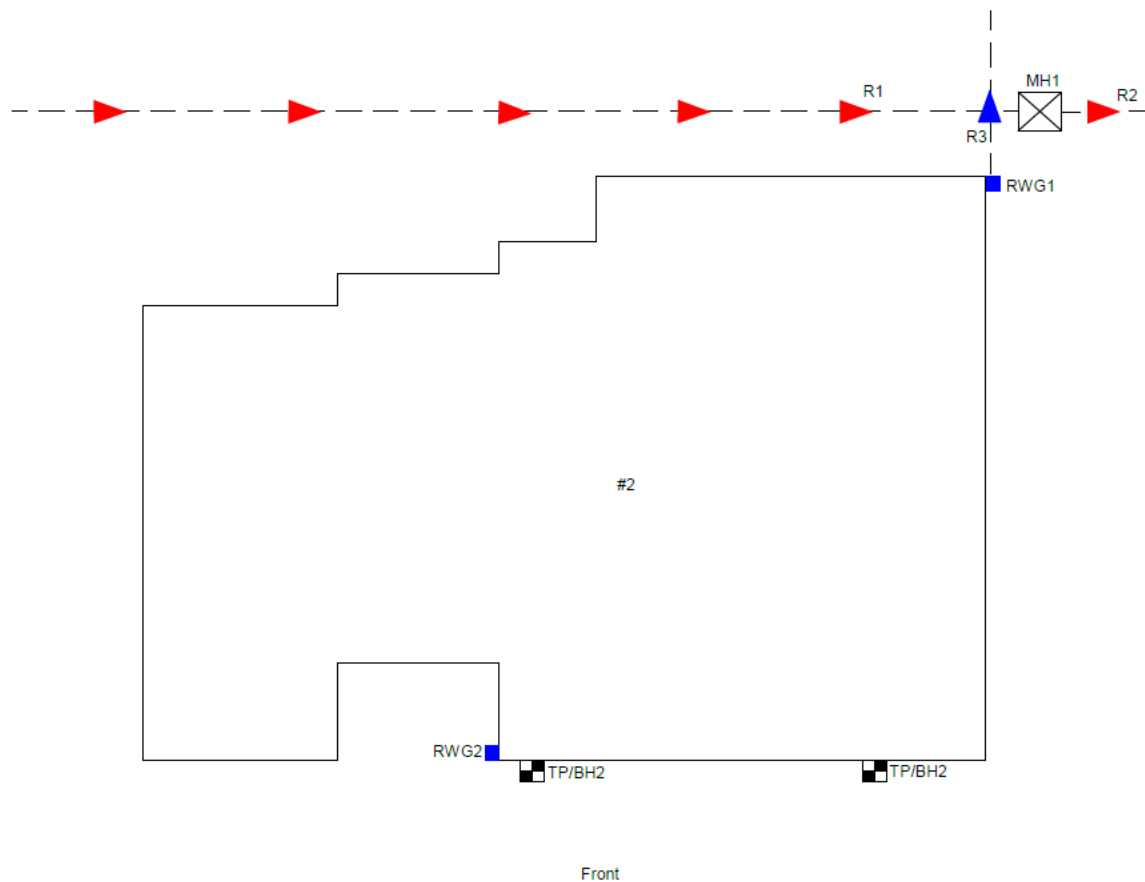
## SITE INVESTIGATIONS

Laboratory tests confirm significant desiccation has occurred where roots were observed, the moisture contents being at or significantly less than 0.5x the Liquid Limit, this indicates abnormal soil drying in the presence of tree roots.

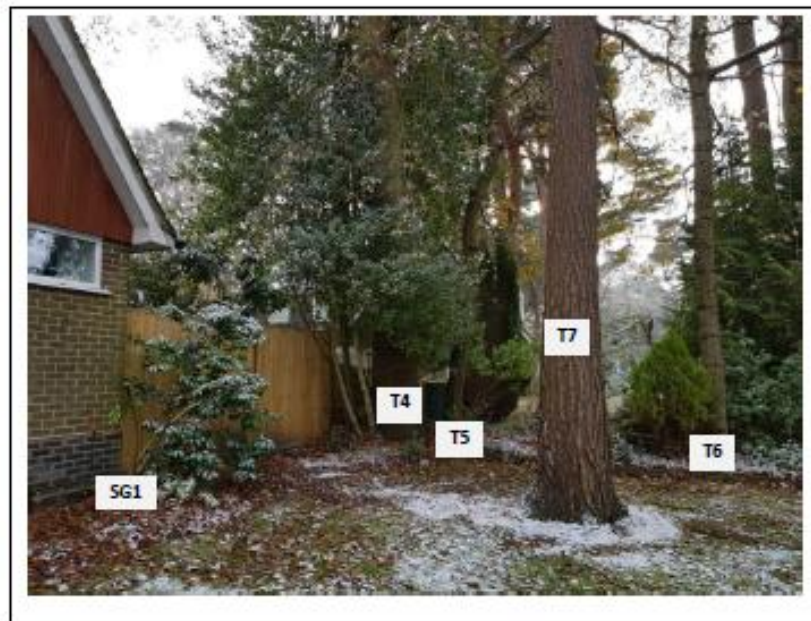
View of bases of trees to front right

The Oak T4, at only 5m is therefore well within its species' potential rooting and influencing distance of the building and would be capable of causing seasonal soil drying beneath foundations. The site investigations confirm significant rooting of Oak beneath foundations in any event.

**T4 Oak** – Fell to near ground level (subject to consent being granted under the TPO)

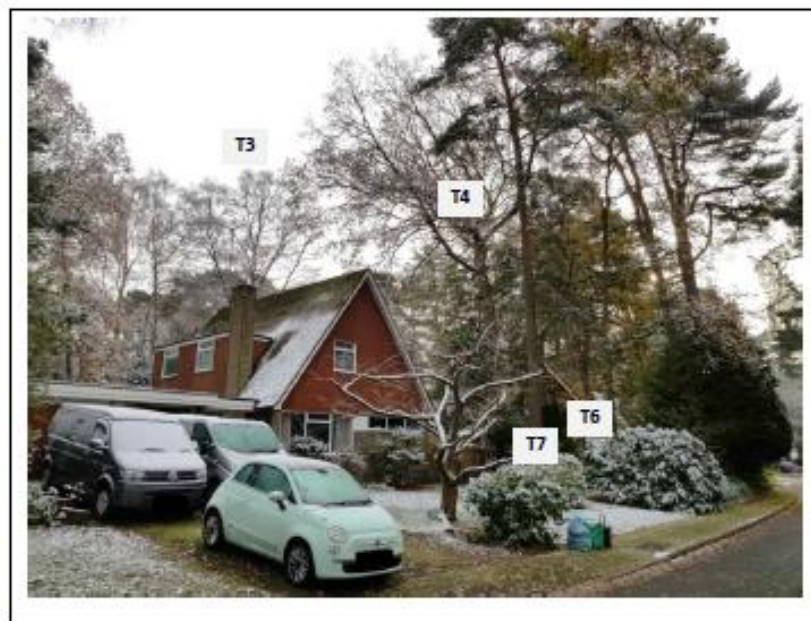
View of trees to front right

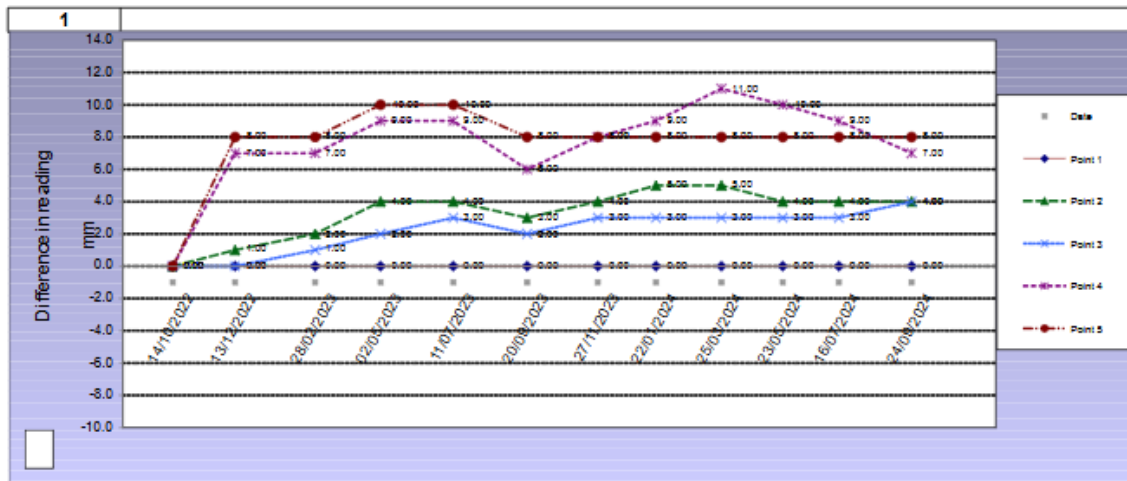
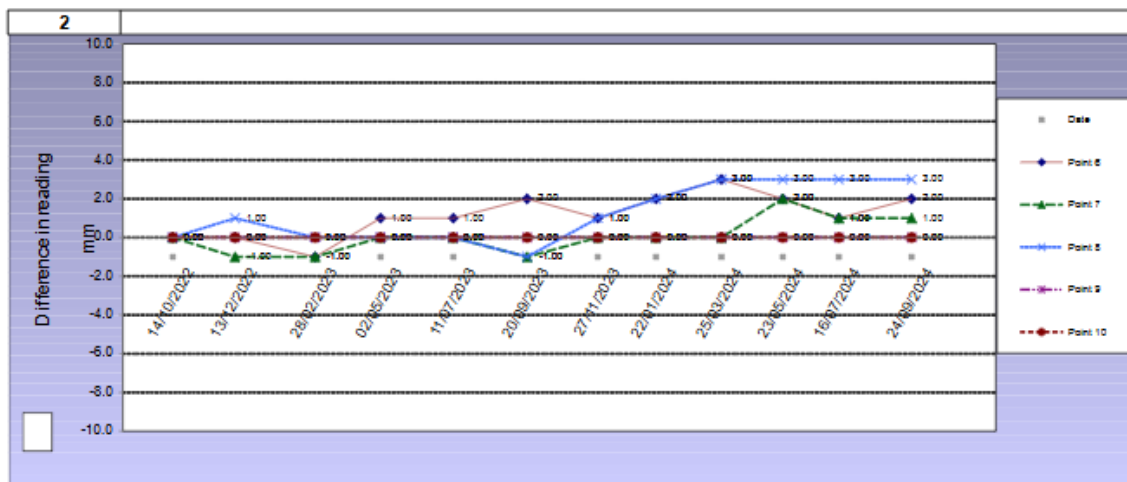
| LEVEL MONITORING - RELATIVE SURVEY READINGS | | | |

The level monitoring indicates a clear seasonal and cyclical pattern of movement consistent with root induced clay shrinkage with the greatest amplitude of movement being consistent with the location of Oak T4 being the main cause of the movement to the front / front right of the building.

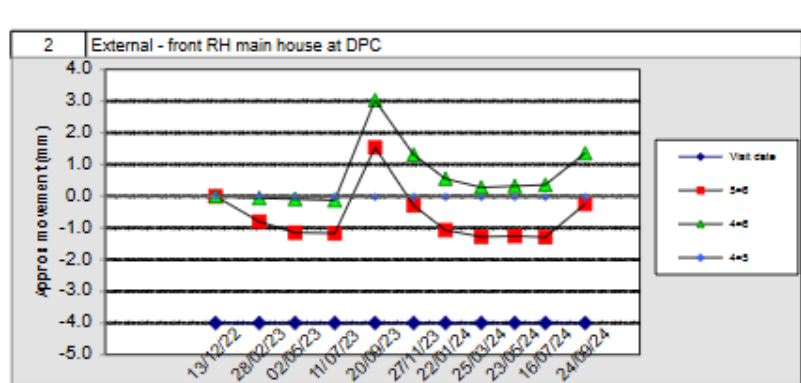
## Crack Monitoring

The crack monitoring confirms a seasonal/cyclical pattern of movement consistent with root induced clay shrinkage subsidence with cracks opening during summer months when roots are active and closing during winter when root activity reduces.
