## Addendum Arboricultural Report

### Subsidence Damage Investigation at:

2 Greenside  
Crowthorne  
RG45 6EX

| REVISION DATE: Rev01 | 22/07/2024 |

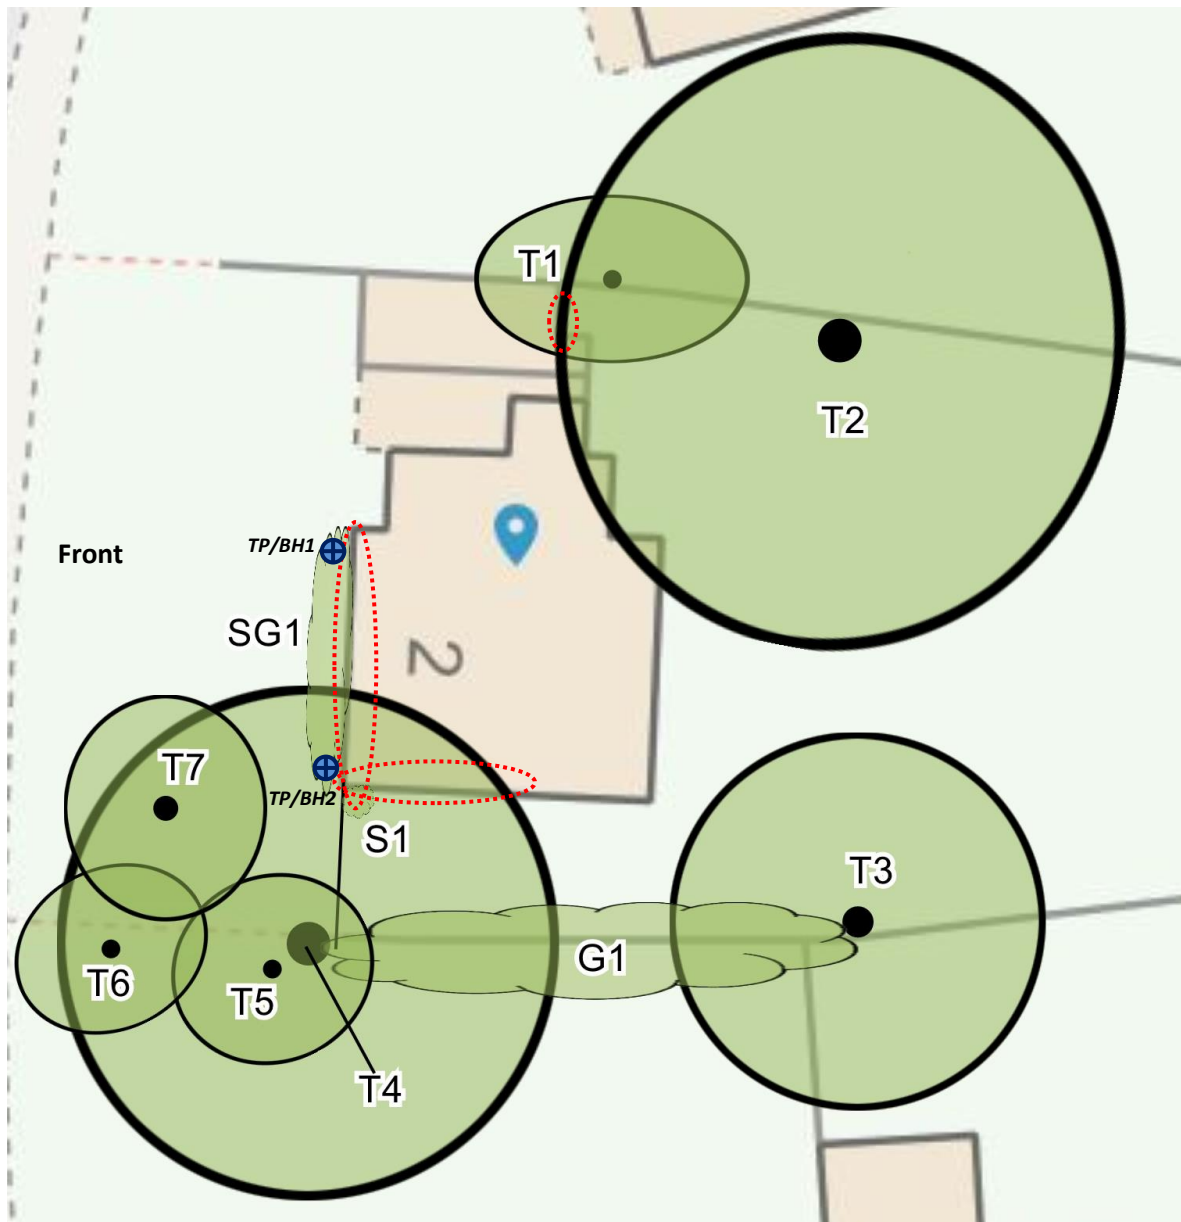
## Site Plan

Approximate areas of damage

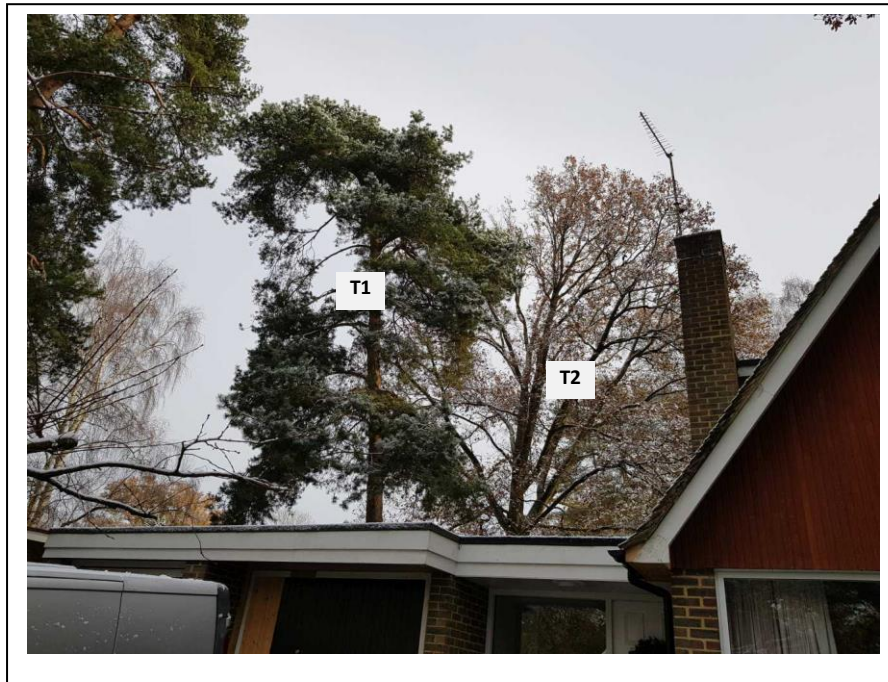
Irrespective of the identification of recovered root samples, the roots of T1 and T2 are also likely to be present below foundation level of the garage.

T1 would only be a factor at the garage so this is now excluded in relation to the Current Claim and placed in Future Risk.

T2 has the potential to be affecting the entire house, so cannot be fully excluded as a factor, however its location relative to the area of damage makes T4 the most likely cause of the damage to the house.

Level monitoring shows that there was recovery at the front right corner of the house, with the rest being fairly stable. This would suggest that the house is able to sustain the effects of T2 without undue harm. Based upon this T2 is moved to Future Risk.

View of T1 and T2 from front

| Tree No. | Species | Ht. (m) | Dia. (mm) | Crown Spread (m) | Dist. to building (m) | Age Classification | Ownership |
|---|---|---|---|---|---|---|---|
| Recommendation | | Remove (fell) to near ground level. | | | | | |
| Recommendation | | Reduce height to 20m and spread to 15m leaving balanced crown. Prune on a triennial cycle to maintain at broadly reduced dimensions. | | | | | |

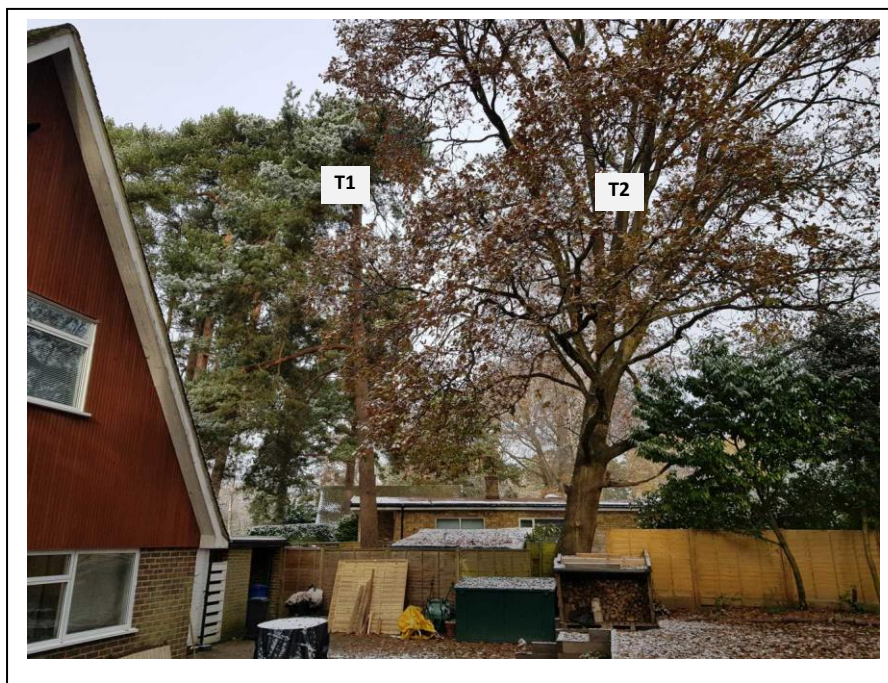
View of T1 and T2 from rear garden

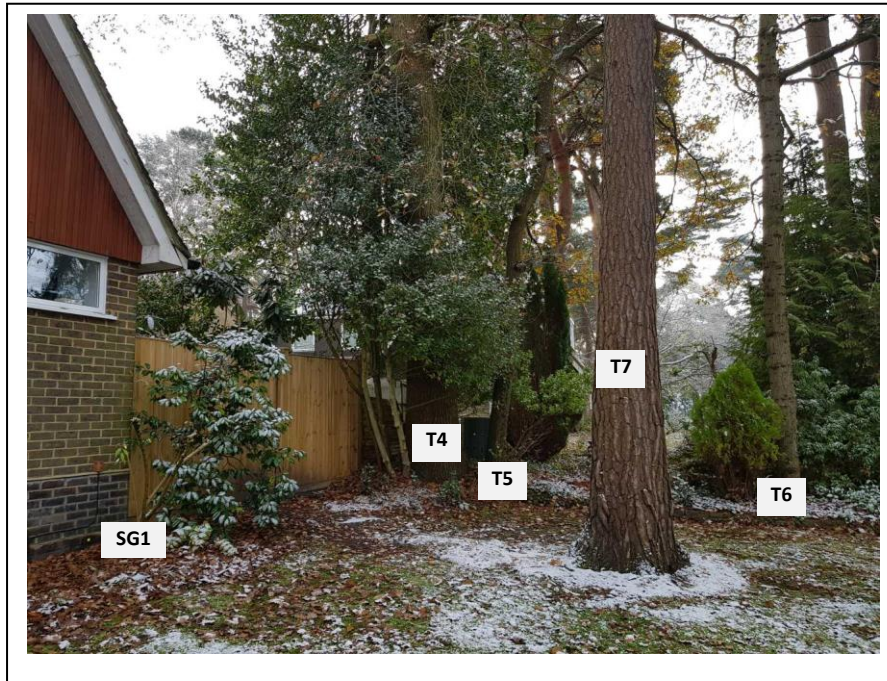
View of bases of trees to front right

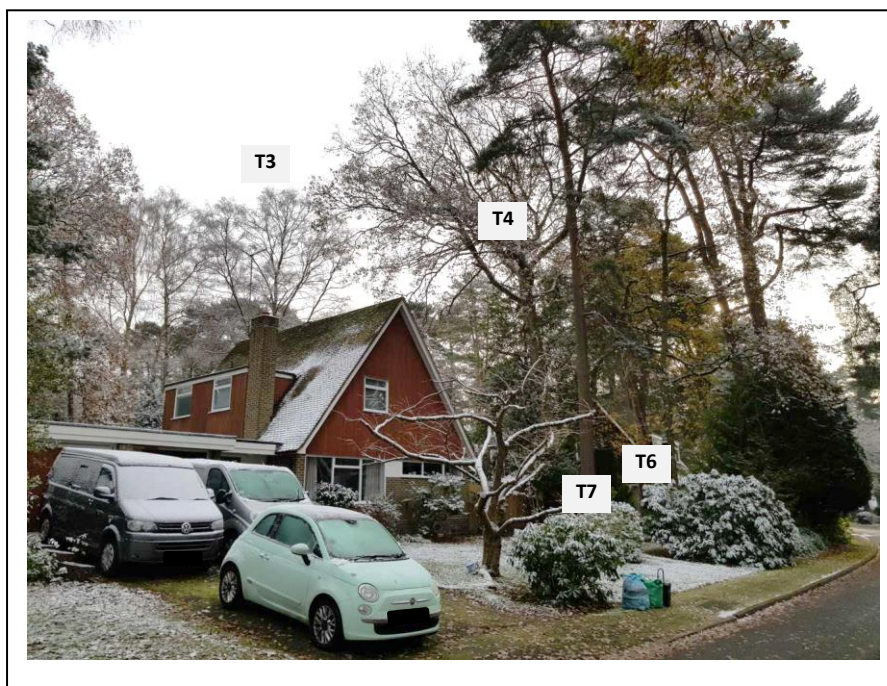
View of trees to front right
