## **THE URS BUILDING**

### **EXTERNAL CONCRETE REPAIR – CONDITION SURVEY**

July 2024

Issued for: Information P.01

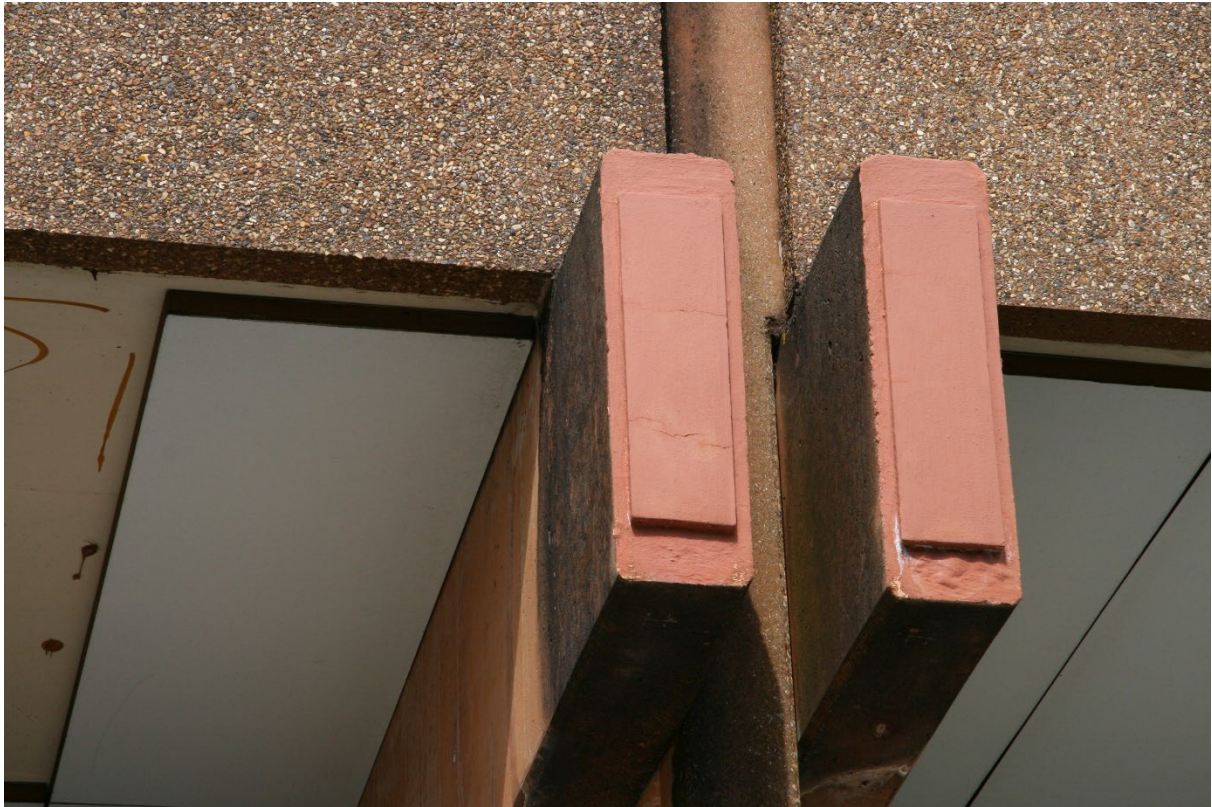
Where cracks appear to be the result of corrosion of reinforcement then they should be treated as for a spall with cutting out of the cracked and spalling material, removal of corroding material from the reinforcement and a concrete repair. Elsewhere a variety of repair strategies have been provided for filling cracks depending on their size and whether they are static or active.

Active cracks should not be repaired until the cause has been identified and progressive movement arrested, otherwise there is a risk of abortive work. On the basis of our inspection, it is not possible to identify which cracks are active and which are not and further investigation and monitoring of some of the cracks will be required. Repair of non-progressive cracks is by means of resin injection, to accommodate small amounts of movement but prevent water ingress.

*Example of Defect Type A1*

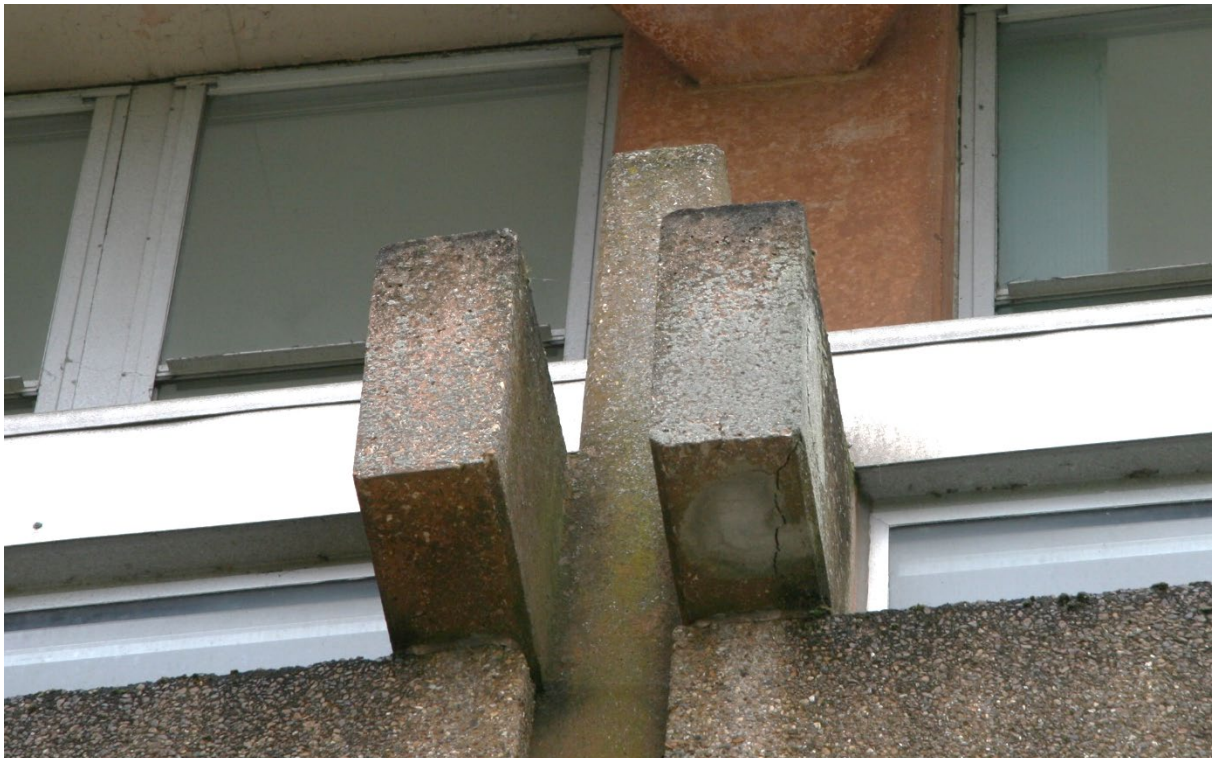
*Example of Defect Type A2*

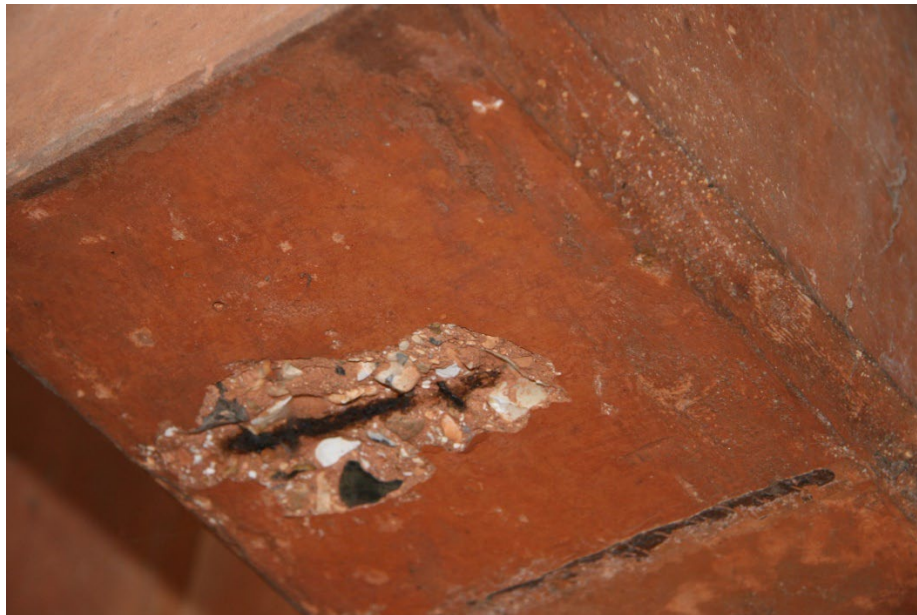
*Example of Defect Type B1*

Areas of spalling concrete will require cutting out of the cracked and spalling material, removal of corroding material from the reinforcement and a concrete repair. The preferred approach to replacing spalled fabric is for a poured concrete repair, or a hand placed mortar repair, as these are most compatible with a conservation approach to repairs using like-for-like materials and achieving coloured and textured finishes to match the existing fabric.

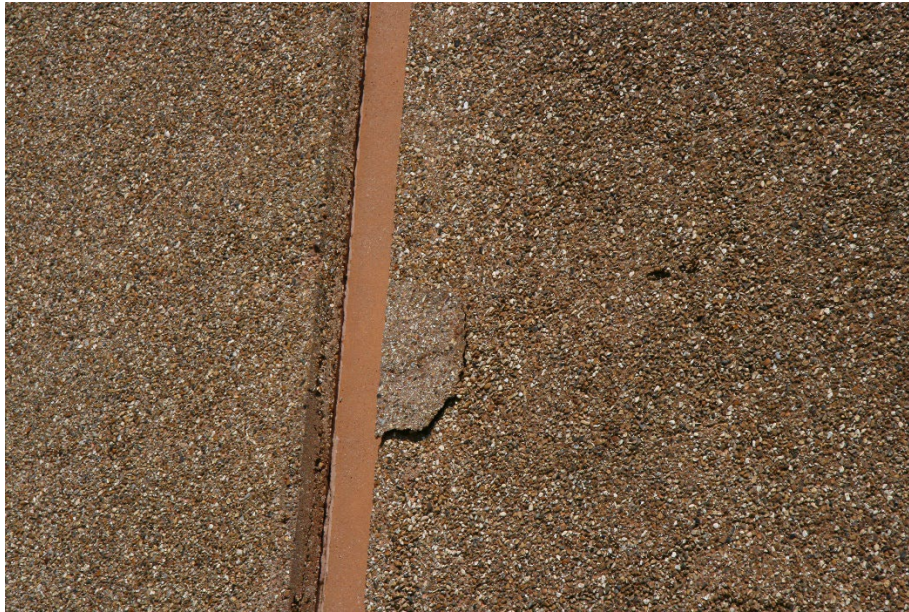
*Example of Defect Type B2*

Where spalling has occurred to originally painted soffits, the use of proprietary repair mortars may be appropriate. Careful replication of surface texture and overpainting will ensure that the proprietary repairs have limited visual impact on the appearance of the building.

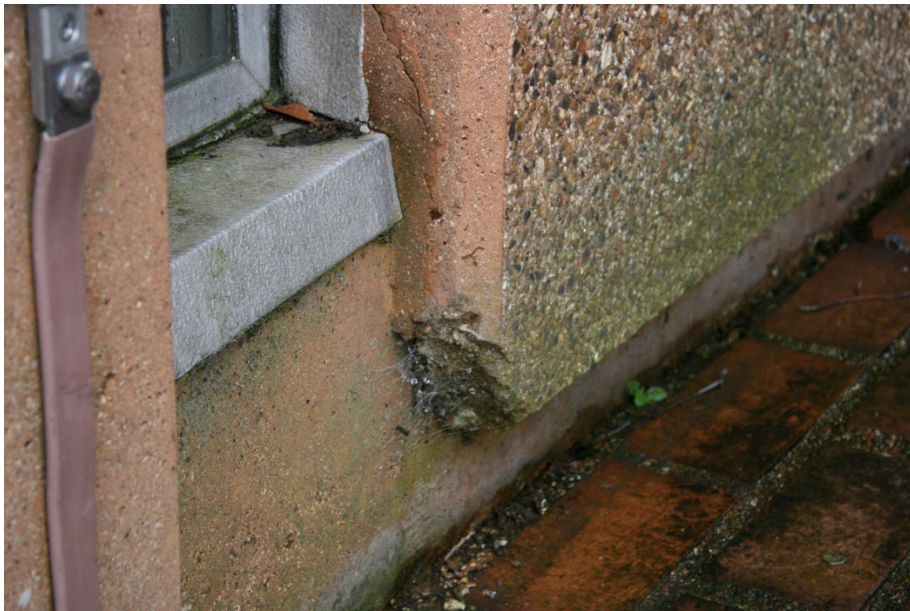
There are a very small number of instances of impact damage to both in situ and pre-cast concrete panels, where there is a small loss of concrete but with no exposure of reinforcement bars. There is no notable pattern to the impact damage and so there are no obvious management actions to avoid future mechanical damage. As noted above, where there has been a loss of concrete, this can reduce the amount of cover over steel reinforcement and pushes the carbonation front closer to the reinforcement, increasing the risk of corrosion and spalling. Localised concrete repairs should be undertaken to reduce the risk of more extensive damage.

*Example of Defect Type B3*

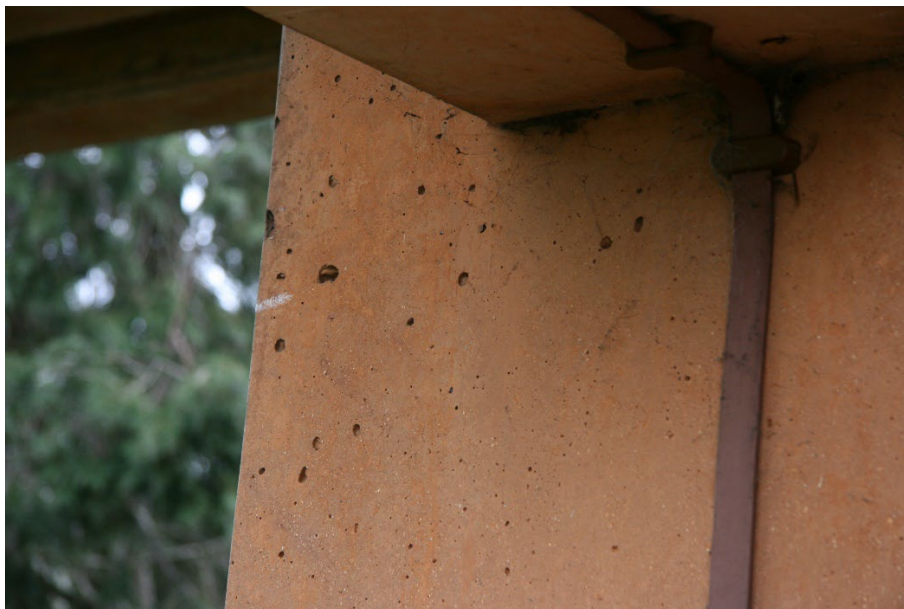
The honeycombing and voids to the sides of beams are relatively minor and are unlikely to be having a significant impact on the rates of carbonation and there is no evidence of cracking or spalling in these areas. The Structural Engineer has expressed no concerns regarding the structural integrity of these areas. Generally, no action is recommended, although deep voids can be filled with a colour matched mortar repair. Alternatively, coating the interior of the void with an anti-carbonation coating could provide some protection should this approach be taken to the building more generally.

*Example of Defect Type B4*

Where honeycombing is more extensive to the undercroft posts and cracking and spalling have been observed, cutting out the honeycombed concrete and undertaking a cast in situ concrete or hand-placed mortar repair is recommended and these defects should be assessed by the Structural Engineer.

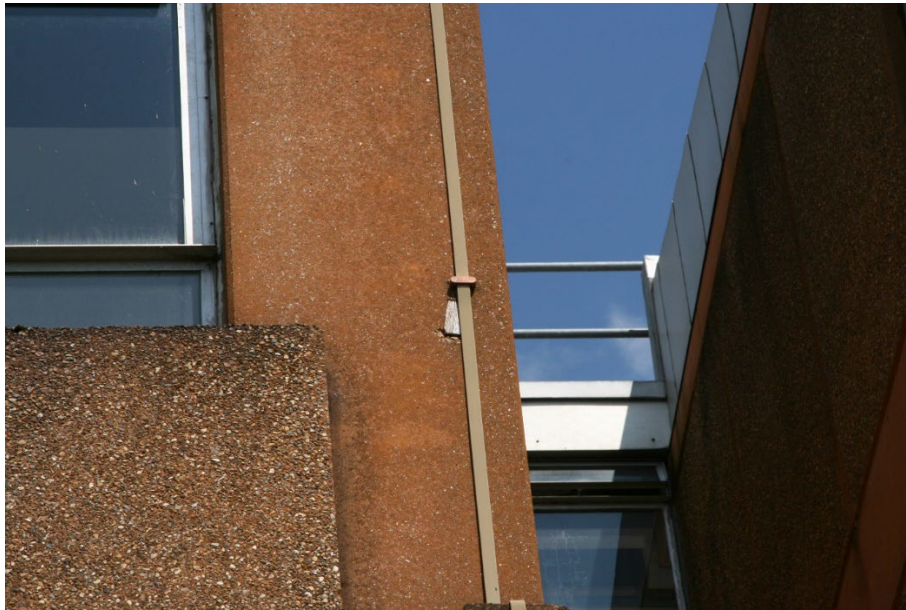
In a number of locations, small pieces of timber were observed, embedded in the concrete. It is likely that these were used as spacers, not removed before the concrete was poured, or as fixing blocks installed after construction. In either case, the presence of the timber on the surface of the concrete is likely to enhance the rate of carbonation in a localised area and should be removed and replaced with a hand-placed mortar repair.

*Example of Defect Type B5*

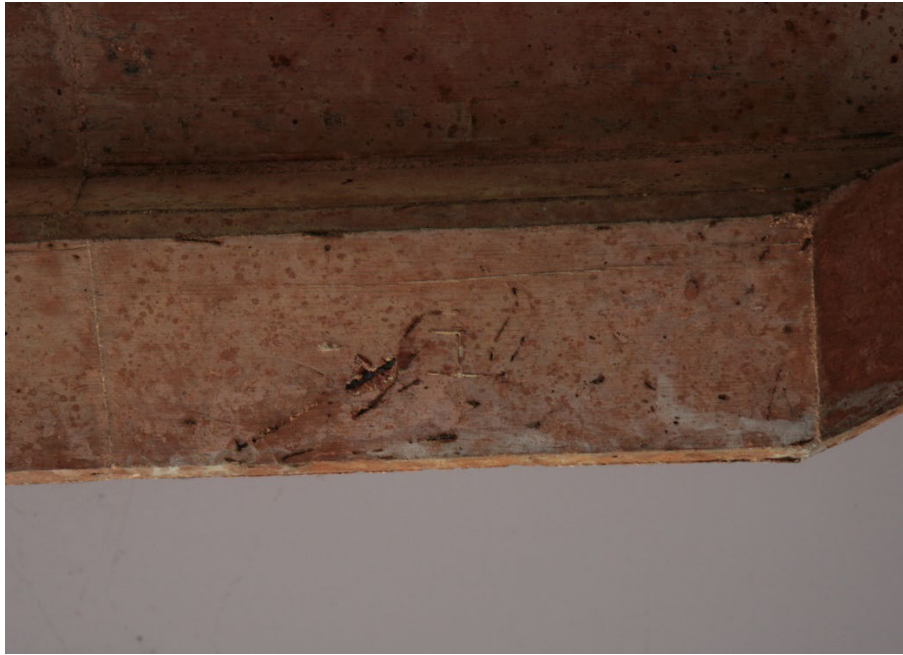
To all undercroft areas, numerous small pieces of metal debris were observed to the underside of the concrete beams and beam ends. These appear to be mostly steel wire off-cuts, which have been cut when tying the reinforcement and allowed to fall into the bottom of the formwork, subsequently being cast into the beams. The metal debris is now corroding and causing small amounts of concrete to spall from the underside of the beams. The presence of small amounts of corroding metal wire on the underside of the beams and minor spalls are unlikely to affect the overall integrity of the concrete structure and reinforcement. Removal is likely to be very disruptive for the limited benefits that it offers and so it is considered to be preferable to leave the metal debris in place and to remove any loose material. Removal of loose and spalling material will need to be undertaken periodically to ensure that falling material does not affect people using the building.

*Example of Defect Type B6*

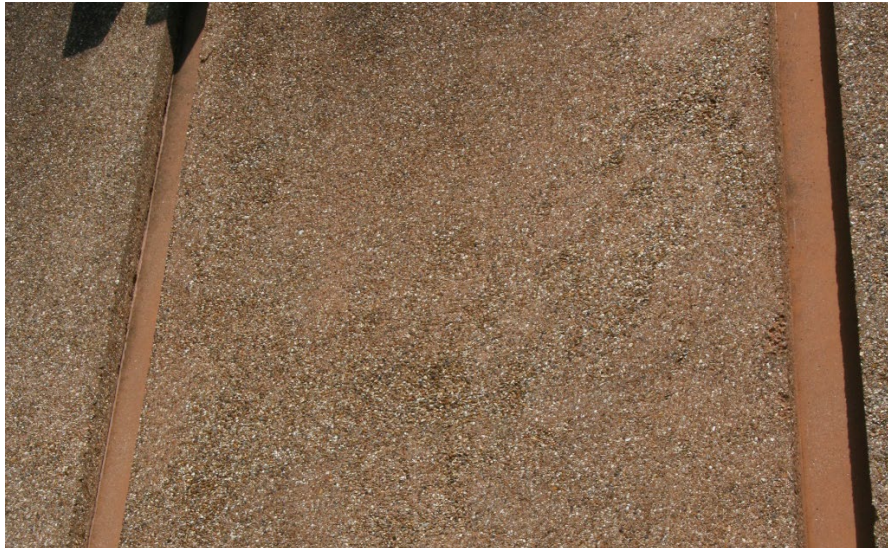
*Example of Defect Type B7*

A tactile inspection should be undertaken to assess to what extent the loss or absence of cement matrix has destabilised the aggregate or whether the impact is mostly superficial and whether the condition can be monitored for deterioration with only limited and localised repairs. The tactile inspection should be reviewed in conjunction with the outcome of intrusive investigations by CRL, to establish whether the loss of cement matrix and aggregate corresponds with a loss of cover to the reinforcement and evidence of associated corrosion.

Where the loss of matrix and aggregate is not extensive, then localised, cast in situ or hand-placed repairs can be undertaken with particular care being paid to the choice of aggregate and mortar mix, based on detailed investigation of the existing and on-site trials and samples.

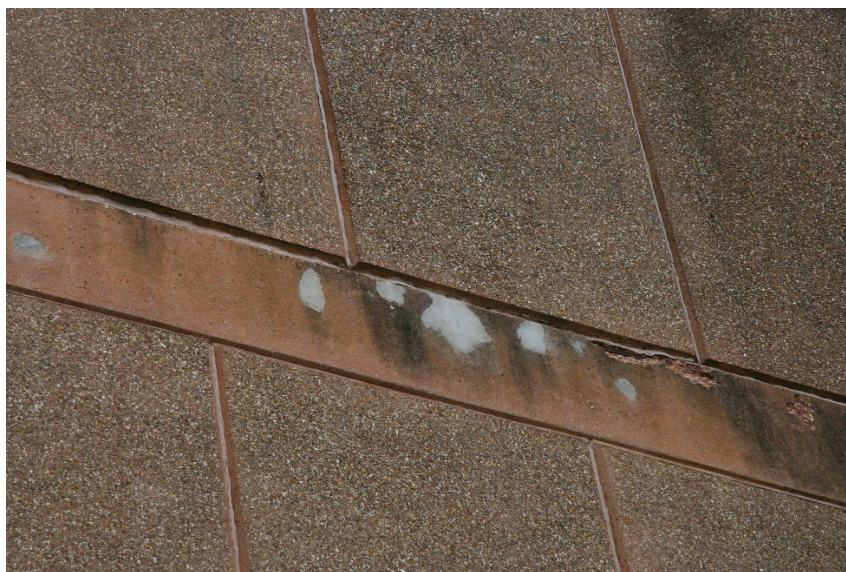
A sizeable proportion of repairs are failing with cracking and spalling which appears to be the result, at least in part, of continued corrosion of the steel reinforcements. The failing repairs will require cutting out and replacement to prevent further corrosion of the reinforcement and more extensive damage.

*Example of Defect Type C1*

Across the building, the poor previous repairs should be renewed with new in-situ concrete or hand-placed mortar repairs, designed to blend with the original concrete fabric.

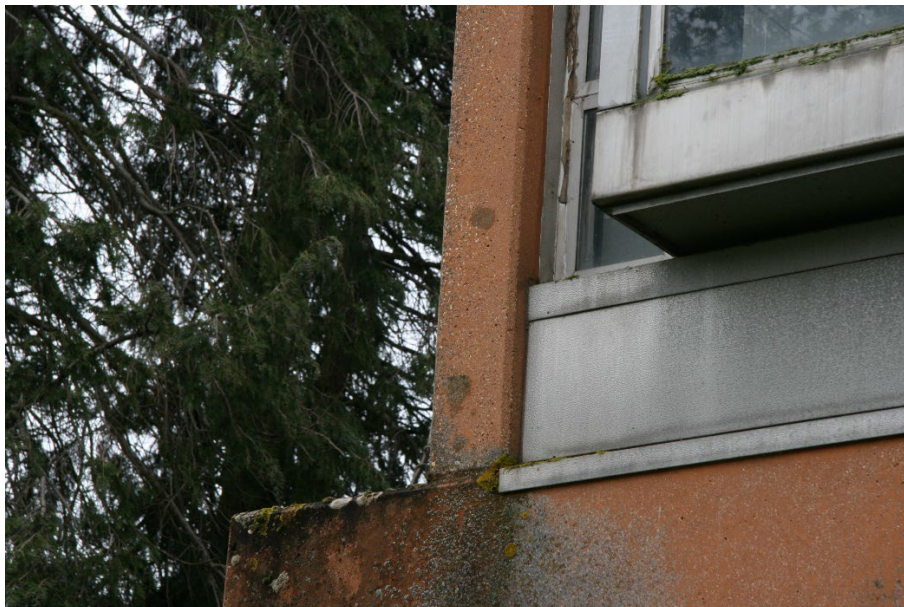
*Example of Defect Type C2*

Where the mortar fills are cracked, loose or missing they should be refilled to reduce the risk of corrosion and associated cracking and spalling. Where the socket is heavily corroding, and this is causing damage to the concrete panel a more extensive repair will be required involving the removal of the socket and an in-situ concrete or hand-placed mortar repair to fill the void. Further investigation will be required to establish the relationship of the socket.

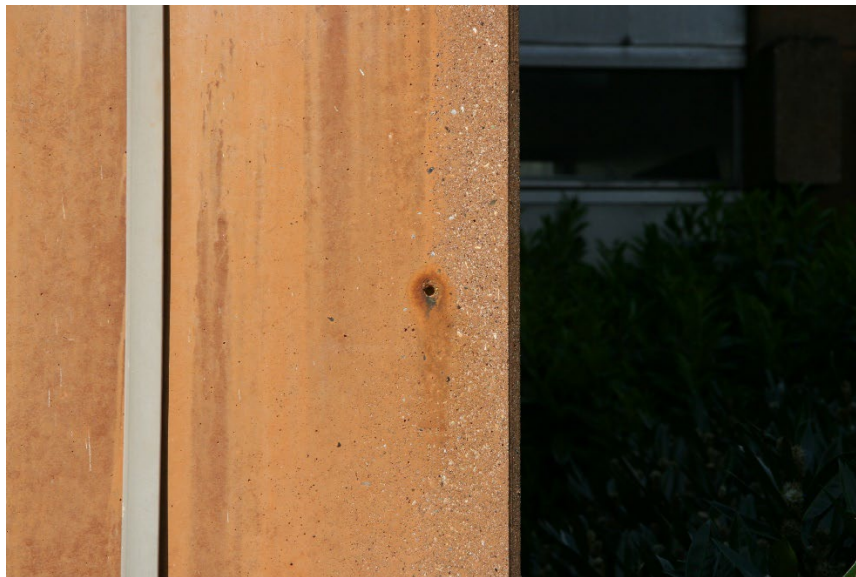
Holes in the concrete are vulnerable to water ingress which could result in corrosion of the steel reinforcements, they also increase the depth of carbonation within a localised area, which also increases the risk of reinforcement corrosion and associated spalling. Holes that are not required for a specific purpose should be filled with a suitable repair mortar and, where still required, holes should be provided with suitable weatherings to reduce the risk of water penetration.

*Example of Defect Type D1*

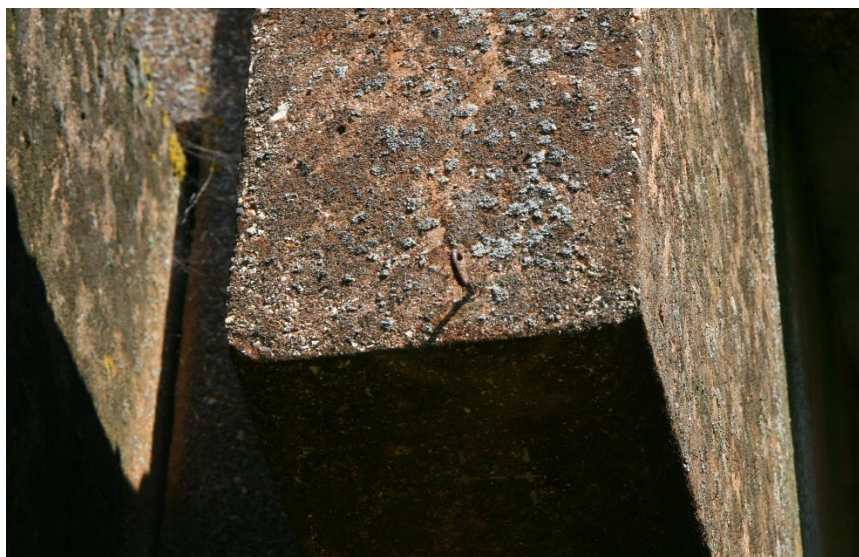
There are numerous fixings around the building, many of which appear to be redundant. In some instances, the fixings are corroding with the potential to cause cracking and spalling of the concrete as well as more superficial rust staining to the surface. A review should be made of the fixings to ascertain which are still required and which are redundant. Where redundant, the fixings should be removed, and the hole filled with a suitable repair mortar. Where the fixings are still required, it may be necessary to change the fixings for a non-ferrous alternative.

*Example of Defect Type D2*

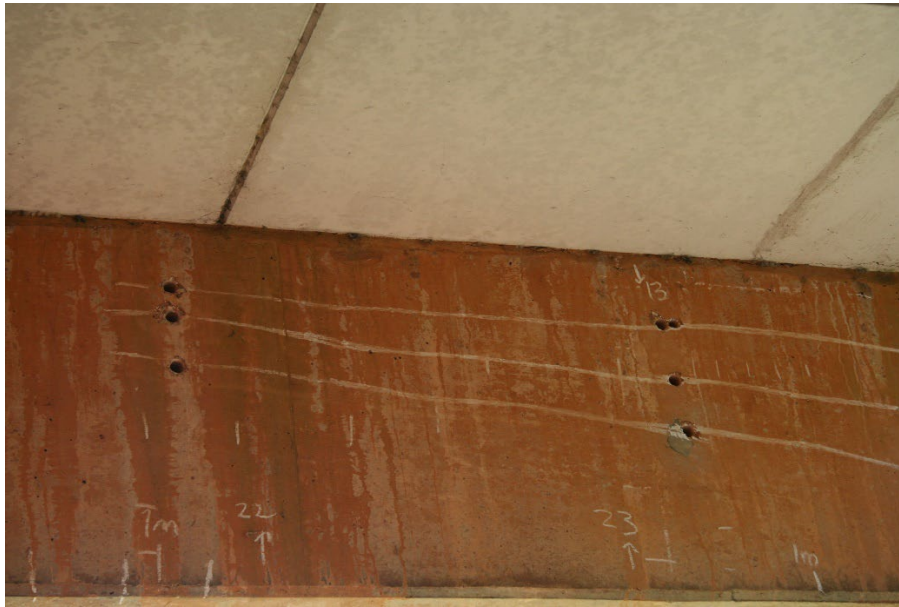
Over the past 10 years there have been a series of intrusive concrete investigations undertaken by CRL, under the supervision of the Structural Engineers at the time. The investigations have involved drilling holes, taking core samples, opening up works to inspect reinforcement and fixing details, hammer testing and various other intrusive investigations, undertaken with the objective of understanding the composition and current condition of the concrete and reinforcements and to assess the extent and rate of deterioration since the previous investigations. The result has been the formation of numerous holes and openings in concrete components across the building. While the holes have generally been filled with proprietary mortars, at the time of the inspection, a new round of intrusive investigations were underway and a number of openings had been formed. It may be that these have subsequently been filled with proprietary repair mortars. In either case, the outline repair methodology for poor previous repairs should be applied.

*Example of Defect Type D3*

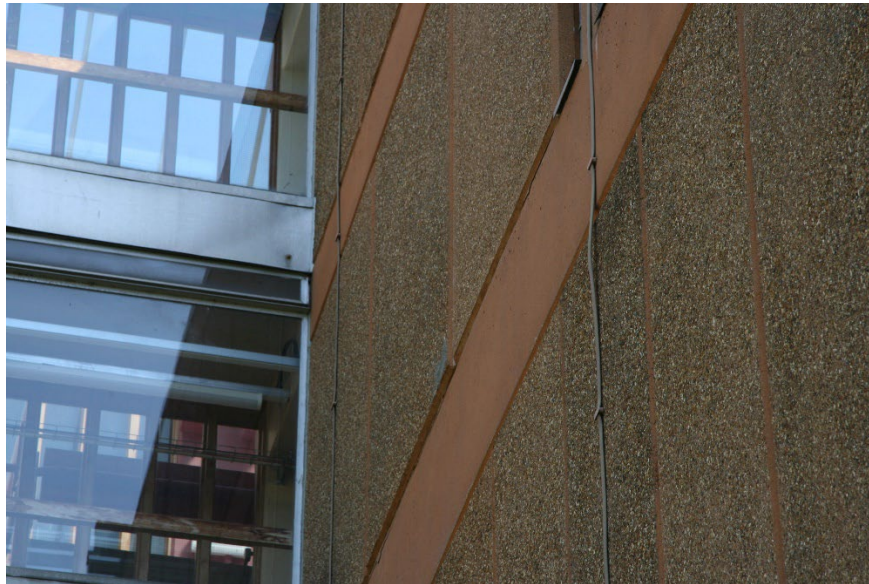
*Example of Defect Type E1*

The Structural Engineer will review and advise on whether the extent of displacement requires the full replacement of any of the pre-cast panels. Replacement should be on the basis of like-for-like replacement with regard to form, colour, aggregate, and finish.

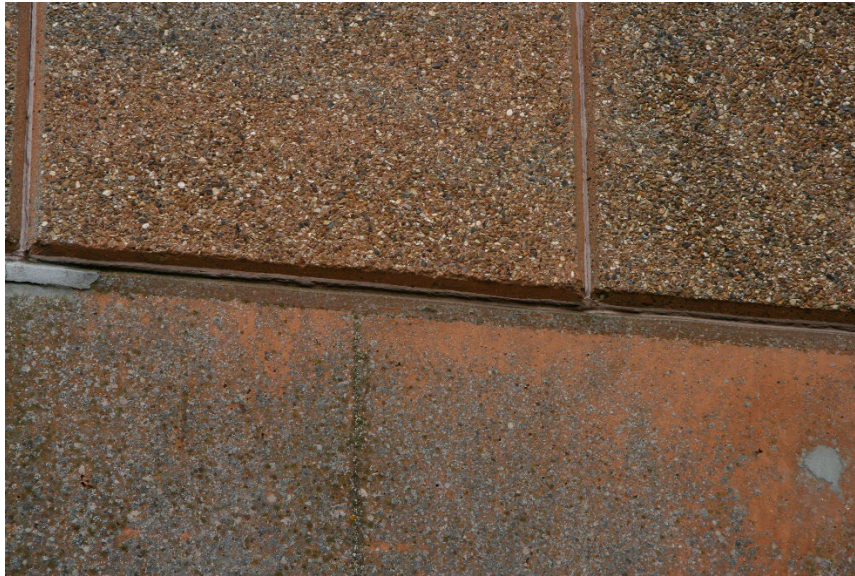
Failure of the seals will affect the performance of the building envelope, potentially causing water ingress into the building and the building structure, accelerating decay. The seals should be renewed across the building.

Where corrosion and spalling were noted to the outer corners of soffits, to the south elevation in particular, it is thought that this is a result of water ingress via the junctions between concrete beams and posts. It may be that water ingress is due to the failure of mastic seals in these locations, although the actual weathering details could not be observed due to restricted sightlines. If on closer inspection it is found that there are failing mortar weatherings to these joints or no weatherings further consideration will be required to establish the best means of weathering these joints.

*Example of Defect Type G1*

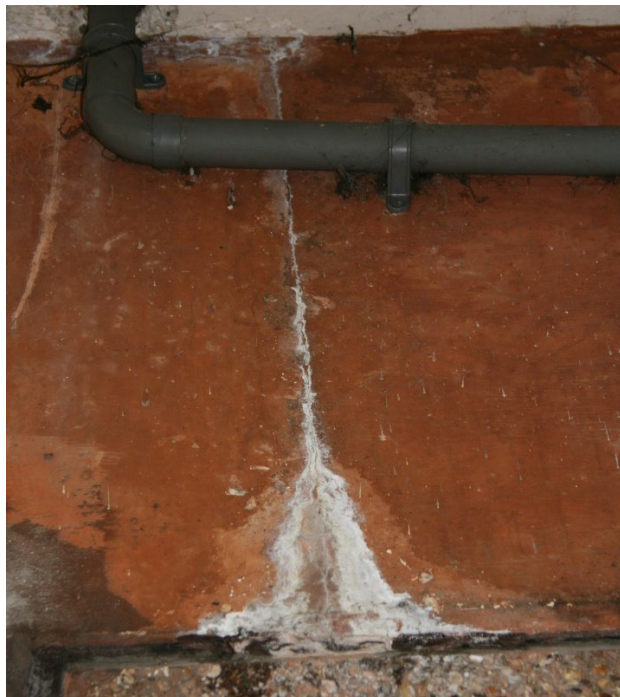
Where water has penetrated through the concrete structure it has caused the calcium hydroxide in the concrete mix to dissolve and leach out of the structure. On contact with the atmosphere the calcium hydroxide reacts with carbon dioxide to form calcium carbonate. As the water evaporates on the surface, hard white deposits are left, which in places form stalactites. At the URS Building the calcium deposits can be found in several locations to the north undercroft. The cause of the water penetration is unknown and should be investigated and remedied.

While the deposits themselves are a cosmetic issue, the process of leaching can lead to durability problems. Water ingress through the structure also risks the corrosion of the steel reinforcements.

*Example of Defect Type H1*

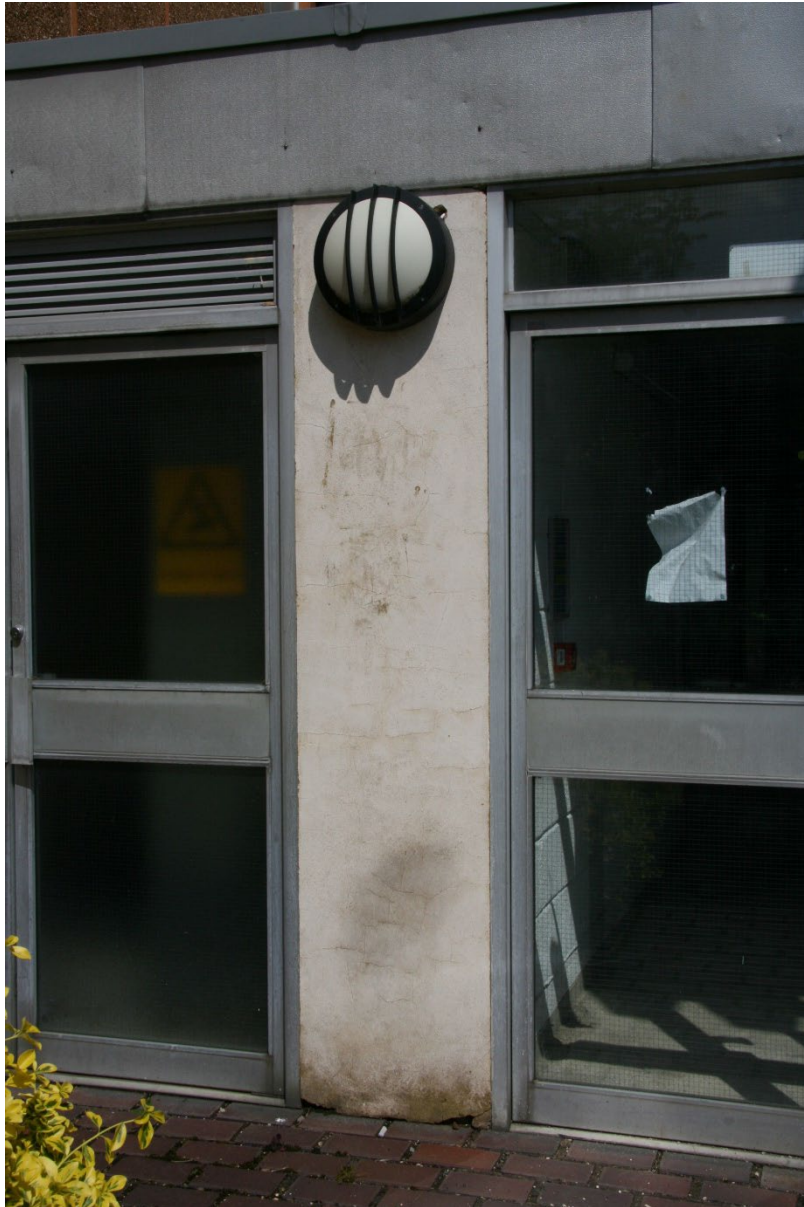
To the south side of the building there is a small area of cement render. The substrate to the rendered panel is unknown.

There is crazing and cracking to the render. The precise cause of the crazing and cracking is unknown but could relate to the quality of the materials and workmanship or the condition of the underlying substrate. Damaged render finishes should be cut back, the substrate inspected for defects, and the render coat renewed.

*Example of Defect Type J1*

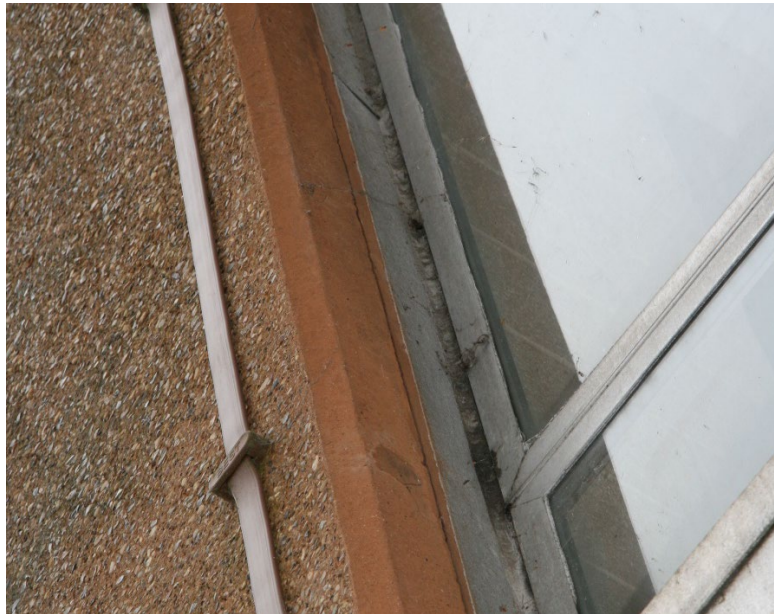
Where mortar joints are visible between concrete components or between concrete components and windows many of these are cracked and loose. In a number of locations mortar is missing from joints altogether. Open and missing joints can allow water to penetrate the fabric/structure with the risk of damage and decay to adjacent fabric. This could be observed where water has tracked in above beam ends and has caused dampness and spalling to the adjacent soffits although it is not clear without close inspection whether this is due to defective mortar or mastic joints, or the absence of weatherings altogether. The defective mortar should be raked out and the joints repointed in a suitable mortar.

*Example of Defect Type K1*

Due to the extensive nature of the cracking of mortar around windows, this defect has only been recorded a limited number of times in the Schedule of Defects and Defect Drawings (Appendix F and Appendix H). As the windows are due to be replaced it is anticipated that all mortar joints around windows will be renewed.

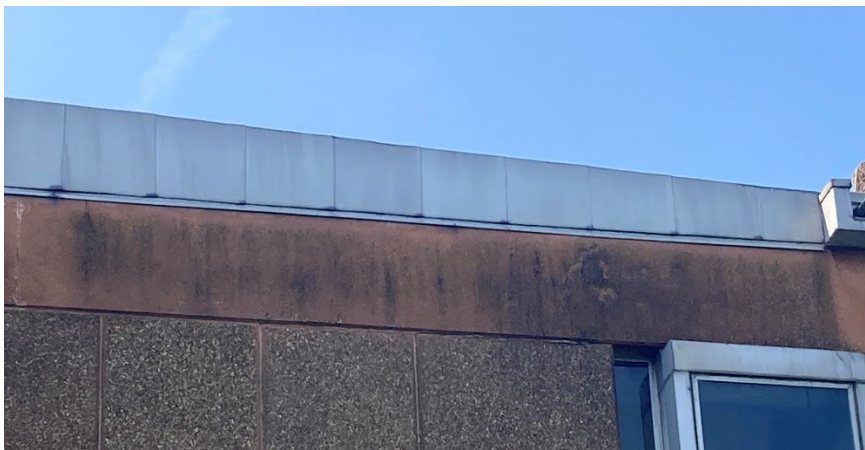
*Example of Defect Type S1*

Mosses, algal staining and to a lesser degree lichens, should be removed to improve the appearance of the building and to reduce the risk of deterioration of the fabric. Where the algal staining is the result of poor detailing of roofs and rainwater goods, this should be addressed by the proposals for renewal.

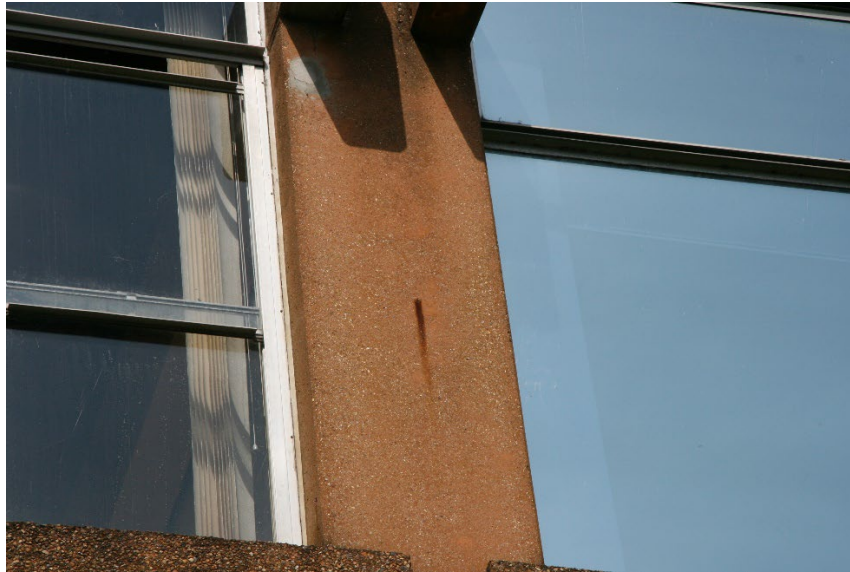
Elsewhere rust staining is the result of the corrosion of fixings or structures fixed to the building. There are a number of instances of redundant fixings which are corroding. As well as causing superficial staining, the expansion of the corroding fixings can cause cracking and spalling to the surrounding concrete which increases the risk of water ingress into the structure and corrosion of the metal reinforcements. The corroding fixings should be removed and the fixing holes made good in an appropriate mortar.

*Example of Defect S2*

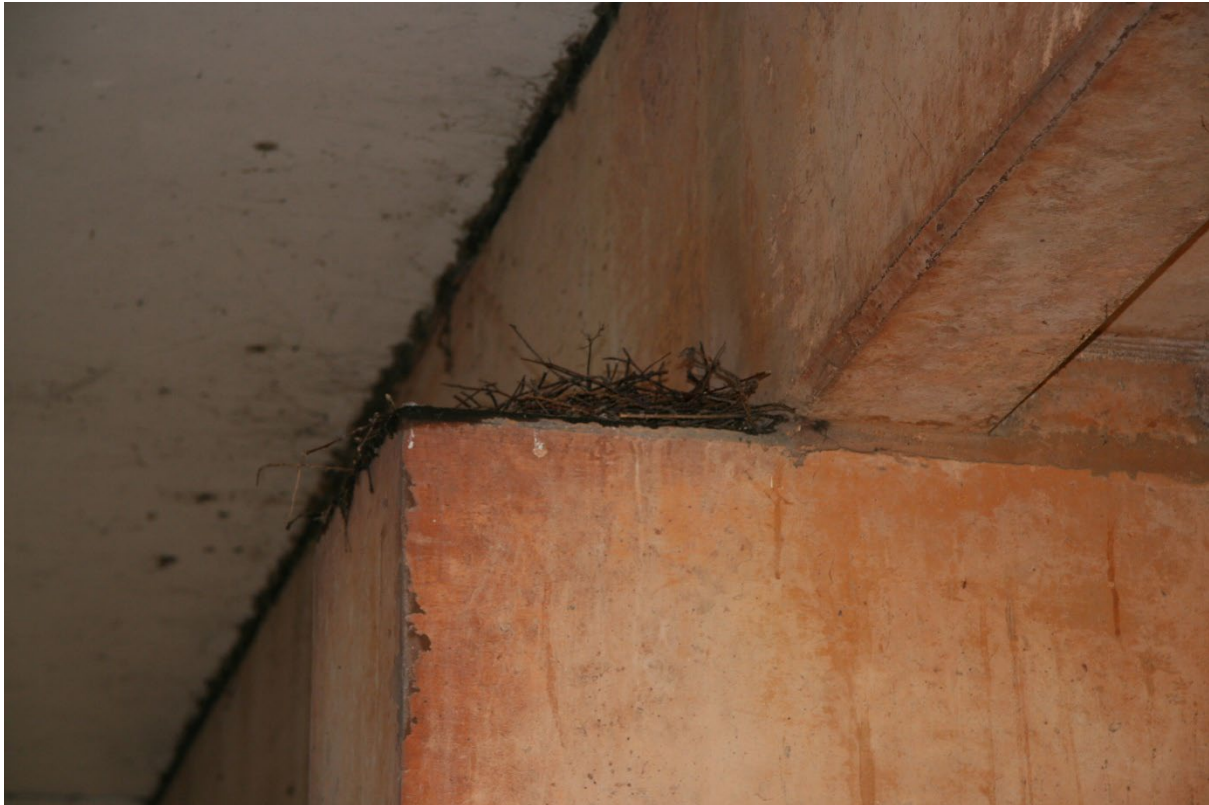
There are areas of pigeon spikes to ledges across the building, including to the undercroft. Despite this, a number of birds' nests were observed to the tops of beams. The bird deterrent strategy should be reviewed as it is not currently entirely effective.

*Example of bird's nest to undercroft beams*
