## **URS BUILDING REFURBISHMENT**

### **EXTERNAL CONCRETE REPAIR – HERITAGE OFFER ADDENDUM**

**SEPTEMBER 2024**

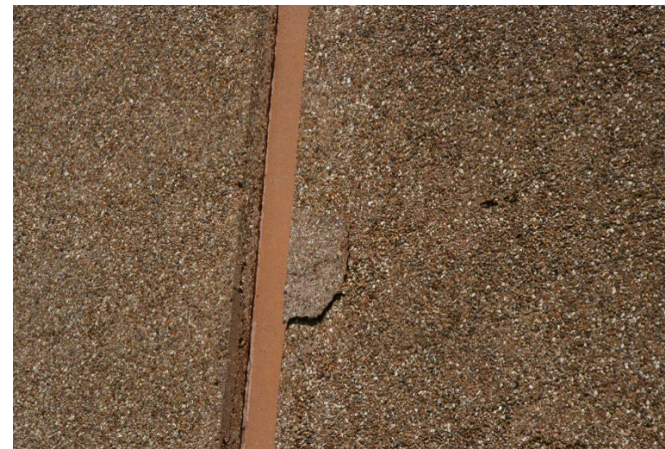
*Example of Defect Type B2*

| <p><b>B2</b></p> <p>Spalling or damaged surface – reinforcement bar is not visible at this stage (note, once defective material removed/ further investigations are completed, reinforcement may be found and the repair type will revert to RB1A)</p> | <p><b>RB2A</b></p> | <p>Identify repair mortar from approved samples as closest match to parent material. Mask/protect adjacent surface to prevent dust, residue/smearing to adjacent concrete.</p> <p><b>Concrete breakout/Cutting Out</b></p> <p>The affected area is to be cut out back to sound substrate, removing all loose/defective material.</p> <p>Mark out damaged area. Extent and shape to be agreed with architect. Use a diamond core drill (diameter size dependent on size of repair areas) with drill guide to mark rounded corners of repair area to prevent spalling/damage to the adjacent fabric (sharp corners are to be avoided). Drill to a suitable depth to reach sound material. Follow by cutting along the edges of the repair area with a diamond blade to the internal angles of the corner. Undercut by 2–4 mm and to a depth of 25mm to create a dovetail to improve adhesion of patch repair.</p> <p>Where delamination is severe, the depth of the repair should be a minimum of 40mm depth to provide sufficient cover. The amount of material removed must however be minimised to ensure the area is not undermined structurally. Where reinforcement is exposed, refer to RB1A for the repair methodology.</p> <p>Carefully break out the remainder of the repair area, taking care not to bruise or damage the substrate using a sharp chisel or jack hammer held at a shallow angle. Remove any loose material and brush clean etc. The base of the cut-out area should be left rough to aid the key/adhesion of the repair material.</p> <p>Temporary structural support is to be provided for the duration of the repair where required, and designed by a suitably qualified engineer.</p> <p><b>Shutters &amp; Formwork &amp; Hand placed repairs</b></p> <p>Shuttering and formwork design will vary and is subject to the area under repair and should replicate the existing finish/profile/details. Shutters likely to be made from plywood to match the fair faced finish. Shutters to be sized according to repair area and butt jointed and sealed to the perimeter to prevent seepage. Insert a letterbox into the top of the formwork/shuttering for the concrete to be poured into. Coat the shuttering with a release agent or retarder as required prior to use. Additional fixings for formwork/shuttering to be avoided where possible.</p> <p>For hand placed repairs, once the repair area has been broken out, prime the repair area using a cement slurry, prior to application of the repair mortar.</p> <p><b>Implementing repair</b></p> <p>Wet the area, sufficiently to avoid the parent material absorbing all water, but do not over wet to avoid poor adhesion. In some instances, a bond coat may be beneficial. Pour the concrete mix (as per agreed sample) in batches through opening/letterbox to repair area and tamp/vibrate to eliminate air until the formwork is</p> |

| | | <p>completely filled and all air gaps eradicated. Ensure water content is minimised to prevent shrinkage. Allow to set before removing the shuttering. Curing time will be subject to environmental conditions and all repairs should be covered in damp blankets.</p> <p>For hand placed repairs, apply and build up the repair in layers.</p> <p><b>Surface finish</b></p> <p>Finishing will be subject to trials/sample areas. Finish to match adjacent/original surface finish, and cover with damp hessian/blankets to ensure sufficient hydration. Ensure access is retained to provide access until curing is complete.</p> <p>Reapply coatings as required and in accordance with manufacturer's instructions (coatings specification subject to trials and analysis).</p> <p><i>NOTE: In some instances, a precast unit may be deemed more appropriate. This is subject to further review and discussion, for example to the damaged concrete ventilation grilles to ground floor perimeter.</i></p> <p><i>NOTE: To painted soffits, it may be appropriate to use a proprietary repair mortar, subject to agreement with the architect, trials, and further discussion with the relevant stakeholders. Proprietary mortars to be installed in accordance with manufacturer's instructions, surface finish to match adjacent surface and to receive paint finish to match adjacent surfaces.</i></p> |

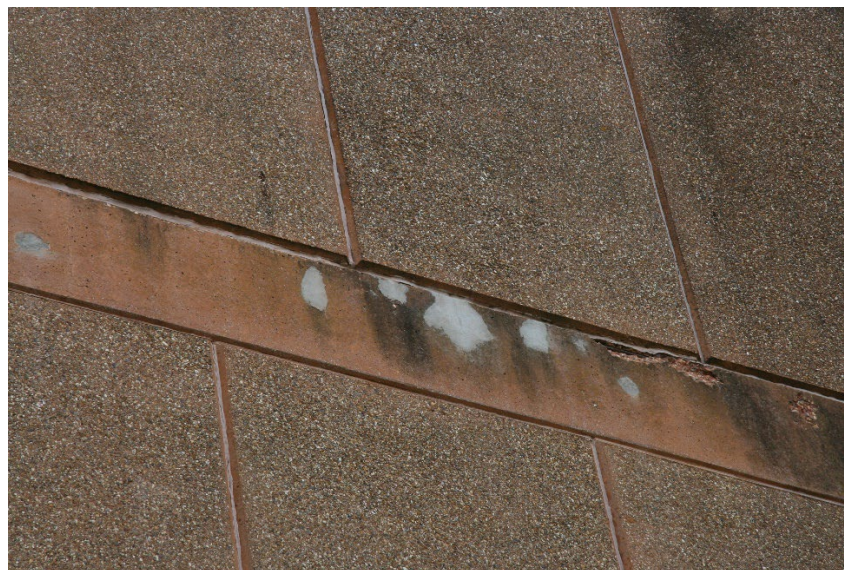
Following previous programmes of intrusive concrete investigations, core drilled holes, opening up and areas of cracked or spalling concrete were repaired using proprietary repair mortars. These repairs were noted to both the in-situ and pre-cast concrete elements. While a reasonable number of the repairs are performing adequately, they are a poor match in terms of texture, colour, profile and overall appearance and are visually jarring.

A sizeable proportion of repairs are failing with cracking and spalling which appears to be the result, at least in part, of continued corrosion of the steel reinforcements. The failing repairs will require cutting out and replacement to prevent further corrosion of the reinforcement and more extensive damage.

*Example of Defect Type C1*

Across the building, the poor previous repairs should be renewed with new in-situ concrete or hand-placed mortar repairs, designed to blend with the original concrete fabric.

| C – Previous Repairs | | |
|---|---|---|
| <b>C1</b><br><br><b>Poor previous repair</b> | <b>RC1A</b> | <p>Identify repair mortar from approved samples as closest match to parent material. Mask/protect adjacent surface to prevent dust, residue/smearing to adjacent concrete.</p> <p><b>Concrete breakout/Cutting Out</b></p> <p>The affected area is to be cut out back to sound substrate, removing all loose/defective material.</p> <p>Mark out damaged area. Extent and shape to be agreed with architect. Use a diamond core drill (diameter size dependent on size of repair areas) with drill guide to mark rounded corners of repair area to prevent spalling/damage to the adjacent fabric (sharp corners are to be avoided). Drill to a suitable depth to reach sound material. Follow by cutting along the edges of the repair area with a diamond blade to the internal angles of the corner. Undercut by 2-4 mm and to a depth of 25mm to create a dovetail to improve adhesion of patch repair.</p> |

| | | <p>Where delamination is severe, the depth of the repair should be a minimum of 40mm depth to provide sufficient cover. The amount of material removed must however be minimised to ensure the area is not undermined structurally. Where reinforcement is exposed, refer to RBIA for the repair methodology.</p> <p>Carefully break out the remainder of the repair area, taking care not to bruise or damage the substrate using a sharp chisel or jack hammer held at a shallow angle. Remove any loose material and brush clean etc. The base of the cut-out area should be left rough to aid the key/adhesion of the repair material.</p> <p>Temporary structural support is to be provided for the duration of the repair where required, and designed by a suitably qualified engineer.</p> <p><b>Shutters &amp; Formwork &amp; Hand placed repairs</b></p> <p>Shuttering and formwork design will vary and is subject to the area under repair and should replicate the existing finish/profile/details. Shutters likely to be made from plywood to match the fair faced finish. Shutters to be sized according to repair area and butt jointed and sealed to the perimeter to prevent seepage. Insert a letterbox into the top of the formwork/shuttering for the concrete to be poured into. Coat the shuttering with a release agent or retarder as required prior to use. Additional fixings for formwork/shuttering to be avoided where possible.</p> <p>For hand placed repairs, once the repair area has been broken out, prime the repair area using a cement slurry, prior to application of the repair mortar.</p> <p><b>Implementing repair</b></p> <p>Wet the area, sufficiently to avoid the parent material absorbing all water, but do not over wet to avoid poor adhesion. In some instances, a bond coat may be beneficial. Pour the concrete mix (as per agreed sample) in batches through opening/letterbox to repair area and tamp/vibrate to eliminate air until the formwork is completely filled and all air gaps eradicated. Ensure water content is minimised to prevent shrinkage. Allow to set before removing the shuttering. Curing time will be subject to environmental conditions and all repairs should be covered in damp blankets.</p> <p>For hand placed repairs, apply and build up the repair in layers.</p> <p><b>Surface finish</b></p> <p>Finishing will be subject to trials/sample areas. Finish to match adjacent/original surface finish, and cover with damp hessian/blankets to ensure sufficient hydration. Ensure access is retained to provide access until curing is complete.</p> |

| | | Reapply coatings as required and in accordance with manufacturer's instructions (coatings specification subject to trials and analysis). |

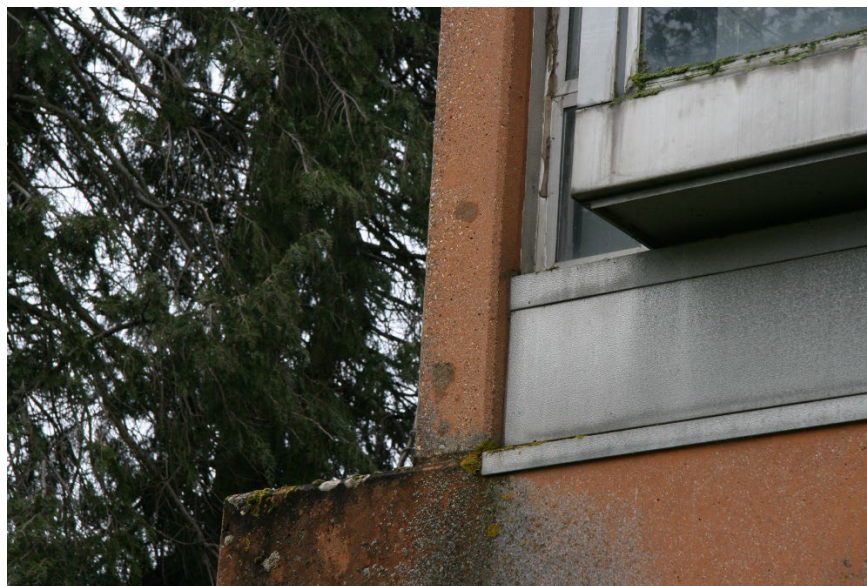
Across the building there are numerous small holes which have been filled with a mortar that matches reasonably closely to the structural components. Many of these filled holes are located in similar locations to the sides or tops of pre-cast panels and other pre-cast components and the mortar appears to fill threaded metal sockets cast into the components, presumably installed to facilitate transport and lifting. The sockets would have been filled as part of the original construction process. The mortar fills are not always a perfect colour match, but they are much better than more recent repairs and only require replacement if they are failing. Where the mortar has fallen out of the socket, there appears to be some light surface corrosion to the inside of the threaded socket. The extent of corrosion is unknown, but only a few loose or missing fills were noted and there were not obvious signs of cracking or spalling of the concrete components around the metal socket positions.

*Example of Defect Type C2*

Where the mortar fills are cracked, loose or missing they should be refilled to reduce the risk of corrosion and associated cracking and spalling. Where the socket is heavily corroding, and this is causing damage to the concrete panel a more extensive repair will be required involving the removal of the socket and an in-situ concrete or hand-placed mortar repair to fill the void. Further investigation will be required to establish the relationship of the socket.

| <p><b>C2</b></p> <p>Construction phase making good</p> | <p><b>RC2A</b></p> | <p>Do nothing, monitor through periodic inspection.</p> |
| | <p><b>RC2B</b></p> | <p>Identify repair mortar from approved samples as closest match to parent material. Mask/protect adjacent surface to prevent dust, residue/smearing to adjacent concrete.</p> <p><b>Concrete breakout/Cutting Out</b></p> <p>The affected area is to be cut out back to sound substrate, removing all loose/defective material.</p> <p>Mark out damaged area. Extent and shape to be agreed with architect. Use a diamond core drill (diameter size dependent on size of repair areas). Drill to a suitable depth to remove mortar fill.</p> <p>Remove any loose material and brush clean etc.</p> <p>Remove rust back to bare metal prior to application of mortar repair.</p> |

| | | <p><b>Shutters &amp; Formwork &amp; Hand placed repairs</b></p> <p>For hand placed repairs, once the repair area has been broken out, prime the repair area using a cement slurry, prior to application of the repair mortar.</p> <p><b>Implementing repair</b></p> <p>To outer concrete, wet the area, sufficiently to avoid the parent material absorbing all water, but do not over wet to avoid poor adhesion. In some instances, a bond coat may be beneficial.</p> <p>For hand placed repairs, apply and build up the repair in layers.</p> <p>Curing time will be subject to environmental conditions and all repairs should be covered in damp blankets.</p> <p><b>Surface finish</b></p> <p>Finishing will be subject to trials/sample areas. Finish to match adjacent/original surface finish, and cover with damp hessian/blankets to ensure sufficient hydration. Ensure access is retained to provide access until curing is complete.</p> <p><i>Note: where the socket is heavily corroding and this is causing damage to the concrete panel a more extensive repair will be required involving the removal of the socket and an in-situ concrete or hand-placed mortar repair to fill the void. Further investigation will be required to establish the relationship of the socket to the reinforcement and a Structural Engineer should be consulted.</i></p> |

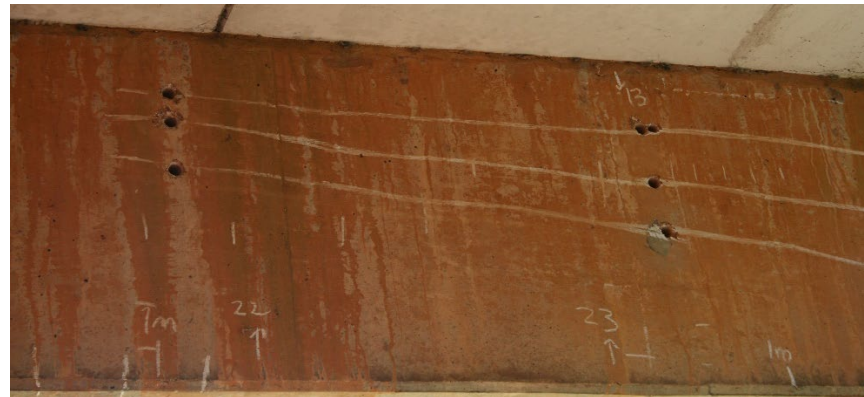
Over the past 10 years there have been a series of intrusive concrete investigations undertaken by CRL, under the supervision of the Structural Engineers at the time. The investigations have involved drilling holes, taking core samples, opening up works to inspect reinforcement and fixing details, hammer testing and various other intrusive investigations, undertake with the objective of understanding the composition and current condition of the concrete and reinforcements and to assess the extent and rate of deterioration since the previous investigations. The result has been the formation of numerous holed and openings in concrete components across the building. While the holes have generally been filled with proprietary mortars, at the time of the inspection, a new round of intrusive investigations were underway and a number of openings had been formed. It may be that these have subsequently been filled with proprietary repair mortars. In either case, the outline repair methodology for poor previous repairs should be applied.

*Example of Defect Type D3*

| D3 | RD3A | Identify repair mortar from approved samples as closest match to parent material. Mask/protect adjacent surface to prevent dust, residue/smearing to adjacent concrete. |
| Testing/investigation holes made by contractors | | <b>Concrete breakout/Cutting Out</b><br><br>The affected area is to be cut out back to sound substrate, removing all loose/defective material.<br><br>Mark out damaged area. Extent and shape to be agreed with architect. Use a diamond core drill (diameter size dependent on size of repair areas) with drill guide to mark rounded corners of repair area to prevent |

| | | <p>spalling/damage to the adjacent fabric (sharp corners are to be avoided). Drill to a suitable depth to reach sound material. Follow by cutting along the edges of the repair area with a diamond blade to the internal angles of the corner. Undercut by 2-4 mm and to a depth of 25mm to create a dovetail to improve adhesion of patch repair.</p> <p>Where delamination is severe, the depth of the repair should be a minimum of 40mm depth to provide sufficient cover. The amount of material removed must however be minimised to ensure the area is not undermined structurally. Where reinforcement is exposed, refer to RB1A for the repair methodology.</p> <p>Carefully break out the remainder of the repair area, taking care not to bruise or damage the substrate using a sharp chisel or jack hammer held at a shallow angle. Remove any loose material and brush clean etc. The base of the cut out area should be left rough to aid the key/adhesion of the repair material.</p> <p>Temporary structural support is to be provided for the duration of the repair where required and designed by a suitably qualified engineer.</p> <p><b>Shutters &amp; Formwork &amp; Hand placed repairs</b></p> <p>Shuttering and formwork design will vary and is subject to the area under repair and should replicate the existing finish/profile/details. Shutters likely to be made from plywood to match the fair faced finish. Shutters to be sized according to repair area and butt jointed and sealed to the perimeter to prevent seepage. Insert a letterbox into the top of the formwork/shuttering for the concrete to be poured into. Coat the shuttering with a release agent or retarder as required prior to use. Additional fixings for formwork/shuttering to be avoided where possible.</p> <p>For hand placed repairs, once the repair area has been broken out, prime the repair area using a cement slurry, prior to application of the repair mortar.</p> <p><b>Implementing repair</b></p> <p>Wet the area, sufficiently to avoid the parent material absorbing all water, but do not over wet to avoid poor adhesion. In some instances, a bond coat may be beneficial. Pour the concrete mix (as per agreed sample) in batches through opening/letterbox to repair area and tamp/vibrate to eliminate air until the formwork is completely filled and all air gaps eradicated. Ensure water content is minimised to prevent shrinkage. Allow to set before removing the shuttering. Curing time will be subject to environmental conditions and all repairs should be covered in damp blankets.</p> <p>For hand placed repairs, apply and build up the repair in layers.</p> <p><b>Surface finish</b></p> |

| | | <p>Finishing will be subject to trials/sample areas. Finish to match adjacent/original surface finish, and cover with damp hessian/blankets to ensure sufficient hydration. Ensure access is retained to provide access until curing is complete.</p> <p>Reapply coatings as required and in accordance with manufacturer's instructions (coatings specification subject to trials and analysis).</p> |

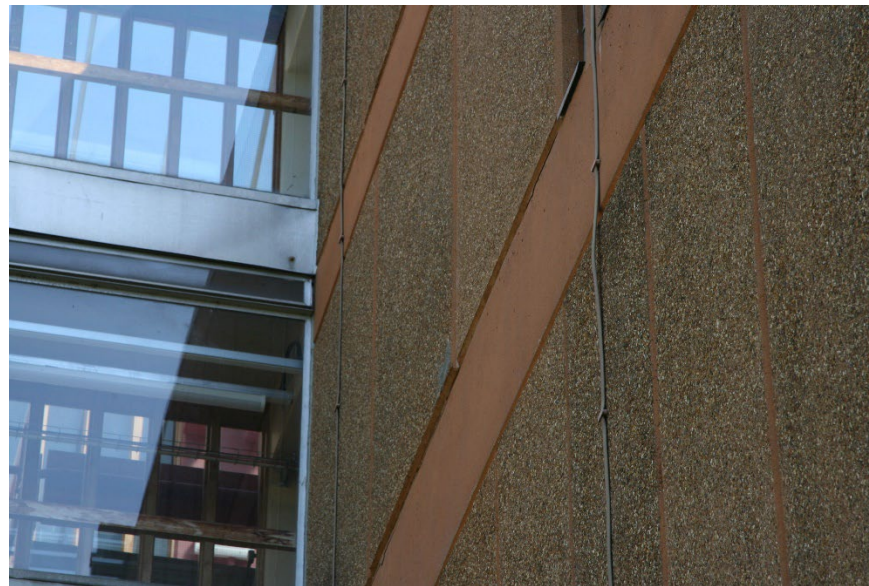
A number of pre-cast panels were noted to be out of plumb, either with the bottom edge appearing to have moved outwards beyond the concrete beam upon which it is supported, or with two adjacent panels moving outwards at their vertical meeting point. Previous intrusive investigations by CRL have established the nature of the pre-cast panel fixings. The bottom edge is secure by metal pins fixed into the bottom of the panels which are located and grouted into a channel on the top edge of the concrete beam and the top corners are secured by angle brackets. Investigations have shown that some of the pins are not securely grouted and this could be the cause of movement to the panels. It is also possible that outward movement of the bottom of the panels has caused the disturbance noted elsewhere to the top edge of the beams.

*Example of Defect Type EI*

The Structural Engineer will review and advise on whether the extent of displacement requires the full replacement of any of the pre-cast panels. Replacement should be on the basis of like-for-like replacement with regard to form, colour, aggregate, and finish.

| E – Concrete out of plumb | | |
|---|---|---|
| <b>EI</b><br><b>Concrete out of plumb.</b> | <b>REIA</b> | Consult structural engineer to ascertain soundness of structure; remedial works according to structural engineer advice on underlying structure to be carried out, with appropriate repair type to be carried out subsequently (e.g. reinstatement of loose concrete, new precast unit etc). |

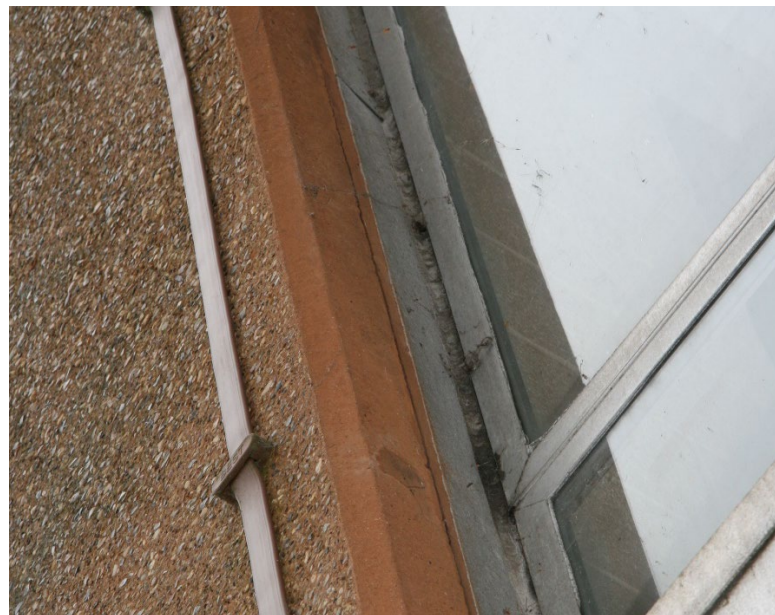
Where mortar joints are visible between concrete components or between concrete components and windows many of these are cracked and loose. In a number of locations mortar is missing from joints altogether. Open and missing joints can allow water to penetrate the fabric/structure with the risk of damage and decay to adjacent fabric. This could be observed where water has tracked in above beam ends and has caused dampness and spalling to the adjacent soffits although it is not clear without close inspection whether this is due to defective mortar or mastic joints, or the absence of weatherings altogether. The defective mortar should be raked out and the joints repointed in a suitable mortar.

Example of Defect Type K1

| K – Mortar | | |
|---|---|---|
| <b>K1</b><br>Missing or damaged mortar | <b>RK1A</b> | Rake out and remove loose/defective material. Brush clean. If necessary, hand grout to solid fill the joint to appropriate depth for pointing. Repoint in mortar to the approved mix / specification (TBC). |
